Table S.2.4.1.3 General Characteristics of Proposed Dam and Intake Site (4/18)

Table S.2.4.1.3 General Characteristics of Proposed Dam and Intake Site (5/18)

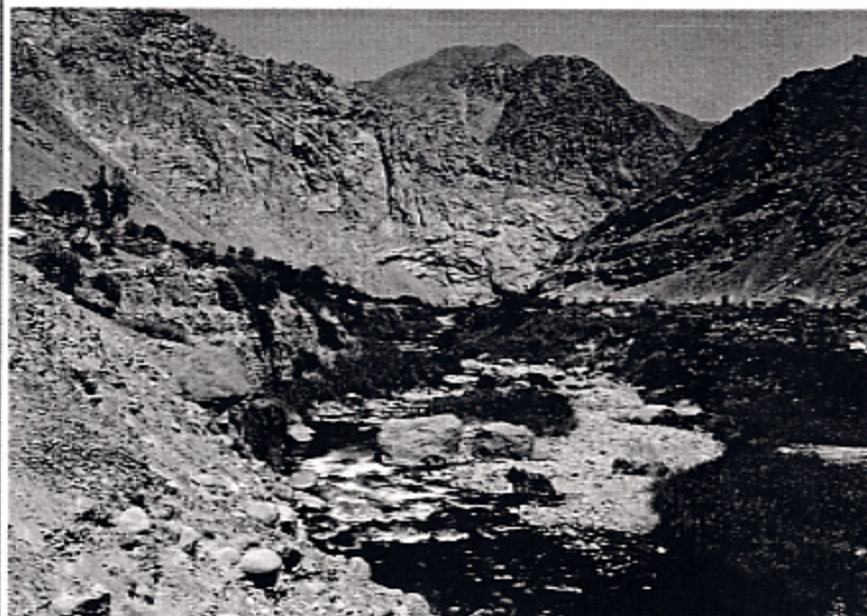
Negative No. 16-1

Site	San Jerónimo I		Department : Lima	Province : Yauyos	District : Caca	River : Cañete			
Topography	Riverbed width	Approximately 85meters including terrace in the left bank.					Dam site	a. Narrow valley is suitable for dam site. b. Granitic bedrocks show some open fractures and joints which can be treated by grouting works.	
	Characters	V-shaped valley with both abutments ranging in angle from 40° to 50° from horizontal. Rocky slope in the right abutment and terrace/ talus deposits in the left margin.							
Schematic section	<p>Qh-td: Talus deposit Qh-ac: Alluvial deposit Qp-td: Terrace deposit Qp-of: Old fluvial deposit KT-1: Andean Batholith</p>						Reservoir	Wide distribution of terrace and talus deposits in both slopes.	
								Evaluation	Topographic and geological condition is relatively favorable, but the thickness and physical properties shall be evaluated for overlying deposit in the site.

Remarks	Talus deposit colluvial type is distributed in large scale behind a proposed dam axes in the right abutment.

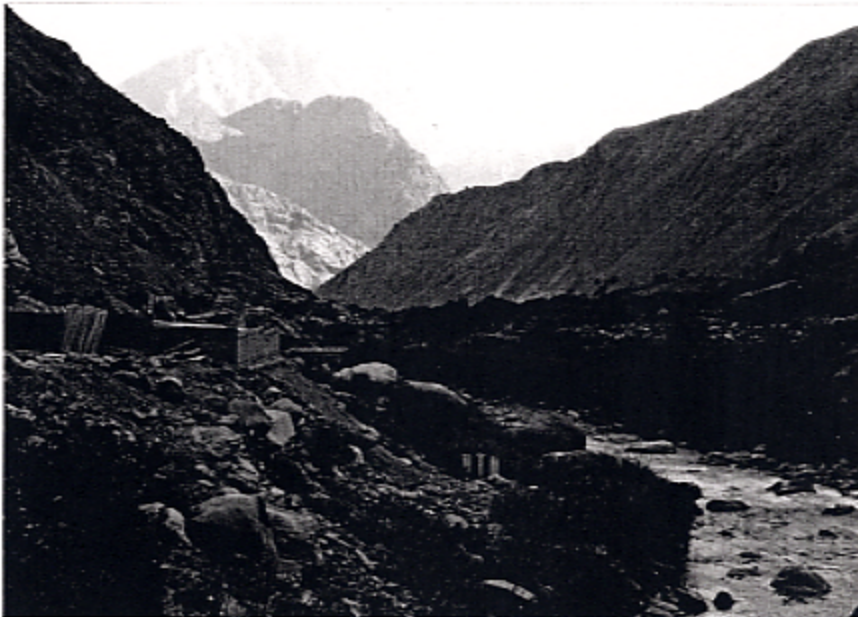
Negative No.1-29

Evaluation		Dam construction is not recommendable due to wide valley and possible thick talus deposits on the right abutment.
Geology	Geology of Basement		Left bank		River bed		Right bank		Issues						
			Lower Tertiary		Lower Tertiary		Lower Tertiary								
			Tantarà Formation		Tantarà Formation		Tantarà Formation								
			Dacitic lava and partially andesitic breccias		Dacitic lava and partially andesitic breccias		Dacitic lava and partially andesitic breccias

Fractures in parallel with flow structure.		Massive		Fracturing								
			No present		No present		No present								
			Slight rusty-weathering along the fracture.		No present		Slight rusty-weathering along the fracture.								
	Overlying Sediment		Some rock fragments		Present fluvial deposit in small scale		Terrace deposit and talus deposit on the slope in large scale.								
	Landslide and/or Failure		No present		No present		Slide of unstable talus deposit								
	Remarks		Terrace and talus deposits are distributed widely in the right abutment. The later deposit shows unstable aspect.
