Table S.2.4.1.3 General Characteristics of Proposed Dam and Intake Site (8/18)

Site		Santo Domingo	Department : Lima	Province : Yauyos	District : Putinza	River : Cañete	
Topography	Riverbed width	Approximately 20 meters including flood plain					
	Characters	Narrow V-shaped valley between left rocky wall about 40° in angle and spur covered by soft sediments in the right abutment.					
Schematic section

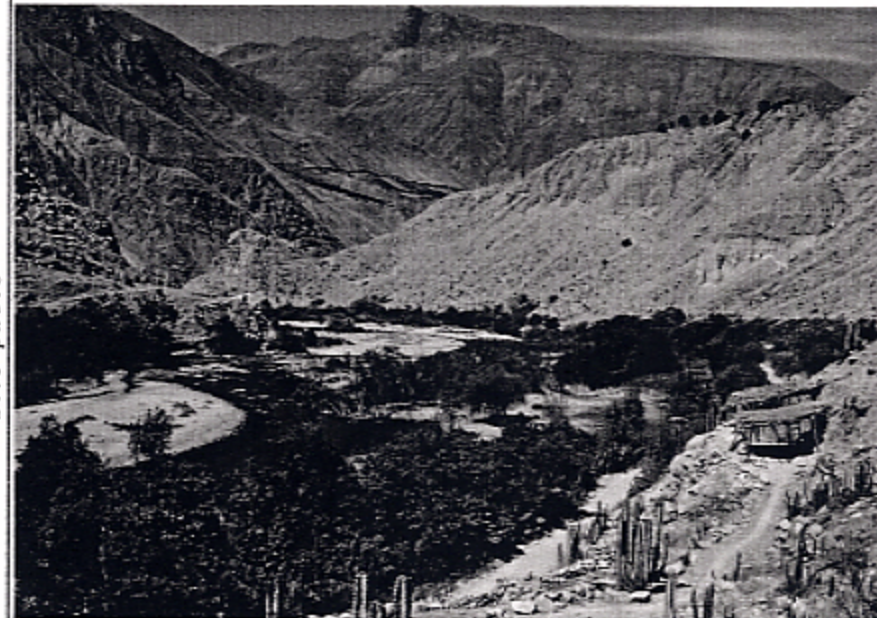
Negative No 3-10

Qh-pf: Present fluvial deposit Qh-td: Talus deposit Qp-of: Old fluvial deposit KT-i: Andean Batholith					
		It is not feasible to construct a dam due to geological problems above mentioned.					
Geology	Geology of Basement	Left bank		River bed		Right bank

u. Cretaceous~I. Tertiary		u. Cretaceous~I. Tertiary		u. Cretaceous~I. Tertiary	
		Andean Batholith		Andean Batholith		Andean Batholith	
		Granodiorite		Granodiorite		Granodiorite	
	Condition of Base-ment	Fault	Some seams in steep angle		No mayor fault is present.		No mayor fault is present.
		Fracture	Normally fractured		No detected		Many fractures of semi-vertical and gentle dip
		Alteration	No present		No detected		No present
		Weathering	Slight rusty-weathering along the fracture.		No detected		Slight rusty-weathering along the fracture.
	Overlying Sediment	Talus deposit colluvial type is distributed wide and unstably.		Present fluvial deposit		Old fluvial deposit and talus deposit overlay the rocky spur.	
	Landslide and/or	Slide of unstable talus deposit in small scale.		No present			
Remarks	Large amount of old fluvial deposit is identified along ancient river channel in the right abutment.

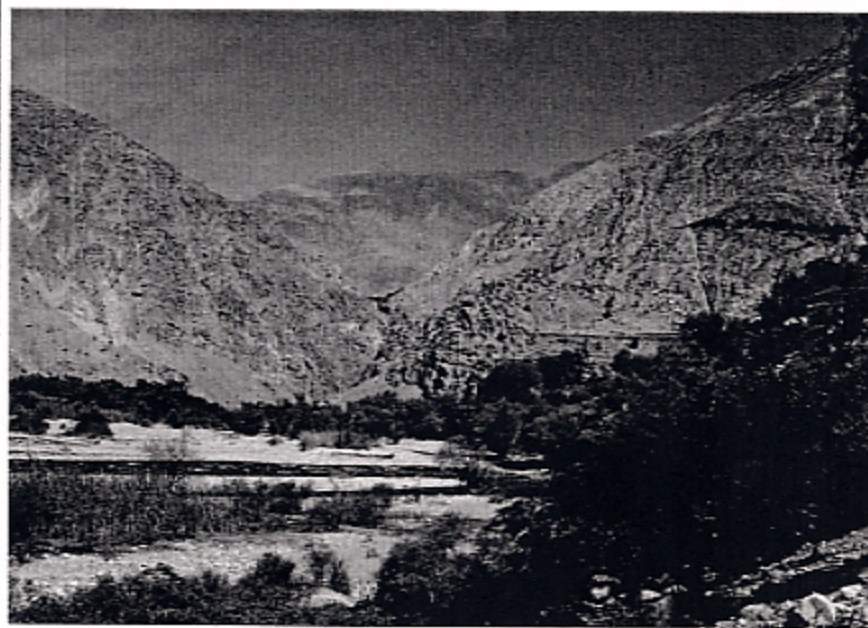
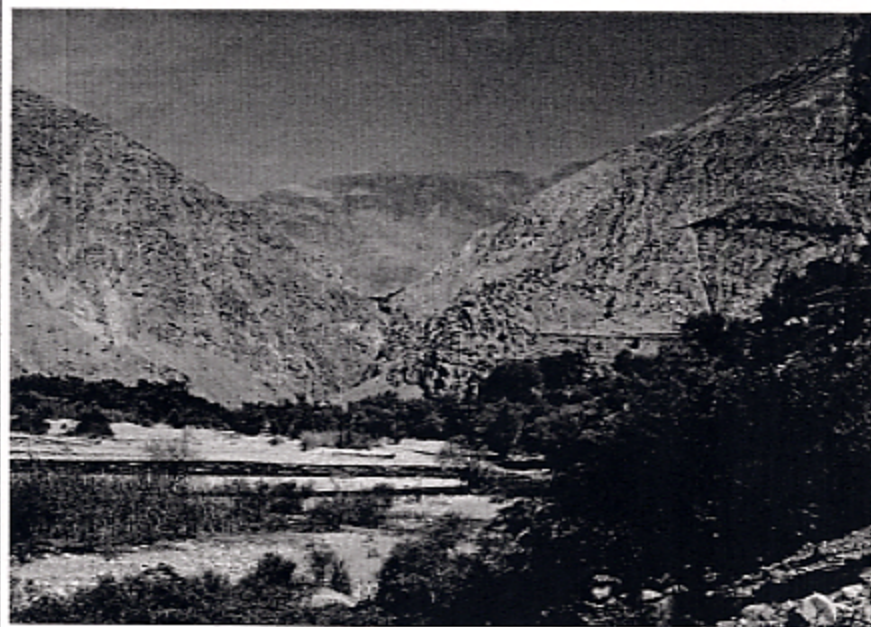
Site	Calachota	Department : Lima	Province : Yauyos	District : Putinza	River : Cañete			
Topography	Riverbed width	Approximately 20 meters included flood plain				Dam site	a. Old fluvial and talus deposits overlay on the granitic basement in the upper part of the right abutment.	
	Characters	Narrow valley between both rocky spurs.					b. Large amount of talus deposit is distributed immediately upstream from the narrow section of the left abutment.	
Schematic section

Reservoir	Topography of the wide valley is suitable, but large-scaled slope failure is distributed on the left side.	
						Evaluation	It is not feasible to construct a dam due to geological defects.	
Geology	Geology of Basement	Left bank		River bed		Right bank		Issues

Fracture	Normally fractured		No detected			
		Alteration	No present		No detected			
		Weathering	Slight rusty-weathering along the fracture. Partially fragile.		No detected			
	Overlying Sediment	Talus deposit colluvial type on the slope		Present fluvial deposit		No-consolidated deposit overlay 30m upward from the riverbed.		
	Landslide and/or Failure	Slide of unstable talus deposit along concaved alignment in small scale.		No present		No present		
	Remarks	Old river channel is located along break-line of right abutment and filled by fluvial and talus materiales.
