Table S.2.4.1.3 General Characteristics of Proposed Dam and Intake Site (10/18)

Table S.2.4.1.3 General Characteristics of Proposed Dam and Intake Site (11/18)

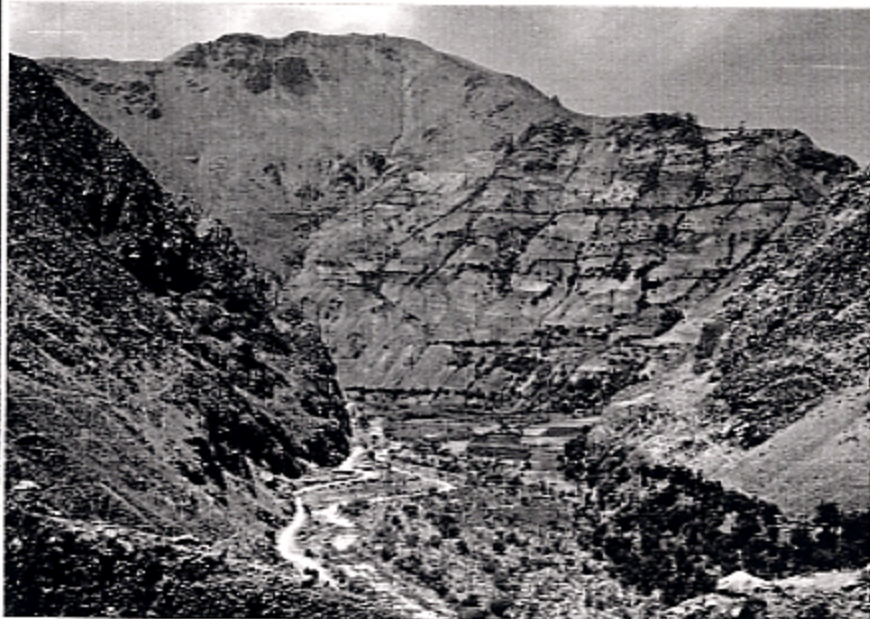
Negative No.17-34

Site	Auco	Department : Lima	Province : Yauyos	District : Colonia	River : Cañete			
Topography	Riverbed width	Approximately 150 meters including alluvial plain.				Dam site	a. Granitic abutment shows appropriate characters in both abutments. b. Soft deposits on the slope will be removed due to the thin..	
	Characters	V-shaped valley between high granitic abutments 60-70° in angle. The valley is varied by fluvial and alluvial deposit.						
Schematic section	EL

Reservoir	a. The valley shows wide and gentle gradient of longitudinal riverbed. b. Unstable deposits are distributed in small portion.	
		Qh-pf: Present fluvial deposit Qh-ad: Alluvial deposit (cone) Qh-td: Talus deposit Qp-of: Old fluvial deposit KT-i: Andean Batholith						
Geology	Geology of Basement	Left bank		River bed		Right bank	Issues	From topographic point of view, this site is suitable for dam site. Some countermeasures against alluviums coming from the Pampa ravine should be required. Grasping of the thickness and mechanic characteristics of the fluvial, alluvial and fluvio-glacial deposit. Study on slope stability and sedimentation in the Pampa ravine.

u. Cretaceous~l. Tertiary		u. Cretaceous~l. Tertiary		u. Cretaceous~l. Tertiary		
		Andean Batholith		Andean Batholith		Andean Batholith		
		Granodiorite, diorite		Granodiorite, diorite		Granodiorite, diorite		
	(hard, leucocratic and rock forming mineral in medium size)							
	Condition of Base-ment	Fault	No mayor fault is present.		No mayor fault is present.		No mayor fault is present.	
		Fracture	Semi-vertical joints sometimes open		No detected		Joints of different angle	
		Alteration	No present		No detected		No present	
		Weathering	Slight rusty-weathering along the fracture.		No present		Slight weathering	
	Overlying Sediment	Overlying bands composed of lod fluvial, talus and fluvio-glacial deposits on the slope.		Alluvial cone (alluvium) deposit		Small talus deposit in the concavity		
	Landslide and/or Failure	No present		No present		No present		
	Remarks	Alluviums have occurred through the Pampa ravine, which is located approximately 500 meters upstream from the proposed dam axis, on March 30 and April 2, 1972. This phenomenon caused many damages. The alluviums have been originated by slope failure of the Mt. Huamanripa.

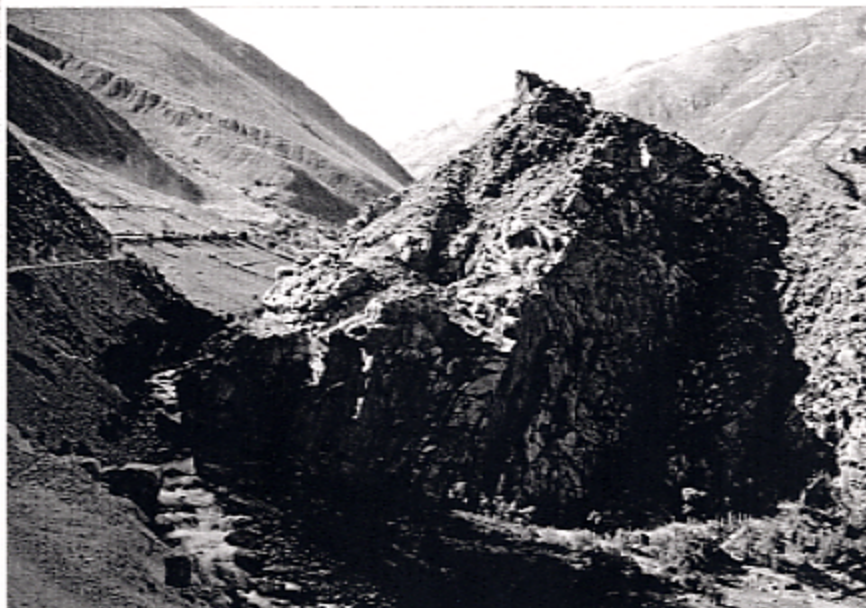
Negative No.3-28

Site	Churchura	Department : Lima	Province : Yauyos	District : Colonia	River : Cañete			
Topography	Riverbed width	Approximately 10 meters				Dam site	a. Many open parallel joints may cause a problem of permeability. b. Thick accumulation of talus deposit in the right slope.	
	Characters	Narrow V-shaped valley between rocky wall in the left abutment and steep slope in the right abutment.						
Schematic section

Reservoir	a. The valley shows wide and gentle slopes covered by little unstable deposits. b. Linear distribution of the fluvio-glacial deposit may be old river channel alignment.	
							Evaluation	From technical point of view, it's not feasible to construct a dam due to many open joints, wide distribution of unstable deposits and presence of alluvial cone.
Geology	Geology of Basement	Left bank	River bed	Right bank	Issues

u. Cretaceous~l. Tertiary	u. Cretaceous~l. Tertiary	u. Cretaceous~l. Tertiary				
		Andean Batholith Granodiorite, granite	Andean Batholith Granodiorite, granite	Andean Batholith Granodiorite, granite				
	Condition of Basement	Fault	No mayor fault is present.	No mayor fault is present.	Site photo			
		Fracture	Open parallel joints trend west-east and dips almost vertical.	No detected		Fractured		
		Alteration	No present	No present		No present		
		Weathering	Slight rusty-weathering along the fracture.	No present		No present		
	Overlying Sediment	Fluvio-glacial and/or glacial deposits overlay behind the granitic hill side.	Present fluvial deposit	Wide distribution of talus deposit of colluvial type				
	Landslide and/or Failure	No present	No present	Sliding of unstable talus deposit				
	Remarks	Exist many gully erosion in the fluvio-glacial deposit in the left slope. Alluvial cone is distributed in the rivermouth of a tributary located immediately upstream from the proposed dam in the left margin.
