Table S.2.4.1.3 General Characteristics of Proposed Dam and Intake Site (12/18)

Table S.2.4.1.3 General Characteristics of Proposed Dam and Intake Site (13/18)

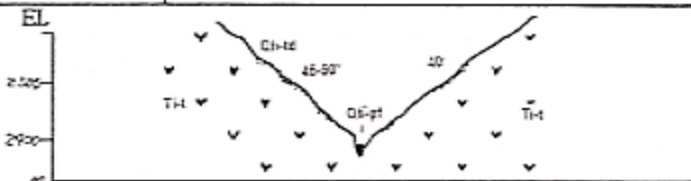
Site		Humuachaca		Department : Lima		Province : Yauyos		District : Yauyos		River : Cañete	
Topography	Riverbed width	Approximately 20 meters									
	Characters	Narrow V-shaped valley between steep rocky slopes generally 40° in angle and 80° in the base of the left margin.									
Schematic section

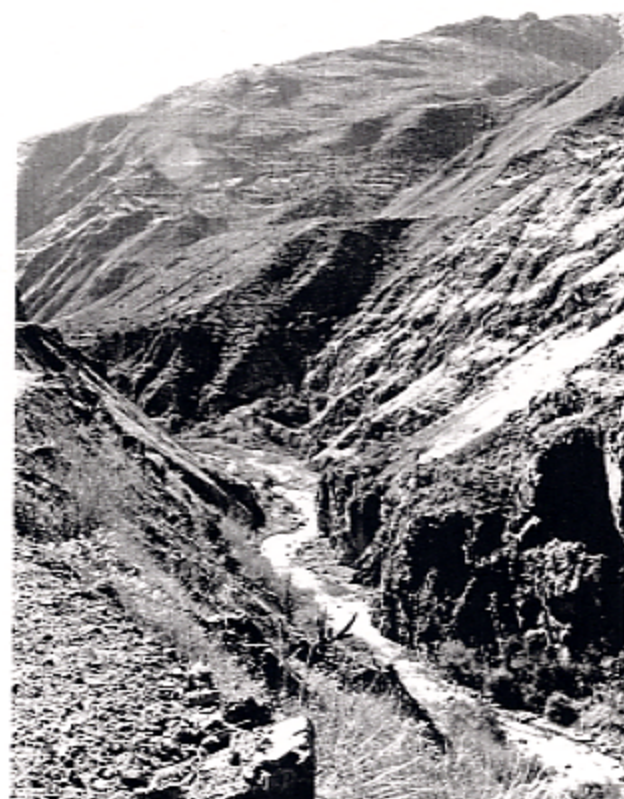
Site photo											
Negative No 6-1

<p>Qh-pf: Present fluvial deposit Qh-ld: Talus deposit Ti-t: Tantarà Formation</p>										
Geology	Geology of Basement		Left bank		River bed		Right bank		Issues	Study on the permeability of basement and countermeasure against alluvial cone from the tributary.	
			Lower Tertiary		Lower Tertiary		Lower Tertiary				
			Tantarà Formation		Tantarà Formation		Tantarà Formation				
			Andesitic lava (partially basaltic)		Andesitic lava (partially basaltic)		Andesitic lava (partially basaltic)				
	Condition of Base-ment	Fault	No detected		No detected		A sheared fault strikes N40° W and dips 75° to SW

Fracture	Many irregular fractures in the surface		Many irregular fractures in the surface		Many irregular fractures in the surface				
		Alteration	Slight alteration		Slight alteration		Crystallization of quarzo and epidote along the fractures.				
		Weathering	Slight weathering		Slight weathering		Slight weathering				
	Overlying Sediment		Small talus deposit of colluvial type on the concavity of slope		Present fluvial deposit consided of principally boulders		Thin talus deposit of colluvial type				
	Landslide and/or Failure		No present		No present		No present				
Remarks		Small tributary is present close to the proposed dam site, which shows an alluvial cone in the rivermouth.

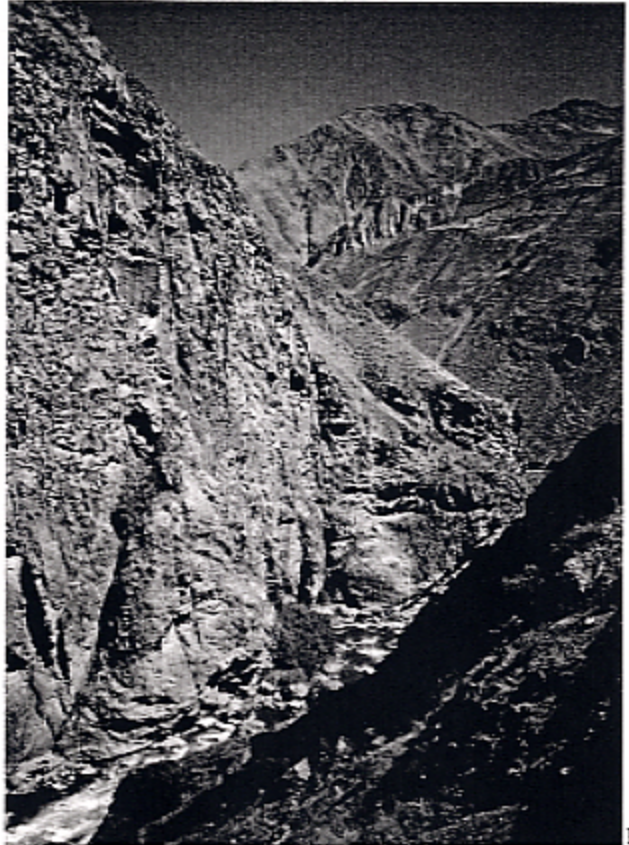
Negative No.7-4

<p>Qh-pf: Present fluvial deposit Qh-td: Talus deposit Qp-fg: Fluvio-glacial deposit Ti-t: Tantarà Formation KT-i: Andean Batholith</p>					Reservoir	The valley is narrow between both steep slopes overlaid by talus deposits.
						Evaluation	a. Topographic and geological conditions are suitable for a high dam. b. The storage capacity will be limited due to narrow valley.
Geology	Geology of Basement		Left bank	River bed	Right bank	Issues	Study on permeability of the basement and distribution of fluvio-glacial deposit will be important.

Landslide and/or Failure		No present	No present	No present		
Remarks		Numerous semi-vertical fractures are concentrically distributed upstream from the proposed dam in the left abutment. Thick fluvio-glacial deposit overlays on the basement in large scale.
