Table S.2.4.1.3 General Characteristics of Proposed Dam and Intake Site (16/18)

Table S.2.4.1.3 General Characteristics of Proposed Dam and Intake Site (17/18)

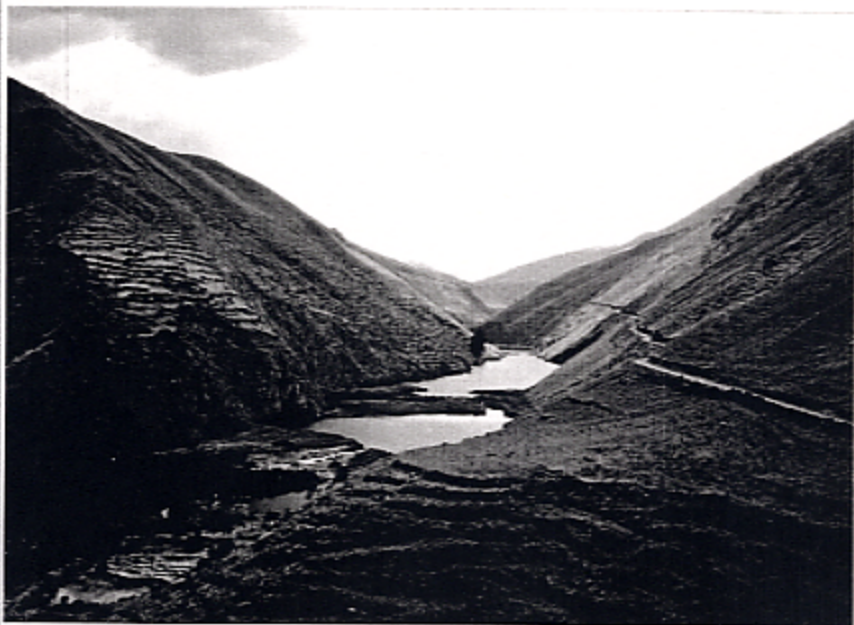
Negative No 4-26

Site	Pampa	Department : Lima	Province : Yauyos	District : Vitis	River : Cañete			
Topography	Riverbed width	Approximately 150 meters				Dam site	Right abutment and riverbed are consist of porous limestone which may bring about large leakage problems.	
	Characters	Glacial eroded valley between gentle slopes 30-35° in grade.						
Schematic section

Reservoir	Glacial till is distributed widely around the reservoir, so the sedimentation in the reservoir is advancing rapidly.	
						Evaluation	Topographic and geological aspects are not feasible to construct a dam.	
						Issues		
Geology	Geology of Basement	Left bank		River bed		Right bank		
		Upper Cretaceous~Lower Tertia		Upper Cretaceous		Upper Cretaceous		
		Andean Batholith		Celendin Formation		Celendin Formation		
		Granodiorite		Limestone and marl with in alternating bed of siliceous shale		Limestone and marl with in alternating bed of siliceous shale

Condition of Base-ment	Fault	Notorious faults are not present		Notorious faults are not present		Notorious faults are not present	
		Fracture	Fractured		Irregular fractures are present.		Many irregular fractures are present	
		Alteration	No present		No present		No present	
		Weathering	Ordinarily weathering showing partially fragile parts		Advanced weathering and water erosive action.		Slight weathering	
	Overlying Sediment	Glacial till		Partially glacial deposit		Glacial till		
	Landslide and/or Failure	No present		No present		Small slope failures are distributed sporadically on the slope.		
Remarks	Geomorpholgy is made up by glacial erosion, transportation and accumulation. Natural dyke shows many concaved features composing of porous limestone outcrops.

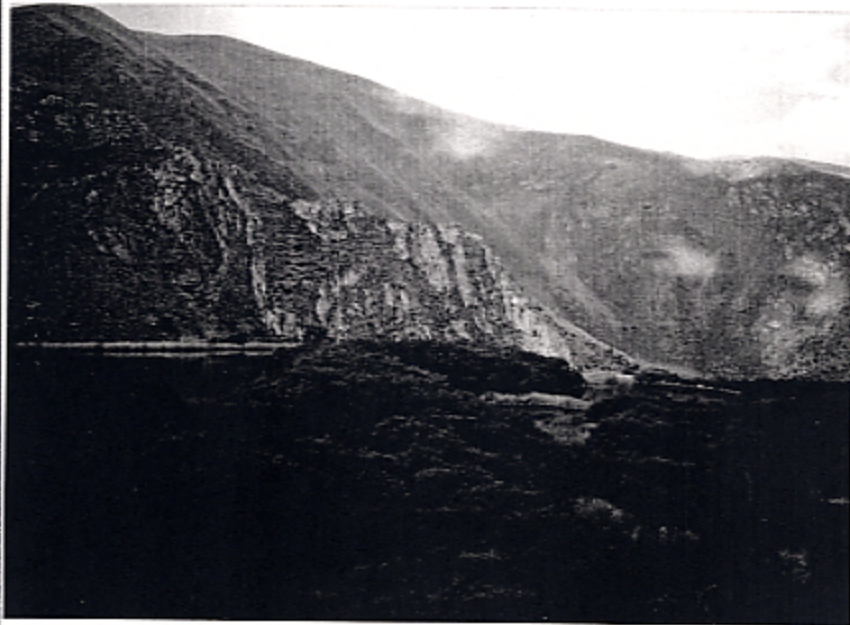
Negative No. 12-F

Site	Huachacara	Department : Lima	Province : Yauyos	District : Huancaya	River : Cañete		
Topography	Riverbed width	Approximately 400 meters				Dam site	a. Wide valley composing of principally porous limestone is not appropriate to construct a dam from engineering and economical points of view.
	Characters	Wide valley in the outlet of Papacocha lake. Fluvio-glacial deposits are accumulated widely on the calcareous basement of the riverbed.					
Schematic section

Reservoir	Dimension of the Papacocha Lake is large between ordinally sloped abutments.
	Qh-pf: Present fluvial deposit Qp-fg: Fluvio-glacial deposit KsTi-c: Casapalca Formation Ks-c: Celendin Formation						
Geology	Geology of Basement		Left bank	River bed	Right bank	Site photo

Condition of Basement	Fault	No major fault is present	No major fault is present	No major fault is present		
		Fracture	Many fractures in parallel to bedding which strikes E-W and dips 60°S.	No detected	Irregular fractures with fine calcite veins.		
		Alteration	No present	No present	No present		
		Weathering	Slight rusty-weathering along the fracture	Deeply weathering	Slightly weathering		
	Overlying Sediment		No present	Fluvio and fluvio-glacial deposits	Fluvio glacial deposit 2 meters in thickness.		
	Landslide and/or Failure		No present	No present	No present		
	Remarks		Many terraced platforms are covered by fluvial and fluvio-glacial deposits and dense vegetation in the outlet of lake. River channel is widely dispersed in the riverbed. Wide swampy area is located in the downstream from the proposed dam site.
