No. 37 Trang Bridge – Component A -

(Binh Thuan Province)

No. 43 Tam Ngan Bridge – Component A -

No. 46 Tan Van Bridge -Component A-

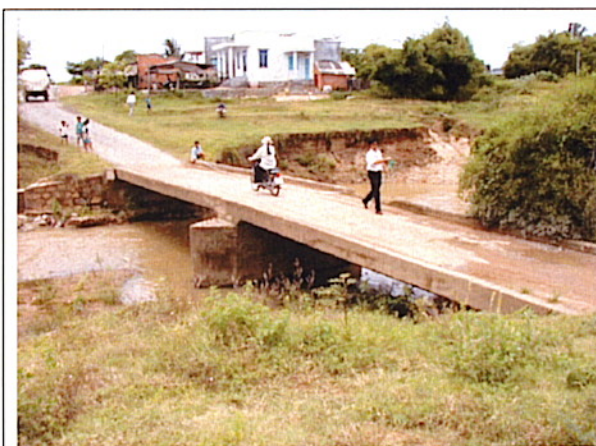
Photo 1: Existing Bridge

<p>Site Information</p>
<p>1) Since the district road, which this bridge is located on, accesses from NR1 to the district center of Ham Thuan Bac, this road is important for the surrounding people to carry agricultural production such as sugarcane and dragon fruit and of daily life.</p>
<p>2) The existing bridge was built before 1975. The damage level of H-beams is observed to be low at the moment although corrosion of the beams has been making progress. In addition, scouring around a pier and abutment was observed. The load of vehicles is limited to 5 ton.</p>
<p>3) Flood occurred in 1983, 1984, 1999 and 2000. HWL is assumed to be 3.0m over the bridge surface in 1999 according to the interview result. Although the flood level in 1984 was higher than it, it became lower after completion of the reservoir at upstream side. The river winds its way and the river banks are significantly eroded by previous flooding.</p>

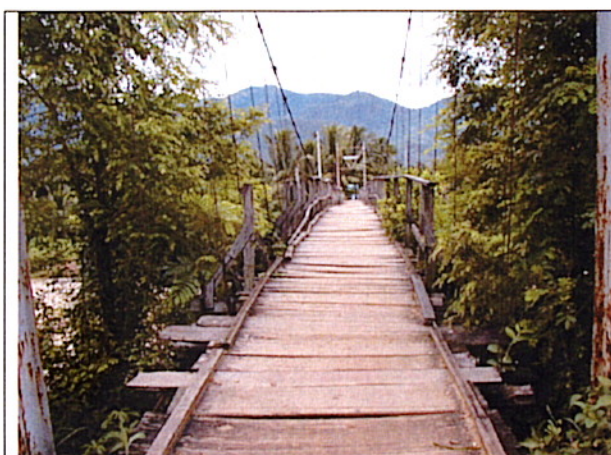
Photo 1: Existing Bridge

2) The existing bridge is a suspension type for pedestrian constructed in 1992. The heavy vehicles cross the river only in dry season. Damages are observed on the deck of the bridge

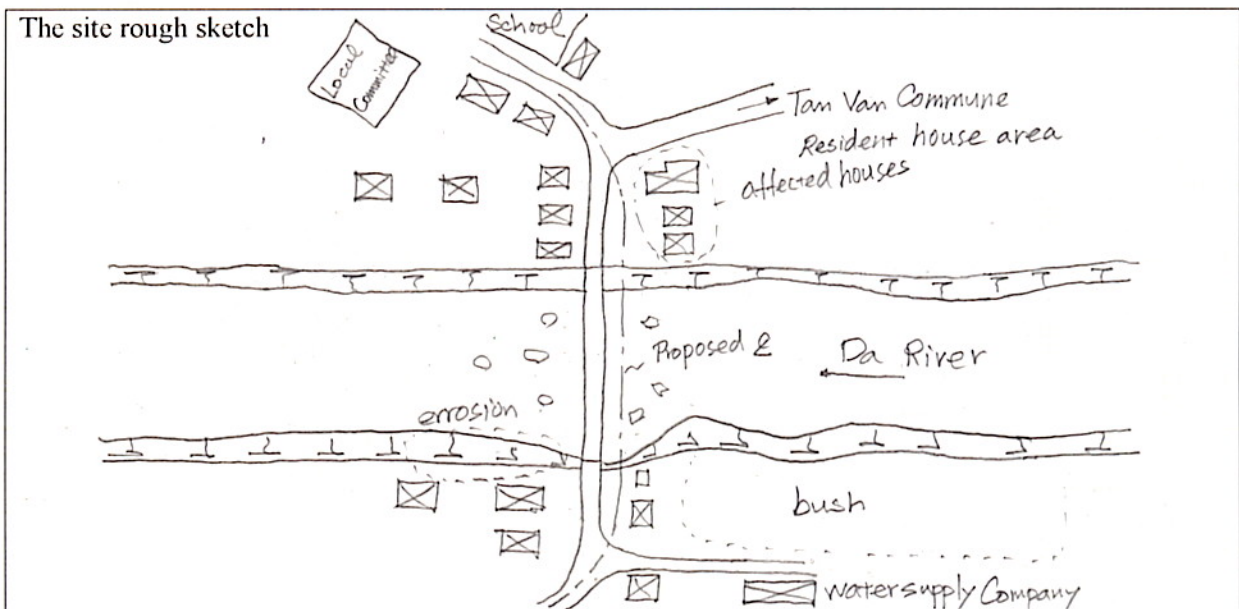
The site rough sketch

- 6) The centerline of the new bridge will be set at around 15m upstream of the existing one. The bridge length is required to be little longer, 78m with 3 spans. 1.0 m of freeboard is required.

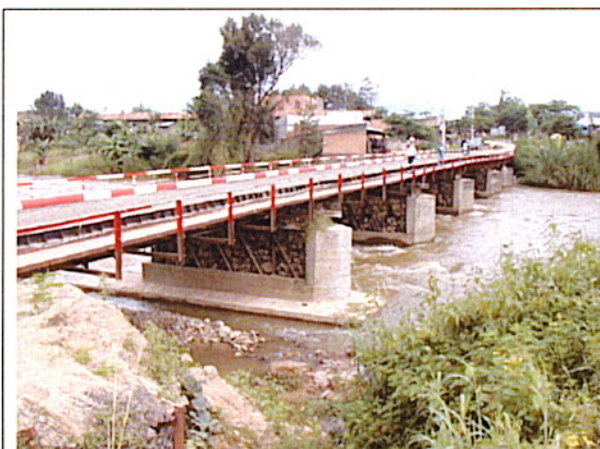
Photo 1: Existing Bridge

- 2) The existing bridge is a H-beam type and its substructure is composed of RC and gabion mattresses constructed in 1978. The flood in 2000 swept A1 abutment away and cause the collapse of the first span. It took three weeks to repair it and the steel-meshed slab was applied instead of the wooden one. Although corrosion on the H-beams is making progress, serious damages are not observed. The load of a vehicle is limited to 13 ton.
