## MASASI, MTWARA REGION

Village Name : *Namkungwi*

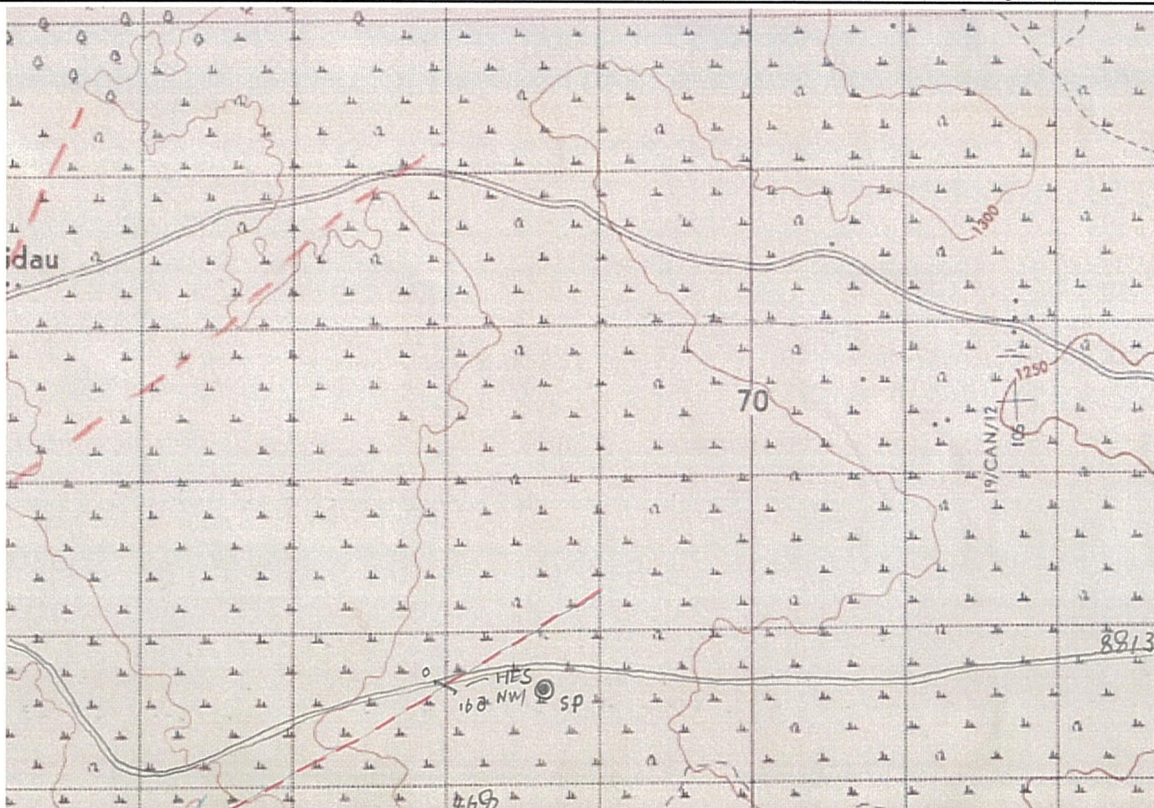
Vertical Electric Survey Result Value range - Sequence -  
Horizontal Electric Survey Result *HES P+160*

Comments  
*HES 1 (468 006 E May hit clear water.  
8812 667 N 414*

Remarks *Rain collector, dug wells.*
