THE GOVERNMENT OF THE PHILIPPINES
THE DEPARTMENT OF PUBLIC WORKS AND HIGHWAYS

**The Study on Sabo and Flood Control for
Western River Basins of Mount Pinatubo in the
Republic of the Philippines**

JAPAN INTERNATIONAL COOPERATION AGENCY

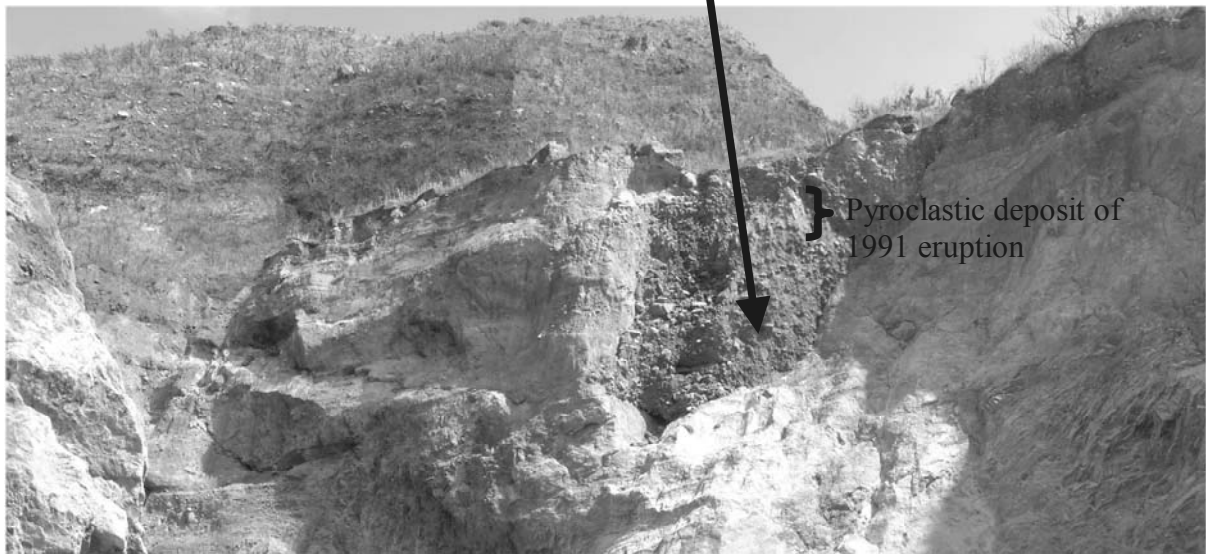
Figure 2.4.6

New fluvio- lacustrine deposit

**Condition of Cliff and Cave at the
Downstream of the Notch after Breach**

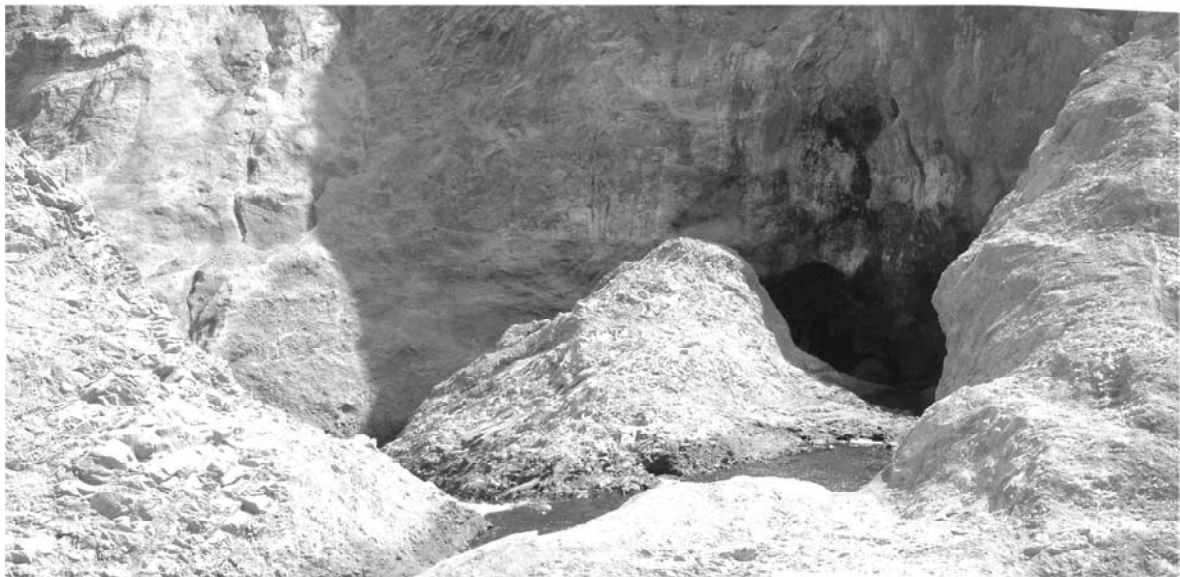
The existing cave about 100 m downstream from the Notch

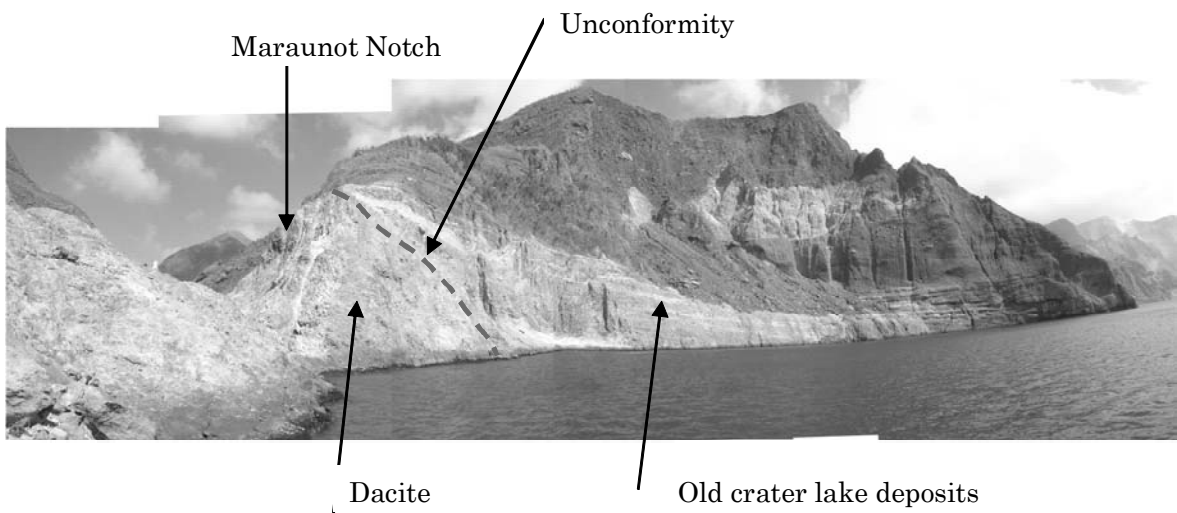
Figure 2.4.14

The view of Crater Lake Side of Ridge of Maraunot Notch

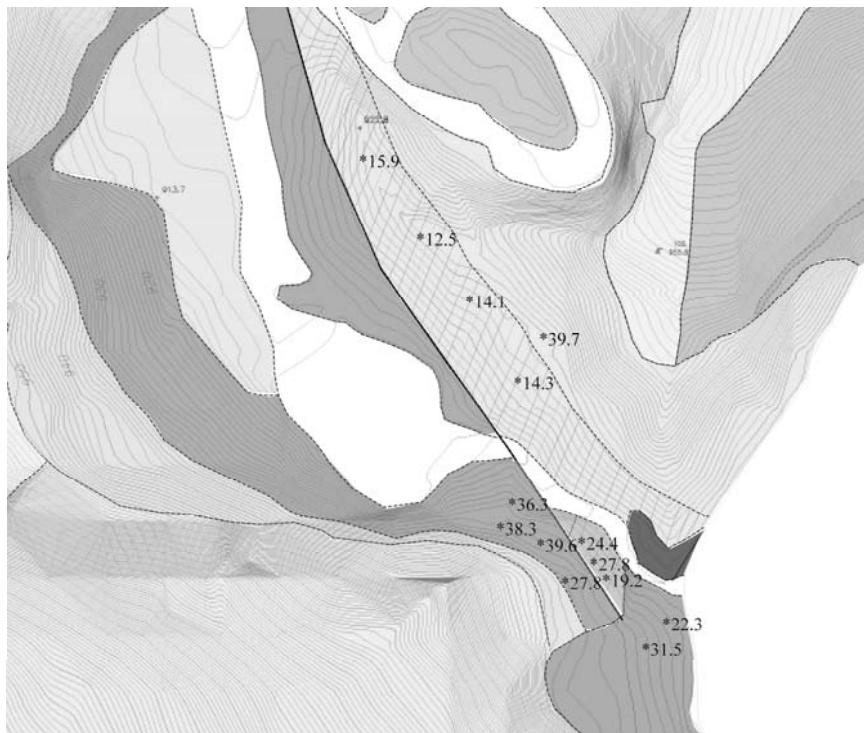
Result of Schmidt Hammer Test
