## SECTOR H

### RIVER CONDITIONS, FLOODING AND INUNDATION

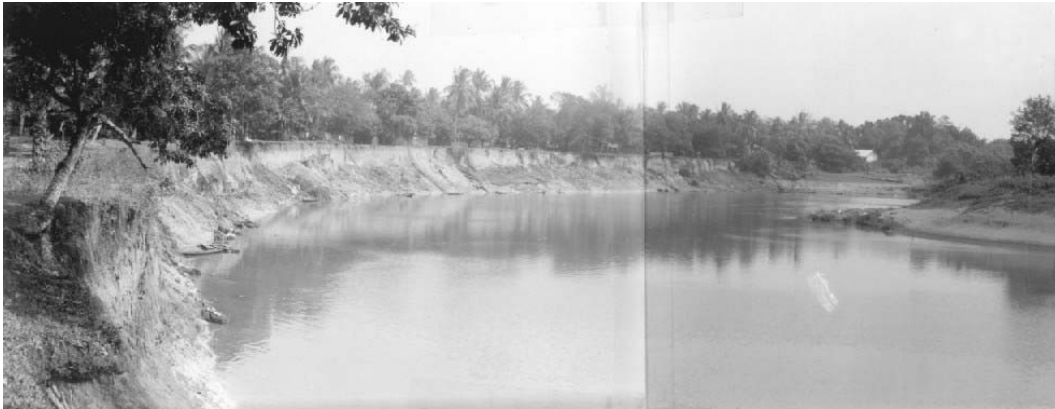
Bank erosion is shown in **Photo H1.2.1** and **Photo H1.2.2**.

**Photo H1.2.1 Bank Erosion at Concave of River**

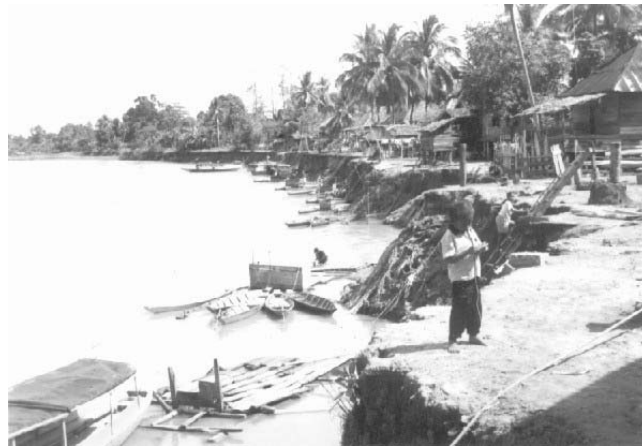
**Photo H1.2.2 Bank Erosion at River Side Village**

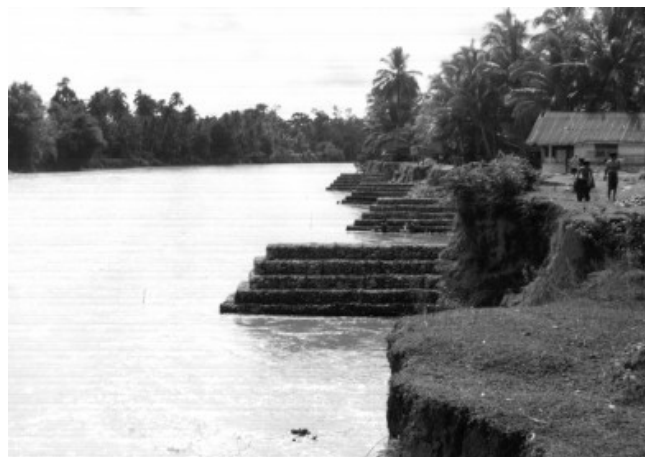
**Photo H2.2.1 Typical Gabion Jetty**

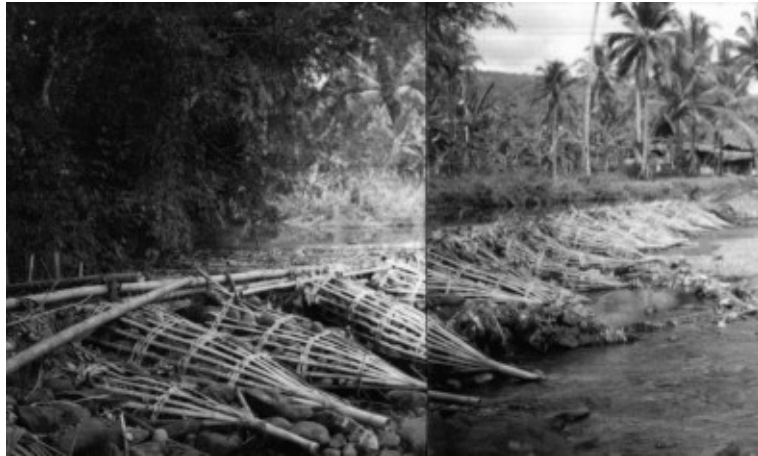
**Photo H2.2.2 Bamboo Net Jetty**

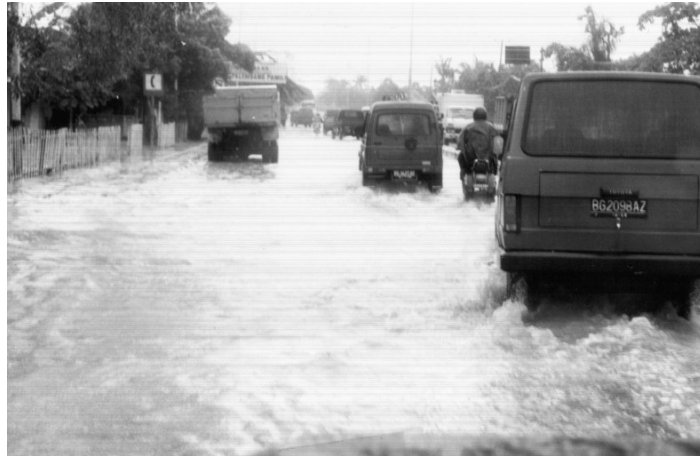
However, the urban center and main roads of Palembang City are still suffering from inundations, since existing capacities of these facilities are still far from the required level. Political, economical and social activities of the city have been interrupted due to these frequent inundations. In addition, the inundation also aggravates seriously the living environment and causes sanitary problems to the residents of the city. Typical inundation of Palembang is shown in **Photo H3.1.1**.

**Photo H3.1.1 Typical Inundation of Palembang**

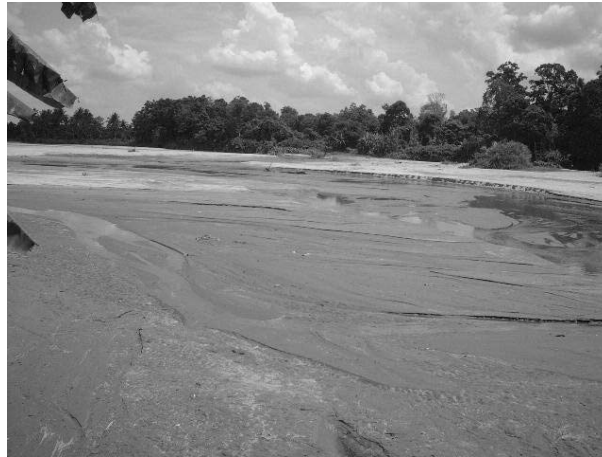
Almost whole reaches of the lower Komerling River have been silted up due to the deposition of sediment, mainly caused by erosion in the upper watershed and geological anticline in the lower basin. The rise of riverbed results not only in the reduction of discharge capacity, but also in the extension of back swamp areas. Sedimentation of the Komerling River is shown in **Photo H4.2.1**.

**Photo H4.2.1 Sedimentation of the Komerling River**

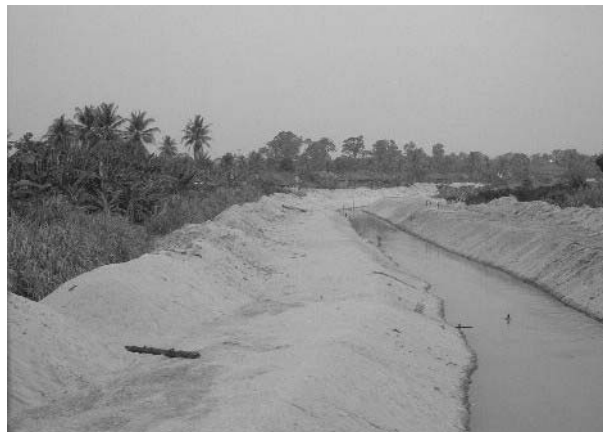
As to the channel dredging, bottom width of the channel is 8m and upper width is 20m. Elevation of bottom of channel is +27 m above mean sea level. Dredged channel is shown in **Photo H4.3.1**.

**Photo H4.3.1 Dredged Channel**
