## **Appendix C**

### **Natural Disaster Mitigation**

#### 1.1 Disaster Emergency Response Plan - Thua Thien-Hue Province

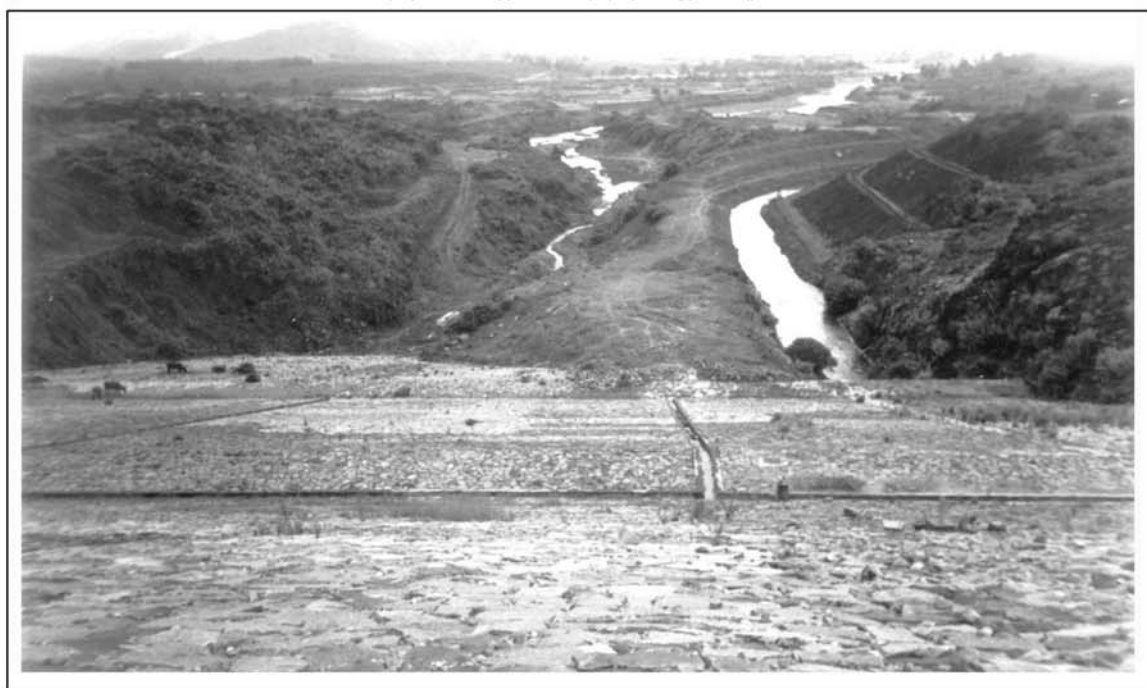
**Photo 2 : Downstream Slope of Truoi Dam, Nov. 2001  
(Centre: Truoi River, Right: Irrigation Canal)**

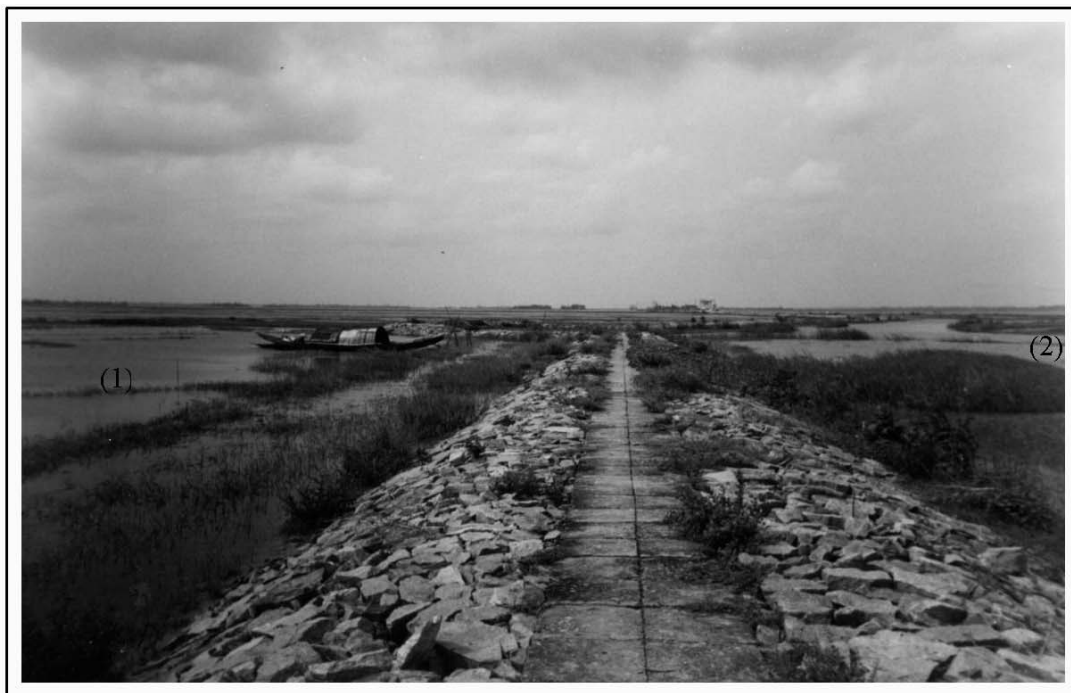
**Photo 7 : Lagoon Dike, Nov. 2001**  
**(Near Cong Quan Outlet)**  
(1) Farm Land, (2) Lagoon

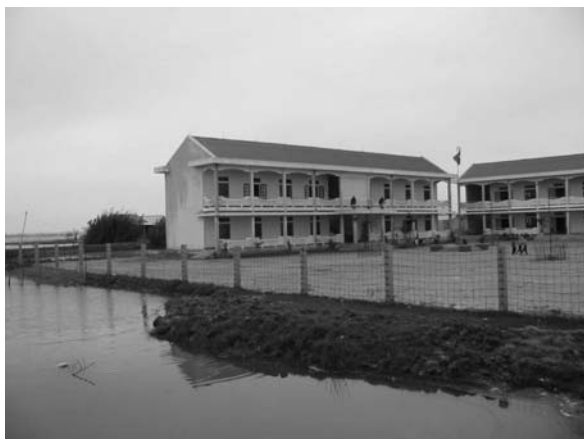
Site visits were also made to the flood-prone areas in the districts of Huong Tra, Huong Thuy, Phu Vang and Phu Loc. It was observed during these visits the preponderance of newly constructed two-storey schools and clinics and the large number of buildings recently constructed using Red Cross housing frames.

Because these flood-prone areas are flat and low lying the two-storey buildings dominated the landscape and were visible for some distance. Interviews with local residence confirmed their satisfaction with the newly constructed buildings within their community. The majority understood the secondary function of the buildings in providing safe havens for both themselves and their families, if required during periods of flooding. For the local residence, it was added reassurance that the buildings were easily accessible and within a short distance of their respective homes.

Photo 9 : Phu Vang District – Two storey primary school (recently constructed) in centre of flood-prone area.

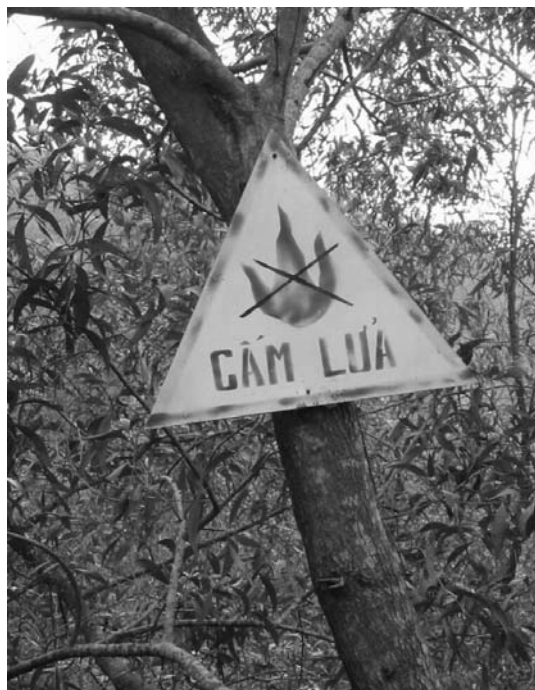
Areas of Phu Loc district form integral parts of the Huong River Basin catchment. The district has the highest forest coverage (57%) in the province with 45,000ha of forest. Prior to 1990 in excess of 40ha of forest were being destroyed annually by forest fires. The main cause of fires was the high temperatures, reaching as high as 40 degrees centigrade for ten consecutive days. Other causes related to unexploded ordnance (UXO), people's negligence and electrical storms.

As a direct result of a well orchestrated and planned forest fire prevention plan commenced in 1991, forest fires in the district were drastically reduced. In 2001 less than 1ha of forest was destroyed by fire. The forest fire mitigation plan, which was so successful, consisted of both structural (construction of look-out towers, fire-breaks and erection of warning signs) and non-structural components (public awareness programs and establishing local fire control boards). Some of the lessons learnt from the implementation of this plan could possibly be used for the implementation of similar plans for flood disaster mitigation.

Photo 10 : Phu Loc District – Roadside sign indicating fires strictly forbidden.

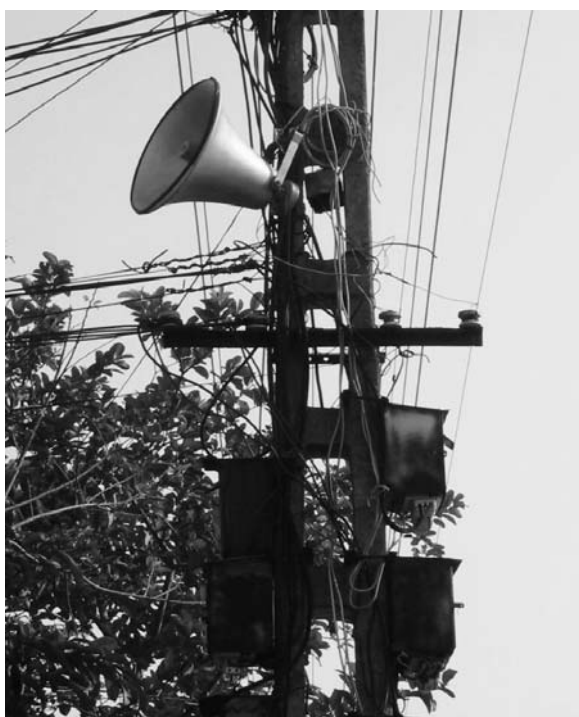
During visits to the flood-prone areas it was also observed the majority of communes equipped with public address systems which consisted in the main of loudspeakers attached to telephone/electrical street poles. The system would be used by the FSC at the commune level, to inform local residents of any impending floods and other danger warnings and as a means of keeping in contact with the local inhabitants during floods.

Photo 12 : Phu Vang District – Public address (PA) system to warn local inhabitants of impending floods.

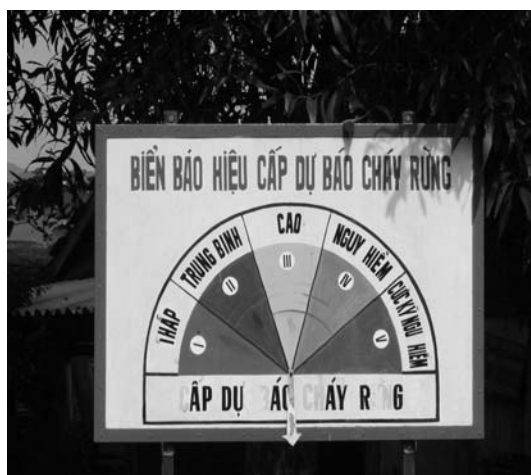
One aspect, which was not anticipated and observed during the site visits to the Huong River Basin catchment and worthy of further consideration was the potential for forest fires. In those parts of the catchment where deforestation had not taken place there was thick dense vegetation. The potential for forest fires in these area would be extremely high, particularly during the dry season when the undergrowth would be dry and highly susceptible to fire.

Photo 11 : Nam Dong District – Sign indicating level of danger for forest fires ranging from low risk (I) to extreme risk (V).

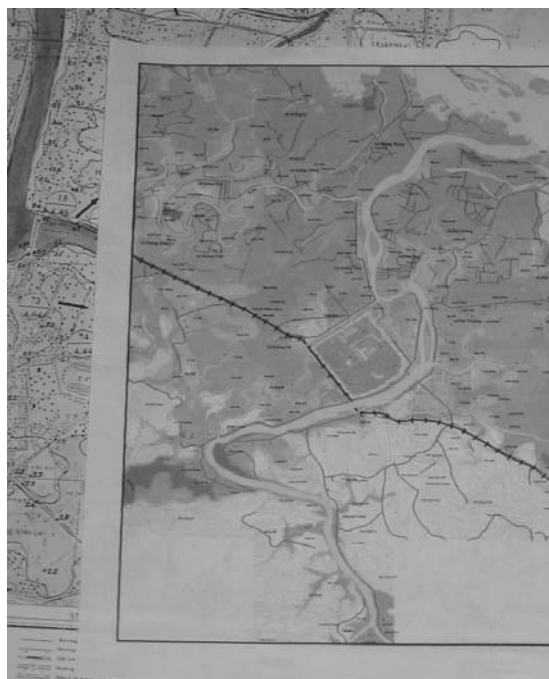
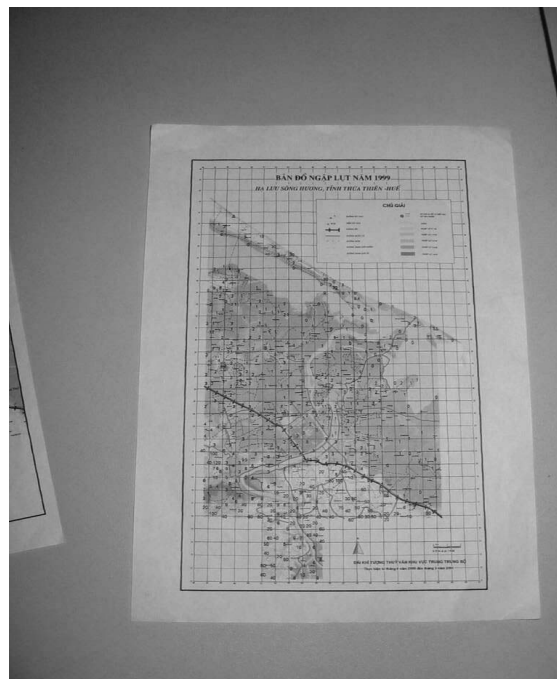
Following the presentation of the 2001 Disaster Emergency Response Plan, outlined previously, an inspection of the complete set of 1:10,000 inundation maps for the 1999 flood was made at the headquarters of DARD in Hue.

Photo 13 : Flood inundation mapping  
Thua Thien-Hue Province.

Photo 14 : Flood inundation mapping  
Thua Thien-Hue Province.

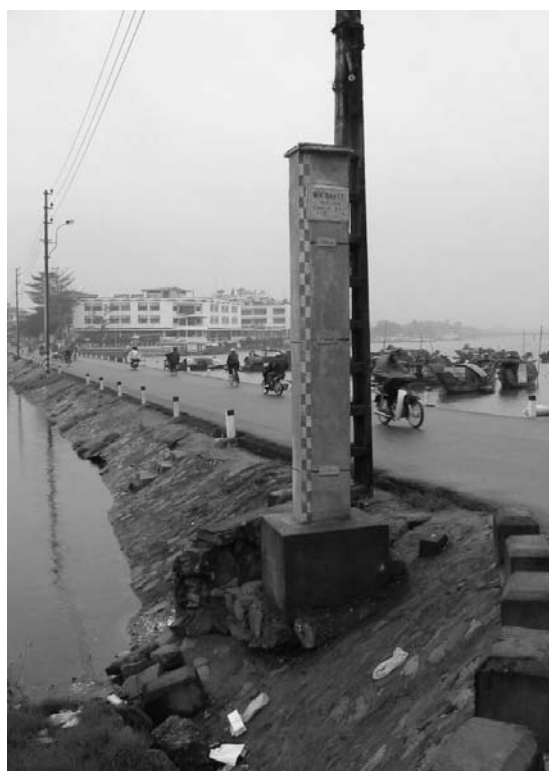
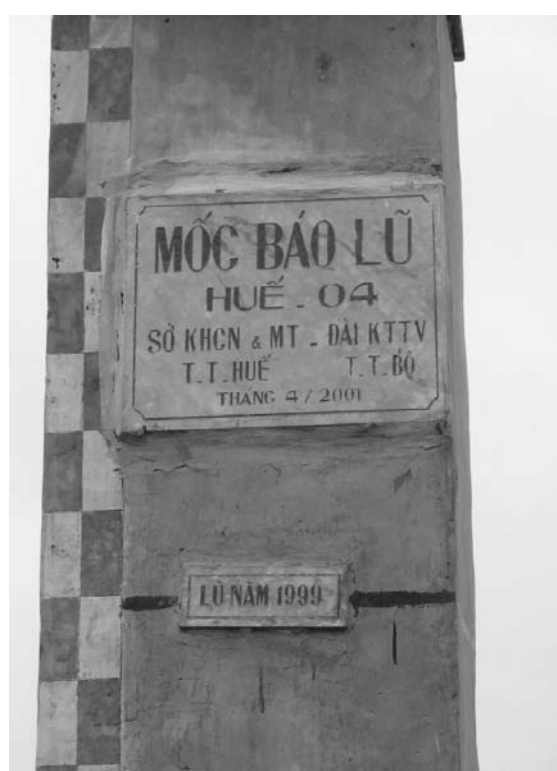
On each of the primary flood level warning monuments are markings giving the 1995 and 1999 flood levels and Flood Level Warning III.

The combined primary and secondary flood level warning monuments to be used in conjunction with the flood inundation maps, make up the current field benchmark network for the Thua Thien-Hue province. During the site visit to the province several primary and secondary flood level warning monuments were inspected.

Photo 15 : Flood level warning  
monument H04 – Hue Thua Thien-Hue

Photo 16 : Flood level warning monument  
H04 – Hue Thua Thien-Hue Province.

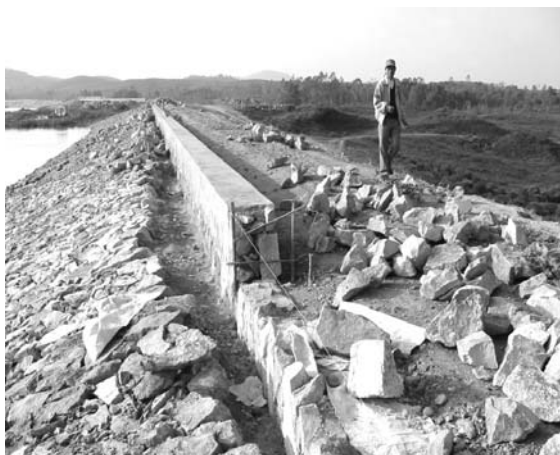
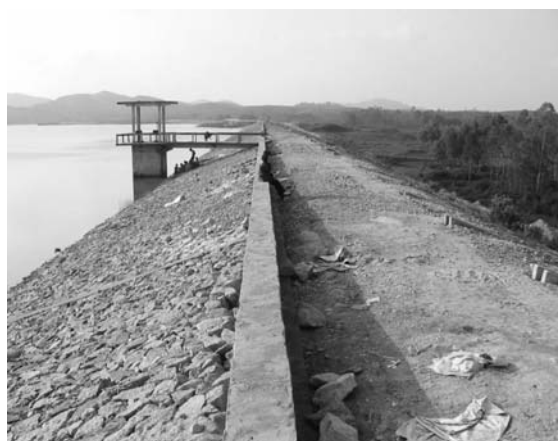
The rehabilitation of existing reservoirs and dams are important structural measures for natural disaster mitigation. As Phu Bai Reservoir was one of the major reservoirs in Thua Thien-Hue province to sustain damage during the 1999 floods, a visit to the dam site was made. Construction was in progress at the time of the visit. Remedial works include the complete refurbishing of the upstream face of the dam with stone pitching; construction of a grid system of concrete open channel drains on the downstream slope of the dam; installation of sluice gates on existing spillway outlet and construction of new irrigation channel from the dam outlet.

Photo 17 : Phu Bai Reservoir, Huong Thuy District - Dam remedial works.

Photo 18 : Phu Bai Reservoir, Huong Thuy District - Dam remedial works.

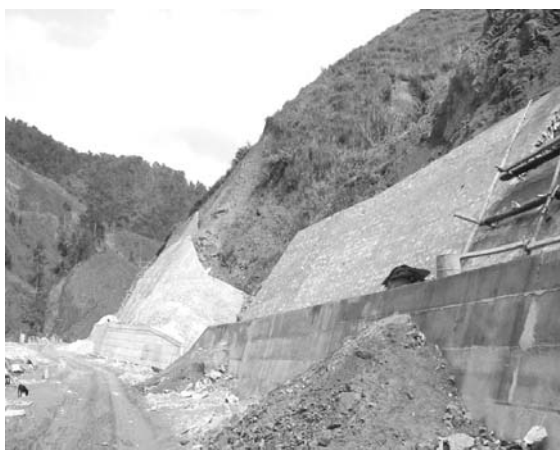
Landslides, direct results of the combined effect of deforestation and flooding were sighted at various locations adjacent to roads and the remedial protective works, local authorities had constructed were observed.

Photo 19 : Road Construction and Protection of Cutting Slope – Huong Tra District

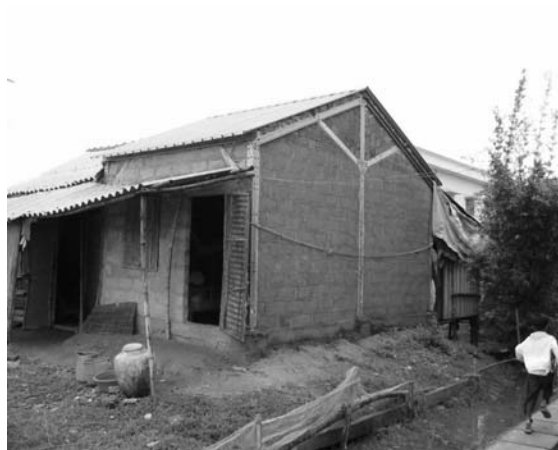
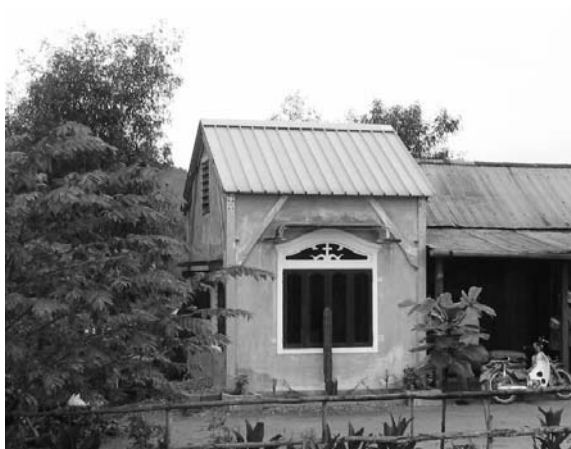
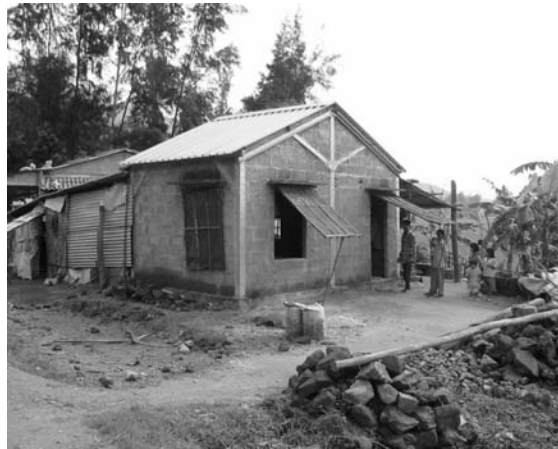
Red Cross housing frames currently consist of two functional models, a 4 column unit (*Hue Model*) and a 6 column unit (*ABC Model*). Both are based on the same principle they are cheap, strong and easy to erect and provide a static core that will remain standing under severe weather conditions. The idea being local inhabitants can add extensions to the core by use of local materials. During storms and floods these extensions would be swept away but the core would remain. The Red Cross have reported that houses using their frames withstanding the November 1999 floods, with only one house failing out of a total of 2,450 constructed in the Central Provinces prior to the floods. To date a total of 4,724 frames (excluding resettlement areas) have been provided for in Thua Thien-Hue province.

Photo 20 : Phu Vang District – Red Cross Housing Frame (ABC Model).

Photo 21 : Huong Tra District – Red Cross Housing Frame (Hue model).

Photo 22 : Phu Loc District – Red Cross Housing Frame (ABC model).

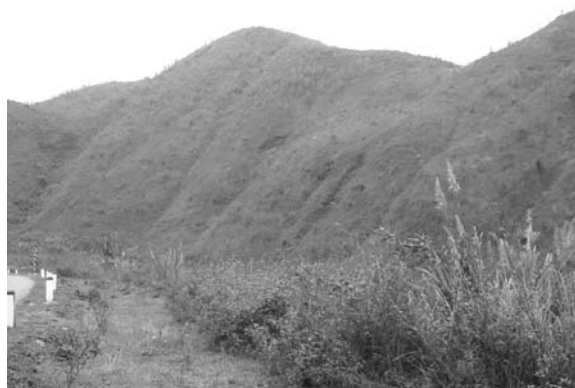
At the site of the proposed Ta Trach dam the vegetation coverage was found only to be bush and scrub at no more than waist height and extending for an area as far as the eye could see.

Photo 23: Deforestation – Huong Tra District

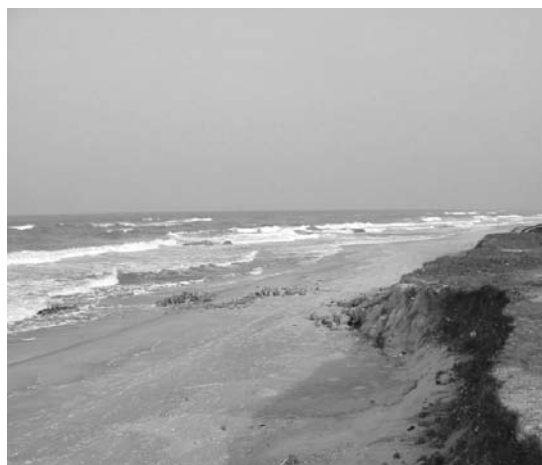
In the course of addressing natural disaster mitigation in the context of preparing a comprehensive master plan for the Huong River Basin, the important aspects of coastal erosion and the breaching of the lagoon were taken into consideration. As part of that exercise site visits were made to the Tam Giang lagoon, the estuaries of Thuan An (sea outlet to the Huong river) and Tu Hien and the adjoining sandbar and coastline where extensive coastal erosion was observed. Currently an internationally funded project entitled *Integrated Coastal Zone Management* is addressing these issues.

Prior to the floods of 1999 there existed only one opening to the sea of the Tam Giang lagoon located in the vicinity of the Thao Lang Barrage. The lagoon is an important economic asset to Vietnam as it is the place for the cultivation of shrimps and seaweed, both large foreign currency earners. However, their cultivation is very much dependant on an optimum salinity of the water being maintained at all times, this being best controlled if there is only one opening of the lagoon to the sea. As a result of the floods of 1999 the sandbar separating the lagoon from the sea was breached at three locations, in addition to the southern opening of the lagoon, the former Tu Hien estuary, being reformed. Two of the openings closed naturally by lateral drift and the 3<sup>rd</sup> one was closed by relevant authorities constructing a road to rejoin the sandbar with the mainland. Dredging is now currently taking place on the landward side to restore the integrity of the lagoon to its natural state before the floods of 1999.

Photo 26 : Coastal erosion of sandbar adjacent to Thuan An estuary.

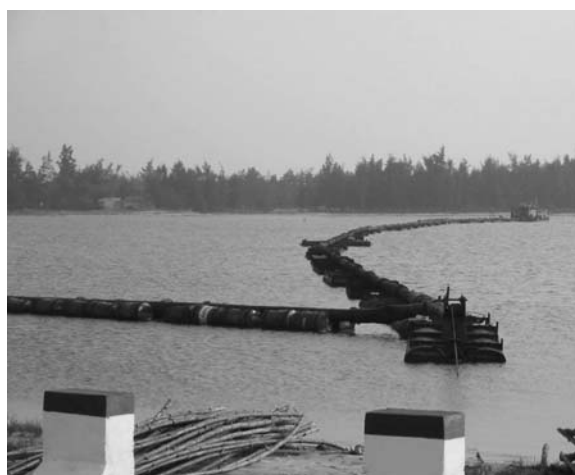
Photo 27 : Dredging of Tam Giang Lagoon
