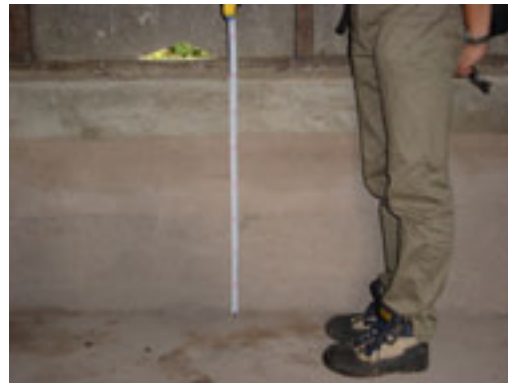
Photo 2.3.7-25 Trace of lahar on the house wall of Finca El Faro

bridge, the lahar overflowed at the several places. At last, it hit Finca El Faro and damaged to the furniture in houses, although there was no damage to the inhabitants. Trace of the lahar is left on the wall of houses, which indicate that the flow came up to the height at about 60cm above the floor.

CONRED declares that following villages are under the risk of lahar; Finca San José, Finca El Faro, Finca La Mosqueta, Finca Santa Marta and Finca La Florida. We visited Finca La Mosqueta besides Finca El Faro, and found several damages caused by past lahars. Those villages situate near Nimá I river, in which a lot of lahars occur. Some early alert system is necessary to evacuate inhabitants safely.

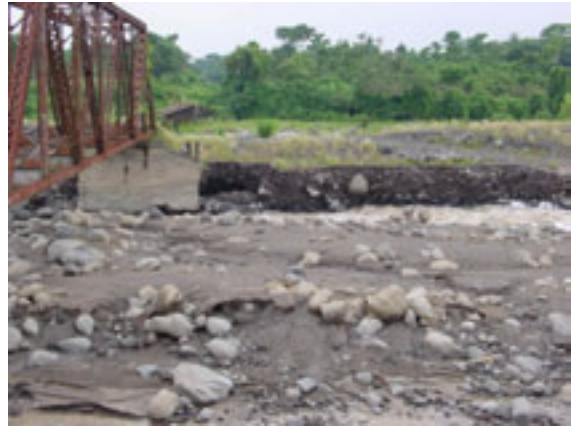
deposits flow down in the future. The river, meandering toward the west, is significantly eroded on the San Sebastián side. Although gabions and stone embankments are used against erosion, the lateral erosion is so active that the western foundation of an old railroad is being eroded. The lahar tends to spread to the western side (San Sebastián). When the water level is low, the river is susceptible to lateral erosion due to meandering. The gabions may be scoured.

Photo 2.3.7-26 Eroded foundation of an old railroad near San Sebastián

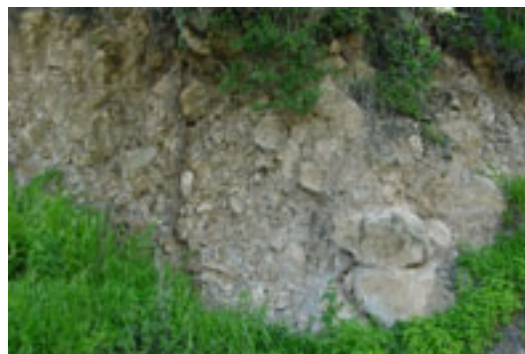
There are several lava domes in the southwest of Amatitlán Lake accompanied with several lava flows. These are andesite lava domes, and steep slope is formed along the rim of the domes. Several rock falls are observed at the rim of the domes.

Photo2.3.7-39 Rock fall at the rim of lava dome

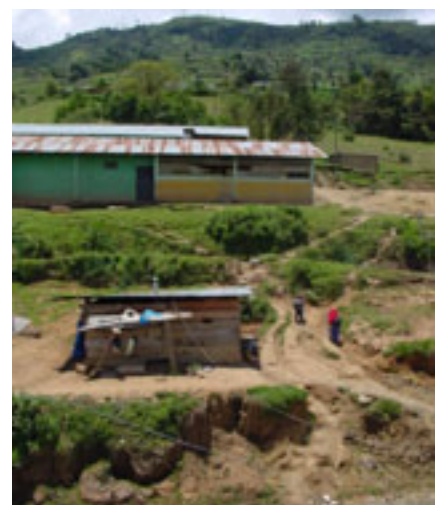
Within the area of the landslide a primary school and about 5 houses are settled, with severe damages in the school especially, at the point that they are moving it from the present place.

Photo2.3.7-48 The primary school damaged by the landslide

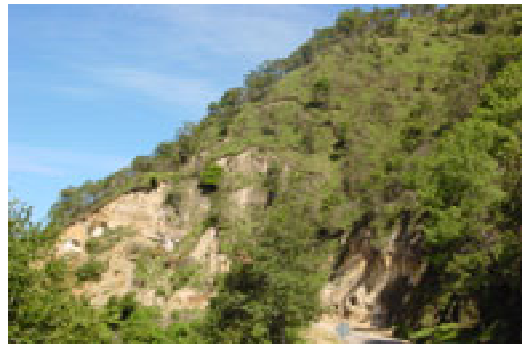
This is an imminent landslide near the previous and older one known as Los Chocoyos. It can be observed with two scarps, one at top of hill and other one fourth down from the top. It cannot be appreciated in the aerial photos due to the narrowness of the cracks. It is composed of very fractured volcanic rock. It may be expected the slope

Photo2.3.7-51 Landslide at 2.5 km west from Los Chocoyos

fail during a coming rainfall or a relative large earthquake.

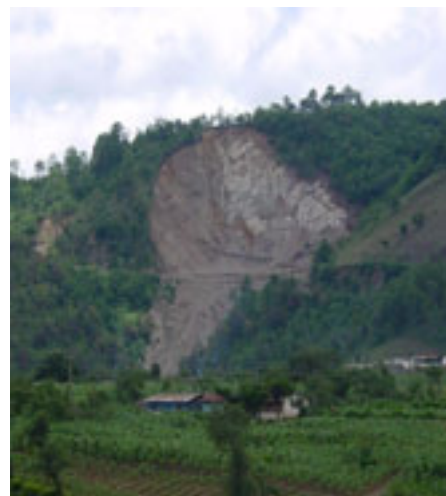
This is a dip slope type of landslide where a mass of deeply altered material is sliding on the bedding plane of intact rock. Instability must have started from the construction of the road at the half hillside.

Photo2.3.7-52 Landslide at Patzún Village

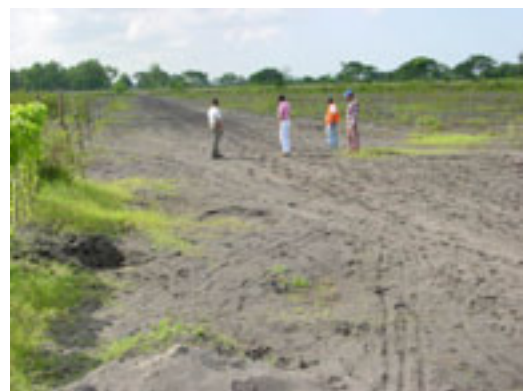
Photo2.3.7-56 Road washed off in the lower reaches

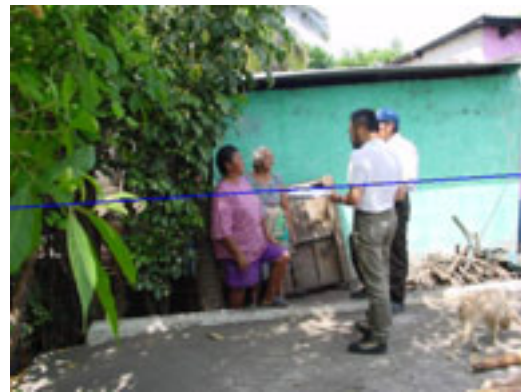
In El Terreno in the east of La Gomera was flooded by Hurricane Mitch at the depth of 0.5 meters for three days. Inhabitants said that the flood at this time had flowed from the north to the south, being probably resulted from the inundation of the Colojate River.

Photo2.3.7-58 La Gomera: The blue line indicates the water level of the flood by Hurricane Mitch.

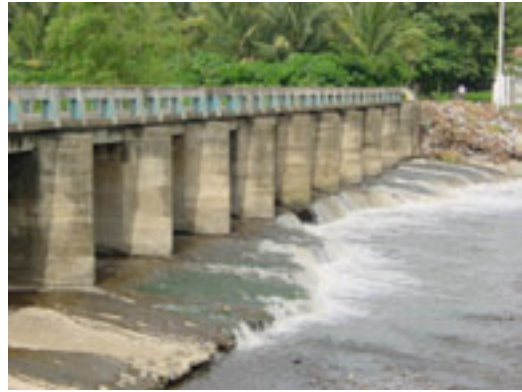
In Masagua, Hurricane Mitch submerged the area around the river. The bridge across the Guacalate River has eroded piers and is in danger. The riverbed deposits around this area consist mainly of gravel from about a few centimeters to 20 centimeters in size.

Photo2.3.7-63 Masagua bridge in danger because the foundation of bridge piers is eroded

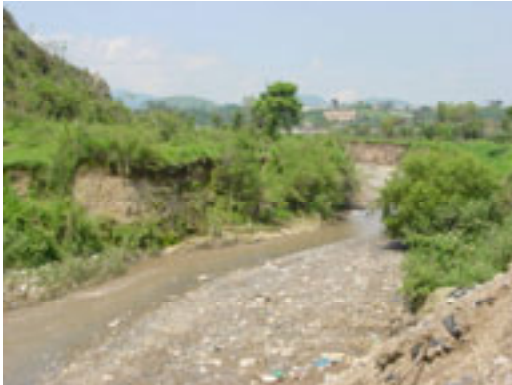
Photo2.3.7-68 Lateral erosion found in the Pinula River
