第2次現地踏査地点の重要調査項目と 環境チェックシート

Checklist for the Second Field Survey for PSPP

第 2 次現地踏査結果 ; JN3 地点

The features of promising potential sites for PSPP

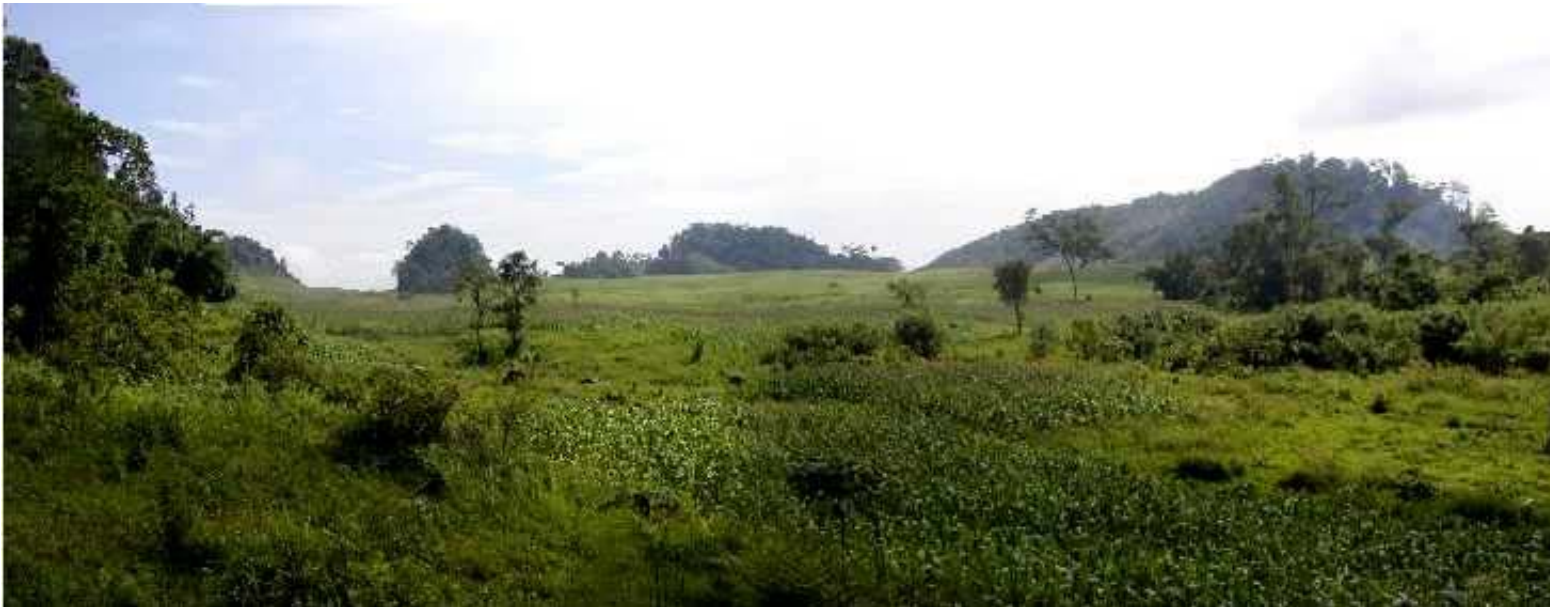
Photo 1

Facing type poundage is suitable for the upper reservoir, which H.W.L. is 880 m based on the topographical condition.

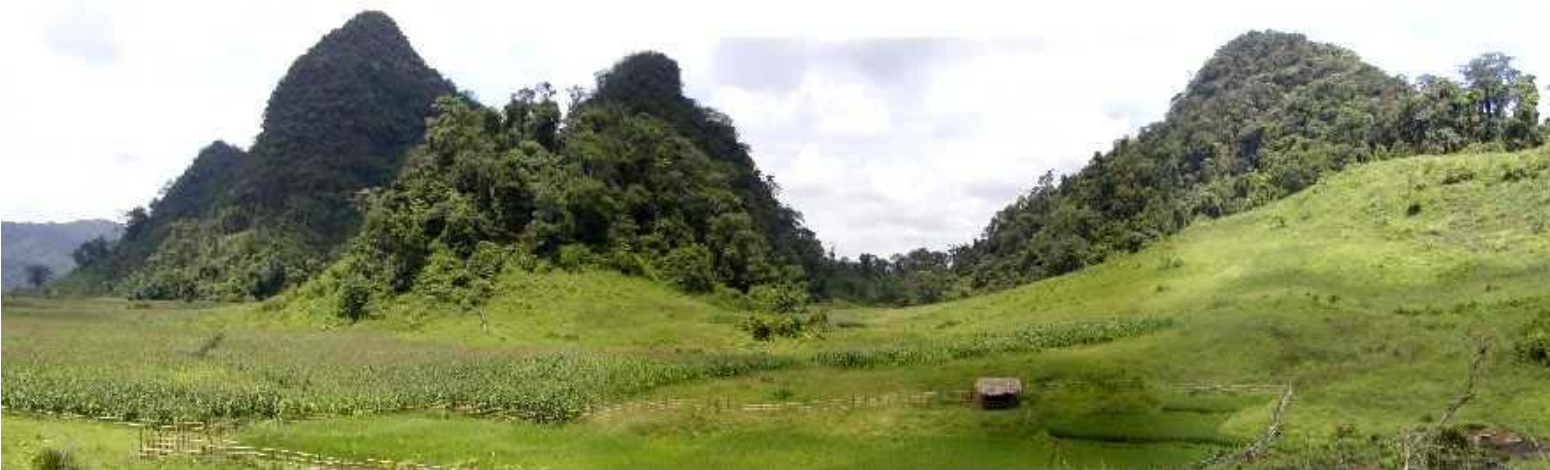
Photo 2

There are mountains composed of limestone in the west side of the plain. A spring is there at EL.860 m of the north part of the reservoir, which makes a paddy field.

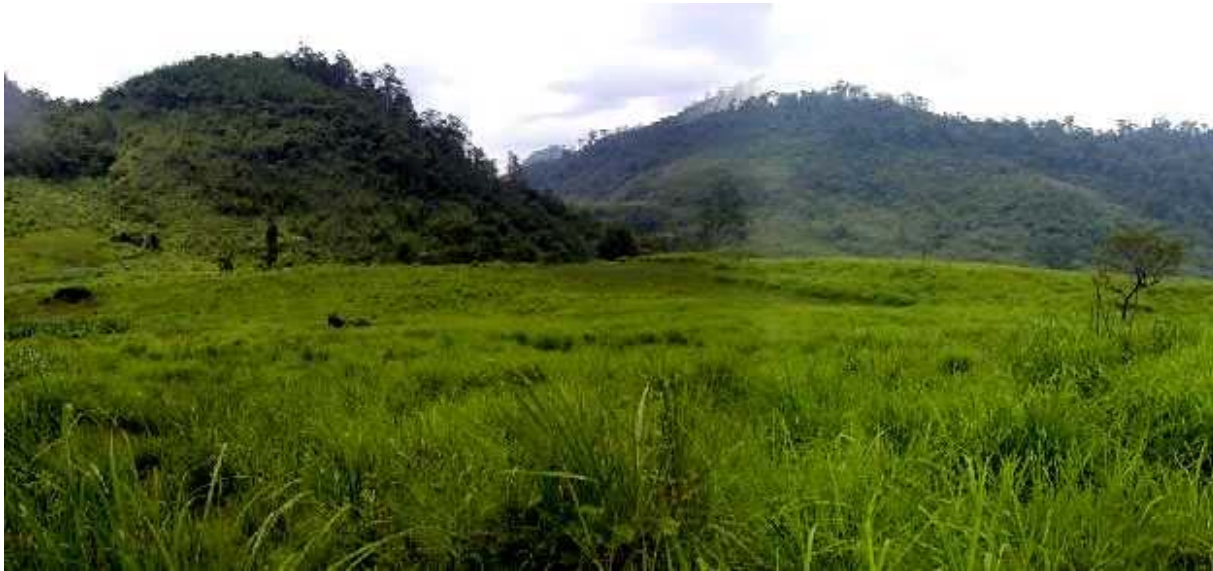
Photo 3

A small hill around EL. 870 m lies from north to south on the center of plain. Location of the reservoir will be shifted to the west part to use the hill as a bank of the reservoir.

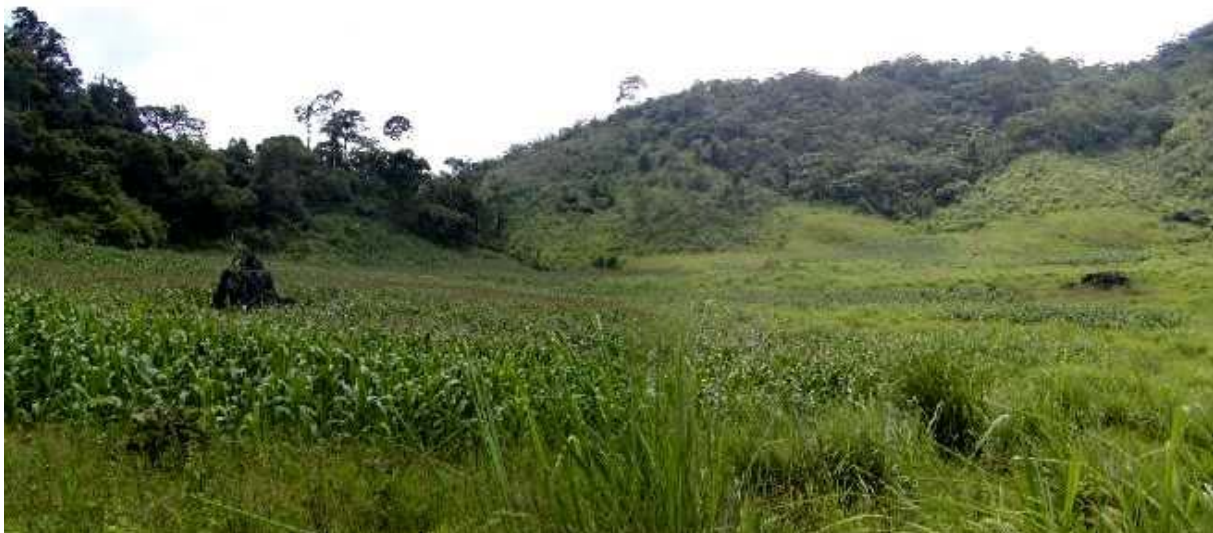
Photo 4

Since the planned intake is situated at the east bank of the reservoir, it is necessary to shift its position to the west of the bank.

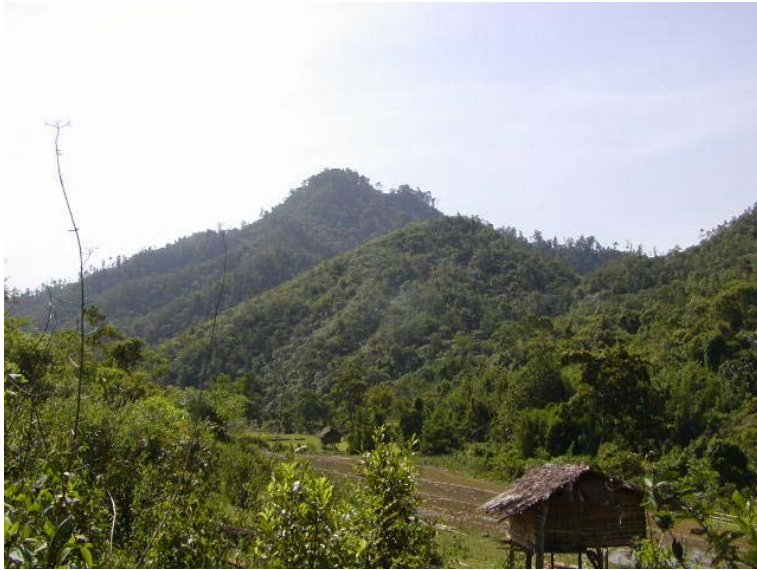
Photo 5

The mountain is at the dam site, looking from the upstream of the main river.

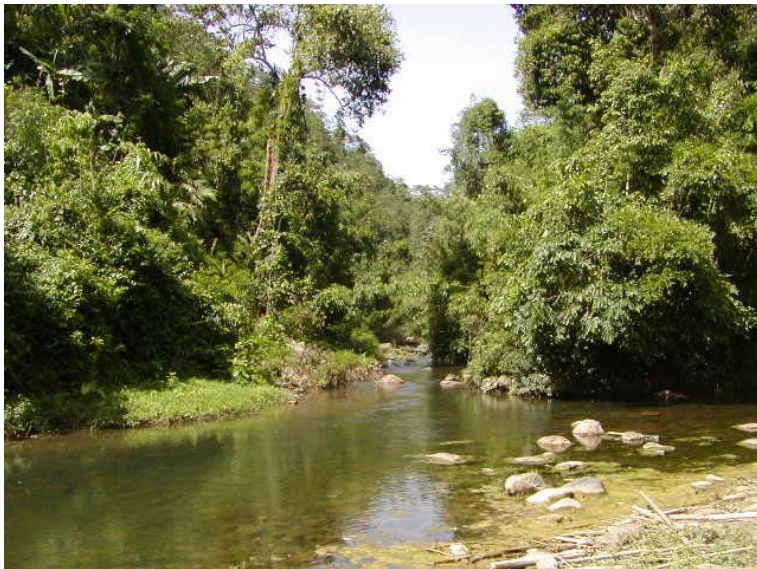
Photo 6

This is the junction of the main river and the tributary that has a dam site.

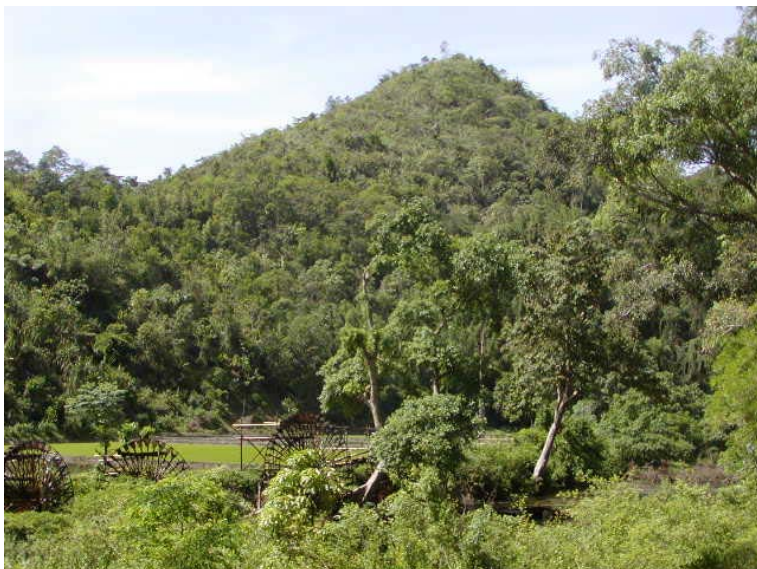
Photo 7

This is around pumping system to store up water from the main river.

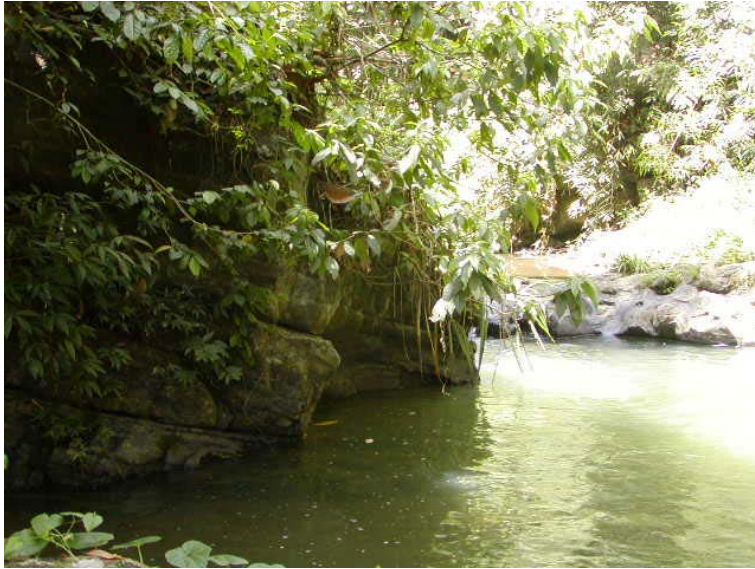
Photo 8

There are outcrops composed of shale around the riverbed of the planned dam site.

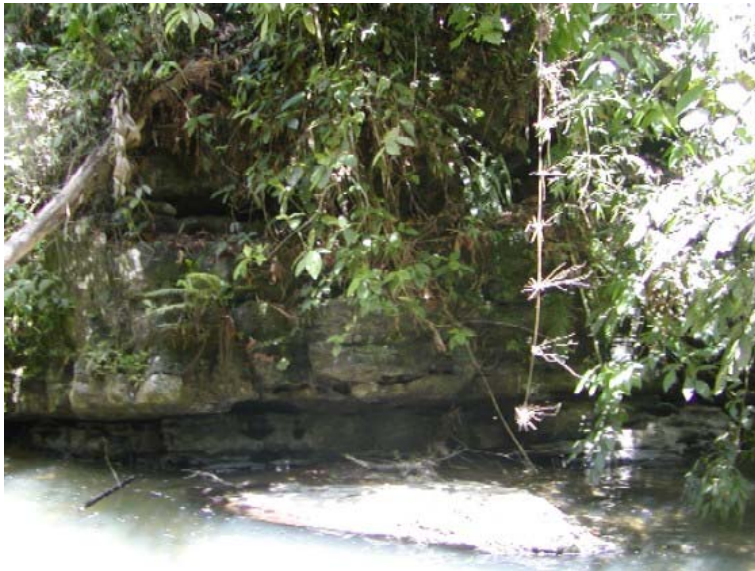
Photo 9

Left bank of the dam site.
(Around riverbed)

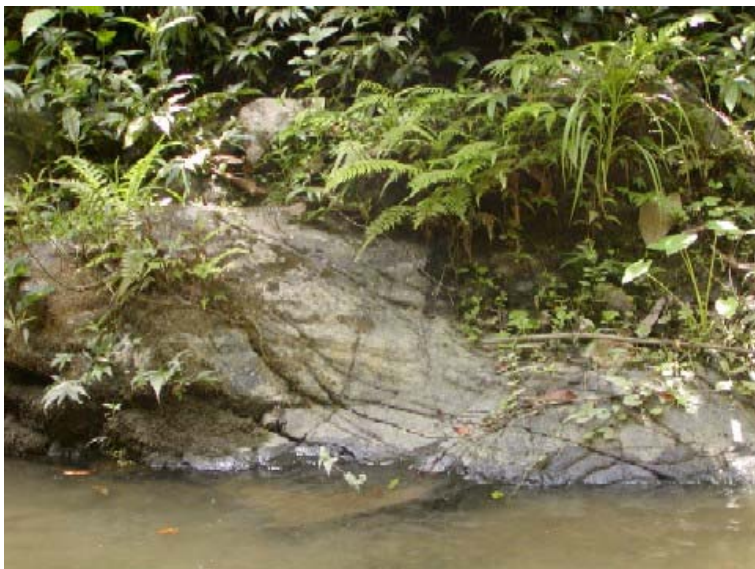
Photo 10

Right bank of the dam site.
(Around riverbed)

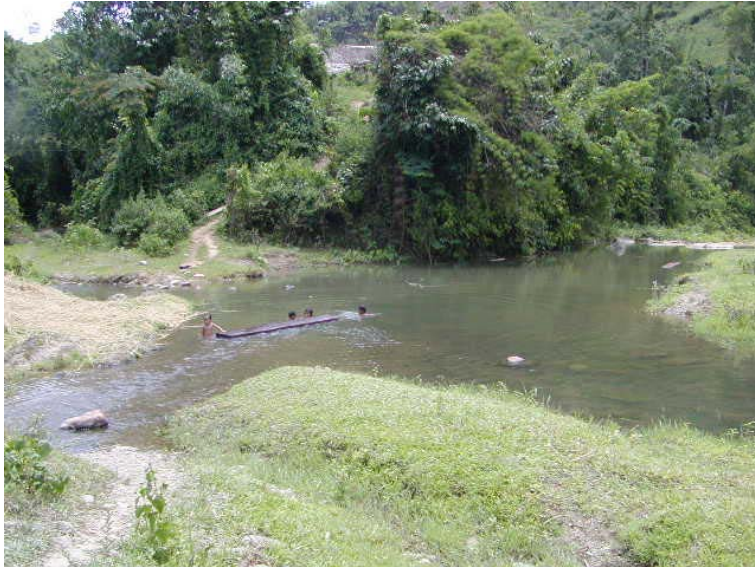
Photo 11

The location of the cofferdam will be selected between the junction of three tributaries and the dam site.

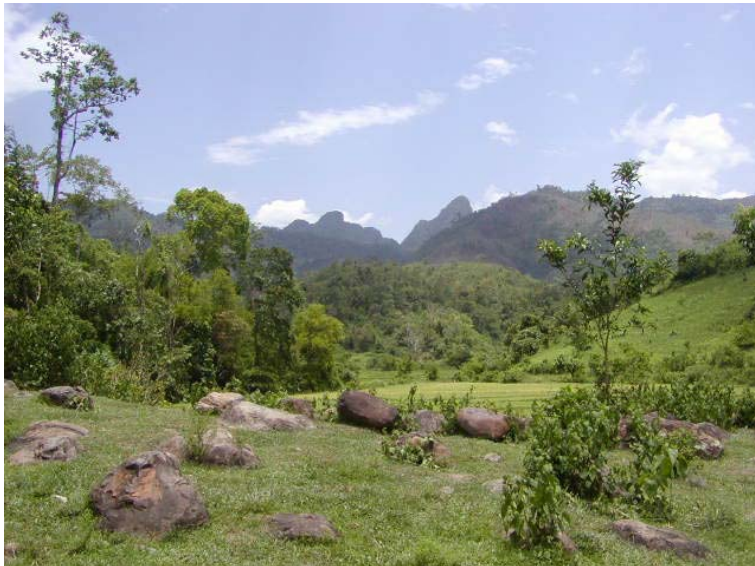
Photo 12

H.W.L. of the planned lower reservoir is 280 m based on the topographical condition.

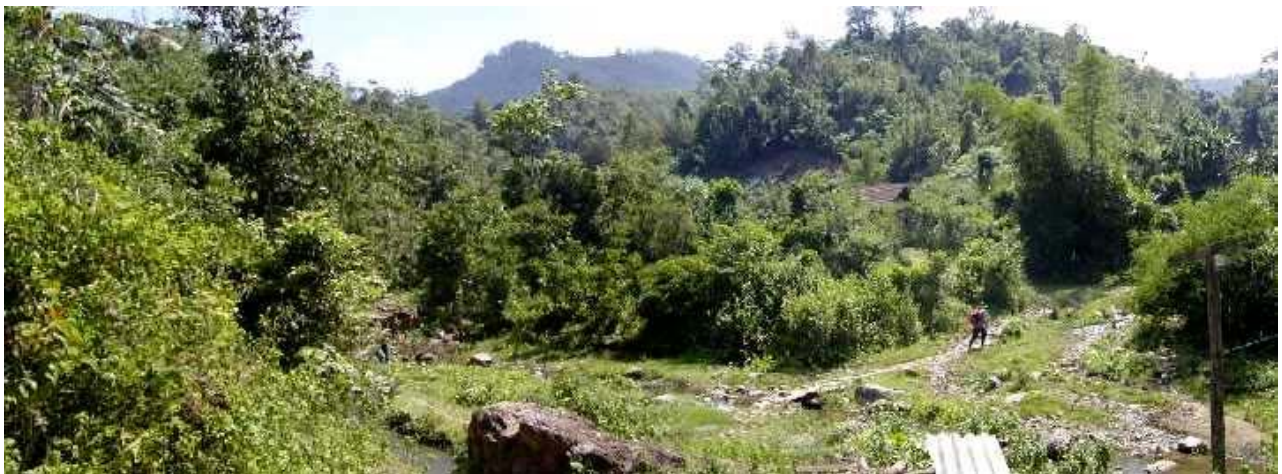
Photo 13 The location of the outlet will be planned under the largest ridge in the surrounding area.
