JN-3 Geological issues (Upper dam site)

添付資料 4-6-2

第 2 次現地踏査結果 ; JN5 地点

The features of promising potential sites for PSPP

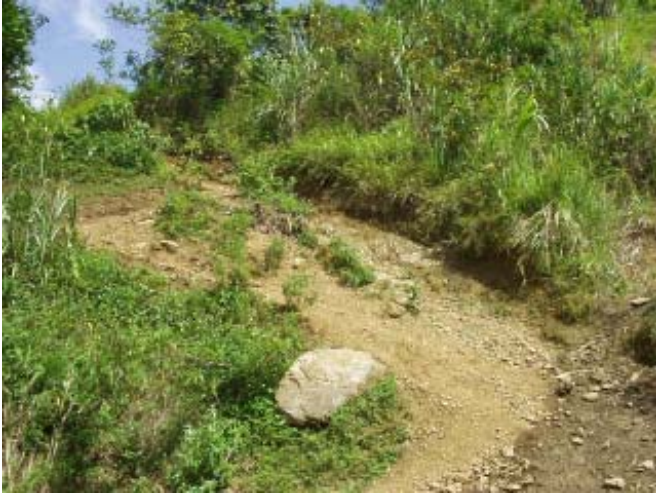
Photo 1

Footpath to the Upper Reservoir

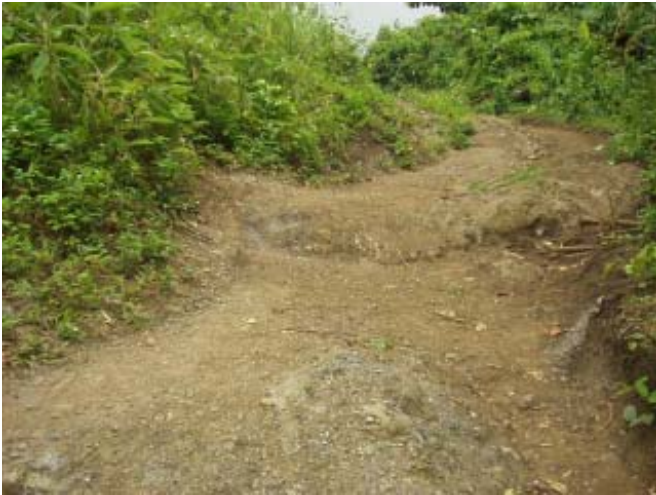
Photo 2

Outcrop of slightly fractured shale

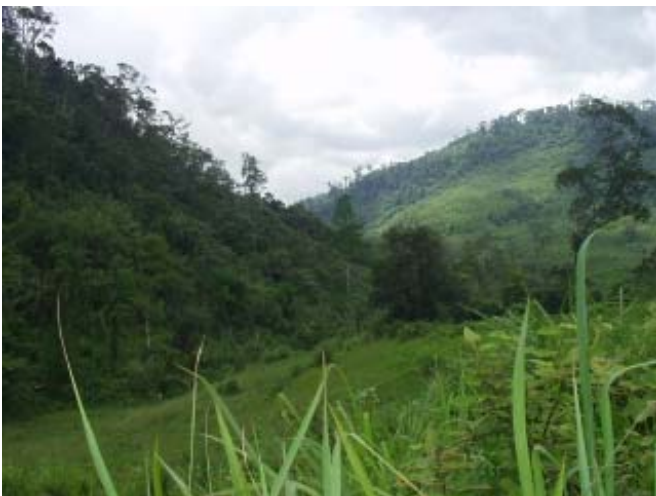
Photo 3

Small hill in the Reservoir

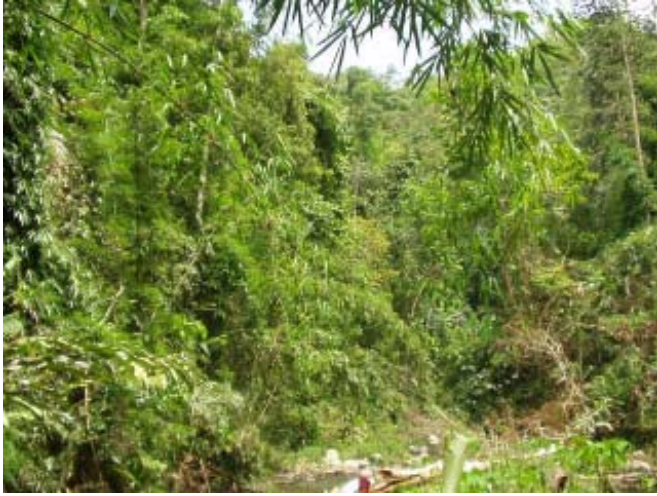
Photo 13

Saddle of the left side hill
(No features of the structural weak zone)

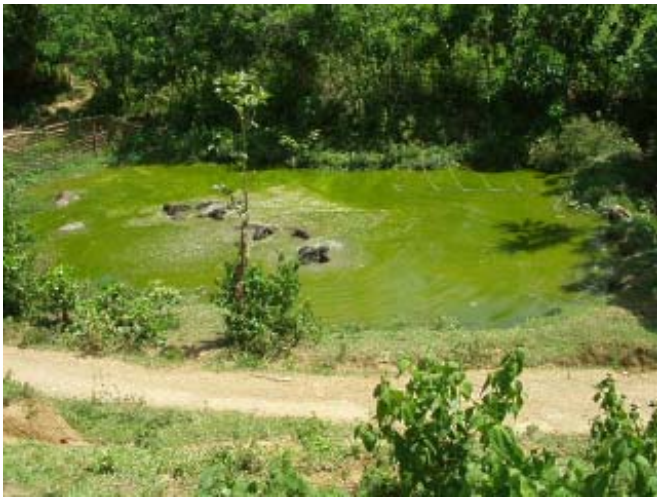
Photo 14

Condition around the bottom of the Reservoir

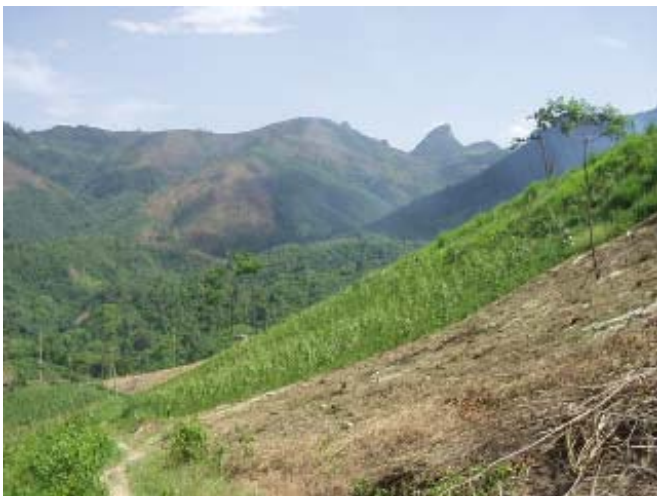
Photo 15

Topographical condition around the upstream of the Reservoir
(Clayish shale)

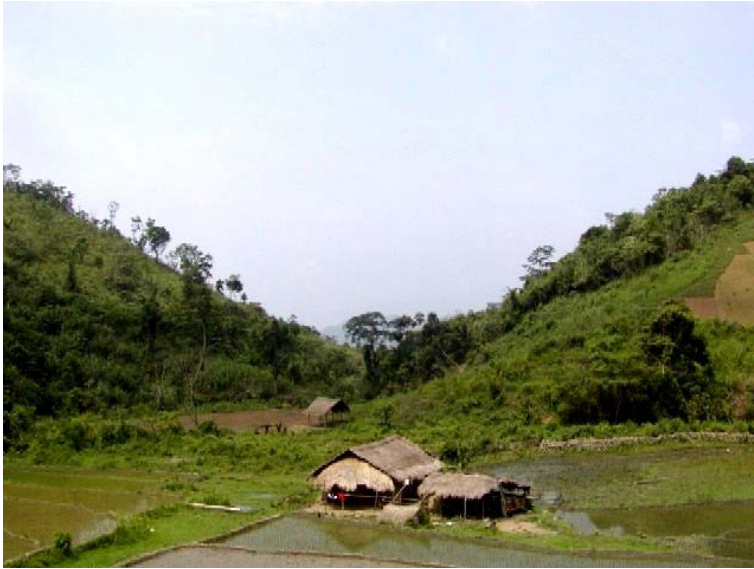
Photo 1

The ridge of the right bank of the planned dam site is a thin and slope is rather gentle. The ridge of left bank has a sufficient width and slope is rather gentle.

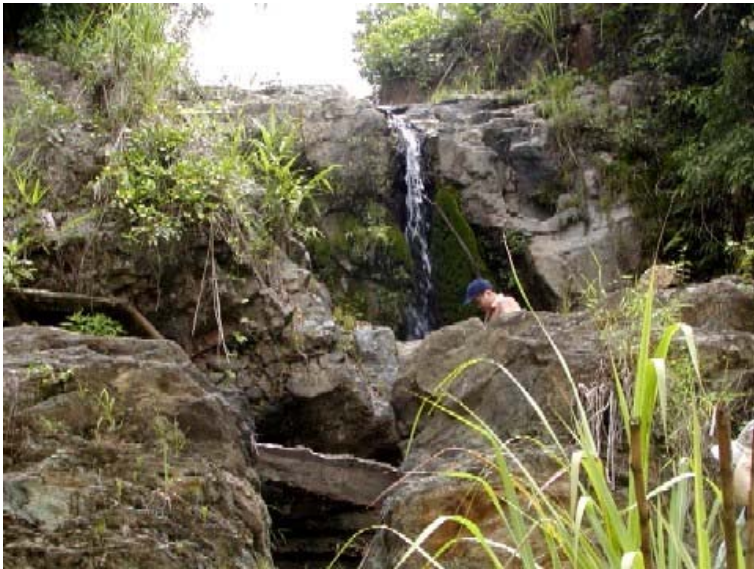
Photo 2

There is a waterfall at the dam site, which is about 5 m height, and outcrop is tuff.

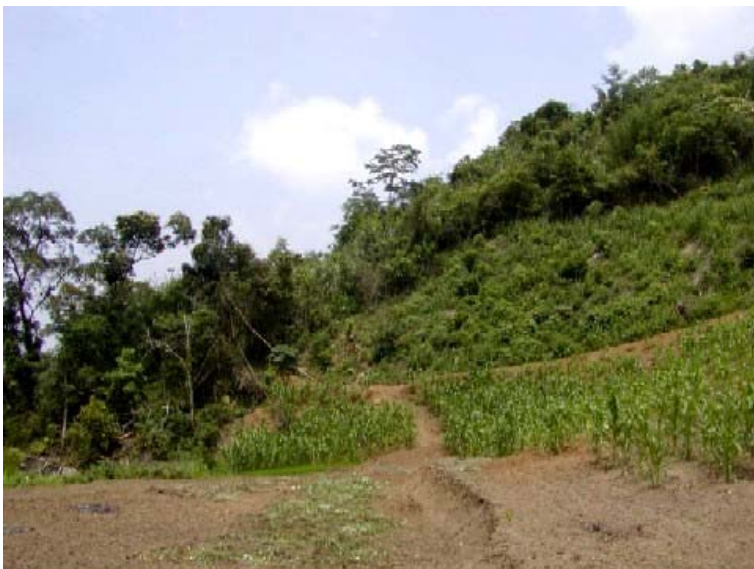
Photo 3

Topography of the upstream of the waterfall is wide and flat, where are used for crop field, and outcrops were not found.

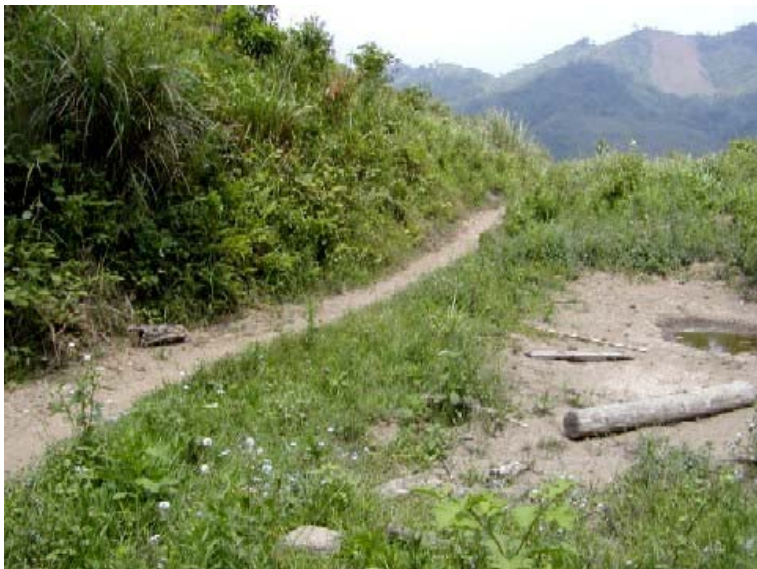
Photo 5

The thin ridge of 35 m long exists in the east part of the reservoir.

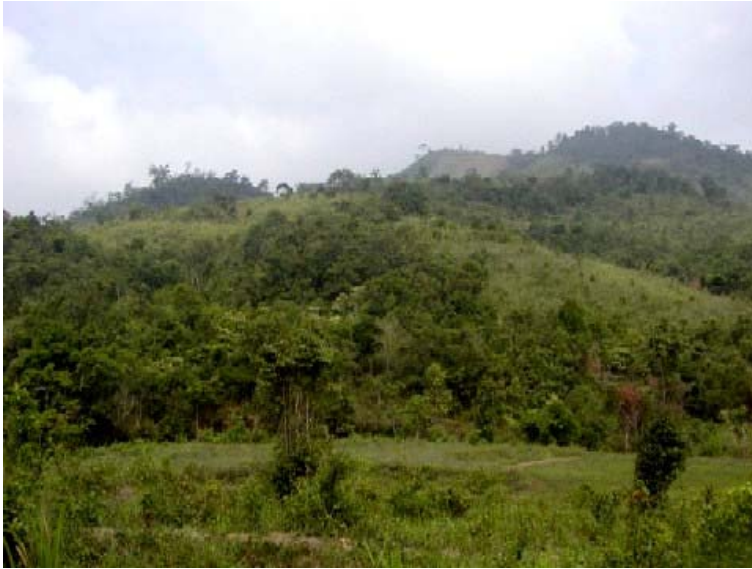
Photo 7

The location of the intake is planned in the ridge, which has a sufficient width and a gentle slope.

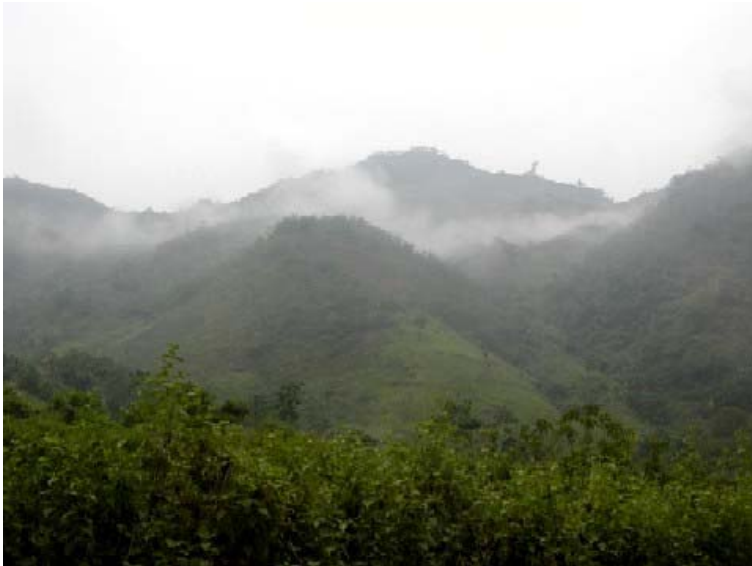
Photo 8

The approach tunnel to the underground powerhouse is planned in secondary sediments.
