JN5— Geological issues (Upper dam site)

**Checklist of Environmental Parameters: JN5**

### **第 2 次現地踏査結果;P5 地点**

The features of promising potential sites for PSPP

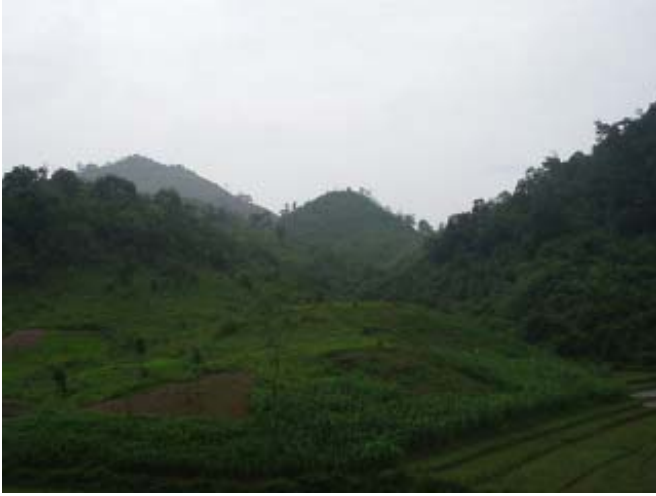
Photo 4

Narrow ridge in the left side of the reservoir

1. Watershed erosion / silt runoff			×	Both areas of dams / reservoirs are not prone to severe erosion. There is a narrow ridge in the left side of the upper reservoir which has experienced several small-scaled landslides.

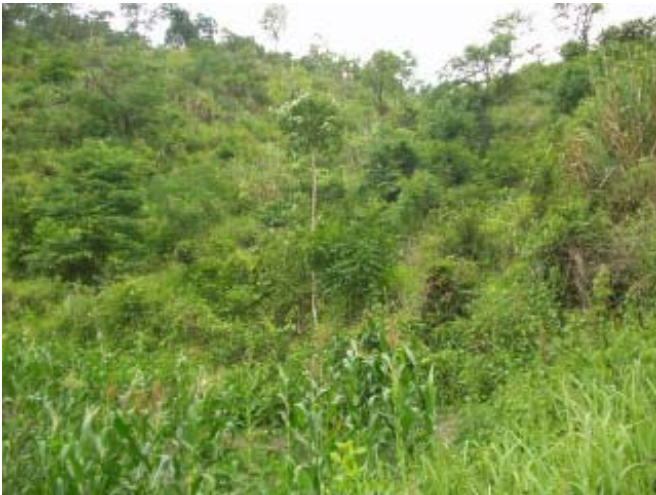
Photo 5

Behind the narrow ridge

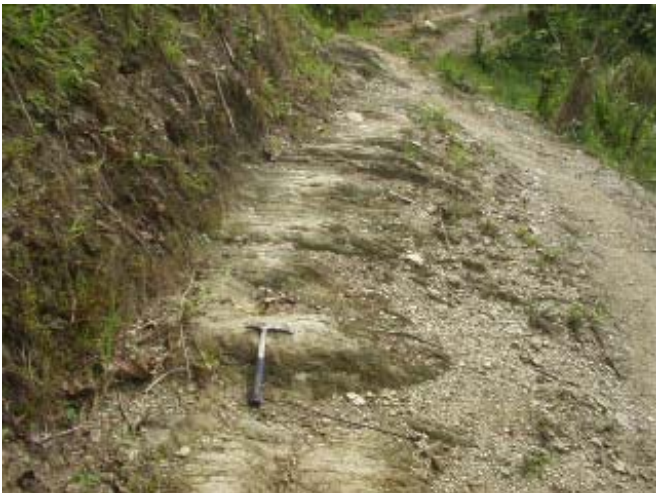
Photo 6

Outcrop of schist  
(Schistosity; N8W75W)

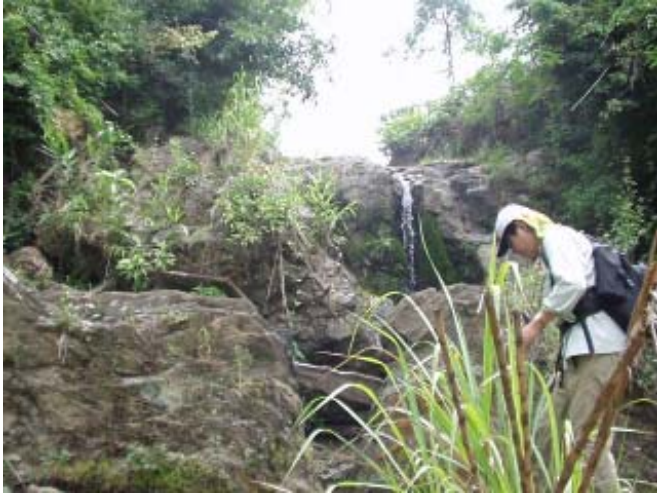
Photo 7

Outcrops of basalt porphyry near the Dam axis

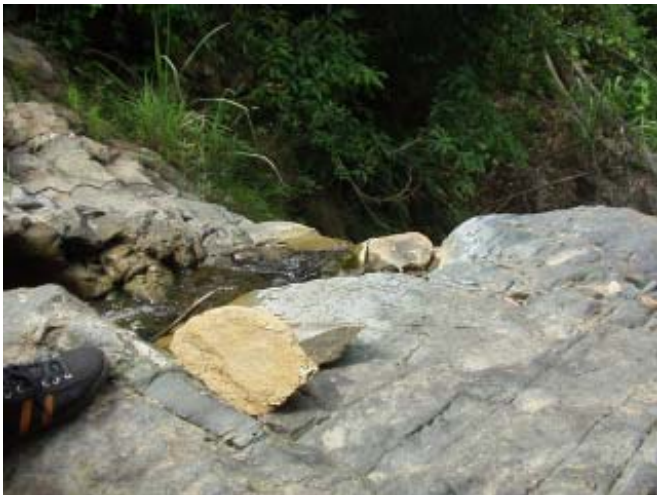
Photo 8

Outcrop of basalt porphyry  
Near the Dam Axis  
(Bedding N24W80SW, joints N80E80E)

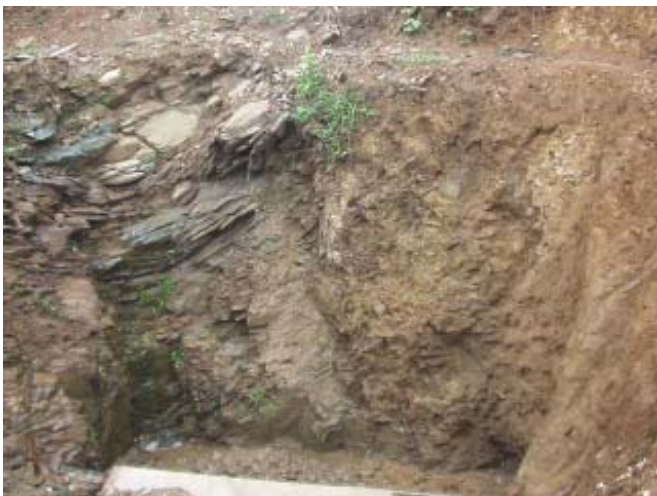
Photo 9

Fractured zone of the schist in the road near the village  
(Some valleys in the slope is easy to collapse)

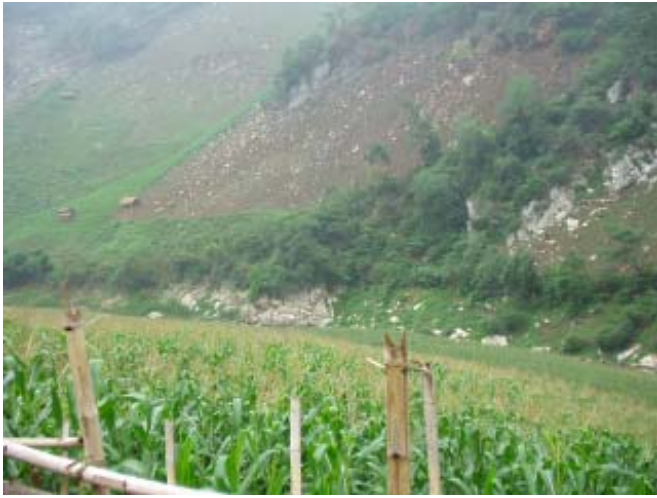
Photo 10

Lower Reservoir  
(Weathered limestone, angle of slope is 30-40degrees)

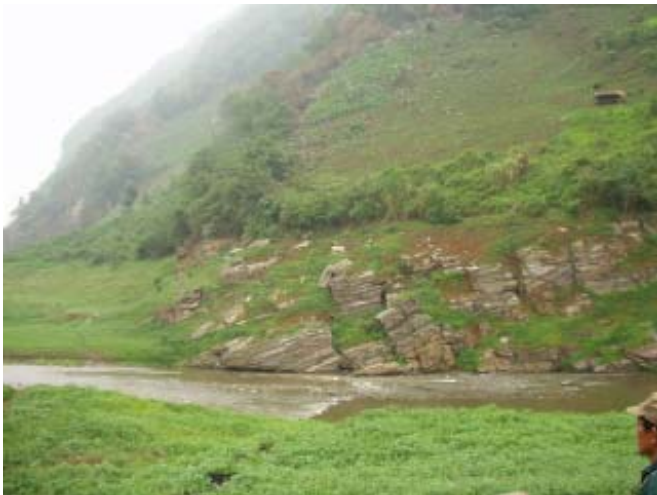
Photo 11

Lower Reservoir  
(Limestone outcrops, bedding is nearly horizontal, angle of slope is 40-50degrees)

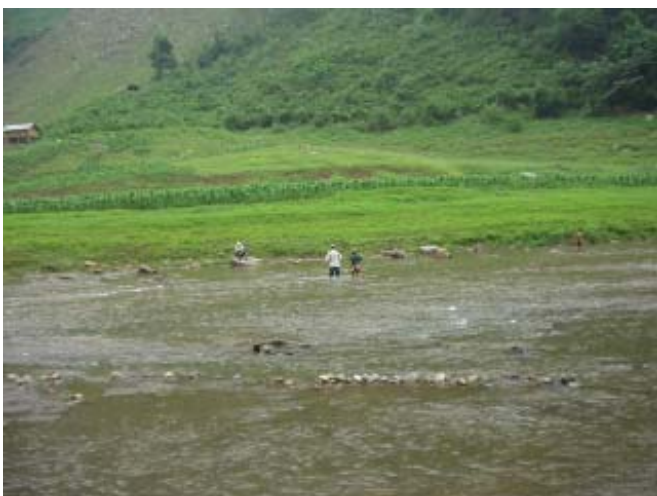
Photo 12

Riverbed in Lower Reservoir  
(Wide and flat area around the riverbed, few hundred meters upstream of Dam axis)

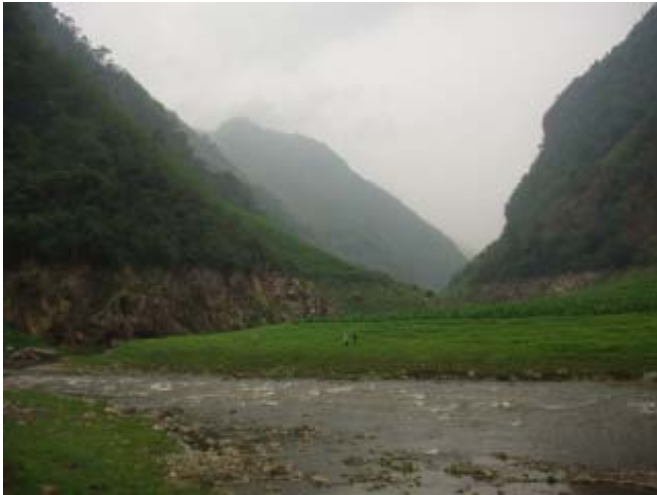
Photo 13

Condition near the Lower Dam axis  
(Steep slopes as 45-50 degrees on the both  
side of the river, same as photo JN5L-3)

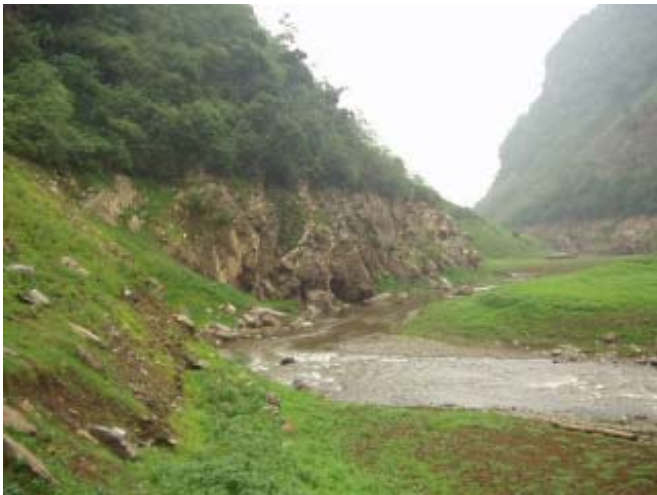
Photo 14

Left side of the slope in the reservoir  
(Limestone outcrops below higher water level  
of Hoa Binh Lake, including some eroded  
holes)

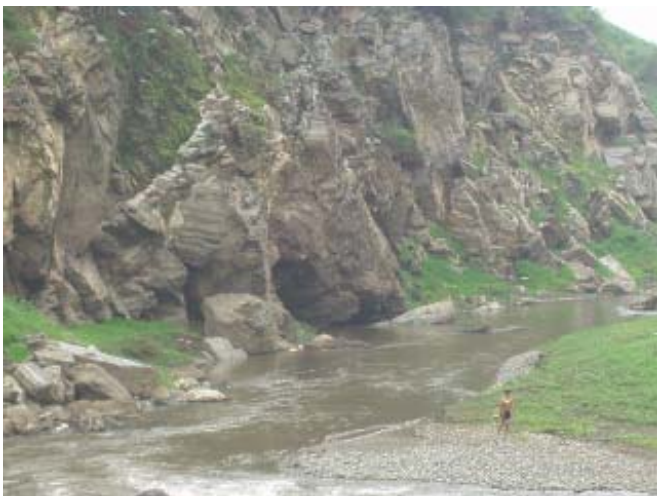
Photo 15

Close up of eroded holes in the limestone  
outcrop  
(as photo above)

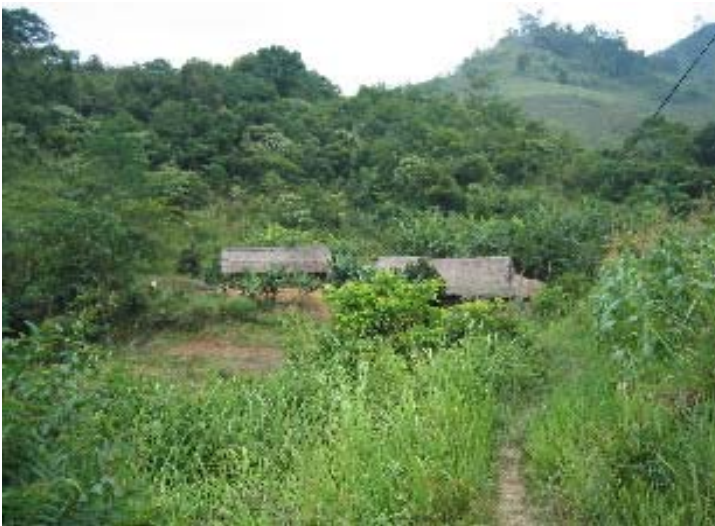
Photo 2

There are a two houses close to the upper dam site. They have rice field in the upper reservoir site.

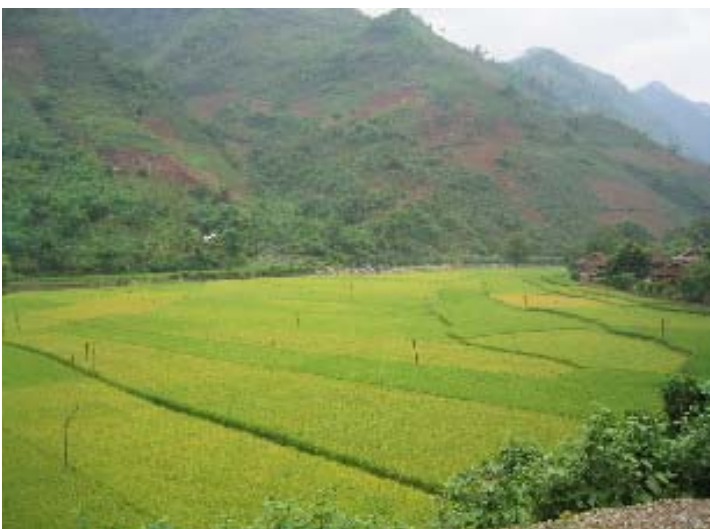
Photo 3

There are rice fields along Sap river, the lower reservoir site. This rice field belong to Keo Lan village.

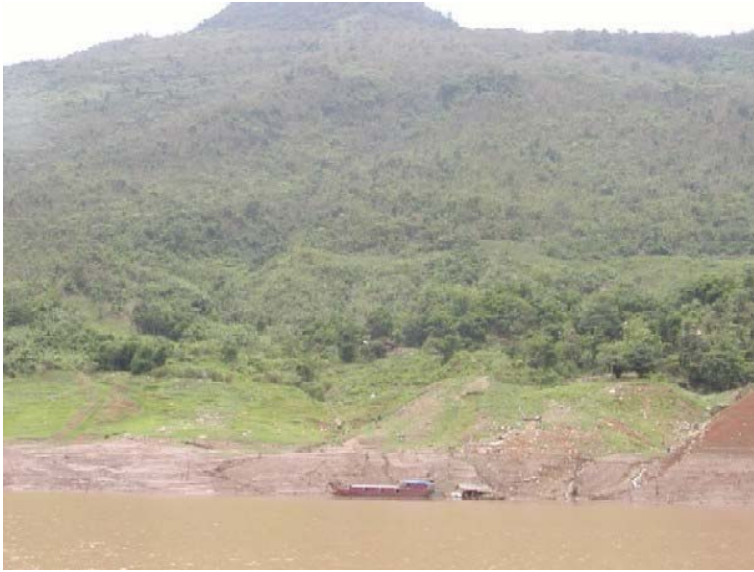
Photo 1

The outlet is planned in the gently sloped small gully.

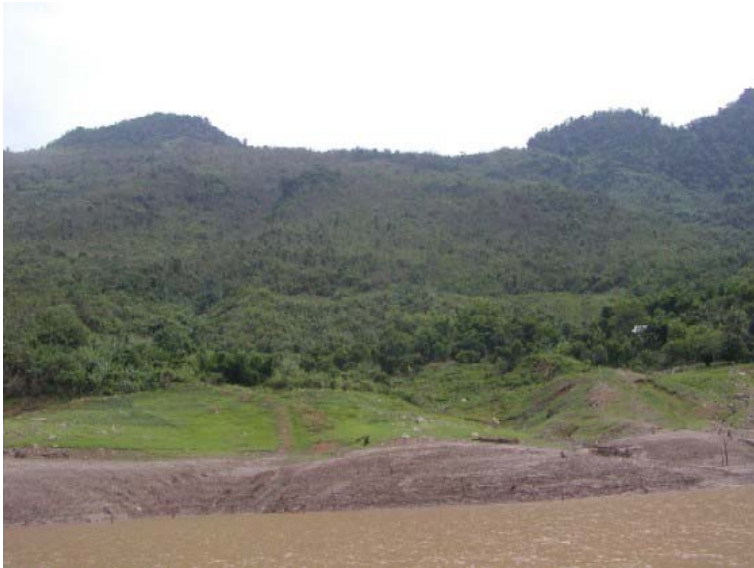
Photo 2

The water level of Hoa Binh Lake was 95 m (20 m lower of H.W.L.). Secondary sediment was found up to H.W.L. of Hoa Binh Lake.

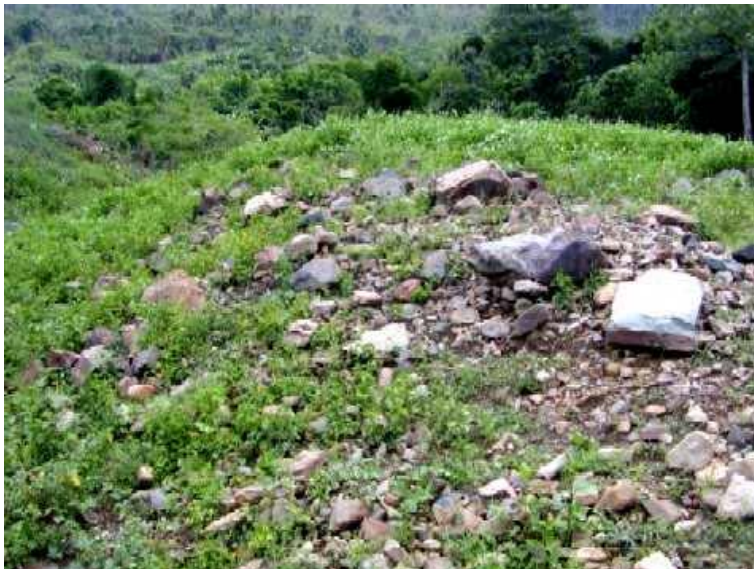
Photo 3

Outcrops were not found around there. Therefore the location of the outlet should be changed.

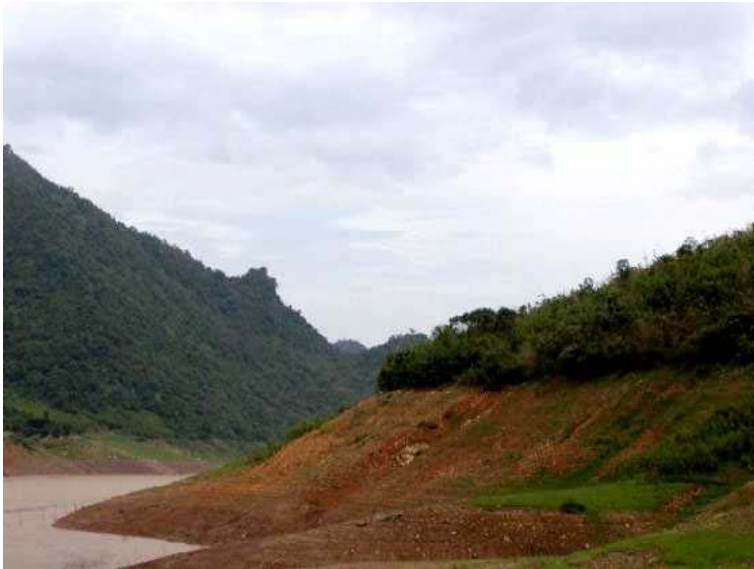
Photo 4

The ridge of the downstream (about 750 m) of the previous plan could be available for the location of the outlet due to little sediment.  
(View from the previous outlet)

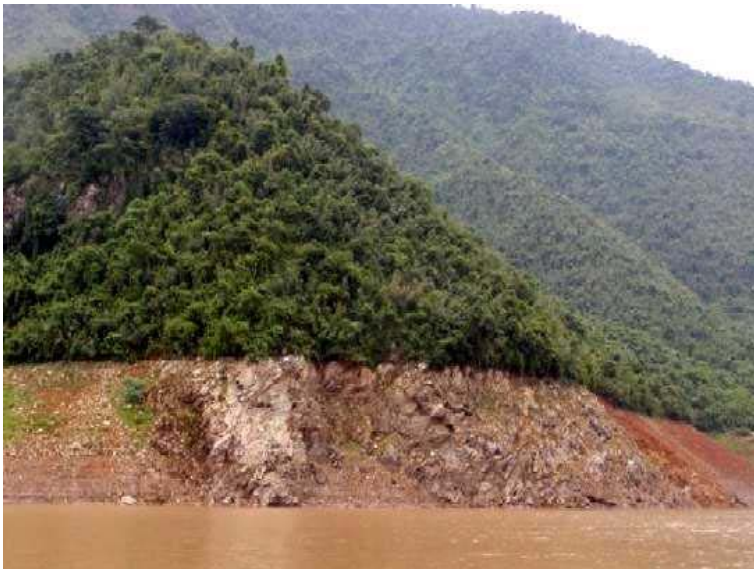
Photo 5

This is the alternative site of the outlet.  
(View from the boat)

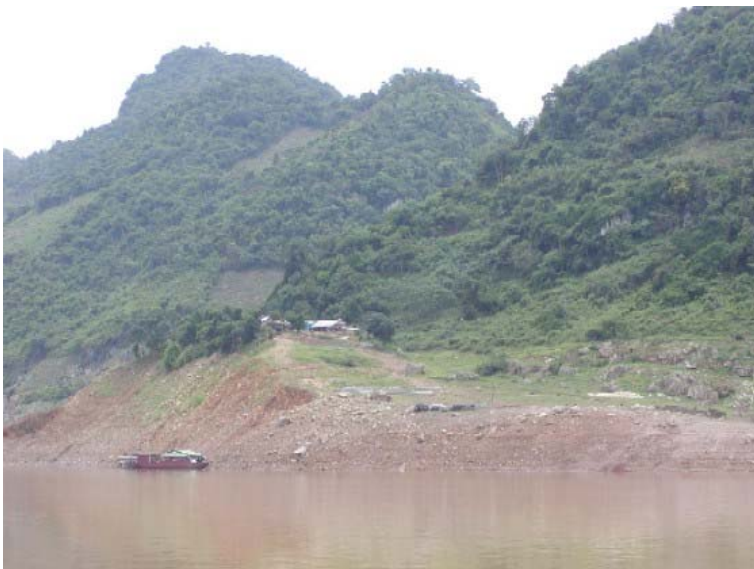
Photo 6

It is necessary to construct a new road about 2.5 km long from Ben Khua village to the outlet.
