P5; Results of the site survey

P5 Geological Section

P5—Geological issues (Outlet & Lower reservoir)

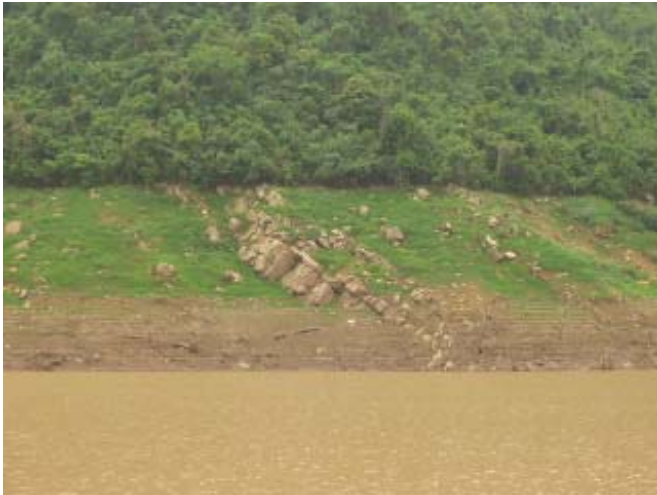
Photo 1

- The number of open hole in the limestone around this area is much more than the other limestone area.
- Outcrops of the limestone in the right side of the Hoa Binh Lake are not clear by the secondary sediments.

Outcrop of limestone
Right side of the Hoa Binh Lake

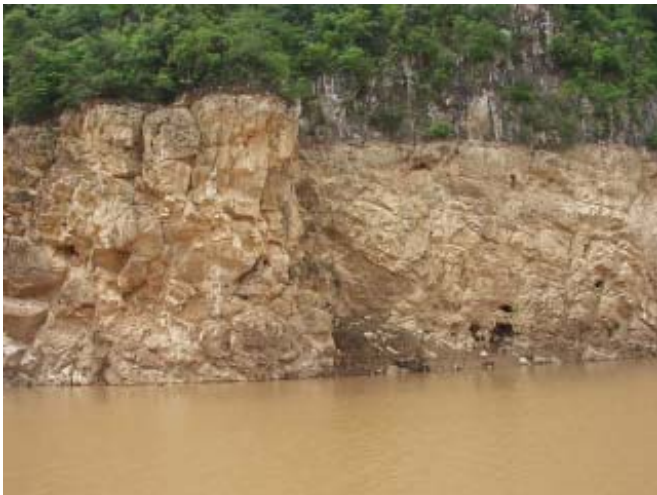
Photo 2

Many open joints are found between the beddings of the limestone and vertical in some places. Dips of the limestone bed are generally 30-40degrees, dips of joints are not only the joints of bedding but nearly vertical. The permeability of rock is probably quite high. The condition of limestone is hard and massive but with many open holes.

Outcrop of limestone
Upstream of the Lower Dam axis of P5

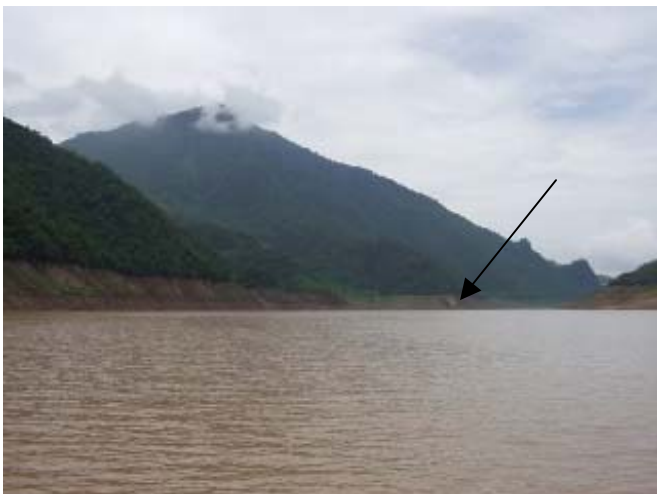
Photo 3

Outcrop of granite
Left side of the Hoa Binh Lake,
Near and upstream of the outlet of P5.

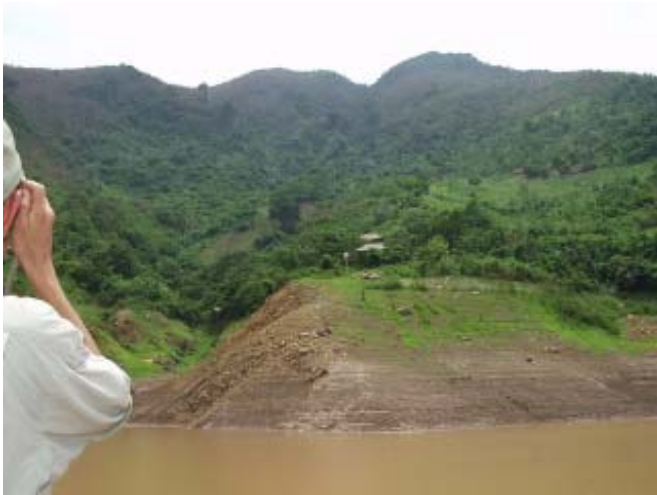
Photo 5

Site around the outlet
