添付資料 4-6-4

第 2 次現地踏査結果 ; JS6 地点

The features of promising potential sites for PSPP

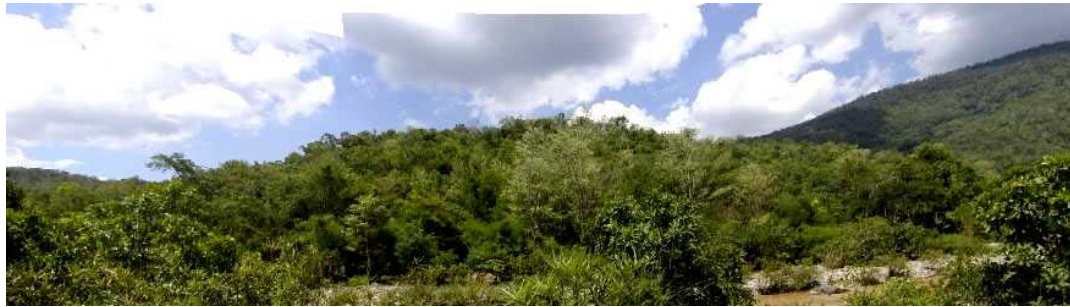
Photo 1

The deep valley, which is about 1km wide, exists on the route of the planned tailrace tunnel.

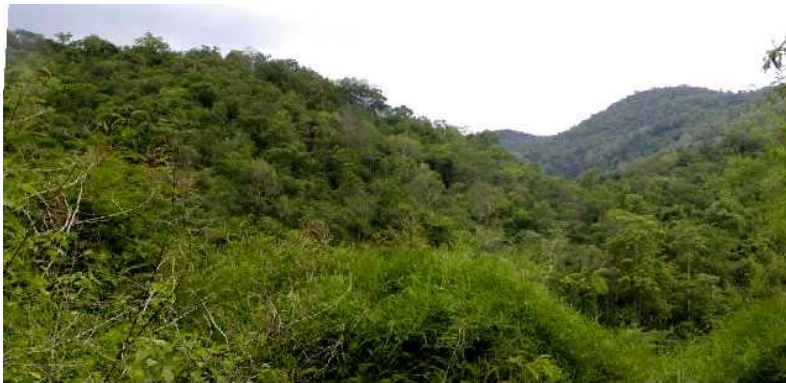
Photo 2

The ridge of the left bank of the planned dam site is quite thin.

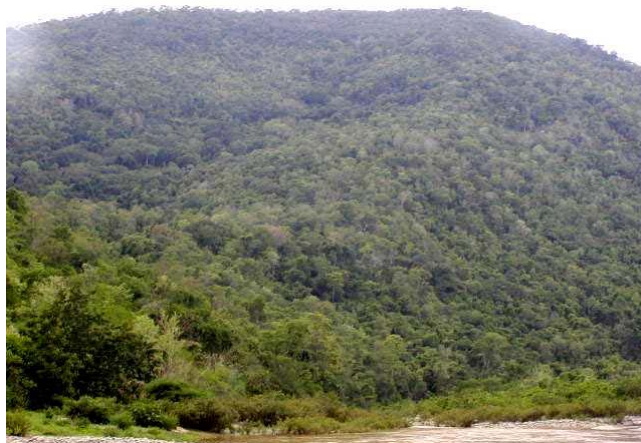
Photo 3

It is necessary to move the dam axis to 300 m downstream, which has a sufficient width and a steep slope.

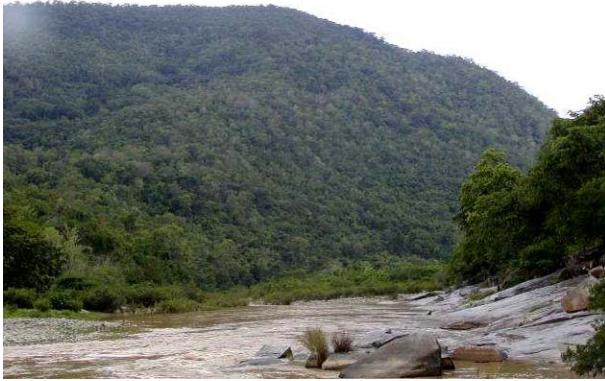
Photo 4

The concrete gravity type dam is suitable for the lower dam. There are outcrops in the riverbed of the dam site.

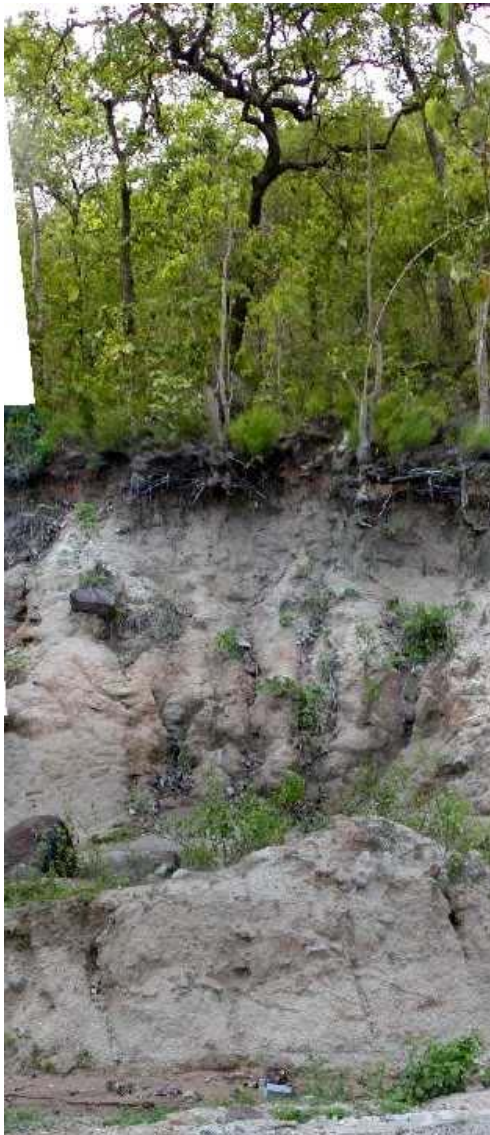
Photo 5

The right bank of the dam site is composed of granite. The surface depth is about 5 m.

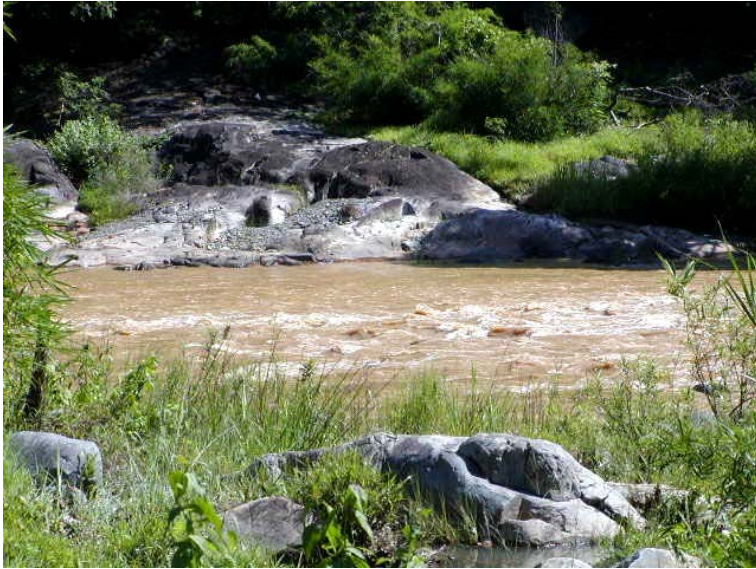
Photo 6

There are outcrops composed of andesite around the upstream of the planned reservoir.

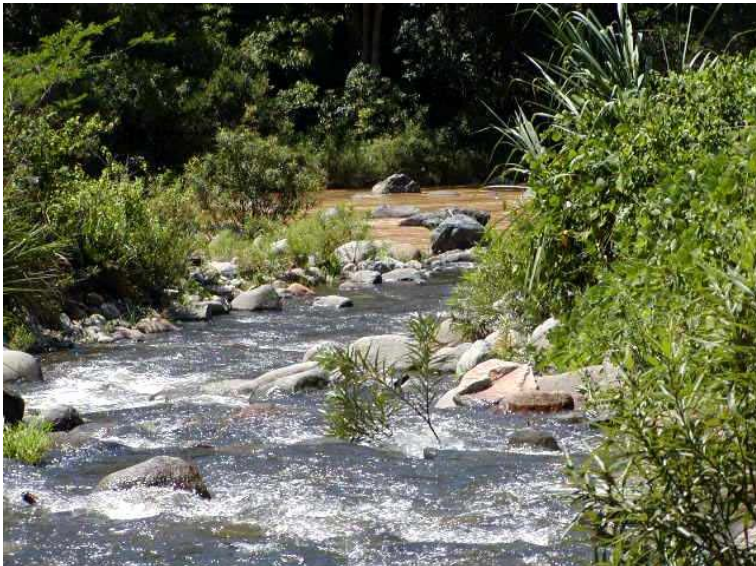
Photo 7

The elevation of 210 m has a junction of the tributary.

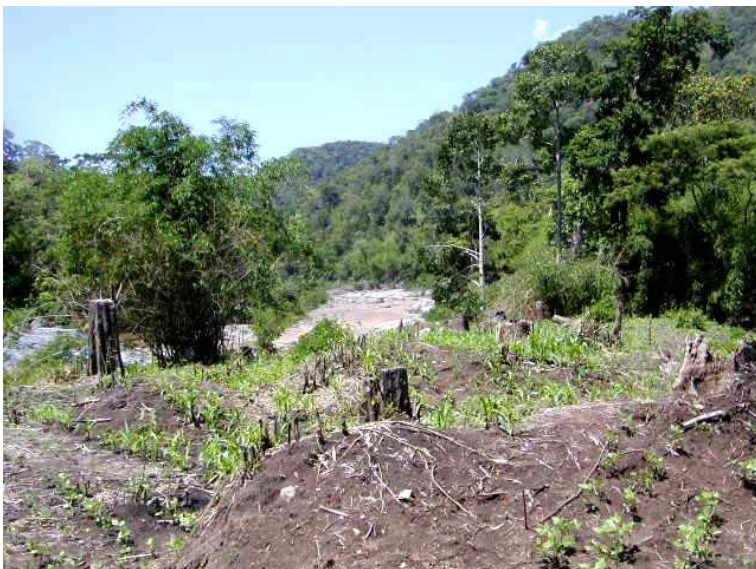
Photo 8

H. W. L. will be 210 m in order to minimize the environmental impact.
