APPENDIX 4-3

Results of the first site reconnaissance

The features of promising potential sites for PSPP

P5 – Upper dam site

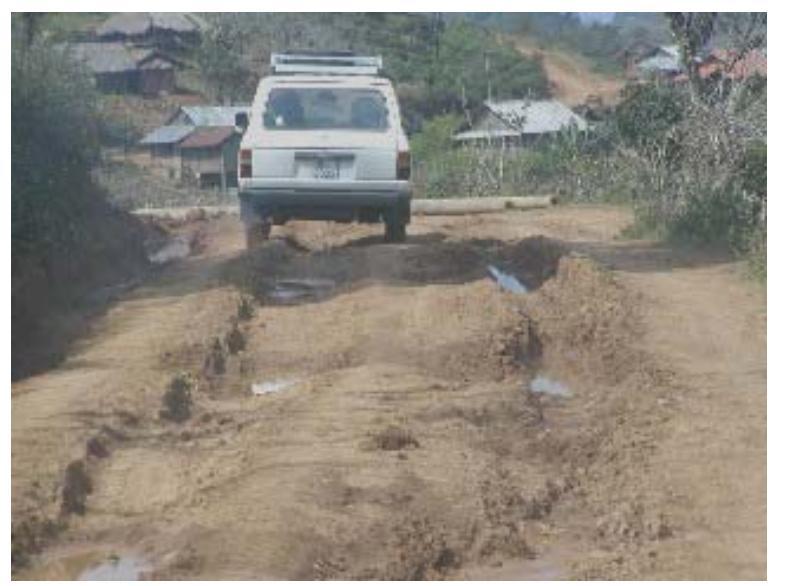
Photo 1

Un-paved road is not condition after rain.

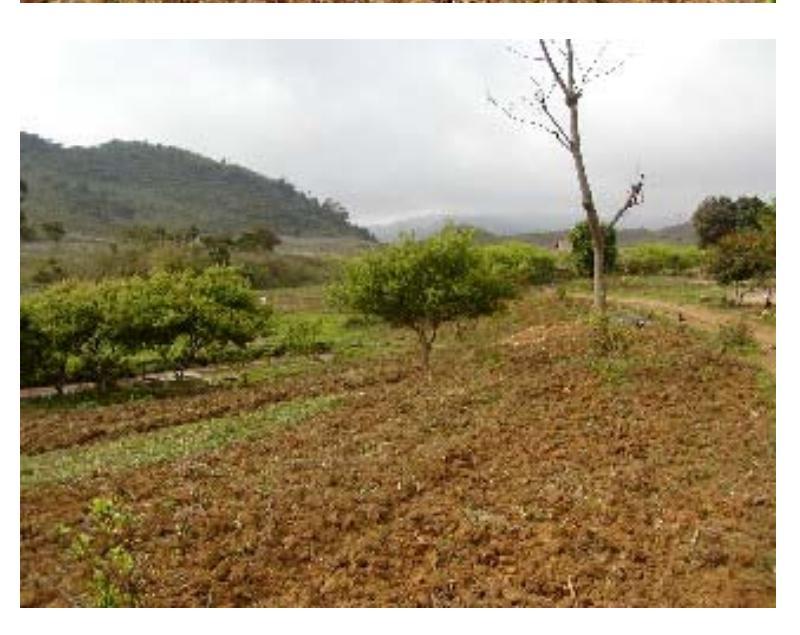
Photo 3

A small valley exists in the upstream side of the reservoir. (View from the west of the reservoir (EL.620m))

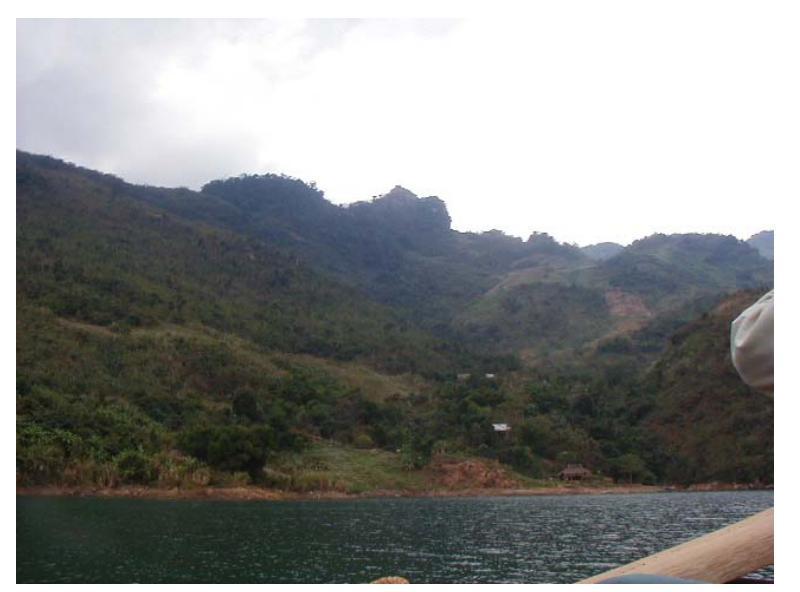
Photo 4

It is thought that a small valley of the downstream of the reservoir is suitable for the location of the outlet.

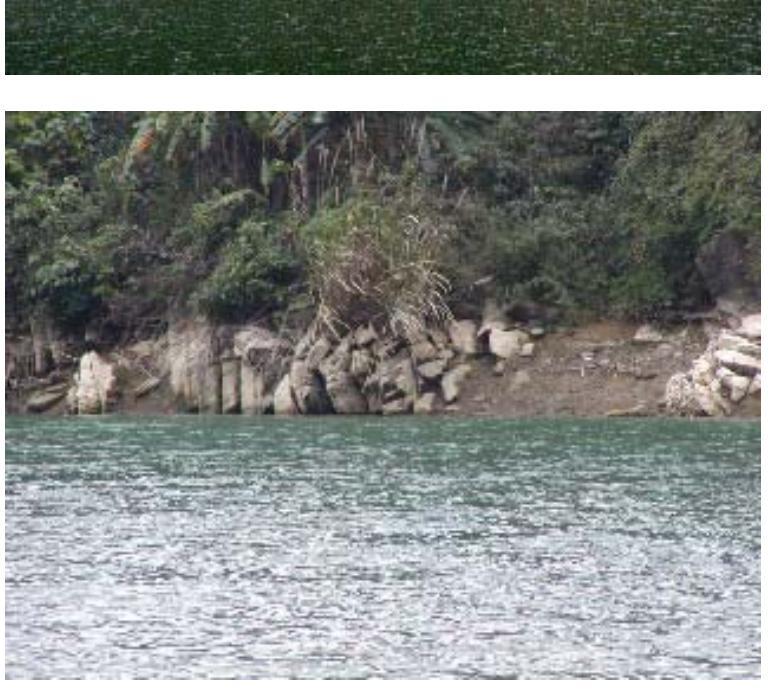
Photo 6

Silurian well-jointed limestone outcropped around the water level in Hoa Binh Lake with 20-30 degrees of beddings and 40-60 degrees in some locations.

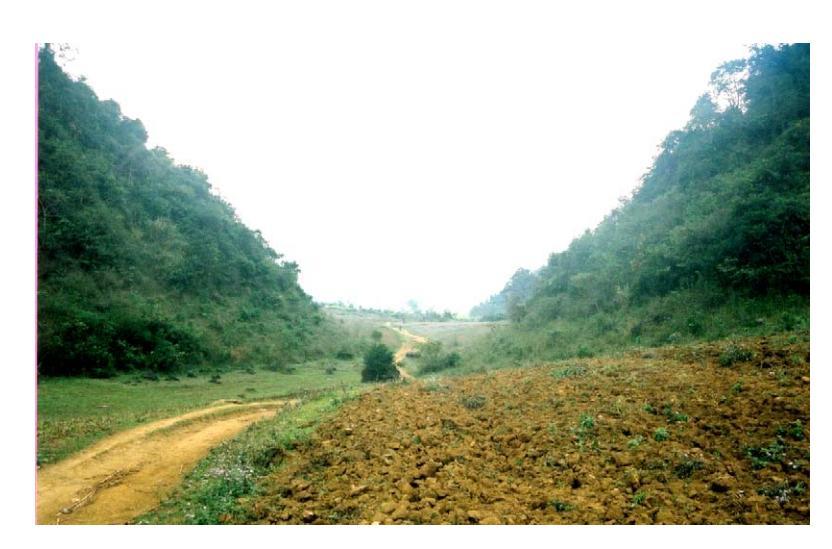
Photo 7

Song Hung village in the proposed upper reservoir.

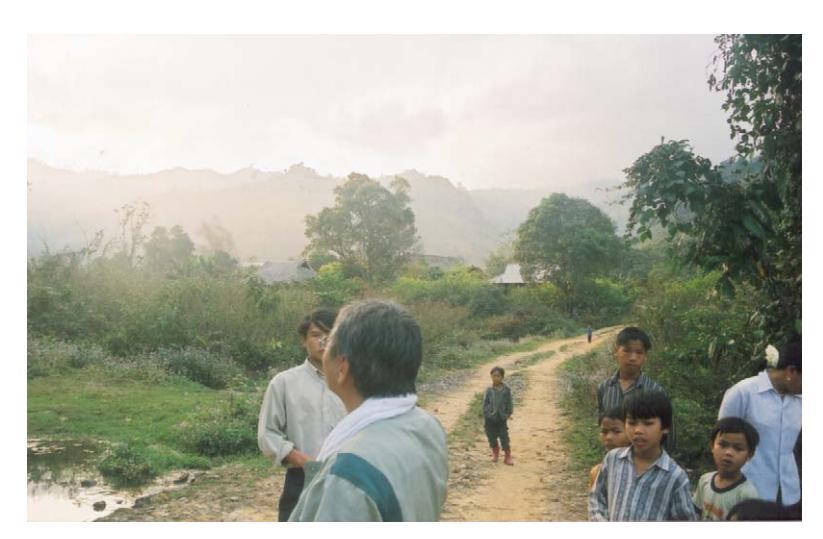
Photo 8

Suoi Ngam village in the proposed upper reservoir.
