## The features of promising potential sites for PSPP

P11B – Upper dam site

P11B – Outlet & Lower dam site

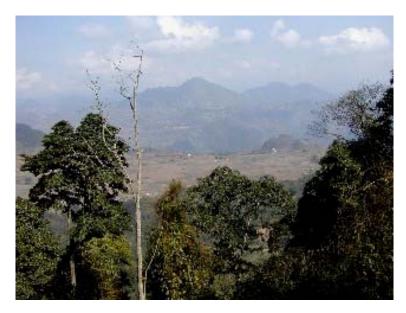
Photo 1

Planned reservoir condition (View from the western slope of the reservoir)

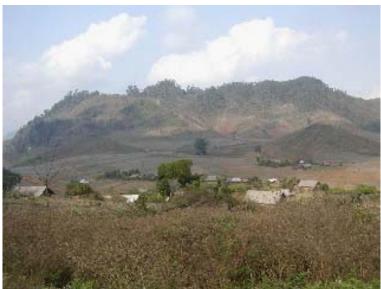
Photo 2

Northeast of the reservoir (View from the upstream of the reservoir)

- The mountains exist in the northeast of the reservoir.

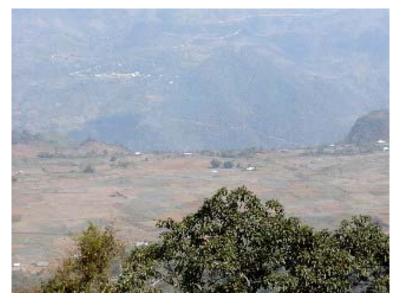
Photo 3

Planned reservoir condition (View from the western slope of the reservoir)

Since the upper dam has a flat topography, the total amount of excavation is presumed to be as much as the reservoir capacity.

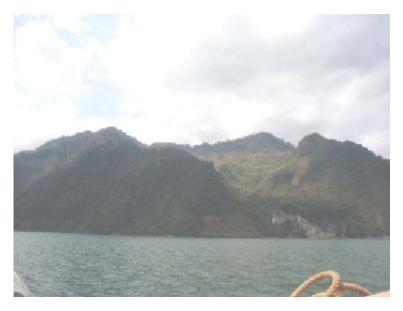
Photo 4

Planned outlet condition (View from a boat)

It is thought that the inlet part is suitable for the location of the outlet.

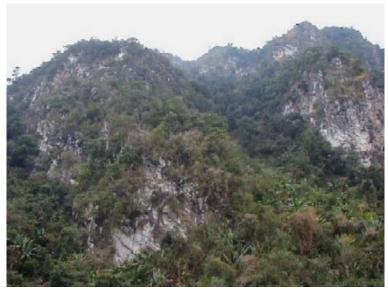
Photo 5

Planned outlet condition (View from a boat)

There are many of the steep slopes of outcropped limestone in higher level.

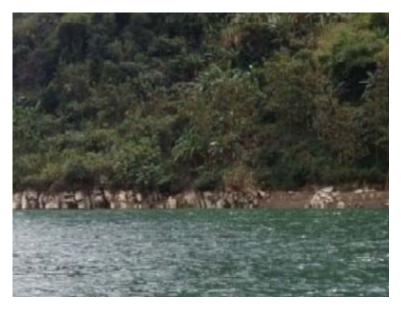
Photo 6

Water level of the reservoir (View from a boat)

Silurian well-jointed limestone outcropped around the water level in Hoa Binh Lake with 20-30 degrees of beddings and 40-60 degrees in some locations.
