JN18 – Upper Reservoir

JN18 - Lower Reservoir

JN18-Environmental issues

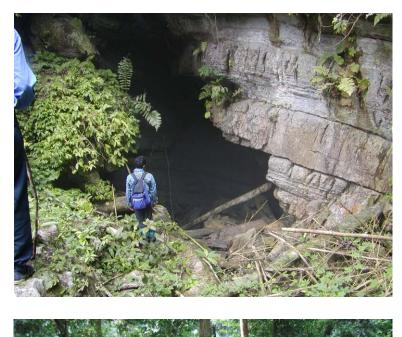
Photo 1

A cave, where the streamline disappears. All water flow into this cave during flood season. Above the cave is vertical rock surface similar to what can be seen on the right side of this picture. This makes the initial plan for dam-typed reservoir impossible or risky.

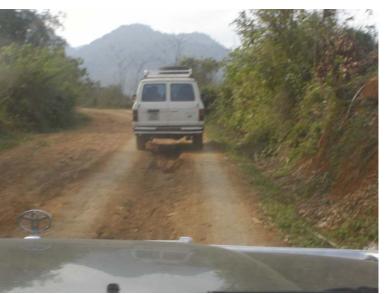
Photo 2

Center of a wide area through with the Lo Lang stream flows. This is the alternative site for bondage-type upper reservoir.

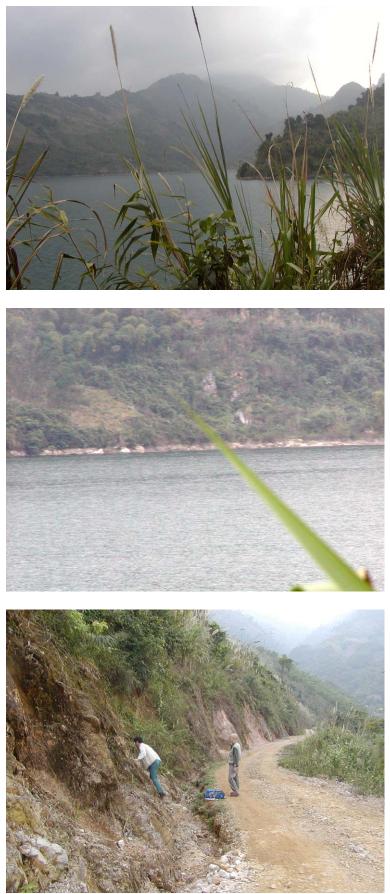
Photo 4

The planed location for the outlet when looked from on the other site of Hoa Binh reservoir.
