APPENDIX 4-6-1

Results of the second site reconnaissance; JN3

The features of promising potential sites for PSPP

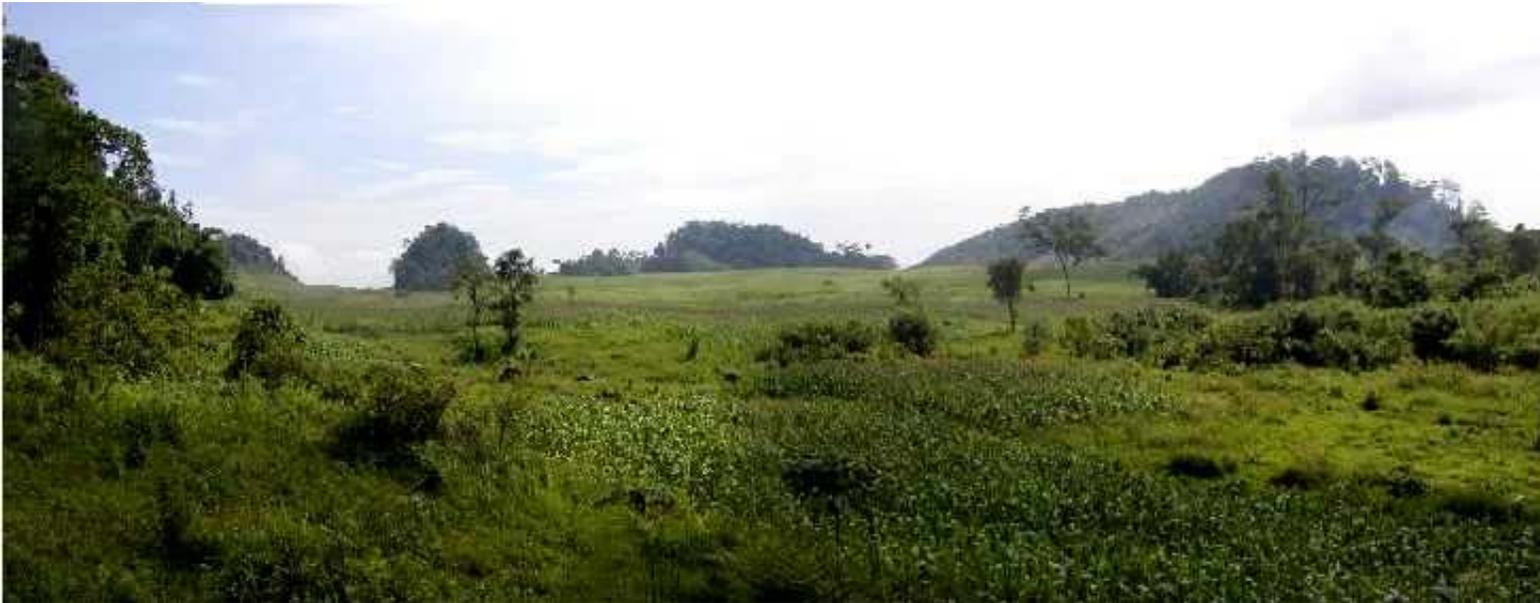
Photo 1

Facing type poundage is suitable for the upper reservoir, which H.W.L. is 880 m based on the topographical condition.

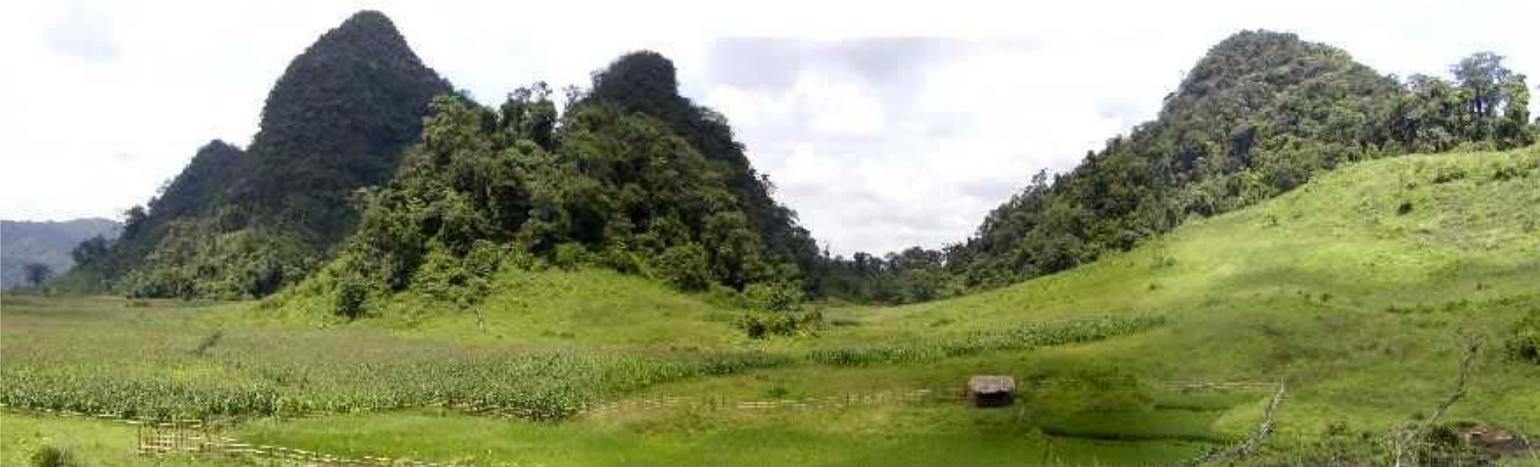
Photo 2

There are mountains composed of limestone in the west side of the plain. A spring is there at EL.860 m of the north part of the reservoir, which makes a paddy field.

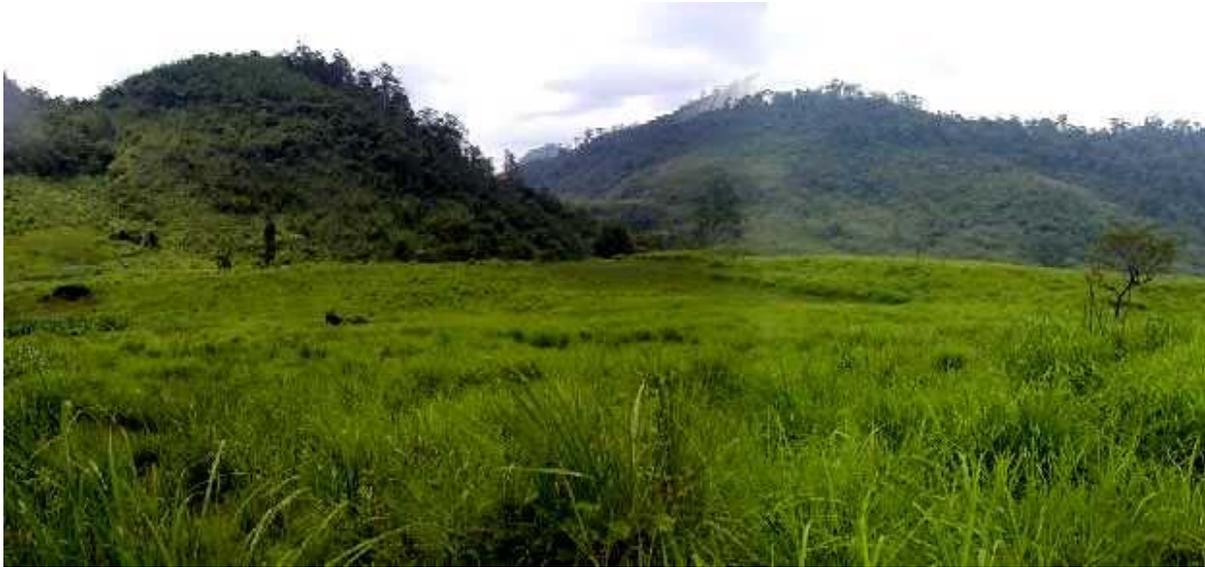
Photo 3

A small hill around EL. 870 m lies from north to south on the center of plain. Location of the reservoir will be shifted to the west part to use the hill as a bank of the reservoir.

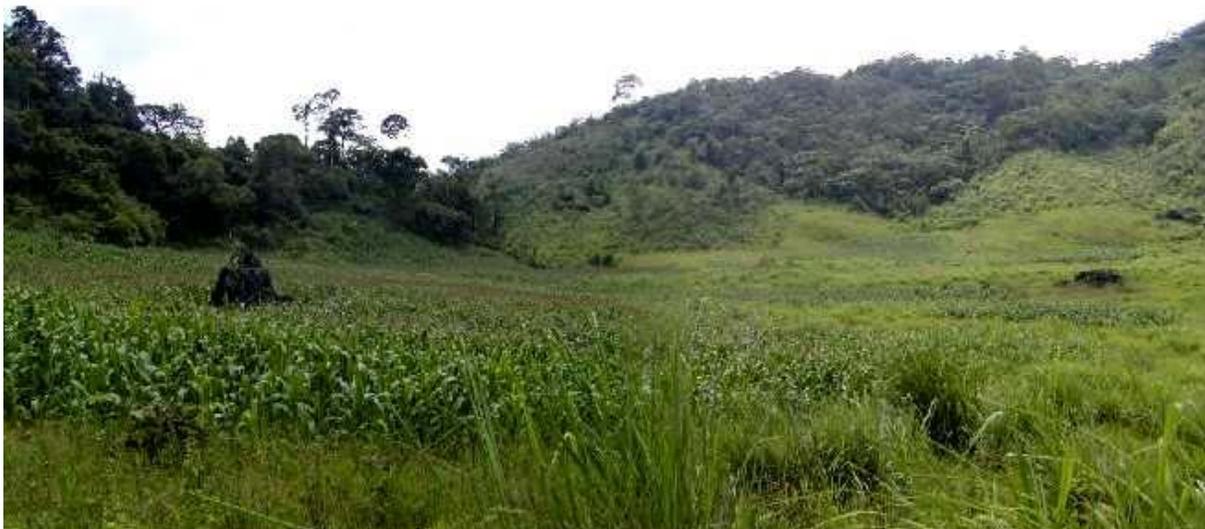
Photo 4

Since the planned intake is situated at the east bank of the reservoir, it is necessary to shift its position to the west of the bank.

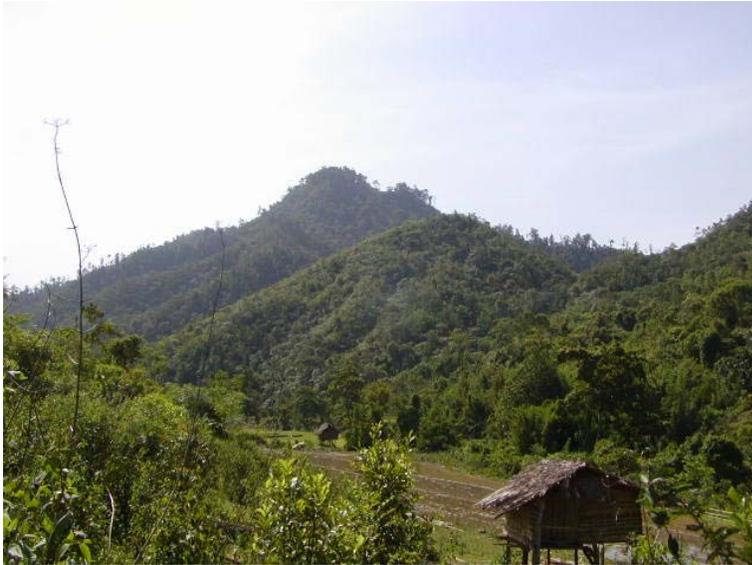
Photo 5

The mountain is at the dam site, looking from the upstream of the main river.

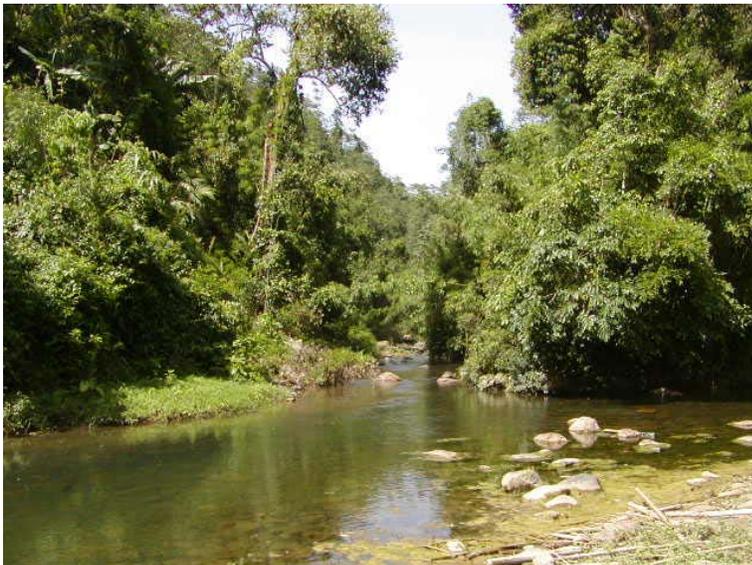
Photo 6

This is the junction of the main river and the tributary that has a dam site.

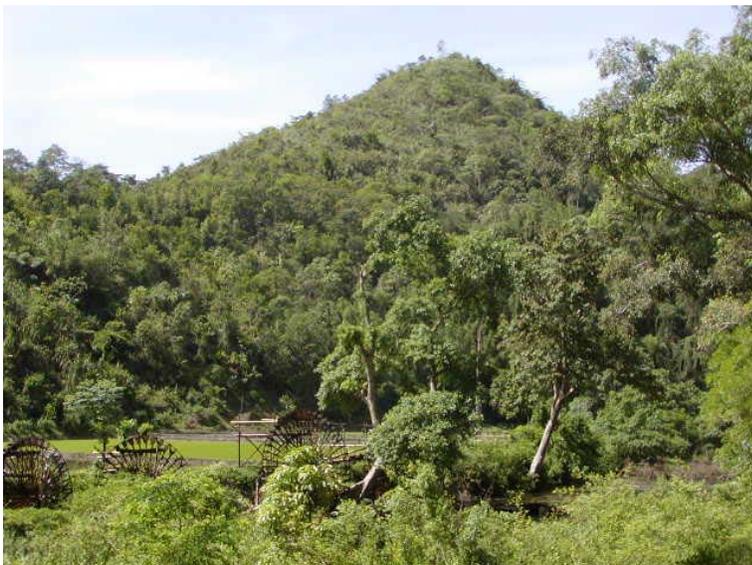
Photo 7

This is around pumping system to store up water from the main river.

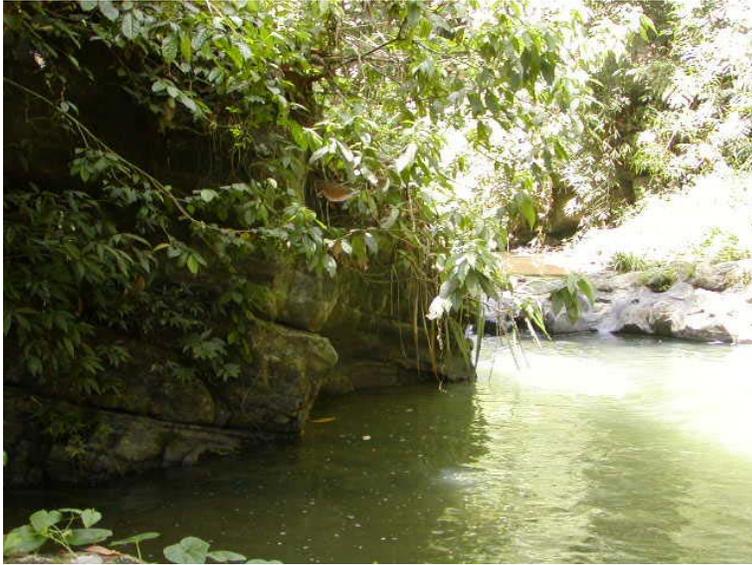
Photo 8

There are outcrops composed of shale around the riverbed of the planned dam site.

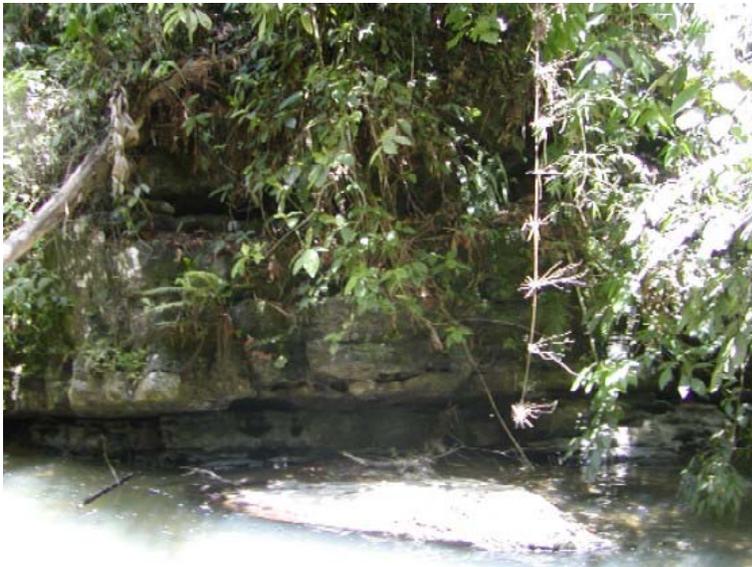
Photo 9

Left bank of the dam site.
(Around riverbed)

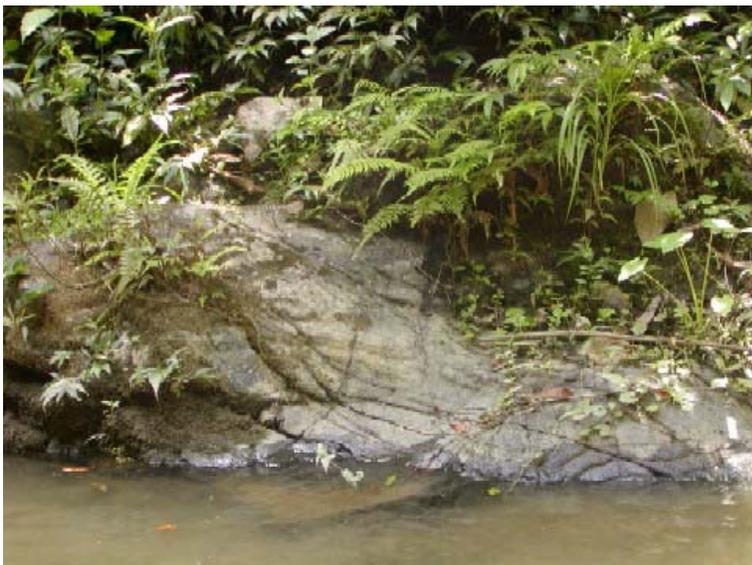
Photo 10

Right bank of the dam site.
(Around riverbed)

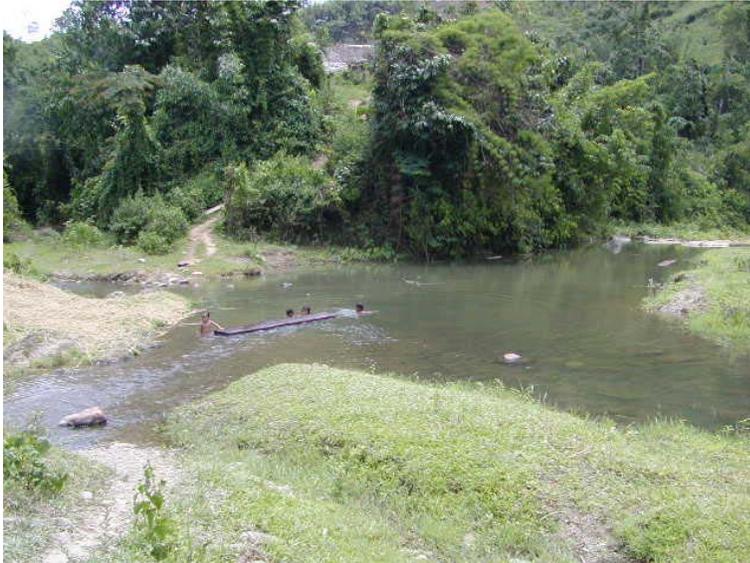
Photo 11

The location of the cofferdam will be selected between the junction of three tributaries and the dam site.

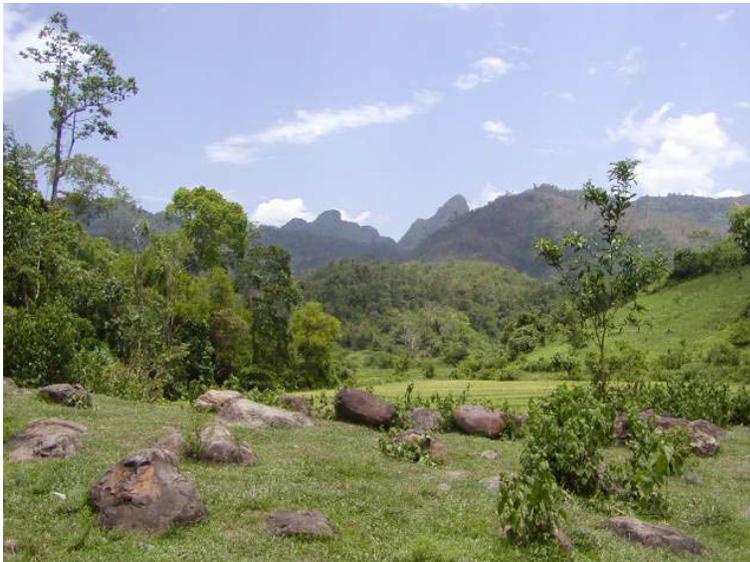
Photo 12

H.W.L. of the planned lower reservoir is 280 m based on the topographical condition.

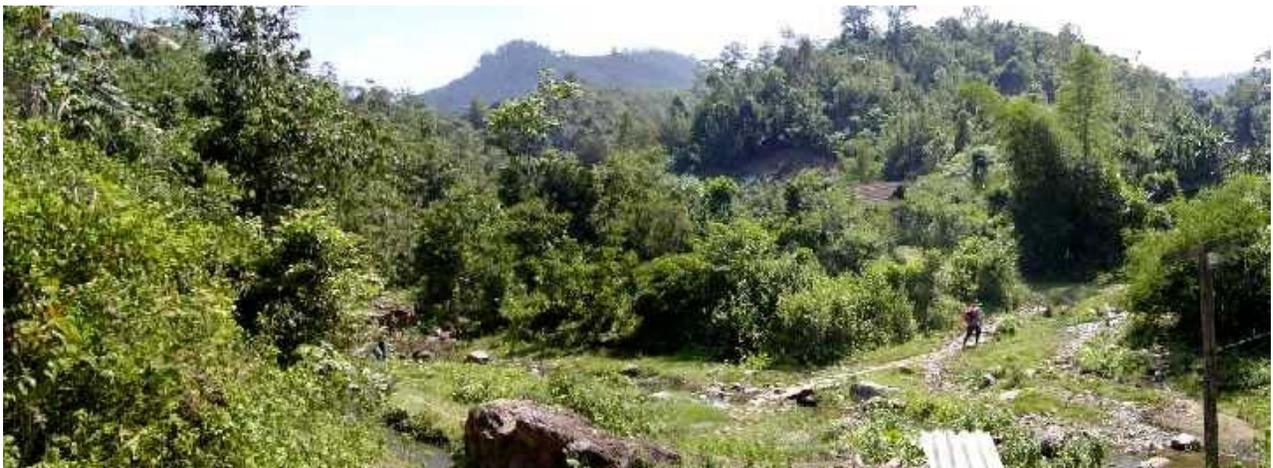
Photo 13 The location of the outlet will be planned under the largest ridge in the surrounding area.
