APPENDIX 4-6-2

Results of the second site reconnaissance ; JN5

The features of promising potential sites for PSPP

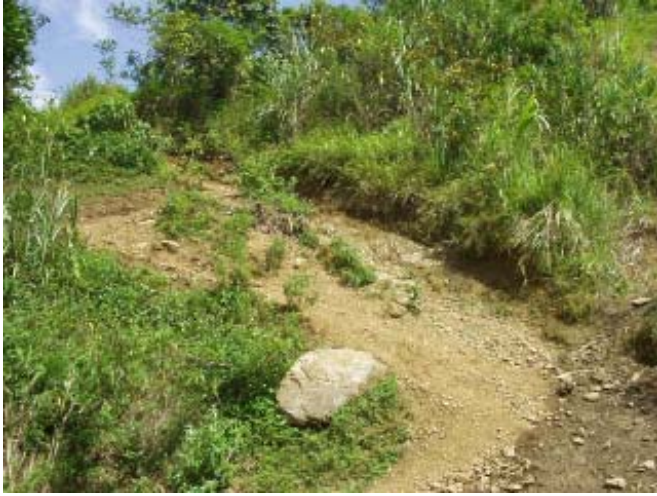
Photo 1

Footpath to the Upper Reservoir

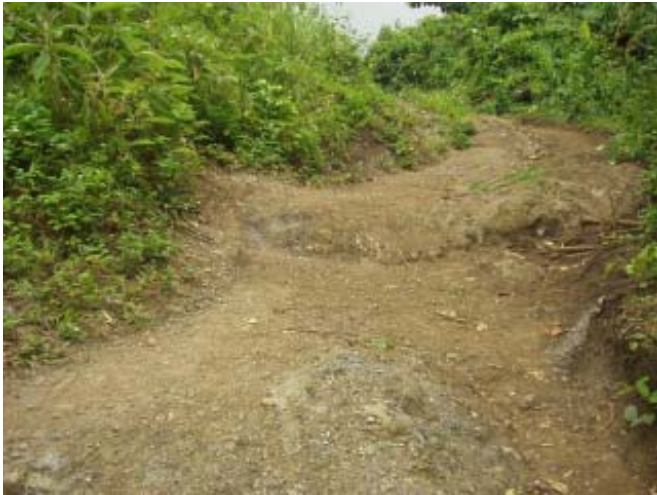
Photo 2

Outcrop of slightly fractured shale

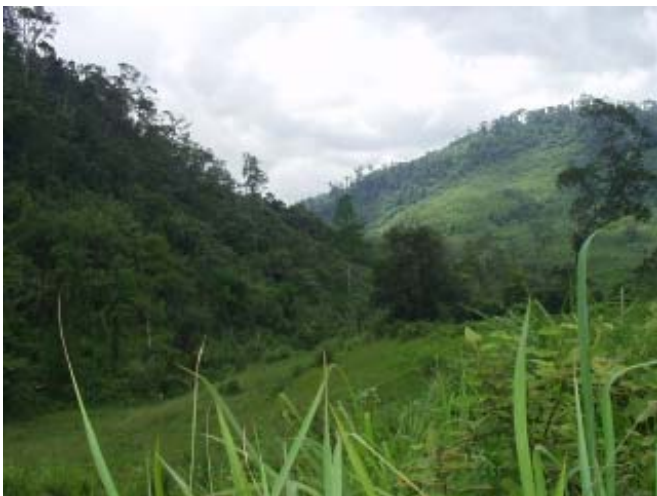
Photo 3

Small hill in the Reservoir

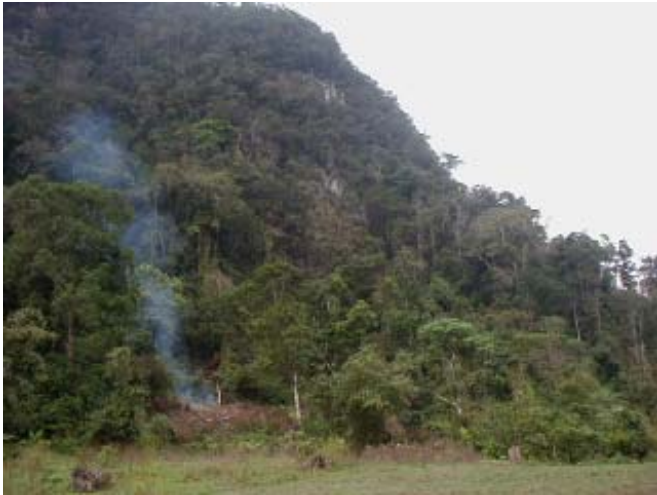
Photo 4

Right side of the Reservoir
Steep slope of the limestone outcrop

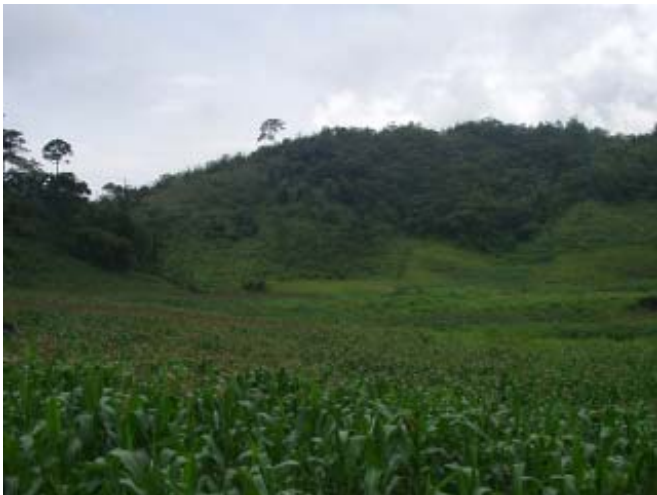
Photo 5

Left side of the Reservoir

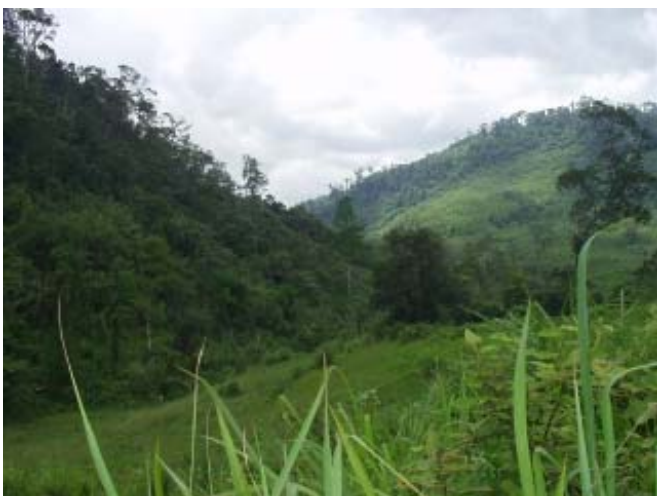
Photo 6

Small stream in the left side of the
Reservoir
(geological boundary of limestone
and sedimentary rocks)

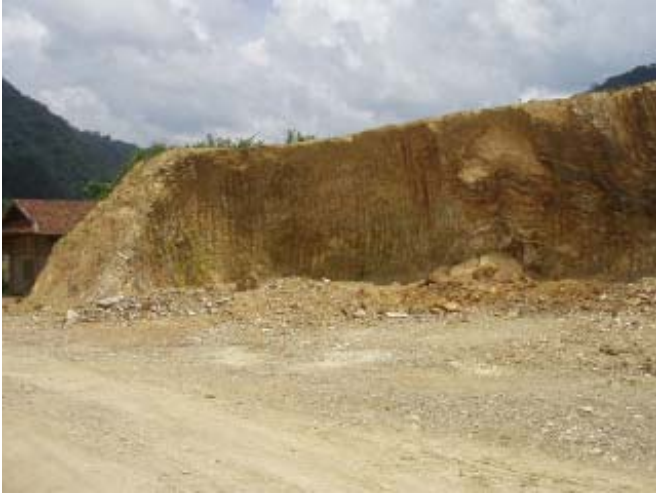
Photo 7

Fractured zone in the Road

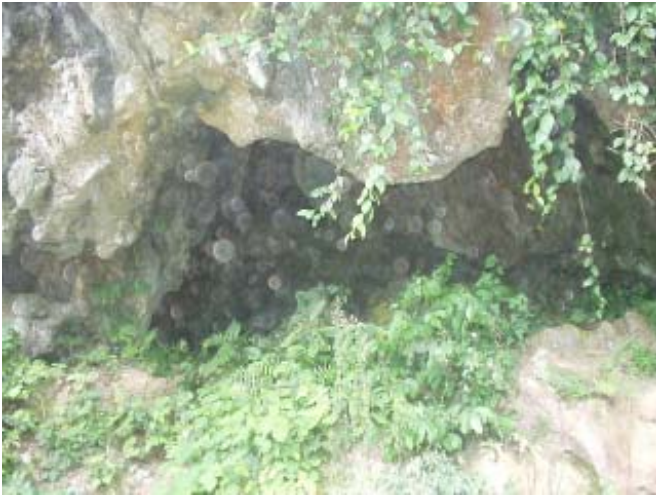
Photo 8

Cave in the limestone along the road

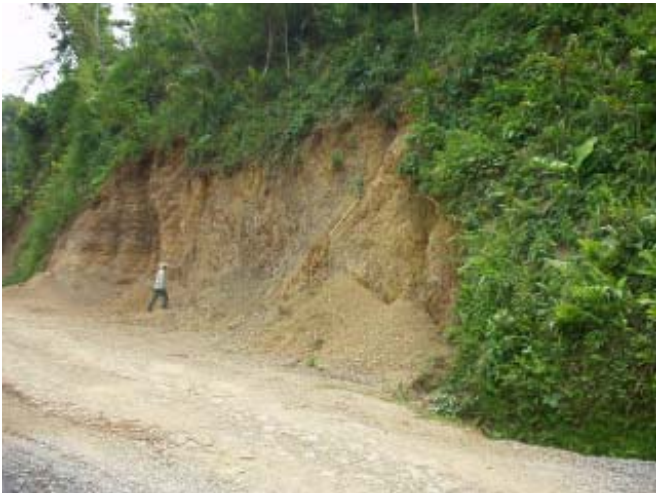
Photo 9

Fractured zone along the road to
Phu Yen

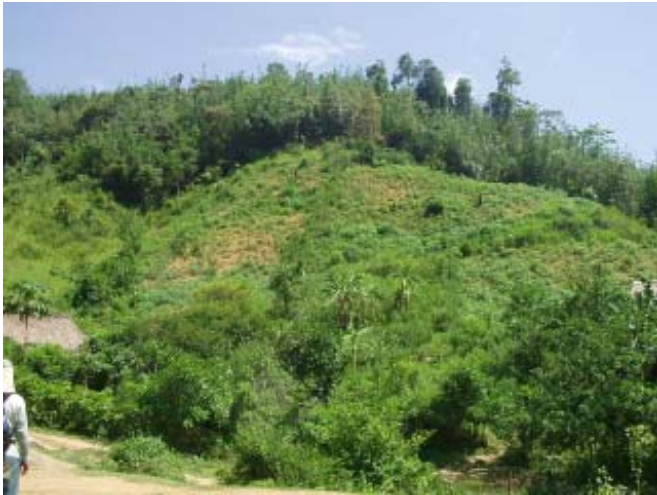
Photo 10

Topographical condition in the Lower Reservoir
(Around the outlet, near the geological boundary on D1st and D2ebn as clayish shale)

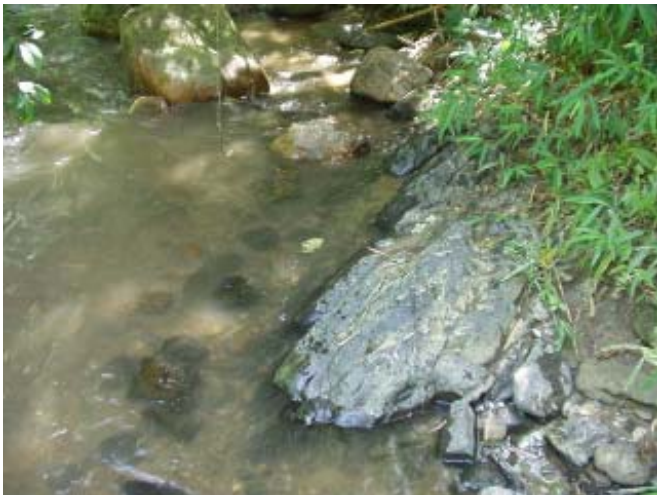
Photo 11

Condition of the outcrop (shale) in the riverbed to the Dam axis
(Clayish shale with no limestone, hard and massive)

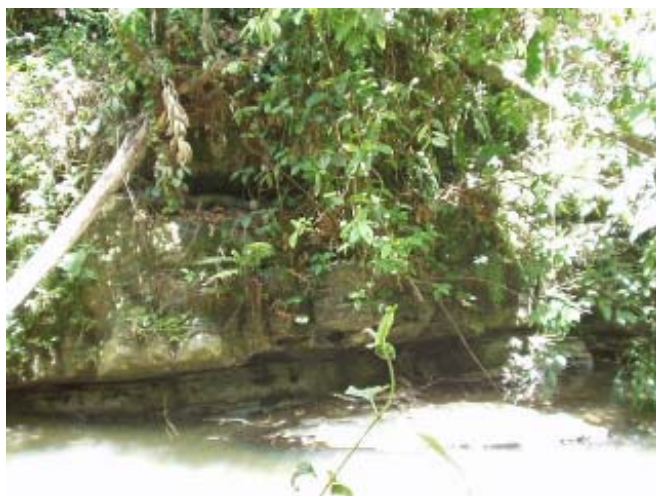
Photo 12

Outcrop of the shale near the Dam axis (thin beds of selective erosion in the clayish shale with limestone)

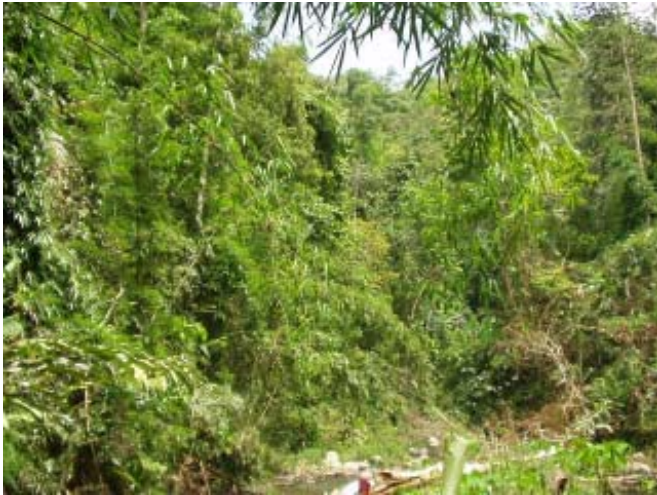
Photo 13

Saddle of the left side hill
(No features of the structural weak zone)

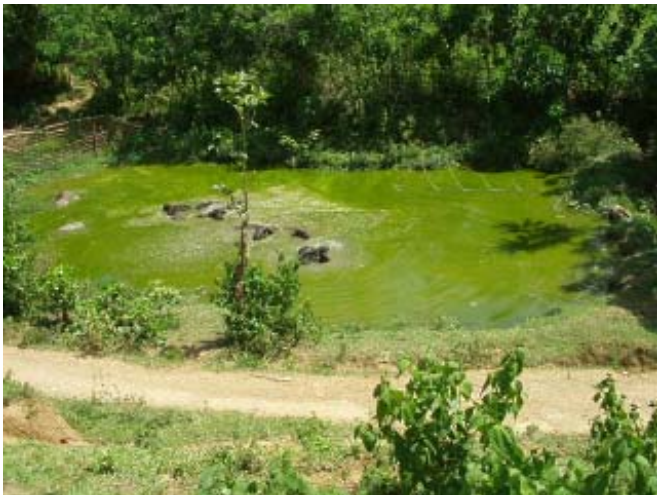
Photo 14

Condition around the bottom of the Reservoir

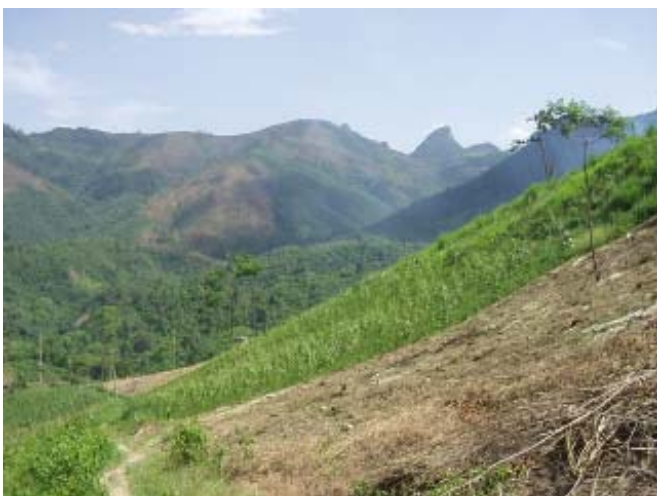
Photo 15

Topographical condition around the upstream of the Reservoir
(Clayish shale)

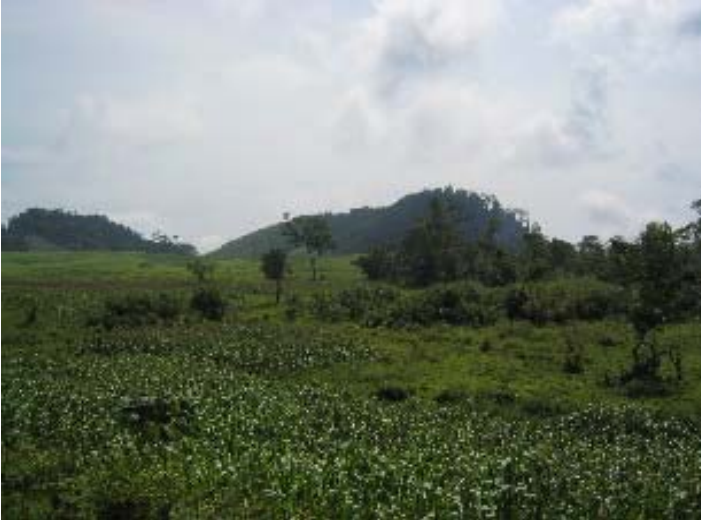
Photo 1

The upper reservoir site was seen from the southwest point. The site is flat and is used for agriculture and grazing buffalo.

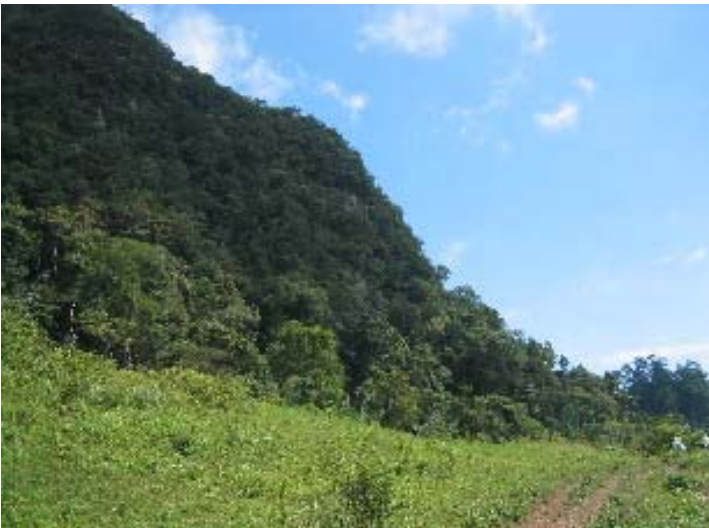
Photo 2

The mountain located west of the upper reservoir site is covered with good secondary forest.

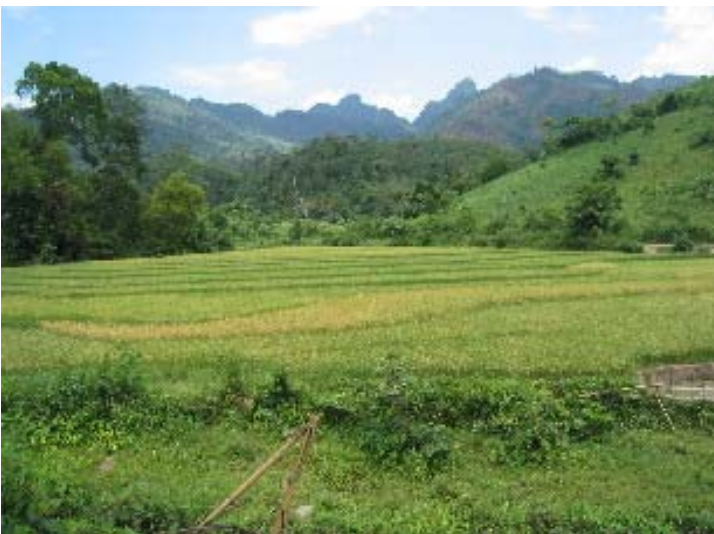
Photo 3

There are rice fields in Thung Lang village at the lower reservoir site.

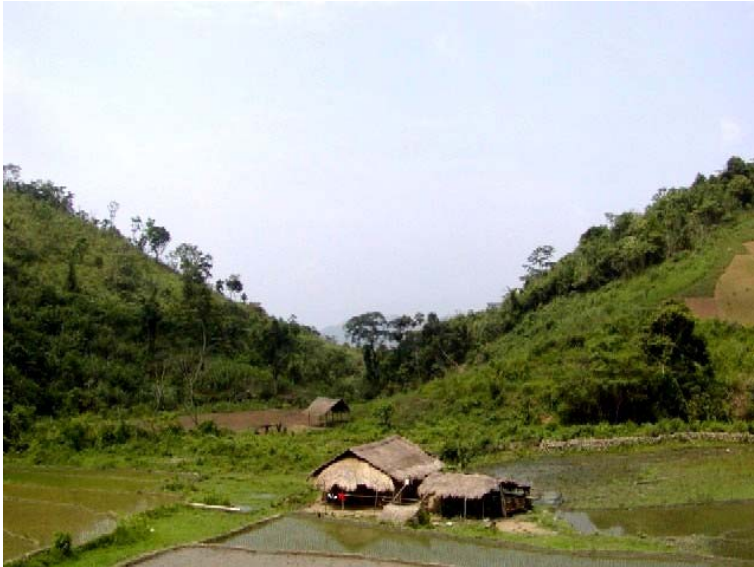
Photo 1

The ridge of the right bank of the planned dam site is a thin and slope is rather gentle. The ridge of left bank has a sufficient width and slope is rather gentle.

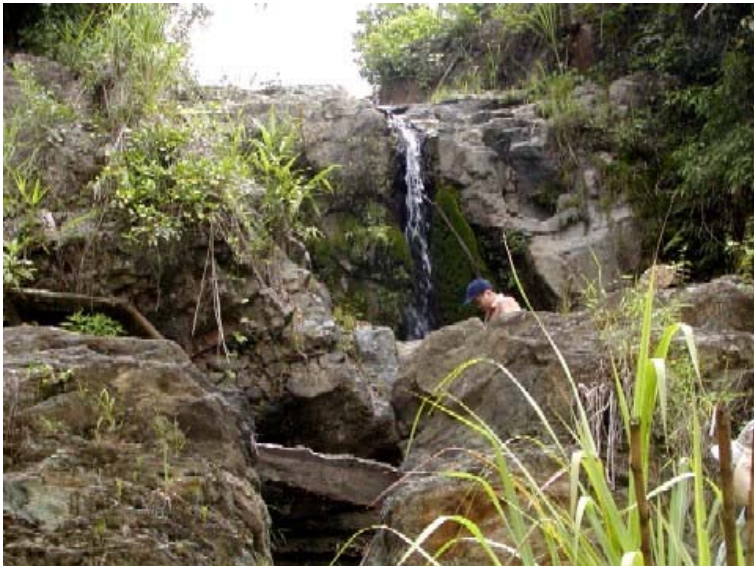
Photo 2

There is a waterfall at the dam site, which is about 5 m height, and outcrop is tuff.

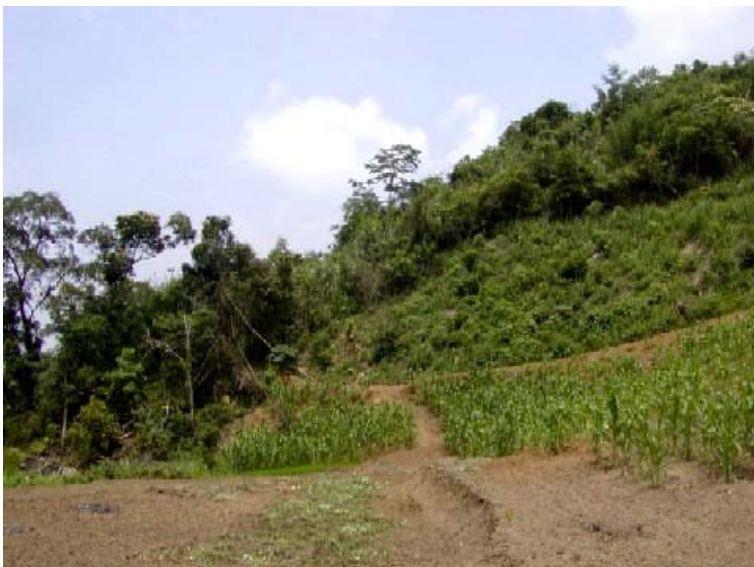
Photo 3

Topography of the upstream of the waterfall is wide and flat, where are used for crop field, and outcrops were not found.

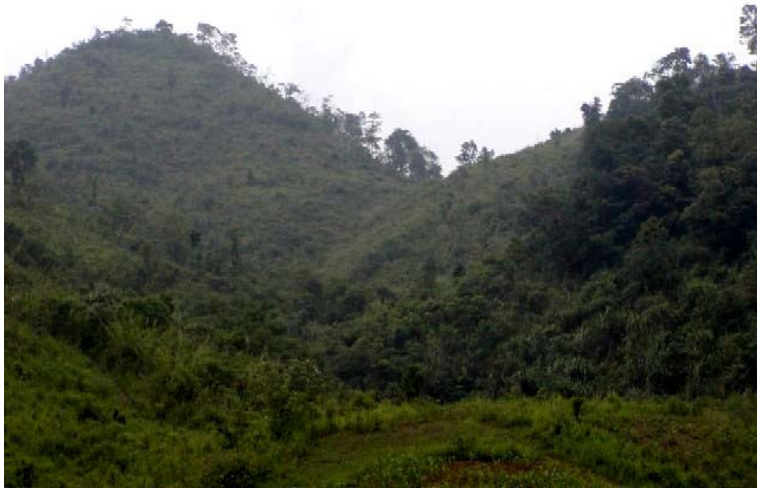
Photo 4

There is a highly weathered col, whose elevation is as low as around 735m, in a series of mountain of the left side of the reservoir.

<p>(Outlet)</p> <ul style="list-style-type: none"> • Checking the geological conditions 	<ul style="list-style-type: none"> • Geological condition of limestone area is generally same as the lower dam site.
	<p>(Others)</p> <ul style="list-style-type: none"> • Checking the condition around the fault zone through the Lower Reservoir 	<ul style="list-style-type: none"> • No features of the structural fault zone was identified. Not only the big one reported in the published map, but also the cohesive weak zone probably exists around the lower dam site.
	<p>(Overall)</p> <ul style="list-style-type: none"> • Checking the geological conditions 	<ul style="list-style-type: none"> • Bottom level of the lower dam is planned between high and low water level of Hoa Binh Lake. Therefore two cofferdams are necessary. • Since small valleys are developed in the upper reservoir area and elevation of some cols are lower than that of topographic map, a saddle dam and curtain grouting will be required as a countermeasure.

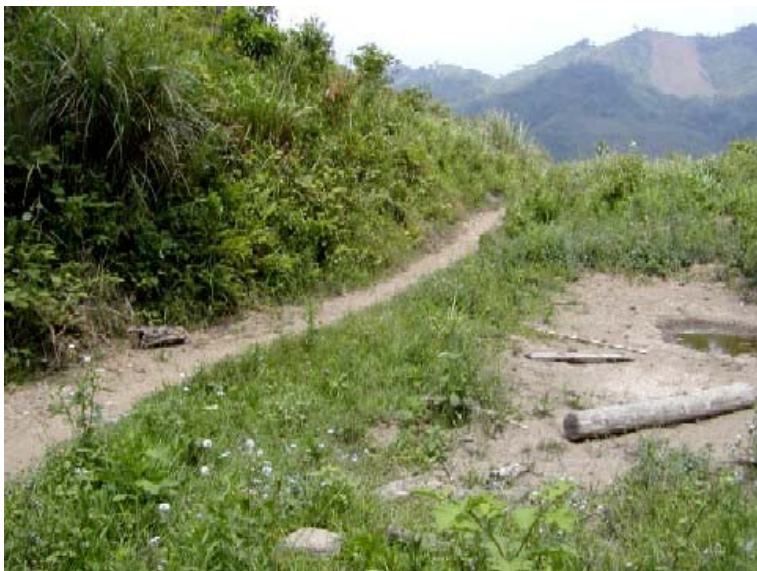
Photo 5

The thin ridge of 35 m long exists in the east part of the reservoir.

Design	<p>(Upper dam/reservoir)</p> <ul style="list-style-type: none"> • Property of the proposed dam axis <p>• Checking the thin ridge of the left valley</p>	<ul style="list-style-type: none"> • There is a waterfall at the dam site, which is about 5 m height. The slope of the riverbed becomes steep downstream from this waterfall. Topography of the upstream of the waterfall is wide and flat, where are used for crop field, and outcrops were not found. • Therefore, the dam axis will be selected at the major ridge in the downstream of the waterfall. • The ridge of the right bank of the planned dam site is a thin and slope is rather gentle. The ridge of left bank has a sufficient width and slope is rather gentle. • Fill-type Dam is not suitable in view of topographic conditions such as steep river slope in the downstream of the waterfall. • The watershed of the upstream of a planned reservoir is 740 m high. • There is a highly weathered col, whose elevation is as low as around 720m, in a series of mountain of the left side of the reservoir. • Therefore countermeasures for stop the leakage ,such as saddle dam /grouting, will be required.

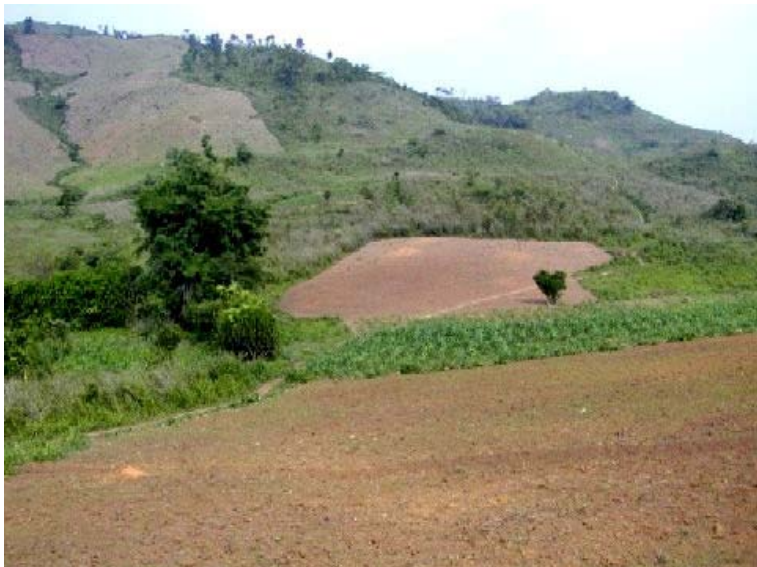
Photo 6

The watershed of the upstream of a planned reservoir is 740 m high.

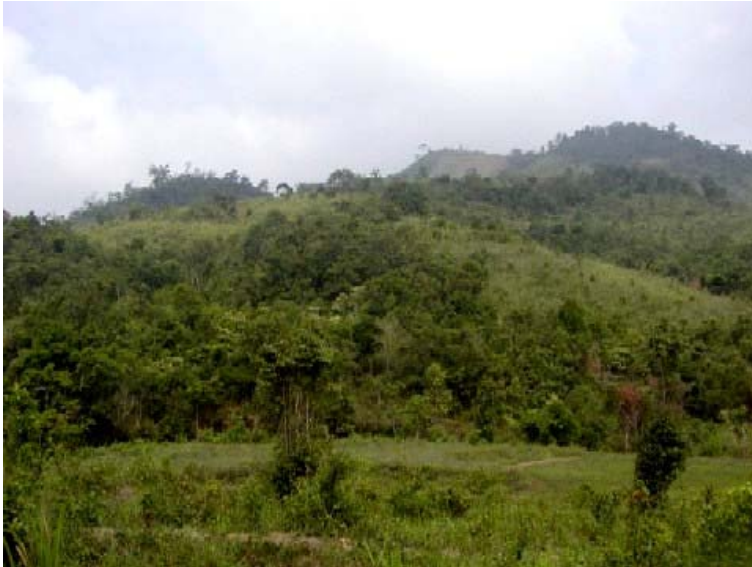
Photo 7

The location of the intake is planned in the ridge, which has a sufficient width and a gentle slope.

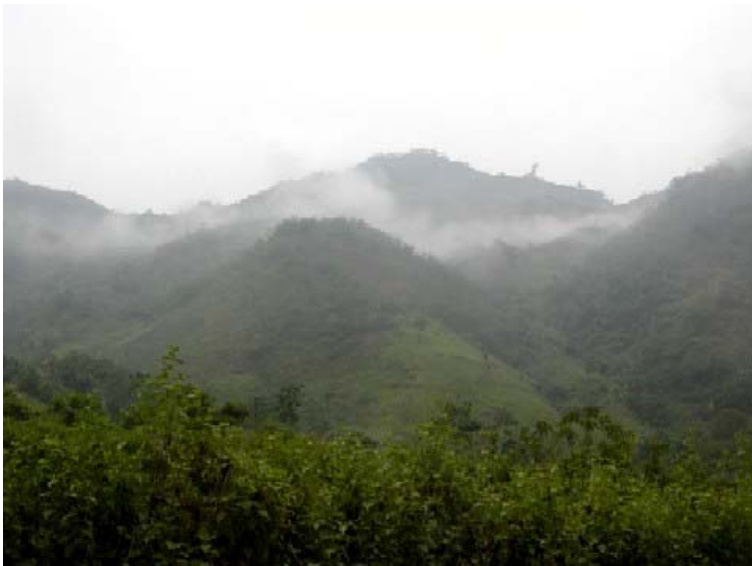
Photo 8

The approach tunnel to the underground powerhouse is planned in secondary sediments.

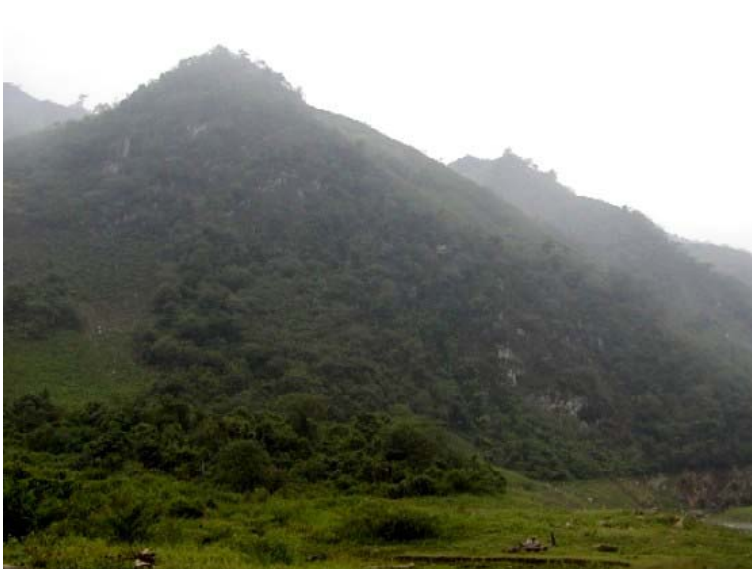
Photo 9

It is necessary to move to the downstream of the ridge.

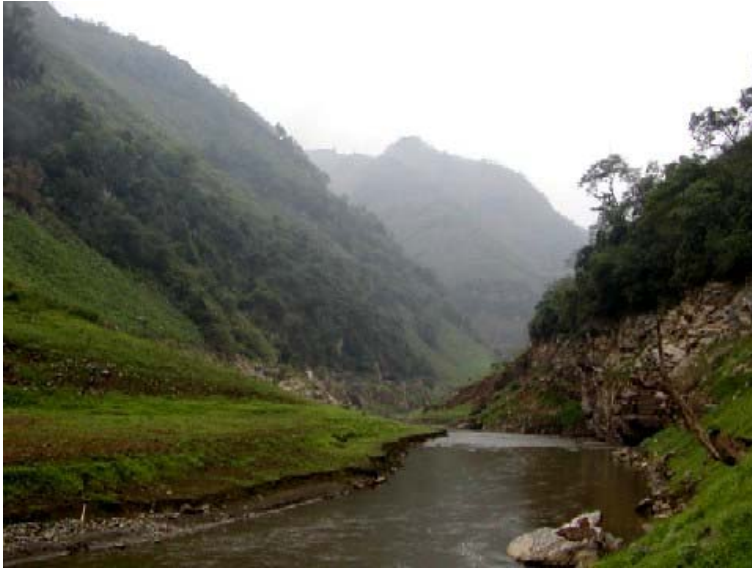
Photo 10

Hard outcrops were found at both sides of the upstream (about 500 m) of the planned dam site. Therefore dam axis will be moved.

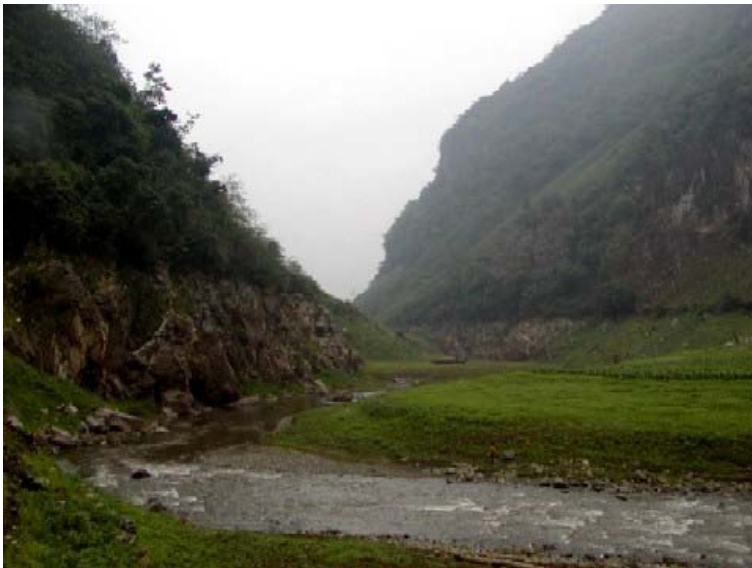
Photo 11

Right bank with steep slopes at the position of the dam site.

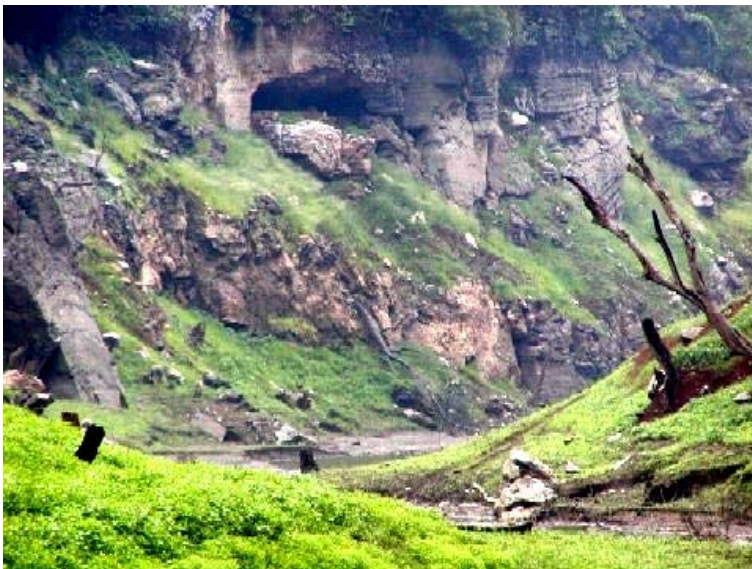
Photo 12

There are outcrops in the left bank of the dam site.
