JN5— Geological issues (Upper dam site)

Results of the second site reconnaissance ; P5

The features of promising potential sites for PSPP

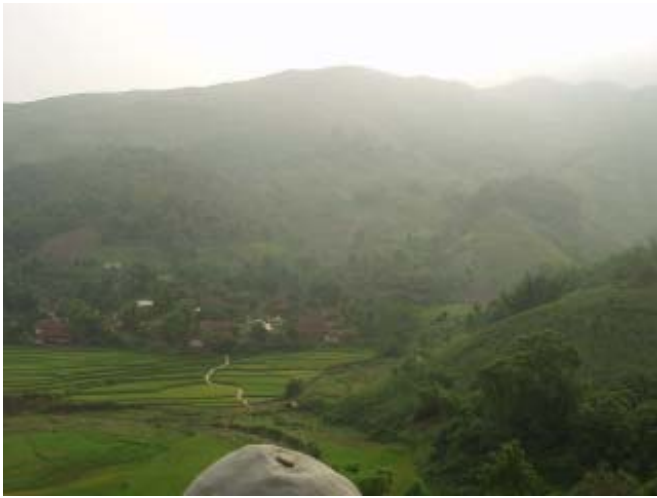
Photo 1

Upper Reservoir

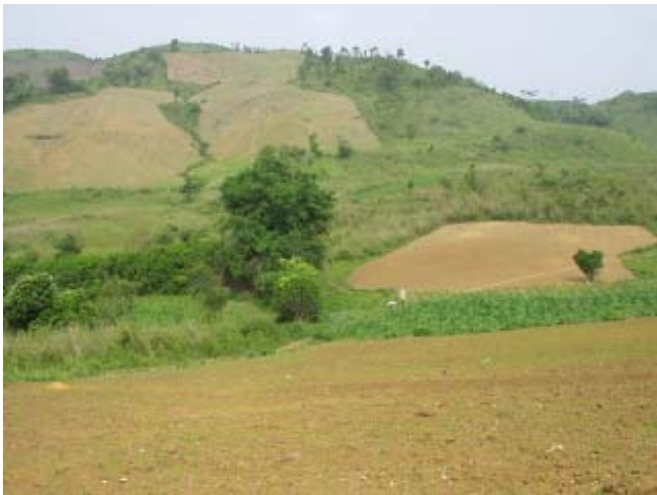
Photo 2

Upper Reservoir

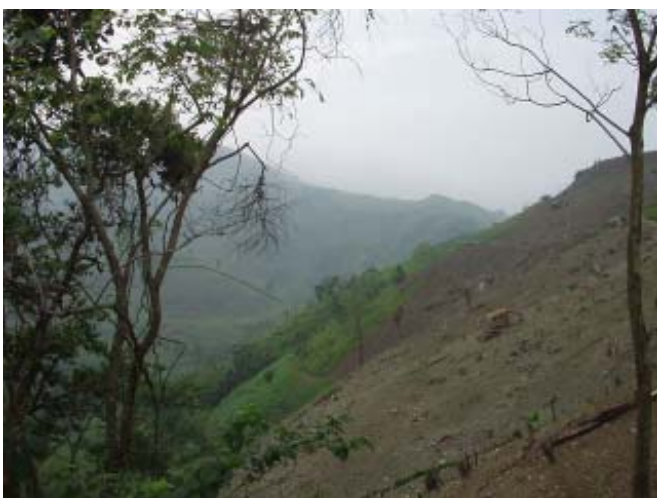
Photo 3

Upper Reservoir

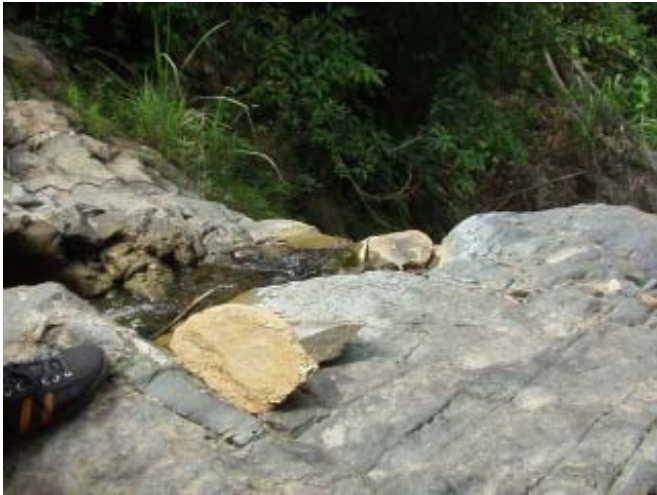
Photo 8

Outcrop of basalt porphyry
Near the Dam Axis
(Bedding N24W80SW, joints N80E80E)

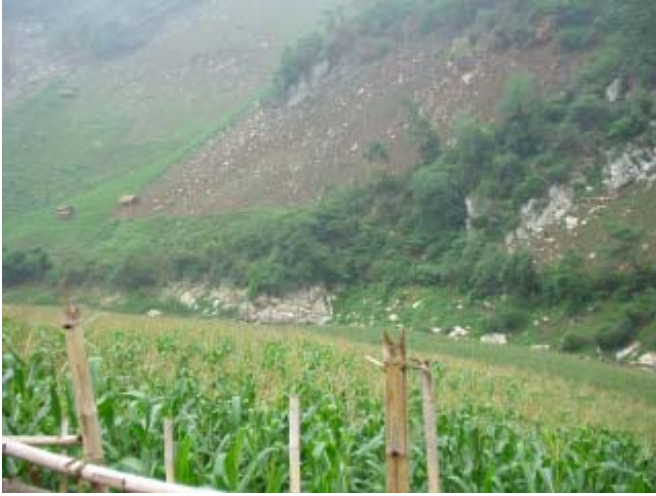
Photo 10

Lower Reservoir
(Weathered limestone, angle of slope is 30-40degrees)

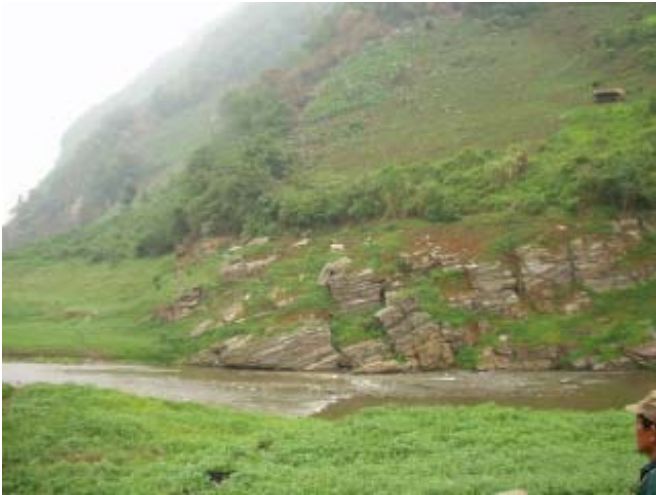
Photo 11

Lower Reservoir
(Limestone outcrops, bedding is nearly horizontal, angle of slope is 40-50degrees)

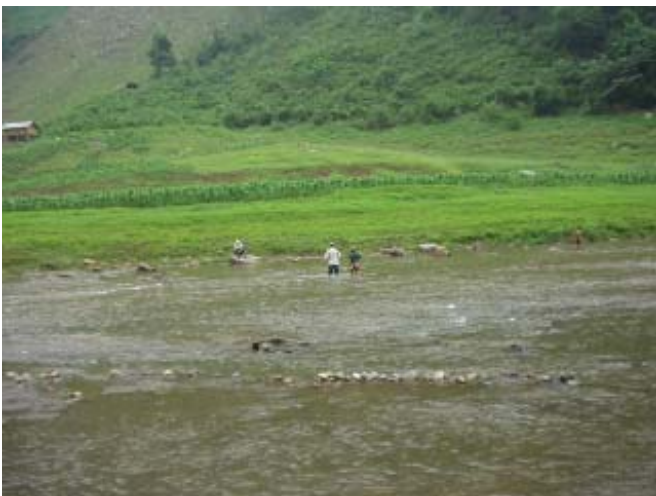
Photo 12

Riverbed in Lower Reservoir
(Wide and flat area around the riverbed, few hundred meters upstream of Dam axis)

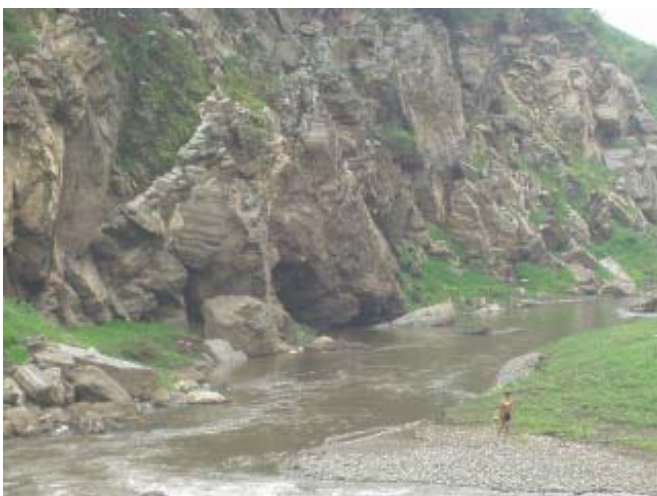
Photo 15

Close up of eroded holes in the limestone
outcrop
(as photo above)

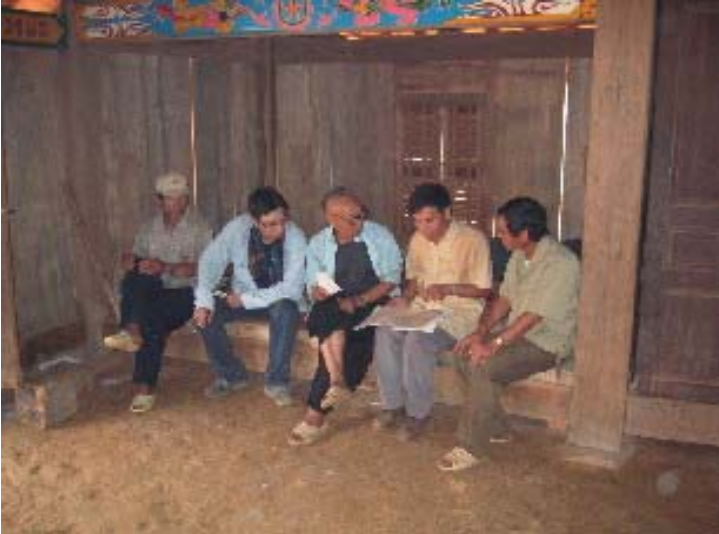
Photo 1

An interview survey was conducted at Suoi On village close to the upper reservoir site.

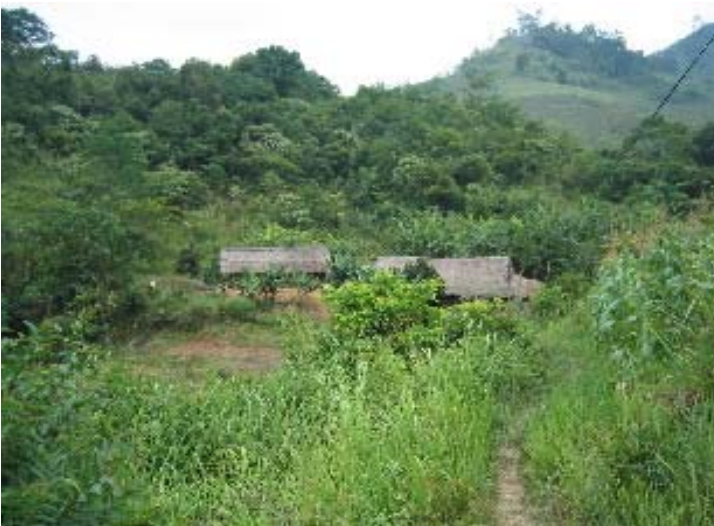
Photo 2

There are a two houses close to the upper dam site. They have rice field in the upper reservoir site.

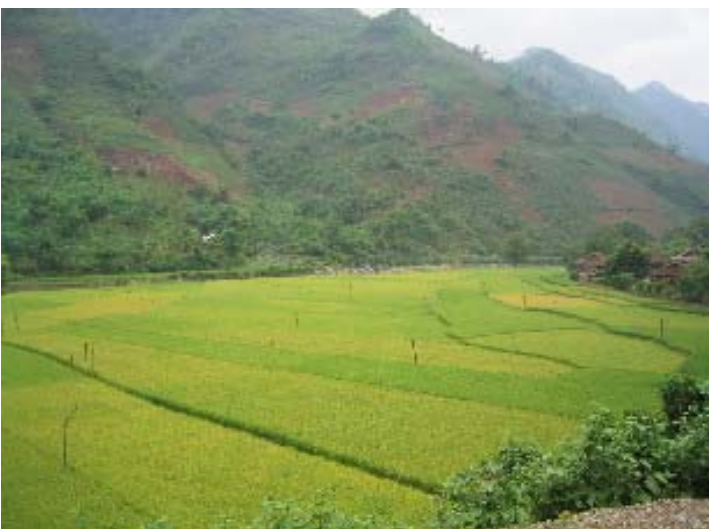
Photo 3

There are rice fields along Sap river, the lower reservoir site. This rice field belong to Keo Lan village.

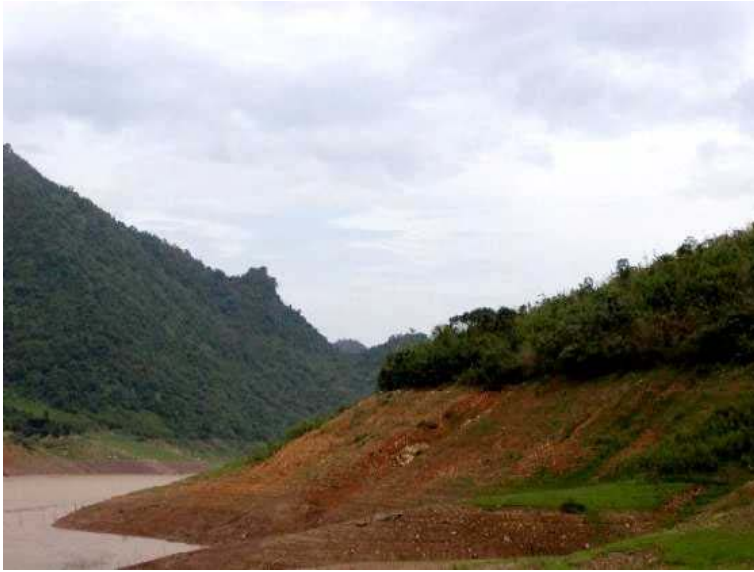
Photo 4

The ridge of the downstream (about 750 m) of the previous plan could be available for the location of the outlet due to little sediment.
(View from the previous outlet)

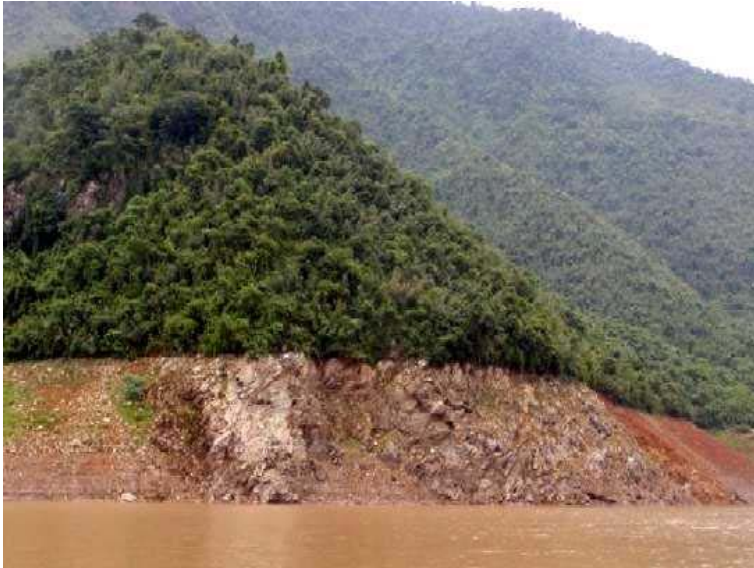
Photo 5

This is the alternative site of the outlet.
(View from the boat)
