**P5; Results of the site survey**

P5—Geological issues (Outlet & Lower reservoir)

**Checklist of Environmental Parameters: P5**

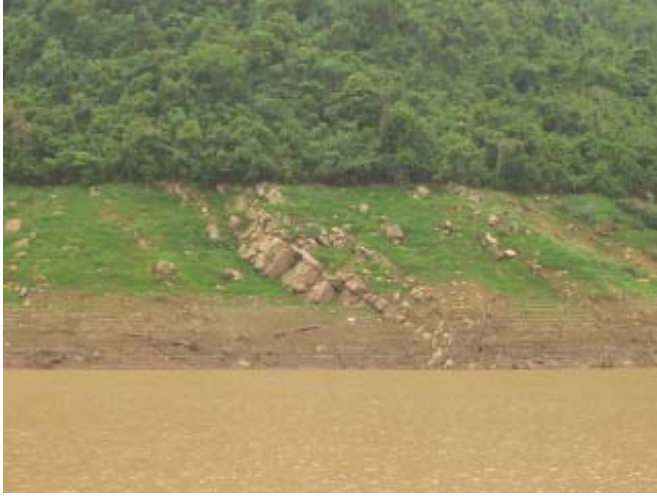
Photo 1

Outcrop of limestone  
Right side of the Hoa Binh Lake

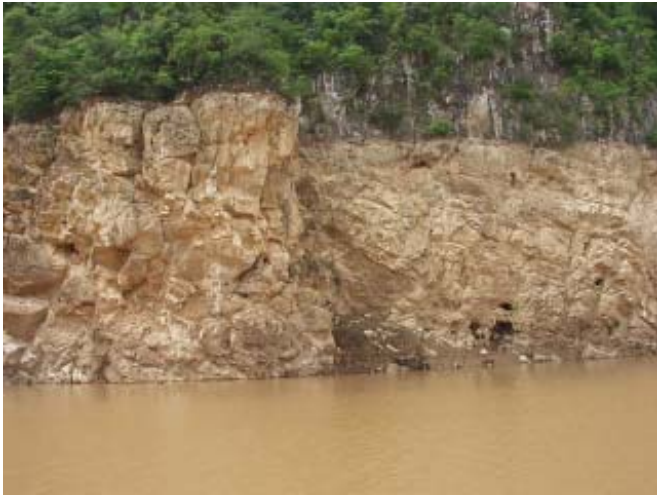
Photo 2

Outcrop of limestone  
Upstream of the Lower Dam axis of P5

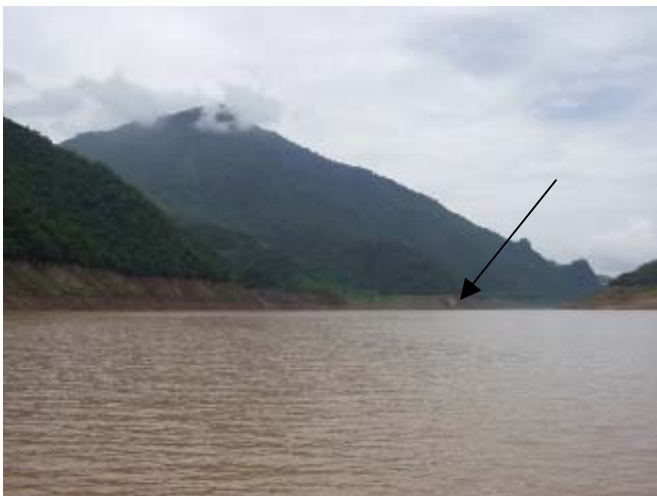
Photo 3

Outcrop of granite  
Left side of the Hoa Binh Lake,  
Near and upstream of the outlet of P5.

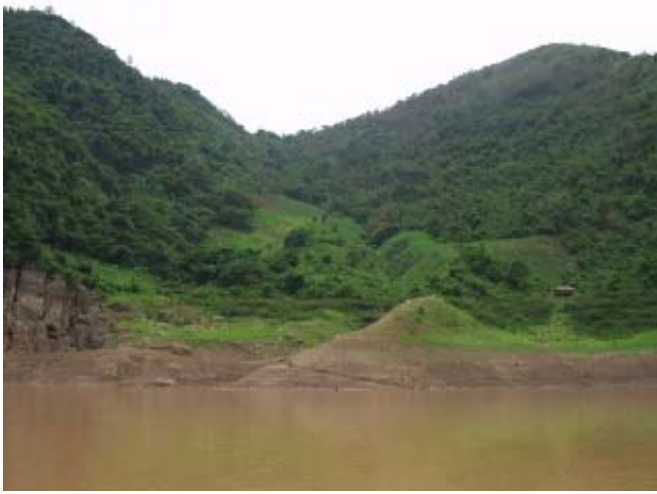
Photo 4

Site around the outlet  
Left side of the Hoa Binh Lake.

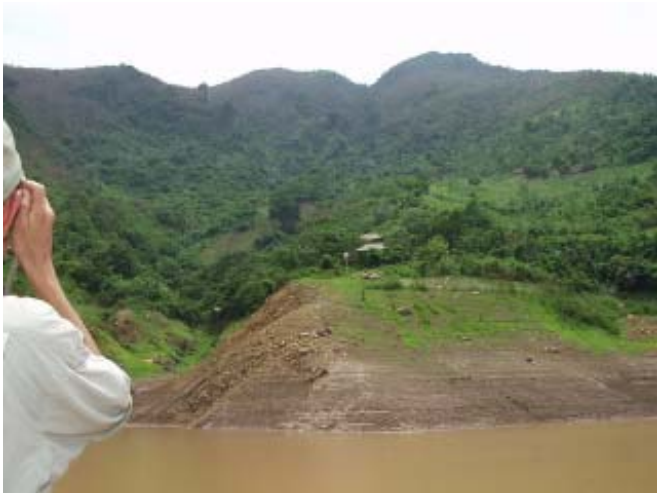
Photo 5

Site around the outlet

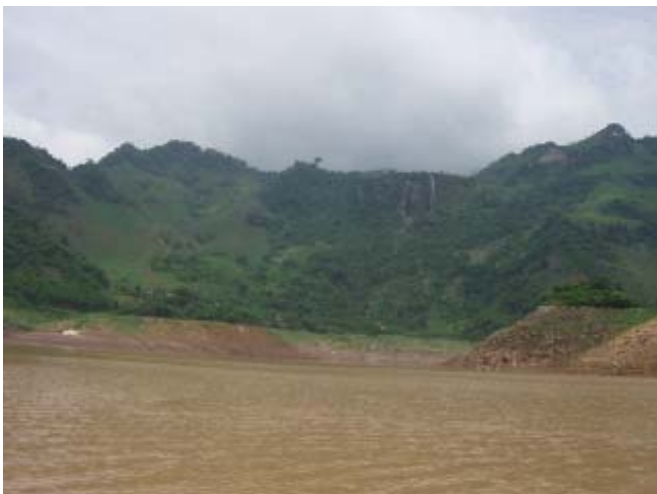
Photo 6

Condition of the Upper Reservoir of P11B  
7-8km upstream of P5B outlet  
Falls from the Upper Reservoir of P11B.

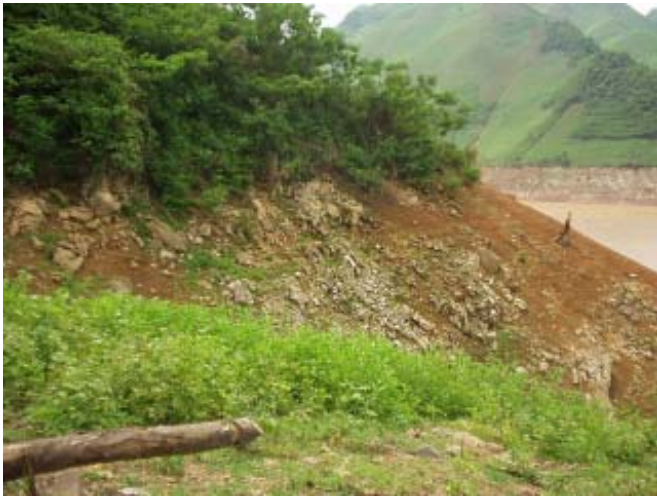
Photo 7

Right side of the Hoa Binh Lake,  
Near the geological boundary of granite ( $\gamma$   
PR3bn) and limestone (PR3sp);  
Highly weathered limestone.

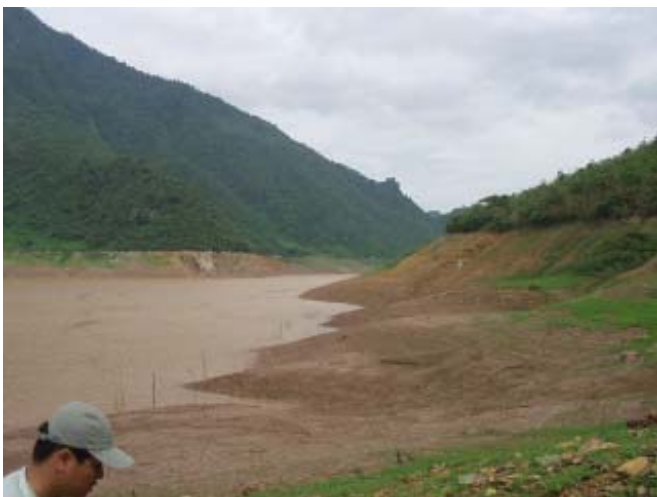
Photo 8

- The number of open hole in the limestone around this area is much more than the other limestone area.
- Outcrops of the limestone in the right side of the Hoa Binh Lake are not clear by the secondary sediments.

Right side of the Hoa Binh Lake  
Around the granite outcropped area,  
Thick secondary sediments or highly  
weathered surface covers the outcrop

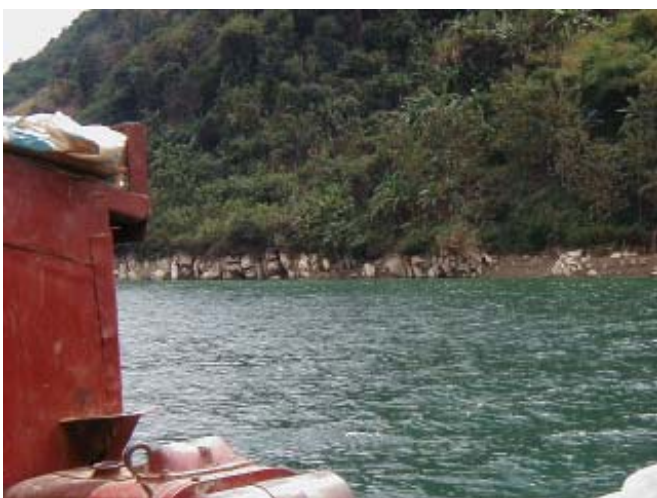
Photo 9

Many open joints are found between the beddings of the limestone and vertical in some places. Dips of the limestone bed are generally 30-40degrees, dips of joints are not only the joints of bedding but nearly vertical. The permeability of rock is probably quite high. The condition of limestone is hard and massive but with many open holes.

Nearly vertical open joint on the right side  
of the Hoa Binh Lake. (Limestone)
