APPENDIX 4-6-4

Results of the second site reconnaissance ; JS6

The features of promising potential sites for PSPP

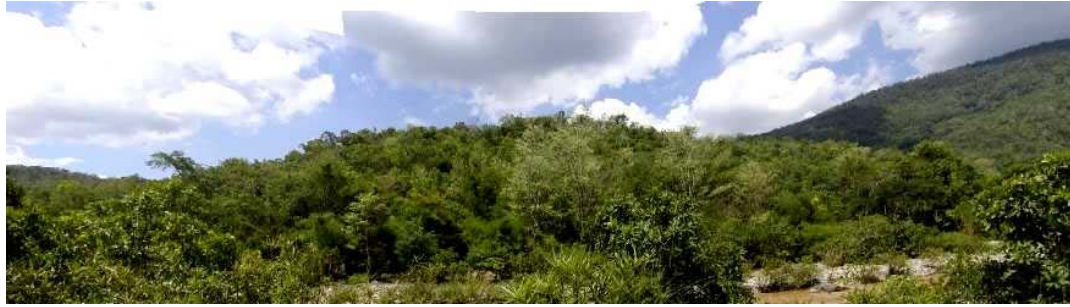
Photo 1

The deep valley, which is about 1km wide, exists on the route of the planned tailrace tunnel.

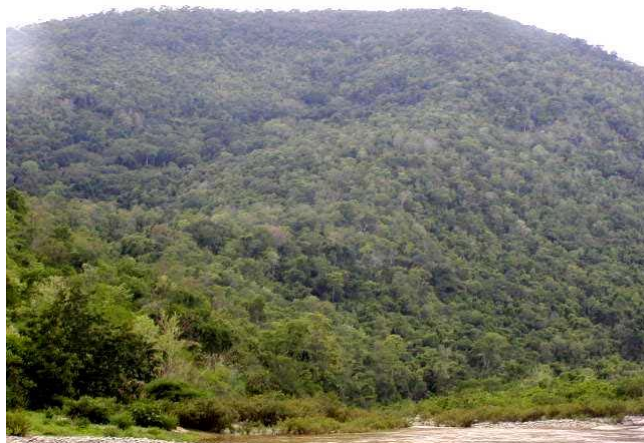
Photo 3

It is necessary to move the dam axis to 300 m downstream, which has a sufficient width and a steep slope.
