PART IV FEASIBILITY STUDY OF SELECTED BRIDGES

19. SECOND AYALA BRIDGE

20. JONES BRIDGE

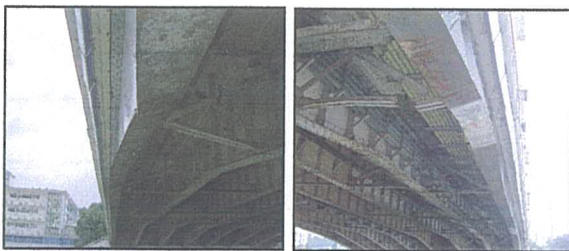
- Rupture of bottom flange up to 1/3 depth of web of exterior girder G1 (upstream) and sway bracing near Pier P2.
- Large lateral deformation of exterior girders on both upstream and downstream side at sections near piers of center span.
- Cracks at welded joint of main girder G7, exterior girders G1 & G8.
- Missing bolts at girders and joint connections.
- Corrosion of some portions of girders and miscellaneous members.

- Collision of vessels caused the deformations and ruptures of exterior girders and sway braces on the upstream and downstream sides.
- Collision of vessel are due to insufficient vertical navigation clearance which is only 3.6m near the piers.
- Corrosion of members are due to peeling off of paint and poor periodical maintenance.

Ruptured Girder due to Vessel Collision

Out-of-Plane Deformations due to Vessel Collision

- Cleaning and Painting the steel structures for the whole bridge.
- Replacement of ruptured sway bracing
- Provide additional girder with new bearing shoes next to existing exterior girder
- Repair and retain existing exterior girder to functions as vessel collision protection
- Remove and reconstruct existing related portion at deck slab, sidewalk, railing and expansion joint.

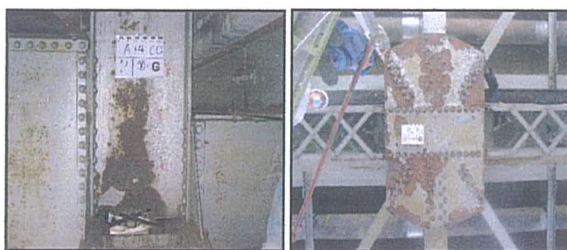
- Floor system mostly on gusset plates, bracing and ties are heavily corroded.
- A total of 44 joints at floor system require improvement works. There are 113 pieces of lateral braces to be cut and replaced, and at least 45 pieces of gusset plates are needed to be replaced.
- A total of 8 joints at floor system are needed to be cleaned and painted.
- Water proofing seals are needed at 51 vertical hangers to prevent water penetrating the floor system.

- The heavily corroded floor system are caused by the water leakage between the opening of deckslab and vertical hanger.
- The corroded stringer near the abutment are caused by water leakage from the expansion joint of slab.
- Aging of steel structures and degrading corrosion protection for steel members.
- Corrosion of member are due to peeling of paint and neglect of periodic maintenance.

Corroded Vertical
Hanger

Corroded Gusset Plate

- Cleaning and painting floor system including corroded vertical hanger and truss.
- Replace expansion joint to seal water leakage.
- Replacement of Gusset Plates.
- Replacement of corroded section of floor beam, longitudinal tie beam and vertical members by cutting affected areas and placing new sections.
- Sealing gap between vertical hanger and sidewalk concrete and provide plates to prevent further corrosion of vertical hanger.
- Removal and reconstruction of deck slab near abutment.
- Replacement of corroded stringers near abutment.

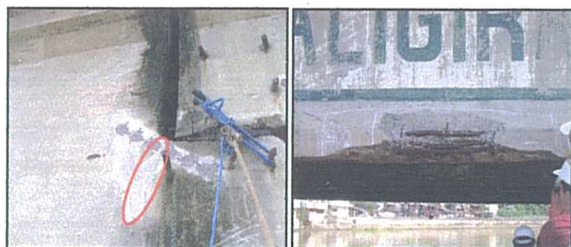
- Cracks at gerber hinge.
- The outer faces of exterior girders were noted with cracks.
- Flexural cracks on girders were found above piers 1 and 2.
- Longitudinal cracks and exposed rebars were observed at midspan of the suspended girder.
- Deflection was observed on girders at center span.

- Cracks of gerber hinge supports were caused by insufficient hanger reinforcement provided on the girder.
- Flexure cracks found on girder sides above pier supports were caused by tension stresses at top fiber at service loads.
- The damages at the midspan of the suspended girder were caused by collision of 2.7 m high container van on top of a vessel navigating towards upstream river.
- Deflection on girders were caused by insufficient longitudinal tendons. Also, the proportioning of side span to center span is less than 0.65. This causes the uplift of girders at abutment side of side span.

Cracks on Gerber Hinge

Collision Damage

- Additional concrete block doweled to abutment and girder as uplift countermeasure.
- Installation of CFRP vertically at web near hinge and longitudinally at top of girder over pier support.
- Repair/Sealing of concrete cracks, honeycomb and spalling.
- Stressing of slanted prestress cables at gerber hinges.
- Reconstruction of diaphragm at gerber hinge.

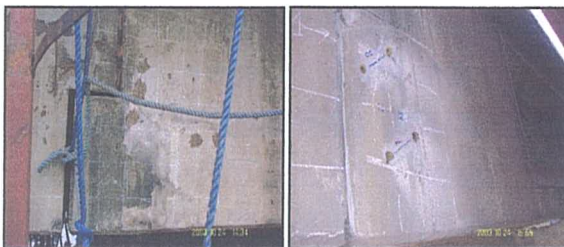
- The outer faces of exterior girders at gerber hinges have many heavy cracks which have caused a rotation in the gerber connection and abnormal vibration in the suspended span.
- The abnormal deflection have also caused flexure cracks on exterior girders at supports Pier 1 and Pier 2.

- Latest code requirements on gerber seat are not met.
- Insufficient flexural and shear reinforcement of gerber.

Cracks on Gerber Hinge

- Repair and sealing of concrete cracks, honeycomb and spalling.
- Rehabilitation of gerber hinge portion with slanted P/S cables.
- Reconstruction of diaphragm and partial reconstruction of deck slab at gerber hinge portion.
- Additional elastomeric bearing pads at diaphragm.
- Installation of transverse P/S cables at diaphragm of gerber hinge portion.

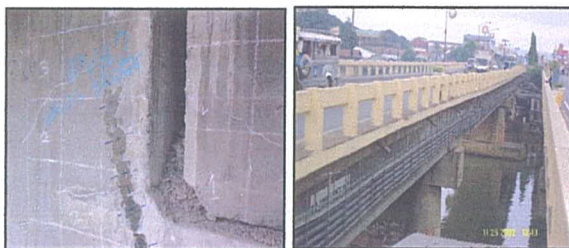
- The outer face of exterior girders at gerber hinges were observed with cracks. The cracks were tested non-destructively to determine its extent inside the girder.
- Flexural cracks were observed on girders at pier supports
- Large deflection was noticeable affecting smooth driving condition.

- Cracks in gerber hinge supports were caused by insufficient hanger reinforcement provided on the girder.
- Flexure cracks of girder at top of pier 2 and pier 3 were caused by tension stresses at top fiber at service loads.
- Large deflections at the cantilever portion were due to insufficient number of longitudinal tendons. Also, the proportioning of side spans to center span are less than 0.65 which means that the tendency of the center span causes uplift to the side spans.

Cracks at Gerber Hinge

Deflection at Girders

- Repair and sealing of concrete cracks, honeycomb and spalling.
- Installation of CFRP (Carbon Fiber Reinforced Polymer) longitudinally at top of girder and horizontally at web over pier support and horizontally at gerber hinge.
- Partial replacement of deck slab over pier support.
- Rehabilitation of gerber hinge portion with slanted P/S cables.
- Reconstruction of diaphragm and slab at gerber hinge.
- Installation of external cables on each side of the girder to counter the deflection.
