**THE STUDY
ON
MEKONG RIVERBANK PROTECTION AROUND
VIENTIANE MUNICIPALITY
IN
THE LAO PEOPLE'S DEMOCRATIC REPUBLIC**

**FINAL REPORT
VOLUME 2
MAIN REPORT**

DECEMBER 2004

**NIKKEN Consultants, Inc.
NEWJEC Inc.**

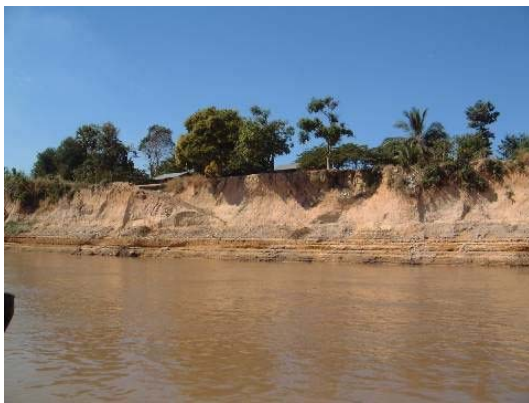
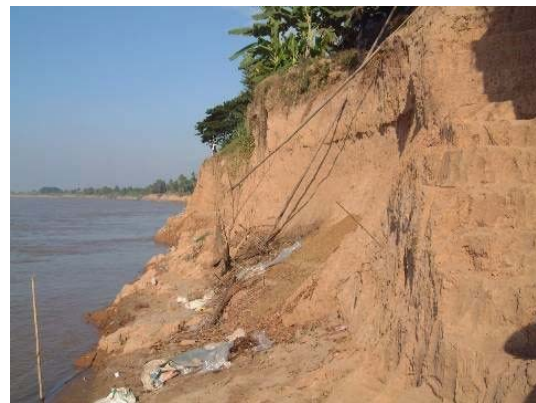
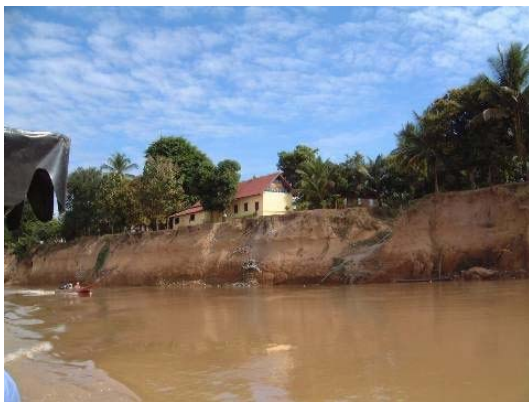
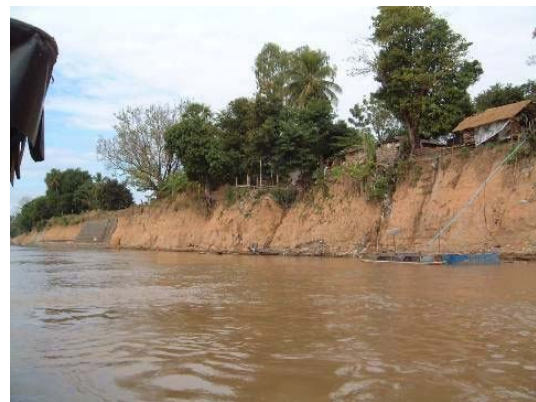
- The riverbanks severely eroded in the Study Area forms vertical cliffs mostly as shown in Figure 2.1.
- The riverbanks in the Study Area seem younger and sediment movements are more active comparing with those in other reaches, since the Study area is located just downstream of the abrupt change of river slope.
- Riverbank generally consists of sandy gravel layer covered with clayey soil (6 m to 8 m deep) on the top. These bank materials are not consolidated and easily be eroded.
- Gabion works are commonly used for bank protection. The existing works are effective to protect the riverbank from erosion, though some works are damaged due to poor foot protection and/or washing away of soil behind the gabion.

Figure 2.1 Eroded Clifty Riverbanks in the Study Area
- Condition in December 2001-

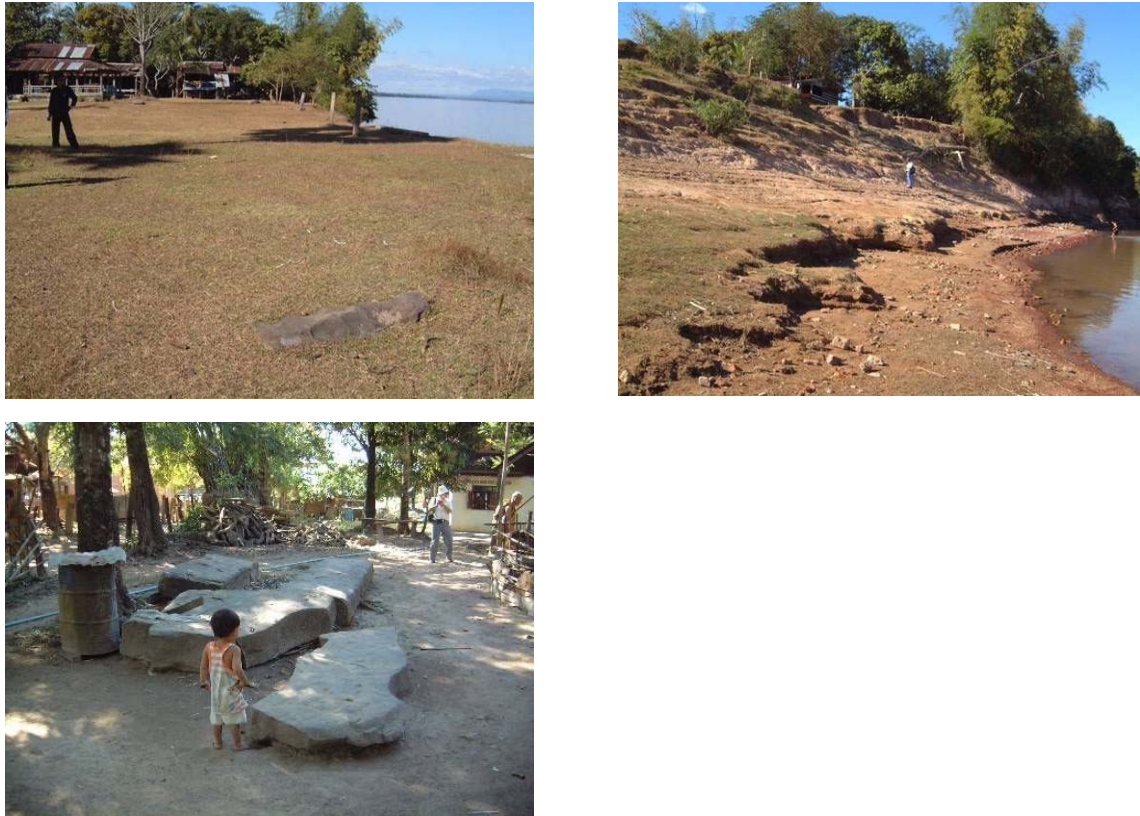
- Vertical cliffs of riverbanks commonly seen in the Study Area are seldom found.
- Near Wat Phu remain (World Heritage) in Champasak province (refer to Figure 2.2): A part of the remnants of exterior wall of Wat Phu located at the eroded riverbank is now under constant threat of collapse. Revetment works covering whole river bank is not recommendable in consideration of the conservation and archaeological prospecting of remains. Groin works might be effective to stabilize the bank by accelerating the sedimentation and vegetation at the foot of eroded bank.

Figure 2.2 Mekong Riverbank near Wat Phu Remain
- Condition in December 2001-

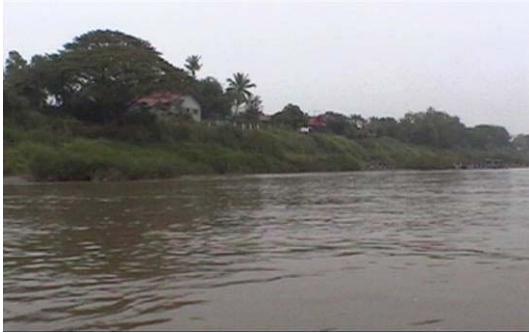
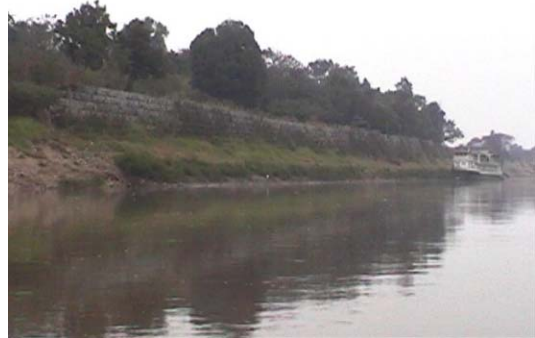
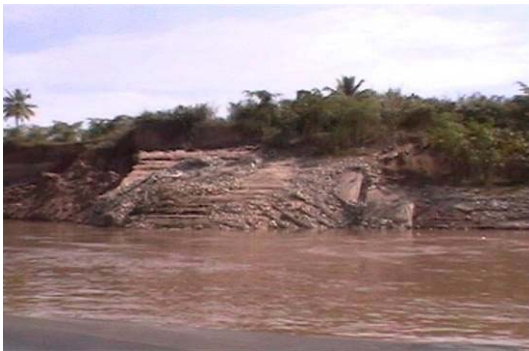
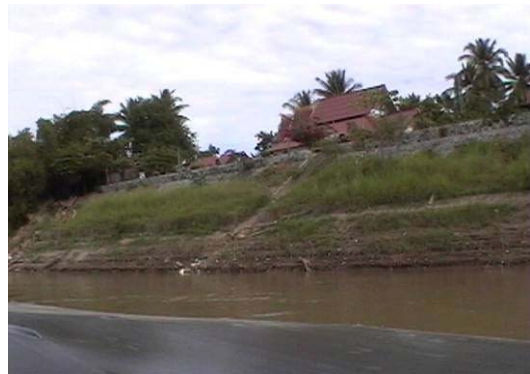
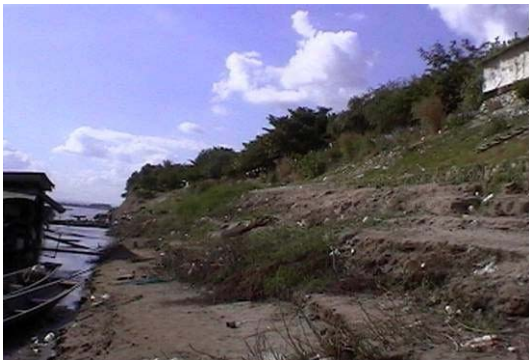
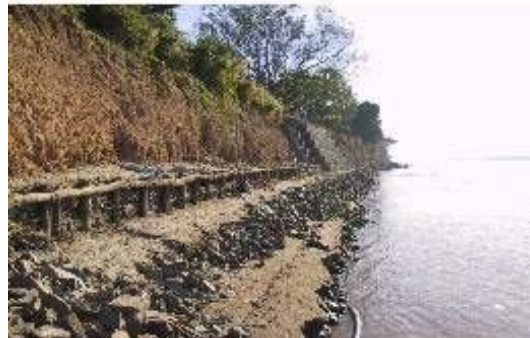
- Bank protection works along the Mekong River around Vientiane City have been implemented since early 1990s.
- Most of the protection works were done by using gabion. As for these works, at many locations, silt deposits with partly covered by vegetation are found. Some of wire nets have been corroded to become thin and partly damaged in a long period after construction.
- At Wat Sibounheuang, a new method using Soda mattress has been tested.
- At Hatdokkeo, gabion at the toe of the slope is damaged and stones in the net-cage are lost, resulting a steep slope of toe without being protected. Existing sand excavation works near the site might have influenced the riverbed degradation in front of the work.

Figure 2.5 Existing Riverbank Protection Works in the Study Area
-Condition in December 2001-

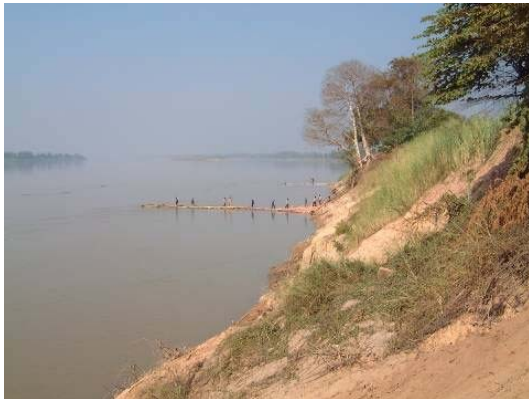
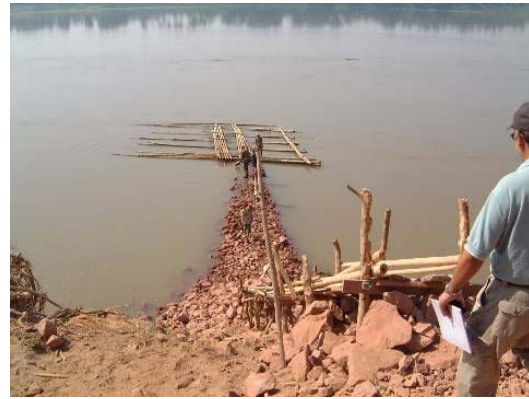
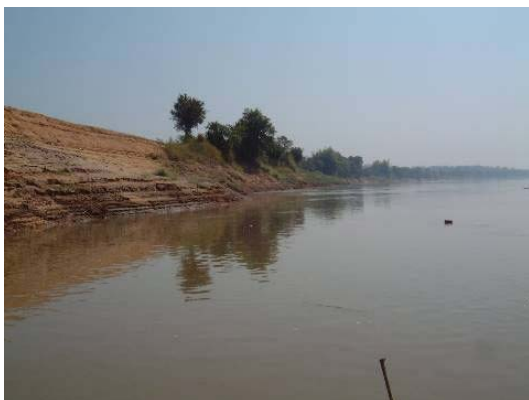
- At the confluence with Nam Xan river in Bolikhamxai province, the riverbank was severely damaged. Repair of embankment founded by groins are under construction. The slopes between groins are considered still vulnerable against erosion. Riprap protection works are recommended for the slope protection in addition to the groins.

Figure 2.6 Riprap Low Groins at Pakkadan
- Condition in February 2002-

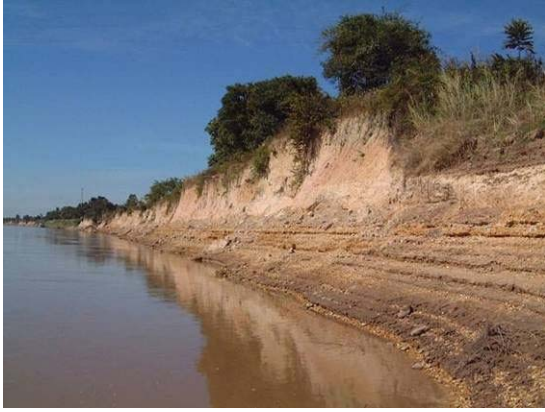
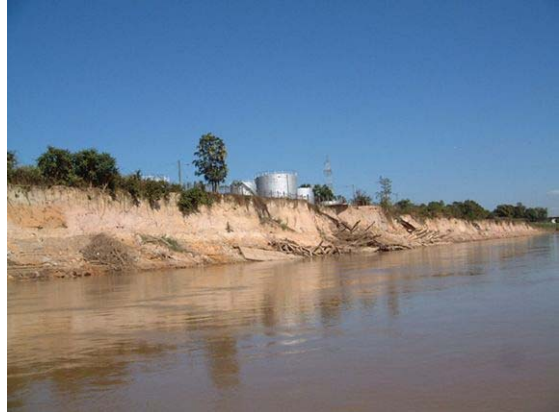
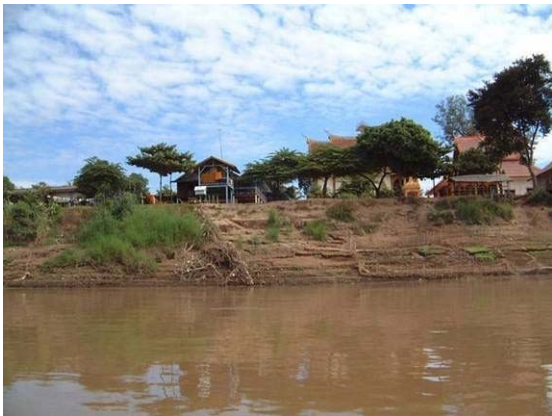
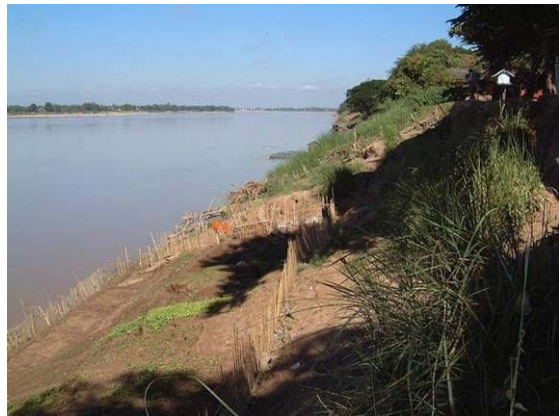
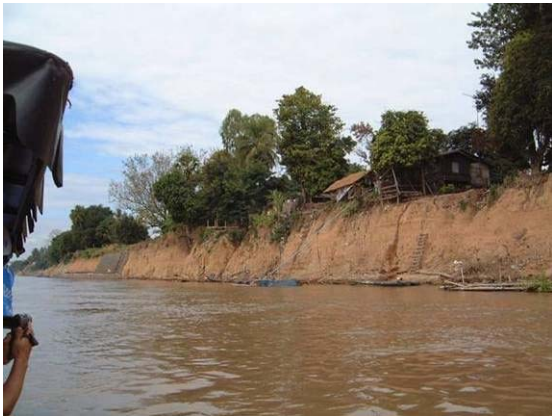
Figure 2.18 Condition of Pilot Work Sites

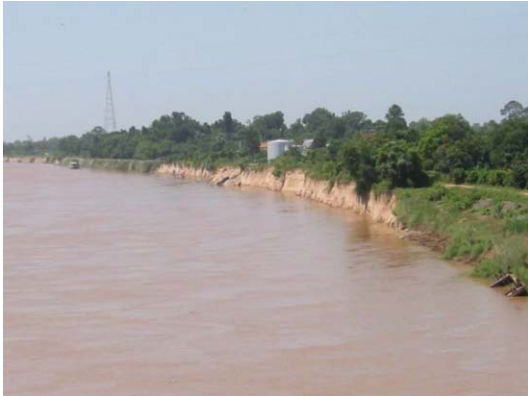
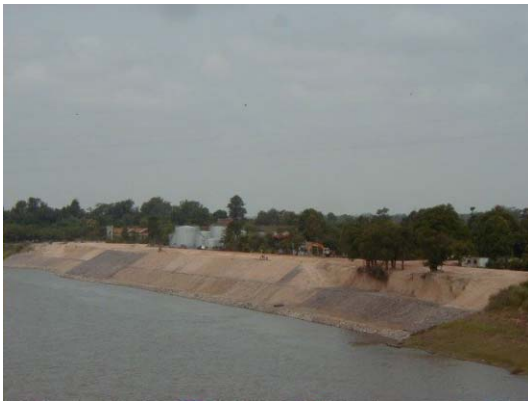
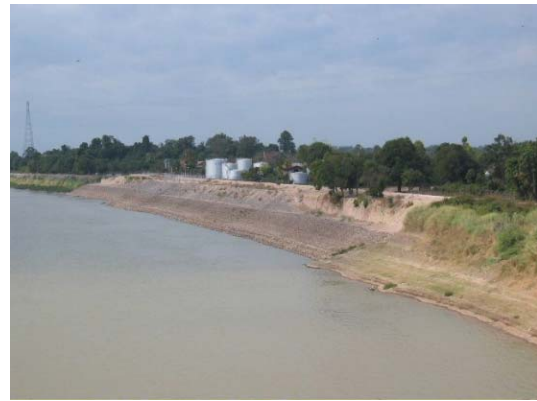
The pilot work at the site was completed in May 2003 based on the revised facility design upgraded in 2nd Work in Lao P.D.R. to cope with the severe erosion caused by August 2002

flood. After completion, willows will grow and will cover the surface of the slope. The photos before and after the execution are as shown in Figure 3.2. The outline of the work is summarized in Table 3.1.

Figure 3.2 Completed Pilot Work at Ban Dongphosi Site

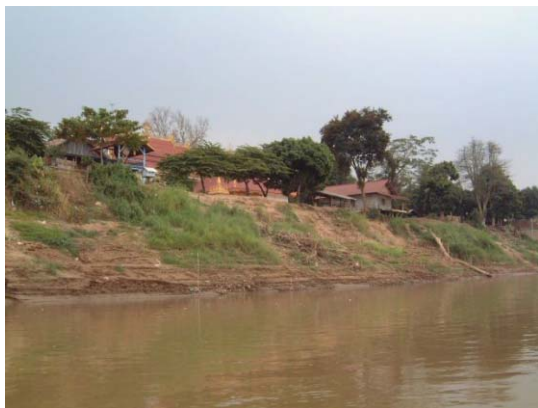
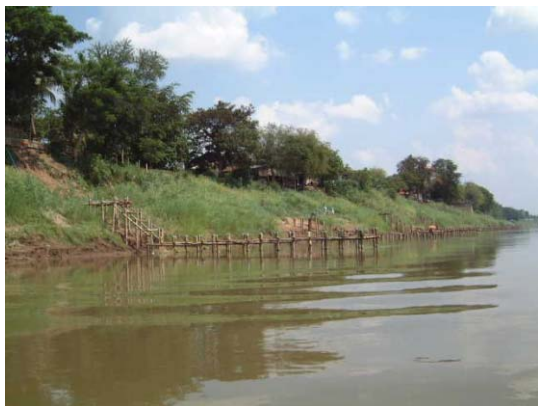
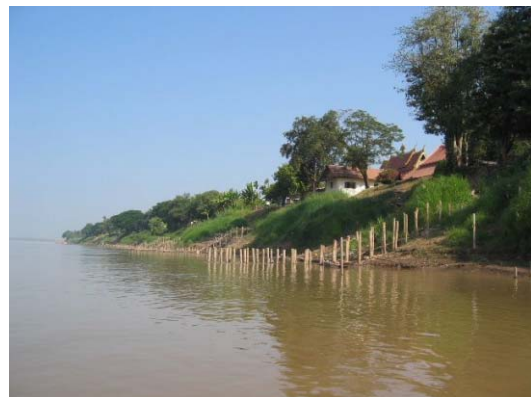
The pilot work at the site was completed in May 2003 based on the original design established in March 2002, 1st Work in Lao P.D.R (refer to Section 2.2). The photos before and after the execution are as shown in Figure 3.5. The outline of the work is summarized in Table 3.5.

Figure 3.5 Completed Pilot Work at Wat Chom Cheng Site

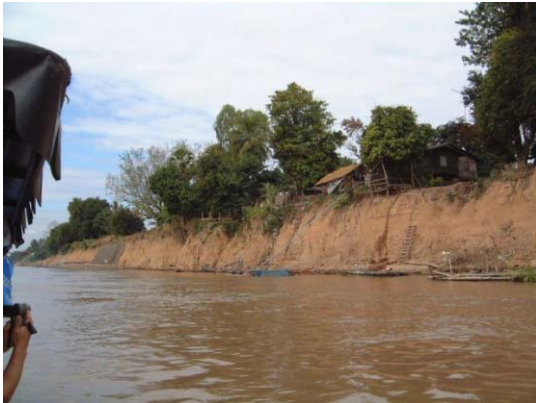
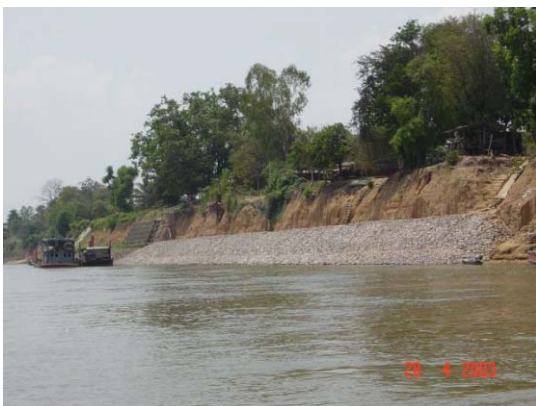
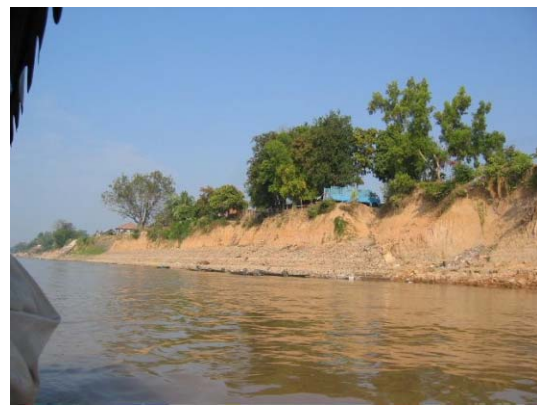
The pilot work at the site was completed in April 2003 based on the original design established in March 2002, 1st Work in Lao P.D.R (refer to Section 2.2). The photos before and after the execution are as shown in Figure 3.7. The outline of the work is summarized in Table 3.7.

Figure 3.7 Completed Pilot Work at Sibounheuang Site
