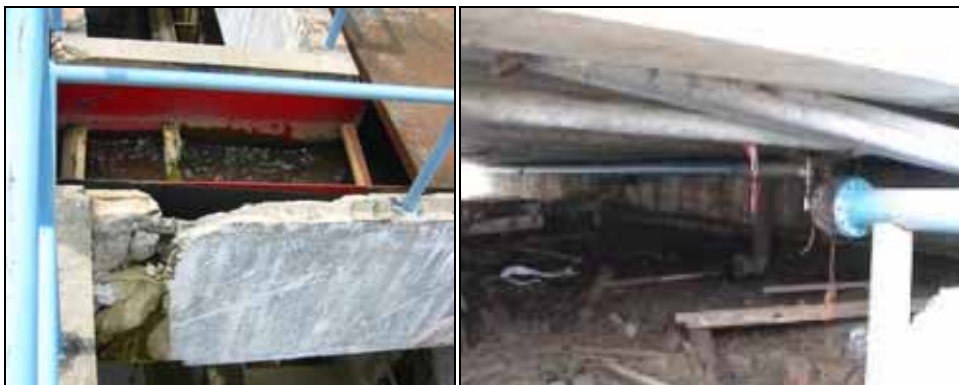
Figure 2.1 Damages in Lambro Water Treatment Plant and Primary Pipe at River-Crossing

Fortunately, there is no serious structural mechanical damage, so that the plant has started its production soon after disaster. Some structure suffered physical damage (Figure 2.1). Installment in auto-desludging equipment in pre-sedimentation and clarifier was out of order after disaster. For operation of the plant various international and domestic organizations concerned are supplying chemicals required.

- (1) To replace two (2) intake pumps, each with a capacity of 208 L/s and one (1) distribution pump with capacity of 147 L/s.
- (2) To replace 600 mm diameter distribution water meter.
- (3) To calibrate a raw water meter and 500 mm diameter distribution water meter.
- (4) To repair installment of automatic de-sludging systems on pre-sedimentation tank and clarifier.
- (5) To replace filter media.

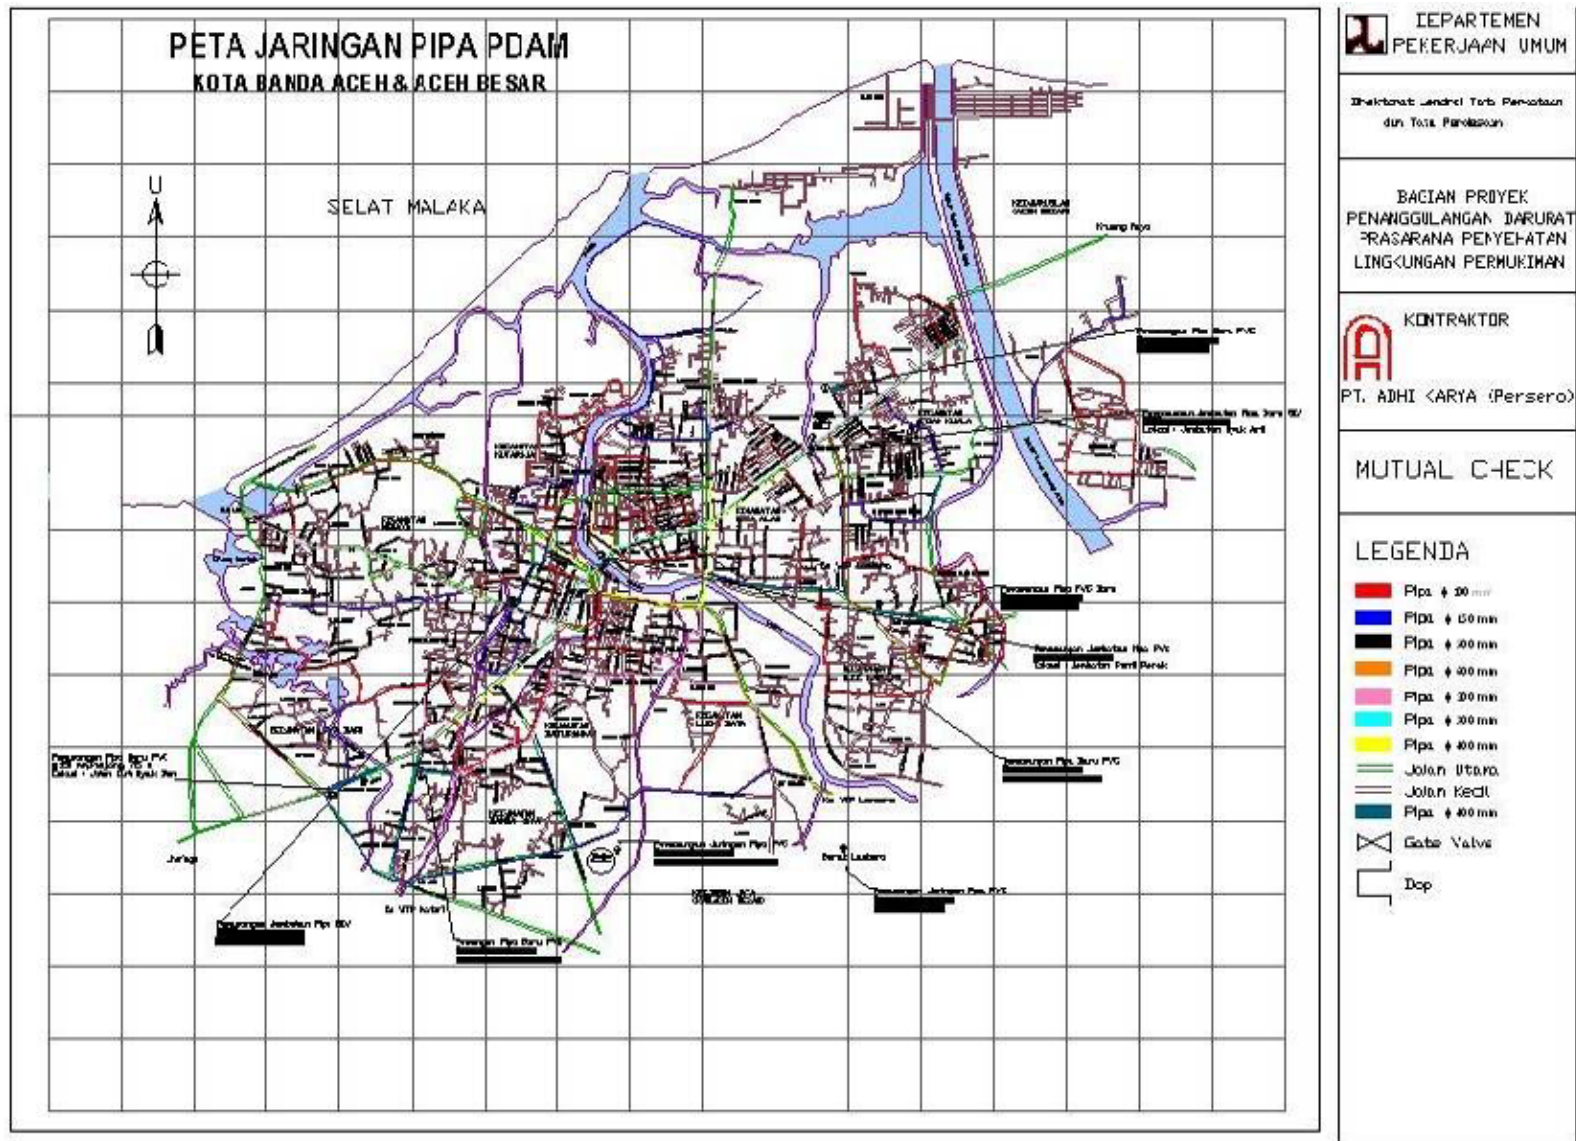
Figure 2.2 Completed Emergency Repair Works of Distribution Network

The distribution pipelines were destroyed in many locations and areas. Though the water treatment plant was operational, it was not possible to distribute the treated water to the service area owing to deterioration of distribution pipelines and also break of primary pipeline especially at river-crossing. An emergency measure was taken immediately after disaster to restore the distribution network through cooperation of international organization and the government organizations/agency such as DPU (Dinas Pekerjaan Umum: Department of Public Works) and PDAM from other regions of the country. Figure 2.2 shows emergency repair works so far completed.
