**National Pesticide  
Analytical  
Laboratory (NPAL)  
& PAL Satellite  
Pictures**

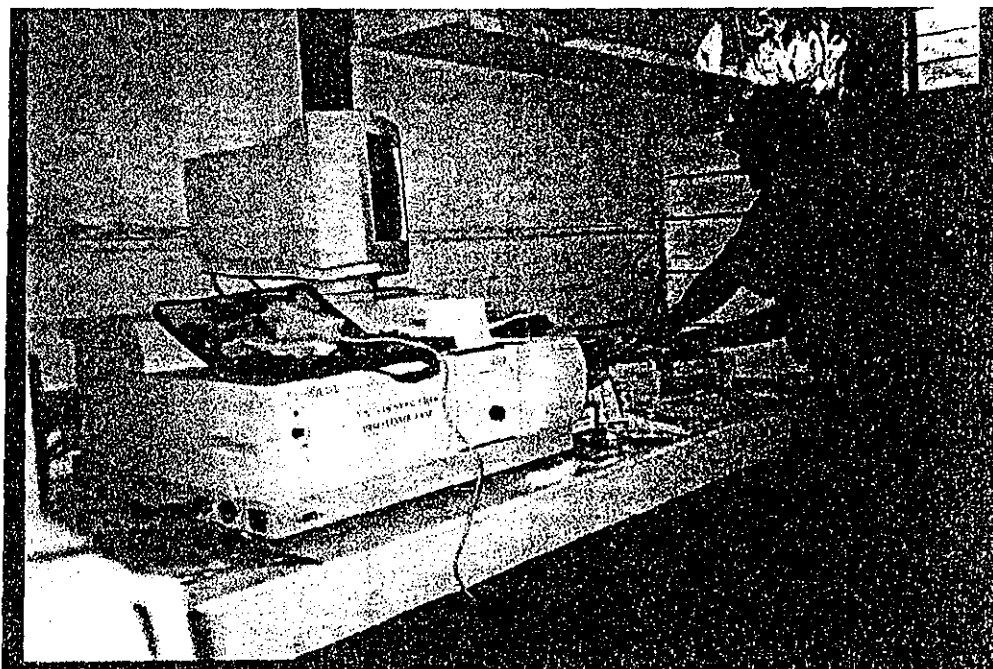
Figure 2 .

Mr. Walfredo Cinco, NPAL Technician doing repairs on the UV-VIS Spectrophotometer in the Baguio PAL.

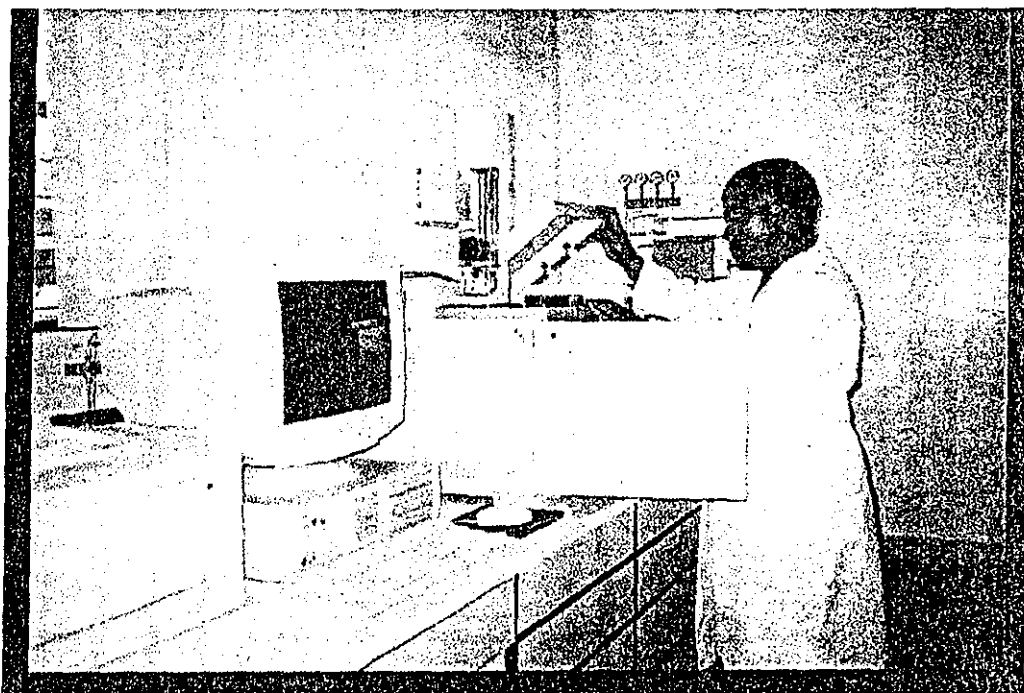
Figure 4 .

Bicol Pal staff troubleshooting a GC.

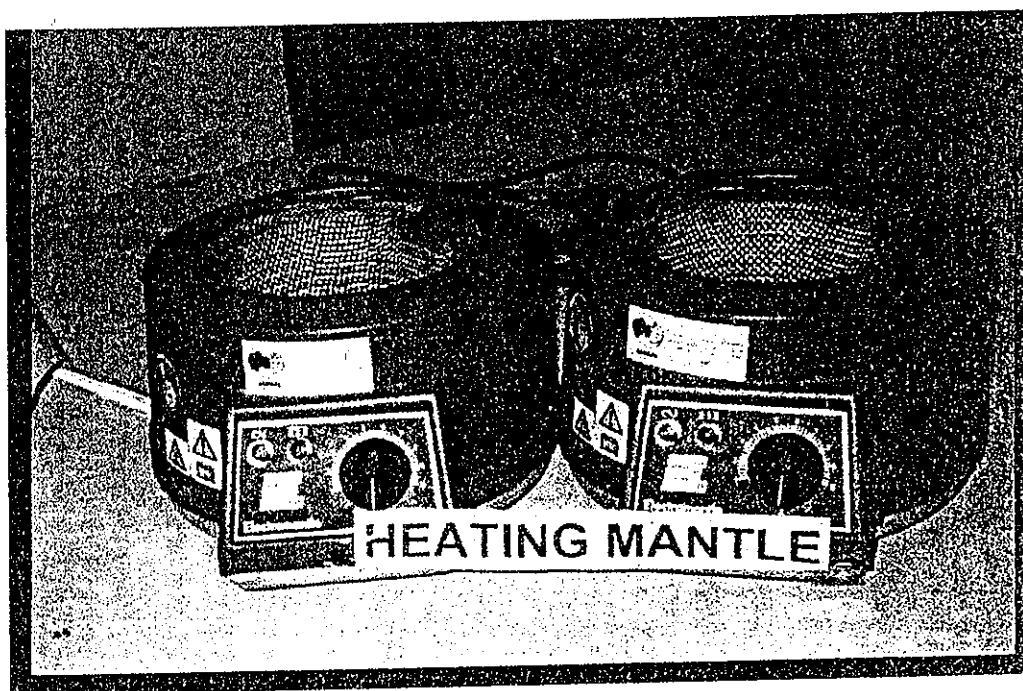
Figure 2 .

Cebu PAL Heating mantle which is never used for analysis.

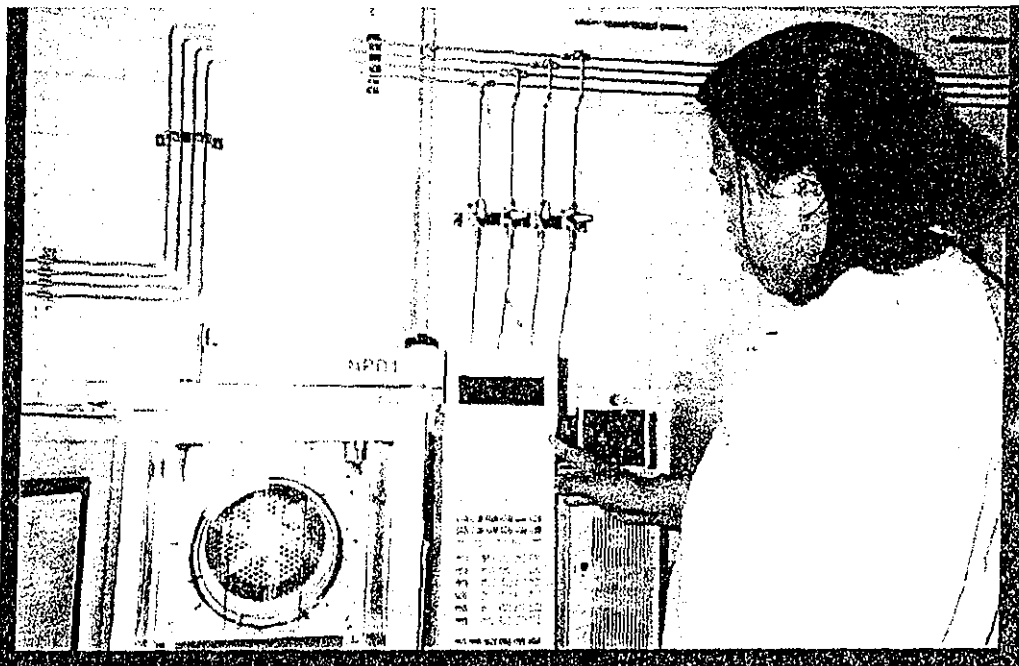
Figure 4 .

Cebu Pal NPD showed to have electrometer fault and disabled EPC

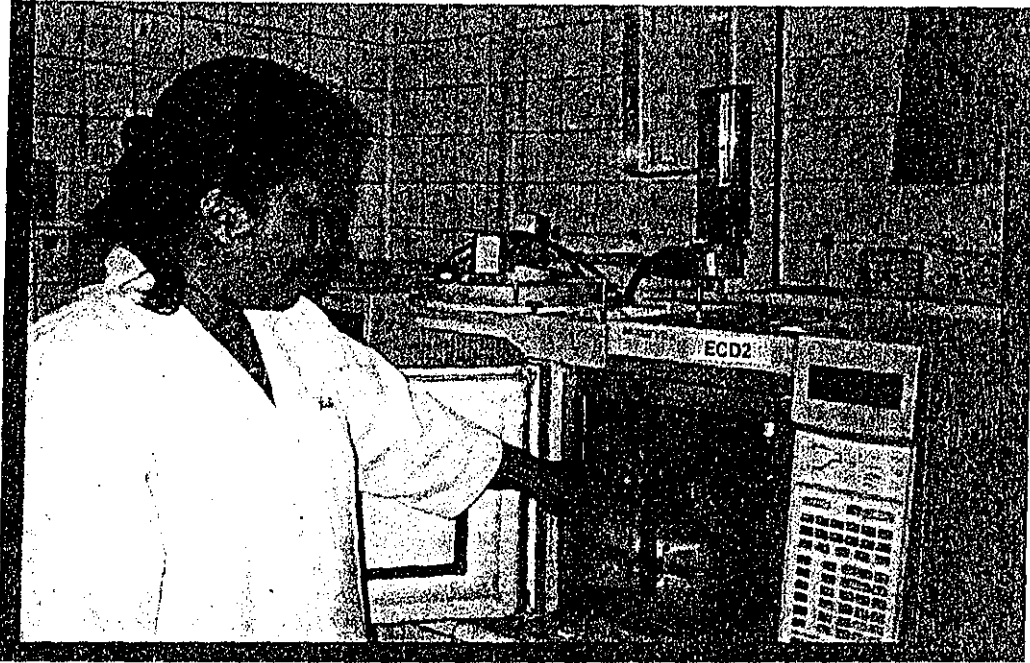
Figure 5 .

Cebu PAL ECD with dual detector not in use due to oven shutdown.

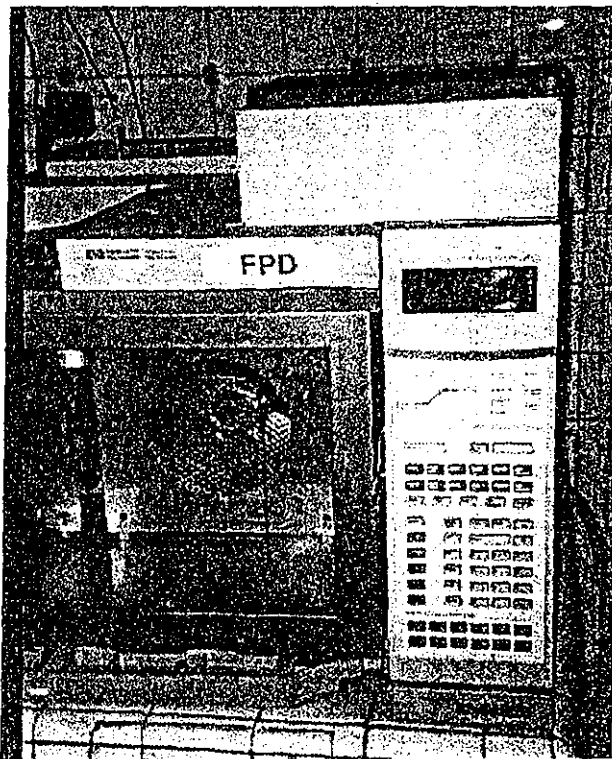
Figure 6 .

Cebu Pal FPD not functioning due to oven sensor and back detector shutdown.

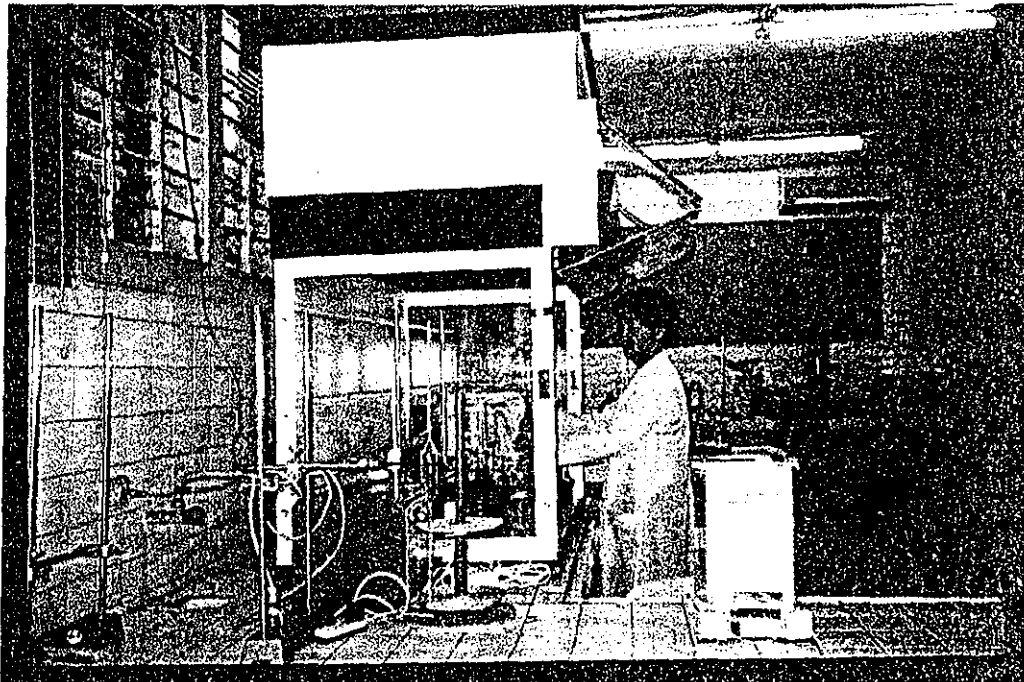
Figure 6 .

Fume hood that needs to be replaced in the Cagayan de Oro PAL.

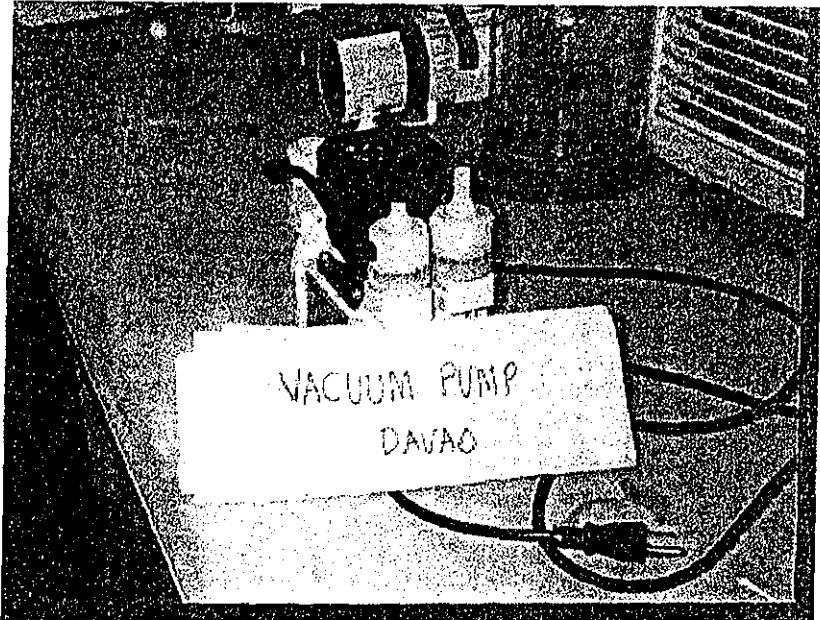
Figure 3 .

Davao PAL vacuum pump, the suction pressure is not enough to sustain a better and complete vacuum filtration.

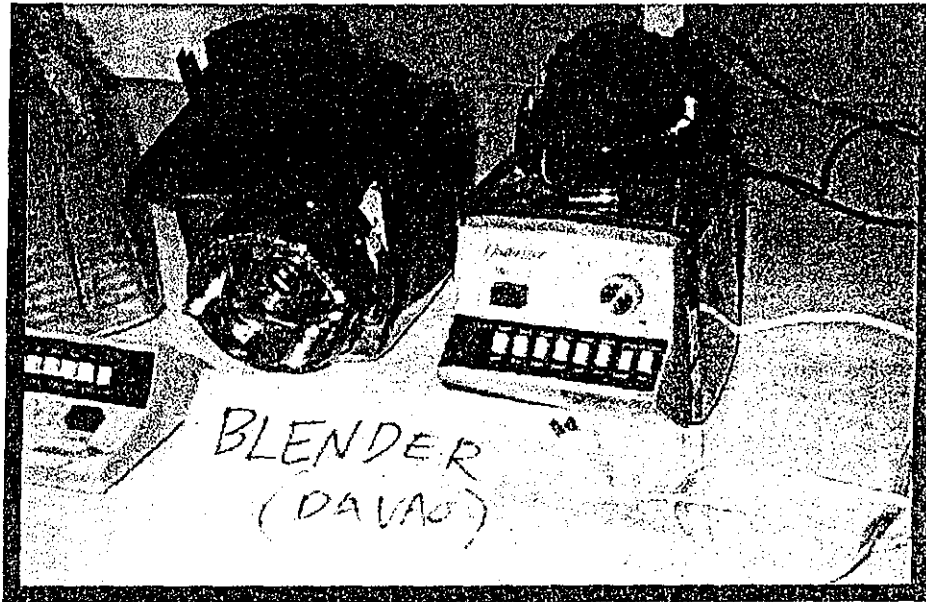
Figure 4 .

Davao PAL Blender Propeller is not working; the base is leaking.

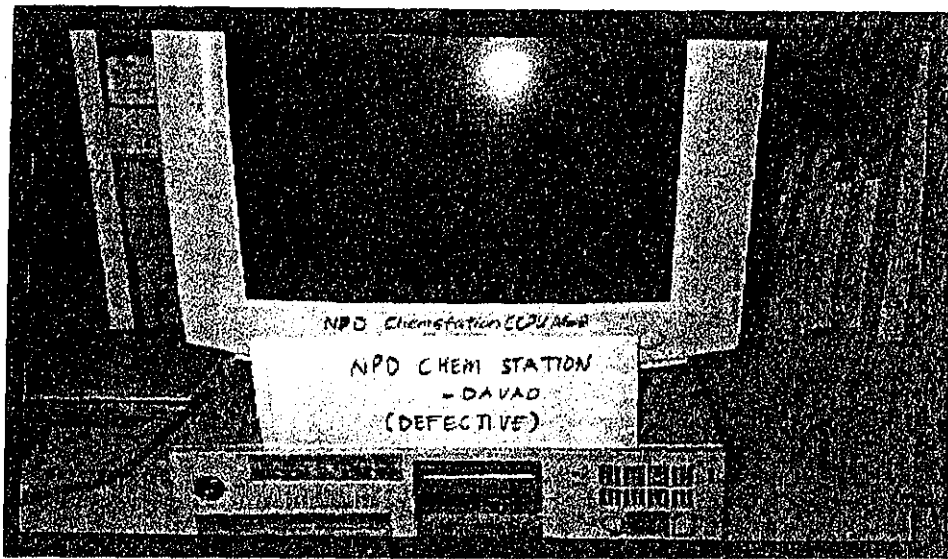
Figure 5 .

Davao Pal NPD CHEMICAL STATION, Processor in the CPU is not working anymore; monitor is blurred until stop functioning.

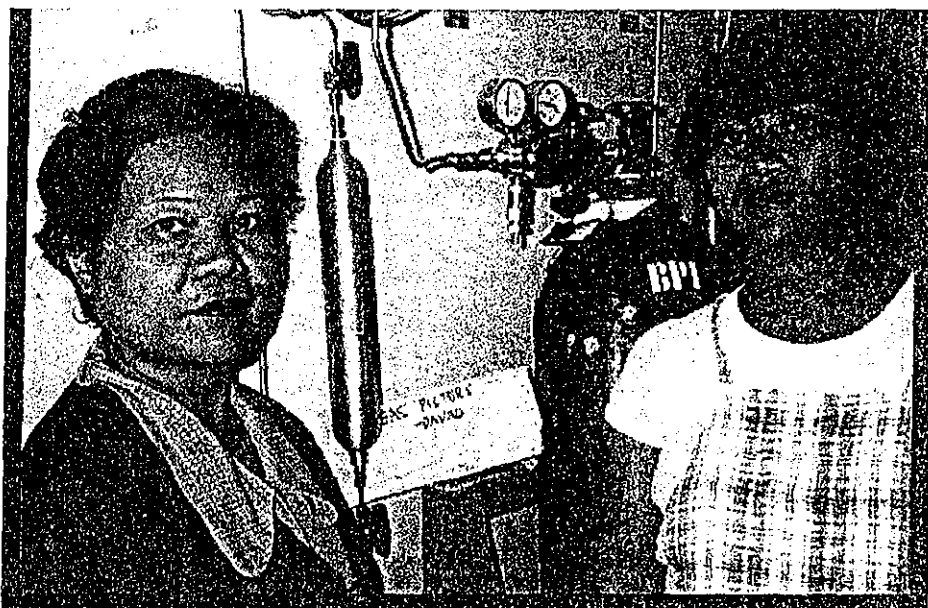
Figure 8 .

Davao PAL GAS FILTERS, Very critical material for filtering Nitrogen, Helium and Hydrogen gases as to supply very clean and pure gases to GC's. When gases are replaced 13 times, this filters should be replaced with new ones but the supply are not available locally aside from being too expensive.
