## 5.2 Port of Lobito

### 5.2.1 Overview

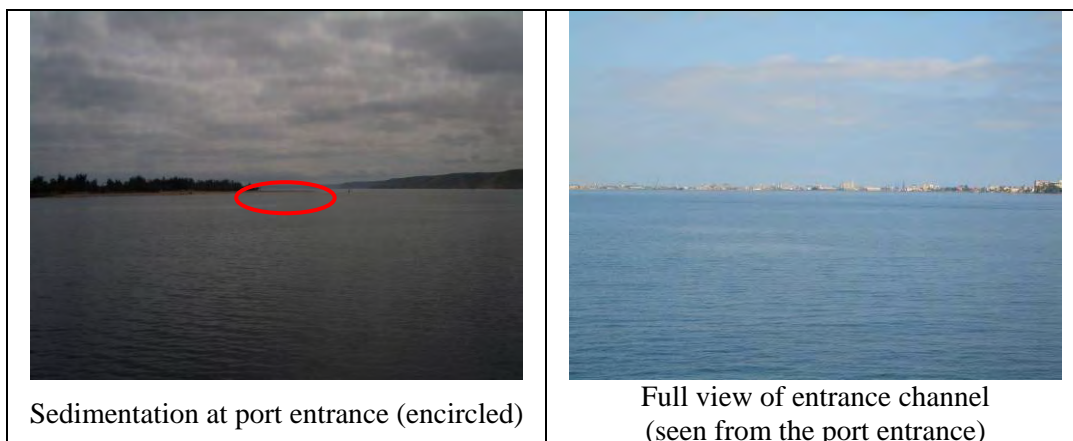
The depth of the entrance channel is approximately -35 meters and becomes shallow abruptly near the wharf. The maximum width of the entrance channel is 1,000 meters. Sedimentation stretched from the sandpit is going on at the starboard side of the port entrance, which is a serious problem of the Port of Lobito (see Photo 5-15).

**Photo 5-15 Present Conditions of Entrance Channel**

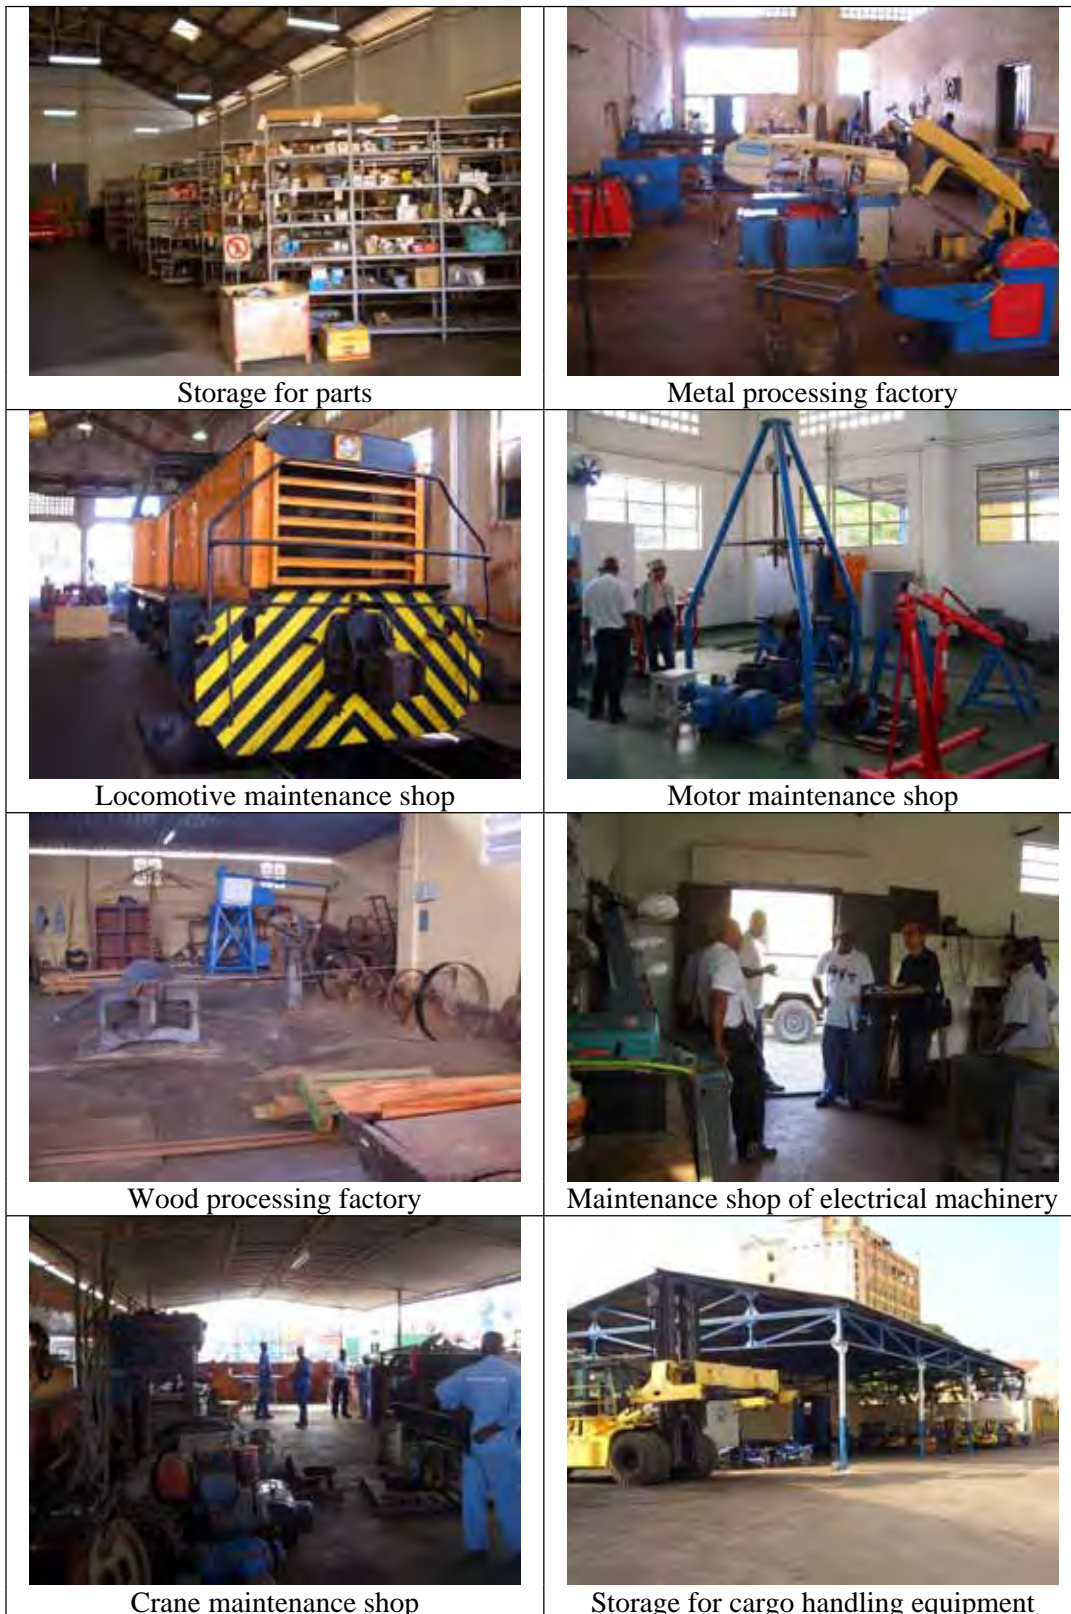
Generally, maintenance shops were well-organized. At the wood processing factory, a very old cutting machine, which reportedly seldom went broke down because of its simple mechanism, was still in operation. However, since it was not equipped with a safety cover on the disk saw, it seemed very dangerous. At the locomotive maintenance shop, three of the four locomotives were being overhauled. The port of Lobito wants to purchase new locomotives. As for the crane maintenance shop, working surroundings were found poorer than the other maintenance shops because it does not have enough walls to keep out wind and rain and has very old machines. Moreover, since it is located far away from the other maintenance shops, the working efficiency is reportedly quite bad (see Photo 5-16). Forklifts and mobile cranes were kept tidily in the store house (see Photo 5-16).

**Photo 5-16 Maintenance Shop**

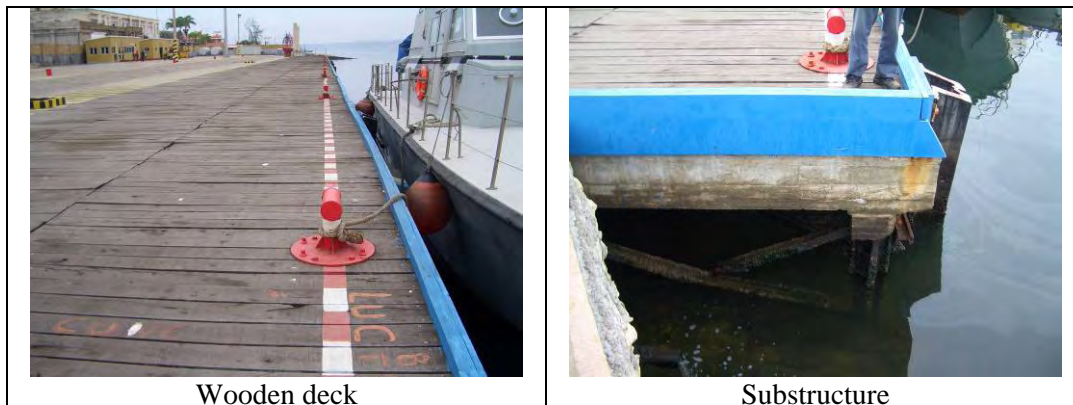
The Cabotage jetty, which was constructed recently, was well maintained. The condition of its wooden deck was found quite well because there is little traffic on the deck unlike in the port of Cabinda. Rubber fenders manufactured by Bridge Stone, which escaped theft during the civil war, were installed on the jetty (see Photo 5-17). Repair works were implemented at several places during the survey

Photo 5-17 Present Status of the Cabotage Jetty

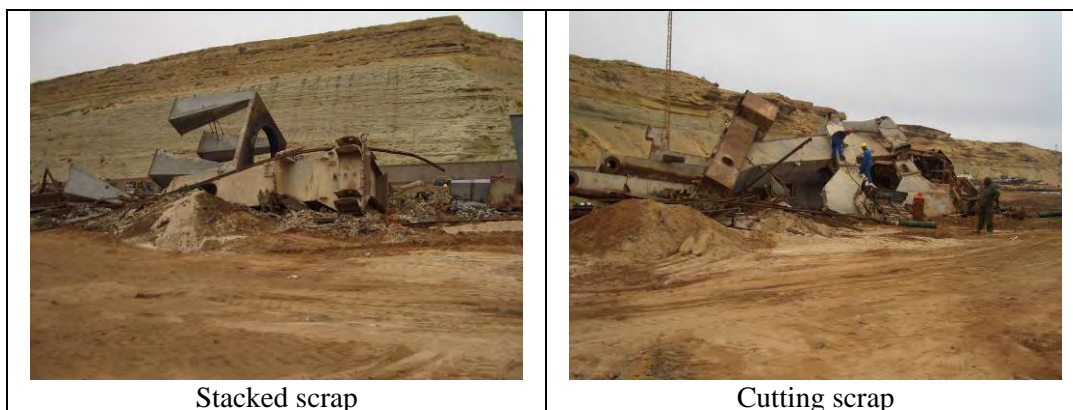
The yard behind the north end of the quay was used as a stacking yard for scrap of demolished cranes etc. The scrap was being cut to the proper size for selling off. The yard will be fairly organized if the process of clearing the scrap progresses favorably (see Photo 5-19).

**Photo 5-19 Scrap Stacking Yard**

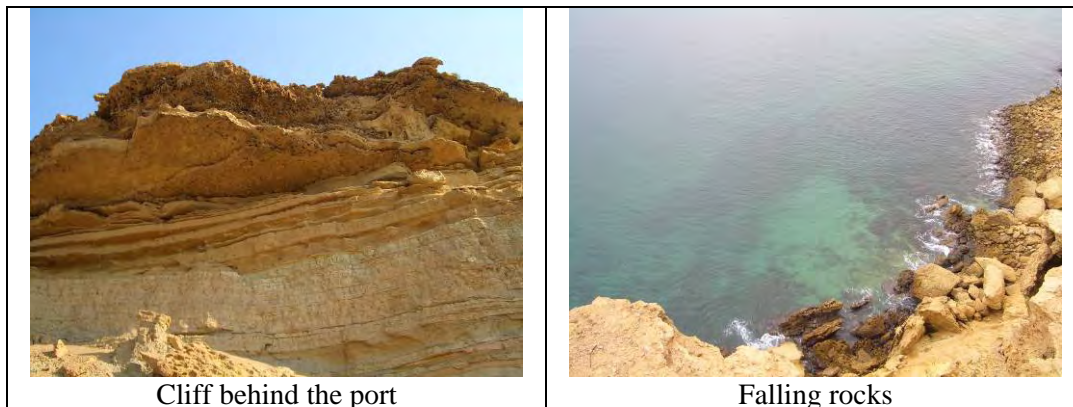
Cliff behind the port

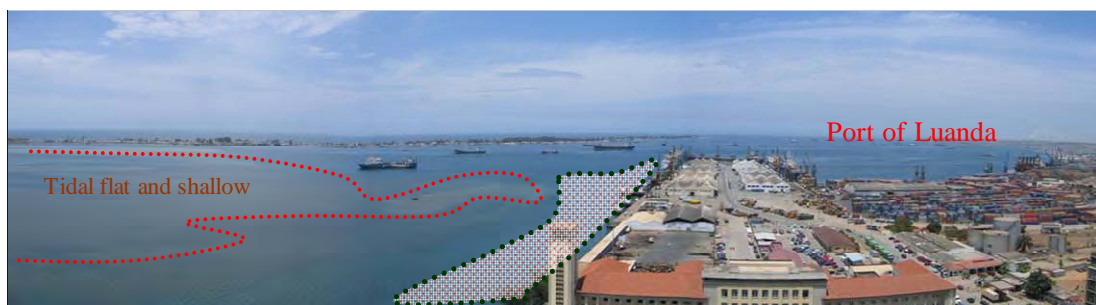
Photo 7-1 Sedimentation in front of Cabotage wharf

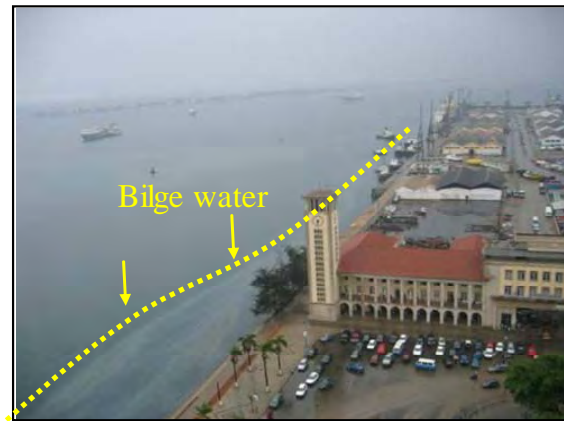
Photo 7-3 Situation of Bilge Water

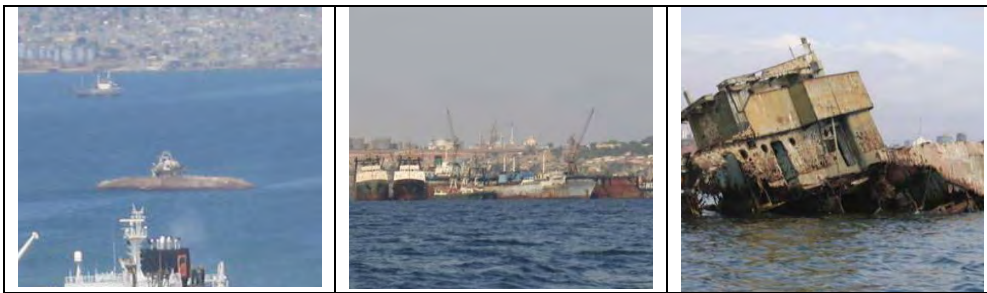
Photo 7-6 Wreck and abandoned boat in Luanda bay

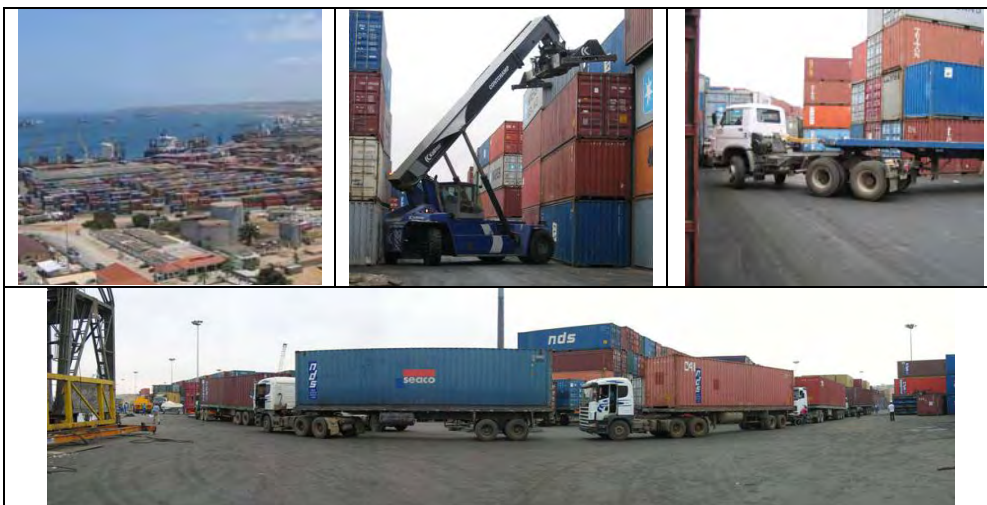
Photo 7-7 Overcrowding problem on Container yard in Port of Luanda
