Boiler RLA

Singrauli Unit 6 (500MW Drum Boiler) Cumulative operation hours: 172,000 hours (27th October to 1st November, 2009)

Unchahar Unit 2 (200MW Drum Boiler) Cumulative operation hours: 139,098 hours (4th November to 9th November, 2009)

JICA Study Team for Enhancing Efficiency of Operating Thermal Power Plant in NTPC-India Boiler RLA

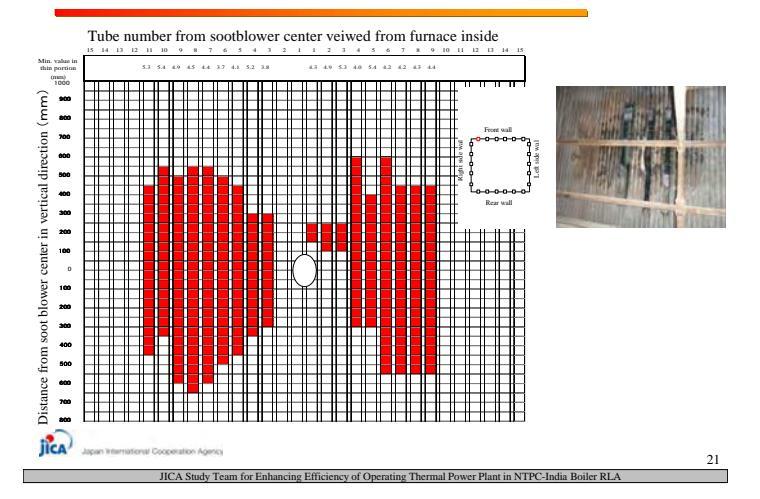
Thickness measurement results of WW (Singrauli #6)

Components	Inspection method	Findings
Water wall tube	Visual check	Erosion of a number of tubes around short soot blower were found. •No erosion at any other portions. •No erosion and decease in thickness around burners.
	Thickness measurement of tubes	Thickness was measured at erosion regions around soot blowerrs near each 4 corner. Min. thickness was 3.7mm/2nd blower in forntwal first from right. f 51* 5.6mm, SA210 Gr.C
	Visual check	Attrition of binding tube ≇4 and ≇5 was found. (Min.2.8mm) Attrition of cooling spacer tubewith front tube of ≇14 panel (Min.5.0mm) Disorder of arrangement at lower part of panel with distortion to adjacent panel. A number of disjointed slide spac
Distion CU	Thickness measurement of tubes	1:Outer tube of rear side portion at sootblower level[24points]→Min.6.3mm φ63.5#6.3mm SA213 TP347H -2:Outer bottom tube [24points]→Min.9.8mm φ54.0#9.5mm SA213 TP347H -3:Attrition of colin

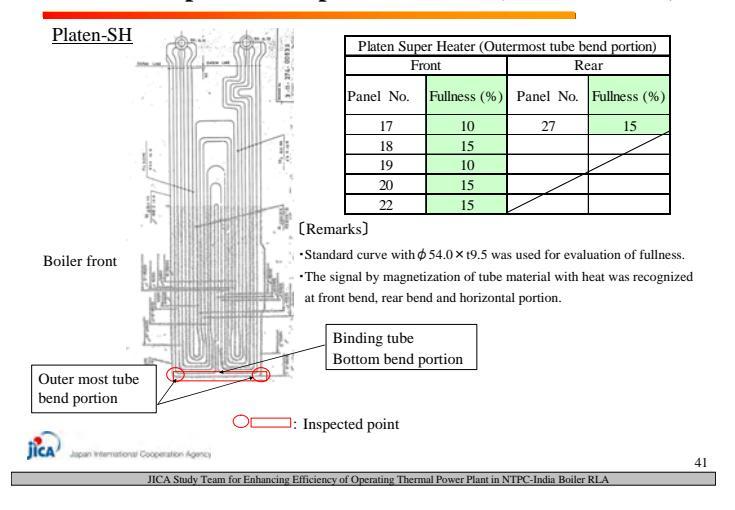
SUS scale deposition inspection results (Singrauli #6)

i atten Sir	SUS scale deposition inspection	Nos. exceeding 10% fullness : 7 /50 (magnetized effect of material)
	Tube sampling for sample tube inspection (inspected in Japan).	#12-3(from leftside) f 47.63*8.6-f 47.63*10, SA213 T22
	Creep rupture test (inspected in Japan)

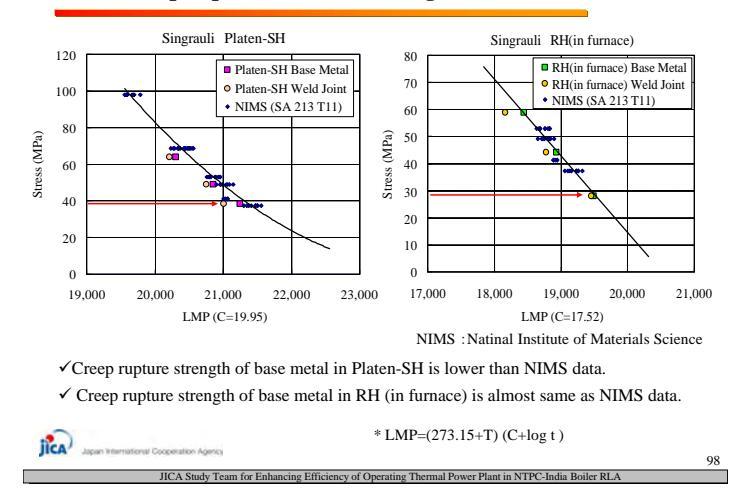
Creep rupture test results Singrauli #6

Test co	ndition	Rupture	LMP*	Fracture	Reduction
Compo	ient	Material	Temp. T (℃)	Stress (MPa)	time t (h)	C=19.95	elongation (%)	of area (%)
			665	49.0	187.7	20,852	102	97
	Base Metal	SA 213 T11	665	63.7	48.7	20,302	87	94
Distan CU			700	38.3	76.1	21,248	88	94
r lateli-3ri		1 SA 213 T11	665	49.0	149.0	20,758	36	92
	Weld Metal		665	63.7	39.0	20,212	44	92
			700	38.3	43.5	21,012	35	95
			Test co	ondition	Rupture	LMP*	Fracture	Reduction
Compo	nent	Material	Test co Temp. T(°C)	Stress (MPa)	Rupture time t (h)	LMP* C=17.52	Fracture elongation (%)	Reduction of area ** (%)
Compo	nent	Material	Test co Temp. T(℃) 665	ndition Stress (MPa) 44.1	Rupture time t (h) 457.0	LMP* C=17.52 18,933	Fracture elongation (%) 53	Reduction of area ** (%) 57
Compo	nent Base Metal	Material SA 213 T11	Test co Temp. T(°C) 665 665	MPa) 58.8	Rupture time t (h) 457.0 139.2	LMP* C=17.52 18,933 18,448	Fracture elongation (%) 53 62	Reduction of area ** (%) 57 63

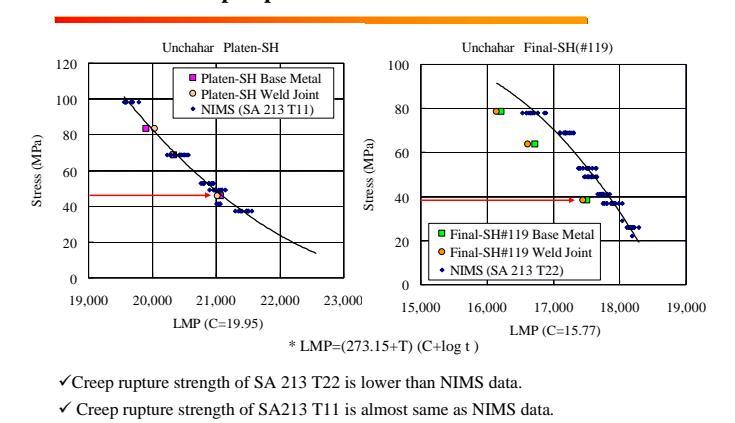
Creep rupture test results Unchahar #2

Test co	ondition	Rupture	LMP	Fracture	Reduction					
Compo	nent	Material	Temp. T(℃)	Stress (MPa)	time t (h)	C=19.95	elongation (%)	of area (%)	Remark				
			635	68.6	278.7	20,341	62	94	Ruptured				
	Base Metal	SA 213 T11	635	83.4	90.8	19,899	57	91	Ruptured				
Distan CLI			665	45.9	322.4	21,072	86	94	Ruptured				
r aten-3ri			635	68.6	264.3	20,320	16	81	Ruptured				
	Weld Metal	SA 213 T11	635	83.4	127.5	20,033	18	82	Ruptured				
			665	45.9	287.5	21,026	13	80	Ruptured				
Compo	nent	Material	Test or Temp. T(°C)	Stress (MPa)	Rupture time t (h)	LMP C=15.77	Fracture elongation (%)	Reduction of area (%)	Remark				
			665	63.7	113.1	16,725	69	91	Ruptured				
	Base Metal	SA 213 T22	665	78.5	32.1	16,212	55	92	Ruptured

E. J. SUM110			700	38.3	162.6	17,503	67	94	Ruptured				
Pinai-SH#119							665	63.7	86.0	16,614	30	84	Ruptured
	Weld Metal	SA 213 T22	665	78.5	27.3	16,146	31	83	Ruptured				
			700	38.3	143.7	17,451	22	81	Ruptured				
LMP=(273.15+T) (C+log t)													
JICA' Japan Int	imational Coopera	ation Agency							10

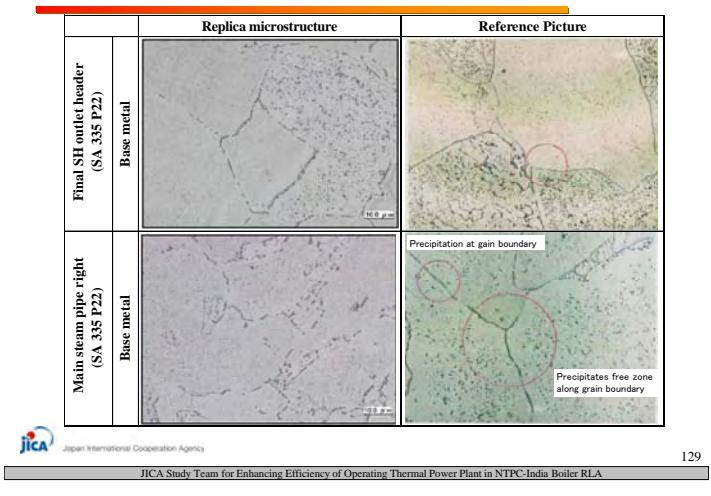
Microstructure observation results (Unchahar #2)

nents		ion		OM (Optical mic Microstruct	roscope observation) ural features				
	Compo		Locat	Observed region	Precipitation at gain boundary	Precipitates free zone along grain boundary				
	ader	er		Base metal	Appeared	Not appeared				
	et he: P22)	head	ential	rential	ential	ential	ential	Intercritical zone	Not appeared	Not appeared
	H out	ide of	umfer weld	Fine grain HAZ	Appeared					
	ial SF (SA	ightsi	Circi	Coarse grain HAZ	Appeared					
	Η	R		Weld metal						
	9		l /alve]	Base metal	Appeared	Not appeared				
	n pip P22)	t	ential stop v	Intercritical zone	Appeared	Not appeared				
	stear 335	Righ	umfere ur the st	umferer r the sto	umferer r the sto	Fine grain HAZ	Appeared			
	Main (SA		Circi (nea	Coarse grain HAZ	Not appeared					
\sim			weld	Weld metal						
JICA)	CA Jupan International Cooperation Agency									
			JICA Stud	y Team for Enhancing Efficier	cy of Operating Thermal Power Plant	in NTPC-India Boiler RLA

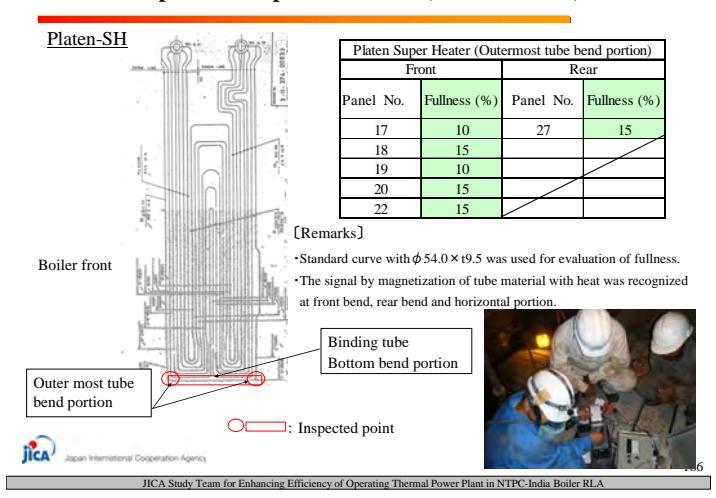
SUS scale deposition inspection results (Unchahar #2)

CREEP RUPTURE TEST*	1 sample tube from Platen-SH in furnace (#3panel- 8th tube from rear), 1 sample tubes from Final-SH in furnace (#119-3rd tube from rear)
	SUS SCALE DEPOSITION INSPECTION	3 tubes with 15% fullness and 2 tubes with 10% fullness at front bend portion. 1 tube with 15% fullness and the others with less than 10%.
REHEATER	VT	No abnormality with panel ar _r angement Slight erosion of tubes at the highest level of short soot blower.
