# IMPLEMENTATION REVIEW STUDY REPORT ON THE PROJECT FOR URGENT IMPROVEMENT OF WATER SUPPLY SYSTEM IN BEMOS-DILI (PHASES II) IN THE DEMOCRATIC REPUBLIC OF TIMOR-LESTE

December 2010

JAPAN INTERNATIONAL COOPERATION AGENCY

SANYU CONSULTANTS INC.

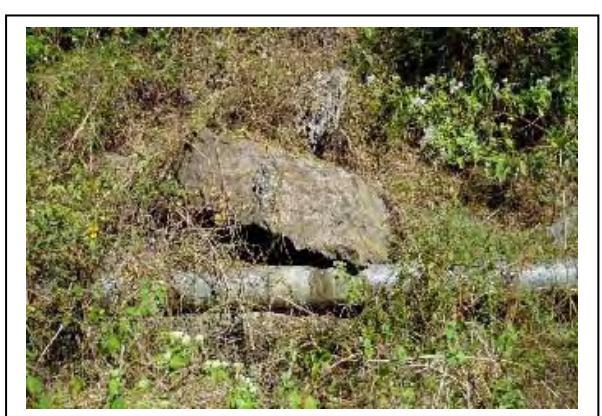
Structure No.11 Mountain foot slope of left bank of Bemos River

Pipeline was setting on the ground in this section, there is many falling rock around pipeline, and some big stone were shown on the pipe.

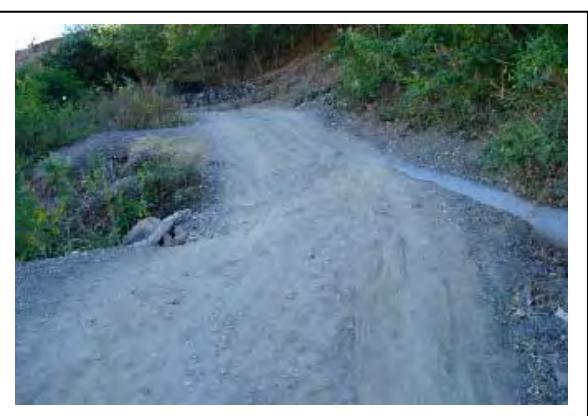
Structure No.12 Comoro river right bank Steep slope road section

In rainy season the heavy rain erode the no pavement road and the pipe was exposed. The car pass on the pipe and road will be eroded, so it is possible to break the pipe.

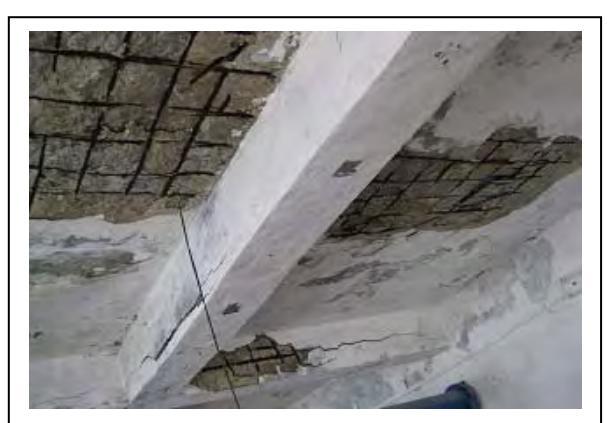
Structure No.14 The Lower Service Reservoir & valve chamber of Bemos water treatment Plant

Reservoir was deteriorated, there are widely concrete peeled on the roof, the roof would be fallen. There are repair portion and crack on the inside wall, there are leakage on outside wall.

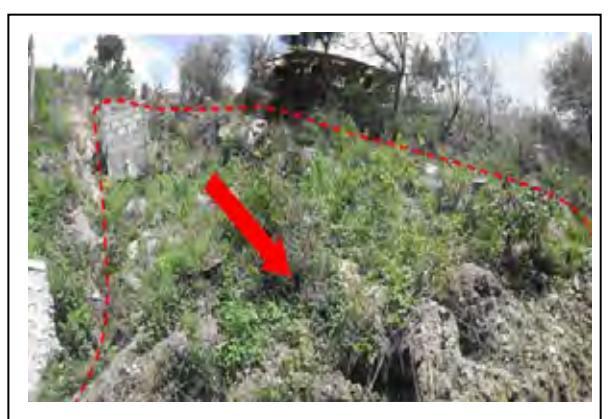
Structure No.15 Land slides at the access road to Bemos water treatment plant The landslide occurred at slope beside the access road to Bemos Water treatment Plant, covered on the road. Landslide soil was sludge with much water just after landslide, dried for dry season. But wet condition in soil, the soil becomes soft again by rain water.

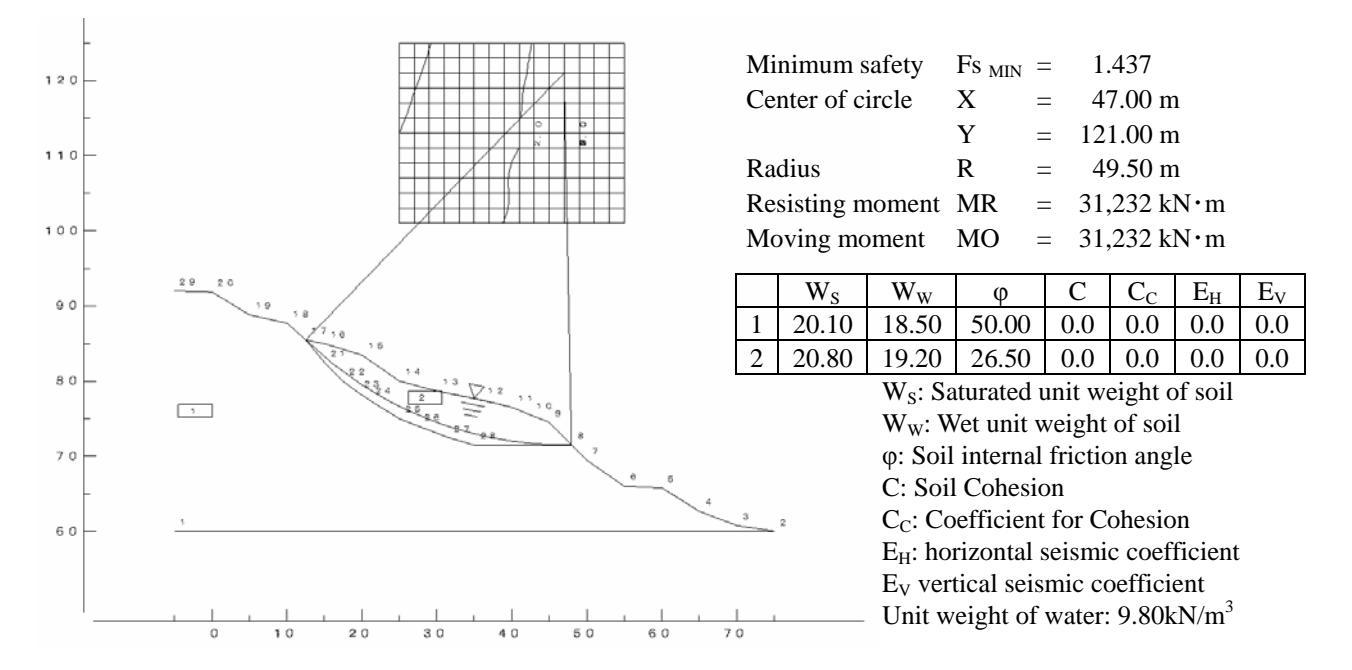
Figure 2-2.16 Stability Analysis Result: CASE 2 Slope Stability after Landslide

Based on the angle of internal friction of soil  $\varphi = 26.5^{\circ}$ , which is calculated by stability analysis when the safety factor is secured at 0.98, the result of the stability analysis after landslide is as follows. It shows that the landslide clod slope is stability, because SF = 1.437. However, if the clod on the access road is removed, landslide maybe occurs again.

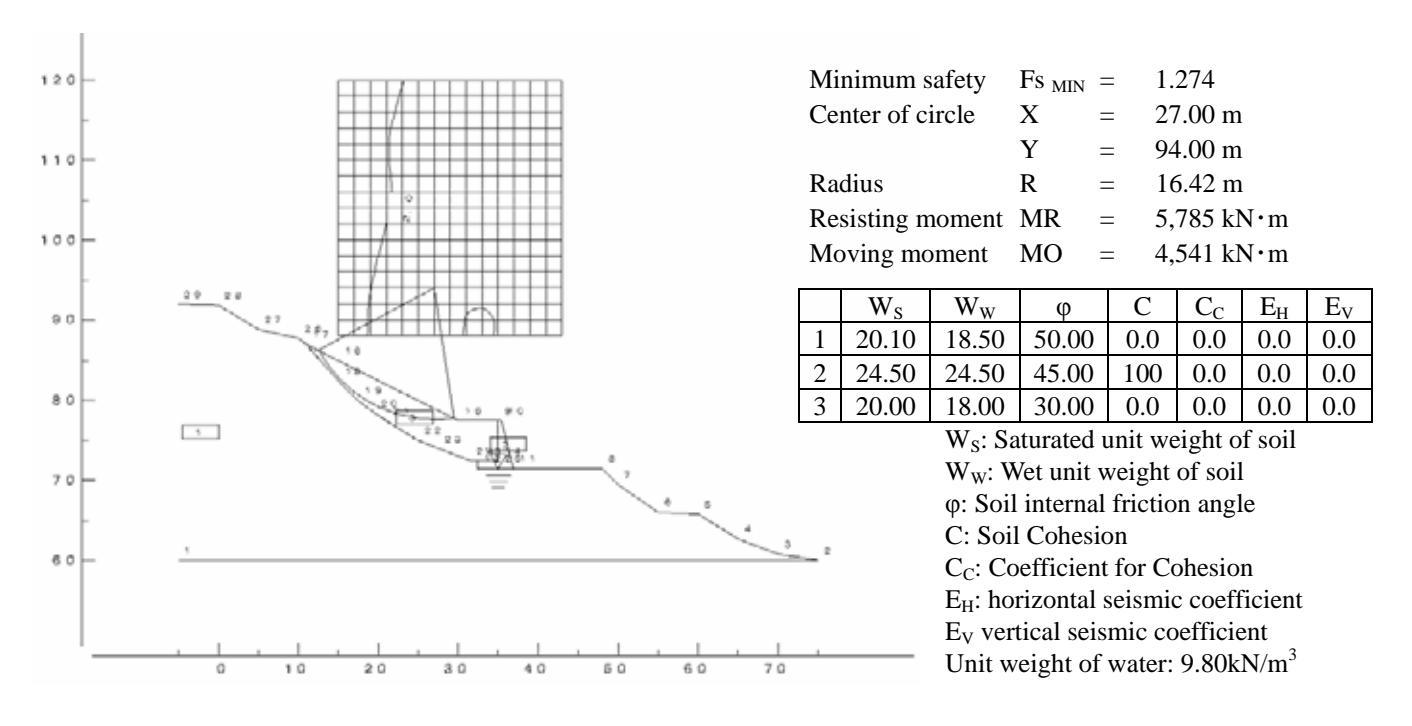
Figure 2-2.18 Stability Analysis Result: CASE 3 Slope Stability after implementation of the countermeasures for Landslide

The result of the analyses is as follows. It shows that the slope is safe after implementation of the countermeasures, because SF = 1.274 > 1.20
