Characteristics of PSPP Potential Site

Site Name		No.19
Location (River name)		Upper Dam / Reservoir : Burdur Bucak Kocayer (Curukini River) Lower Dam / Reservoir : Burdur Bucak (Karacaoren II Lake)
Profile	Installed Capacity P (MW)	1,000
	Design Discharge Q (m ³ /s)	249
	Effective Head H (m)	507
	Peak Duration Hour (hrs)	7
Geography / Geology	General Geology	<ul style="list-style-type: none"> - The regional geology belongs to the upper Miocene series. Only geology of right bank of Existing Karacaoren II lake is Cretaceous system, and they lay from the west to the east sequentially, Karpuzcay formation (Tmkp) of upper Burdigalian to Serravallian age, Aksu formation (Tma) of Tortonian to Serravallian age. - Karpuzcay formation (Tmkp) consists of sandstone, claystone, siltstone, and conglomerate. Aksu formation (Tma) consists of conglomerate. - N50W/30NE strike and dip was measured at a conglomerate outcrop where southern part of Karacaoren II dam site which geology belongs to Karpuzcay formation. On the other hand, N15W/35NE strike and dip was measured at a calcilutite outcrop on the slope of northern national road, and a fossil of bivalve was found in the outcrop.

Appendix 5-5

R

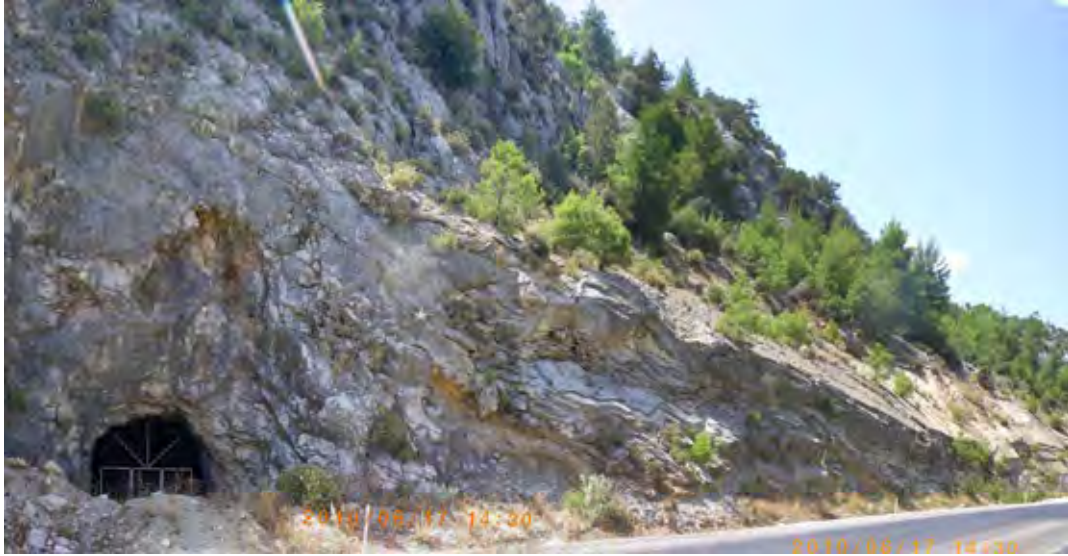
Photo 1 Regional Geology

Lower bedrock of Cretaceous limestone and upper order of Karpuzcay formation (Tmkp)
 Strike and dip of bedding plane of Karpuzcay formation (Tmkp) is N15W/35NE

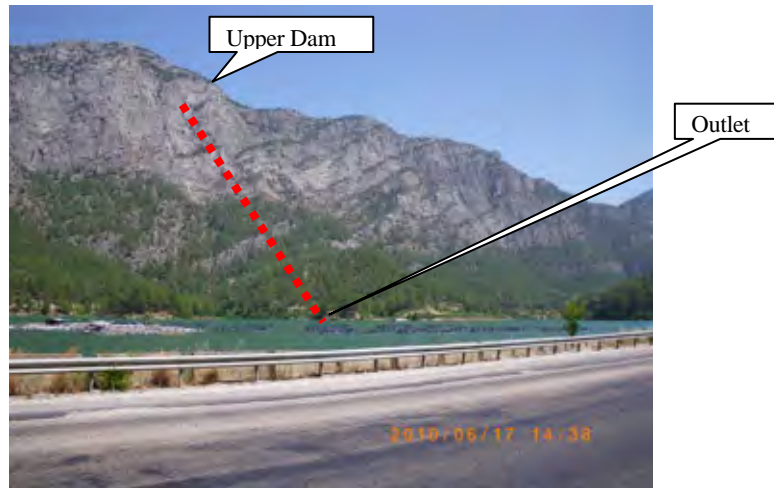
Photo 4 Regional Geology

The upper order of Aksu (Tma) and lower order of Karpuzcay formation (Tmkp) Alternation of siltstone and claystone which lays under the Conglomerate of the upper order is weathered and eroded, and forms a gentle slope.

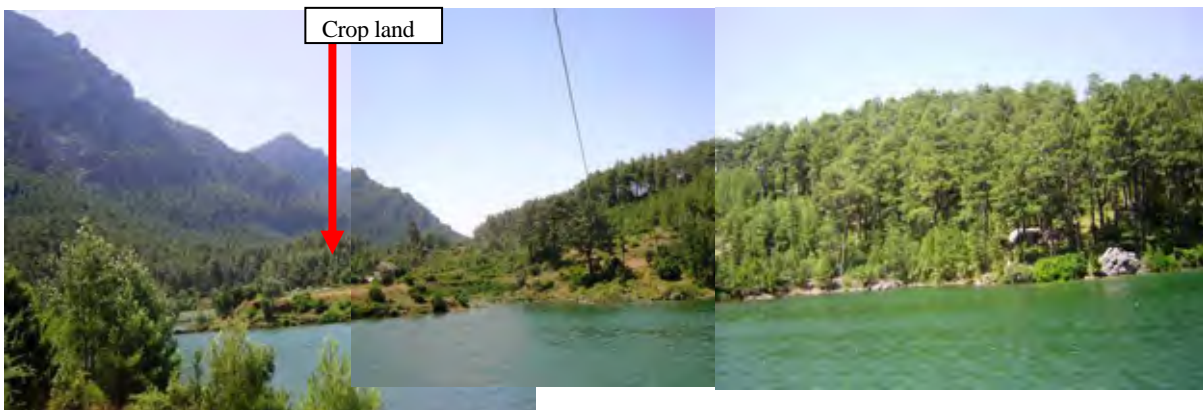
Photo 5 Original outlet site viewing from the upstream

The original outlet site is located at a flat terrace used for farm which height is about 3 meter from the HWL of the reservoir and the slope is gentle with approximately 20 degrees.

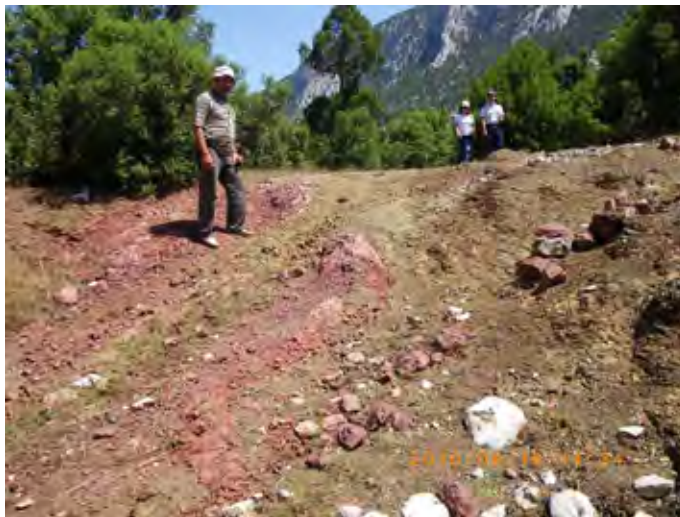
Photo 2 River bed in the upper reservoir

Ophiolitic mélangé of Kirkdirek formation (KKm) distributes at the right bank of the river, and is weathered from moderately to highly. The rock is easily crushable by hammer.

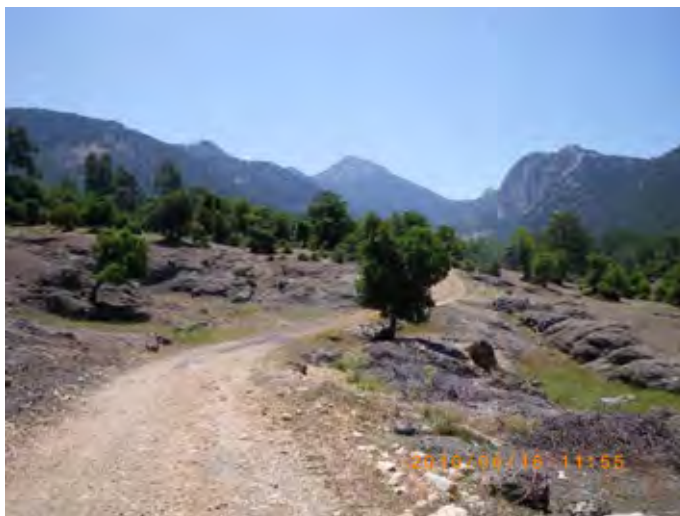
Photo 3 Kirkdirek formation (KKm) in the upper reservoir (right bank)

Rocks are weathered and forms even topography.

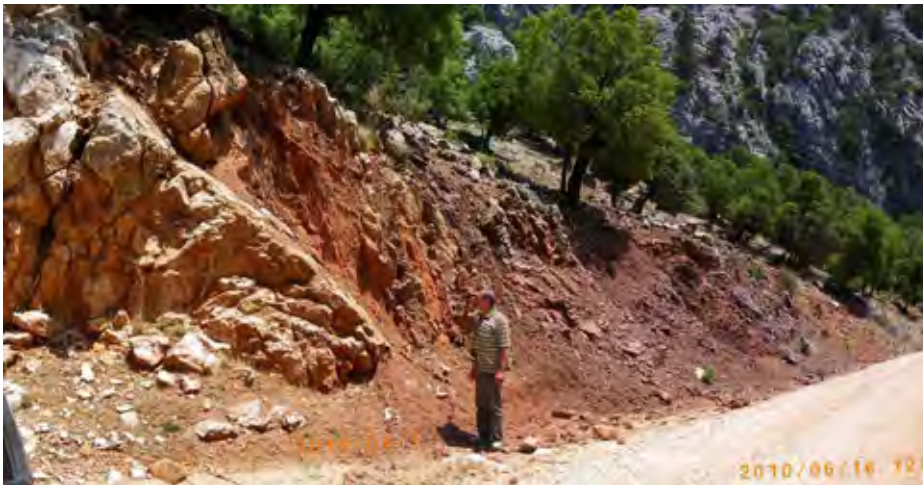
Photo 5 In the upper reservoir (right bank)

Older ophiolite of Kırkdirek formation(right) and younger limestone of Tekedağı formation(left) risen by thrust

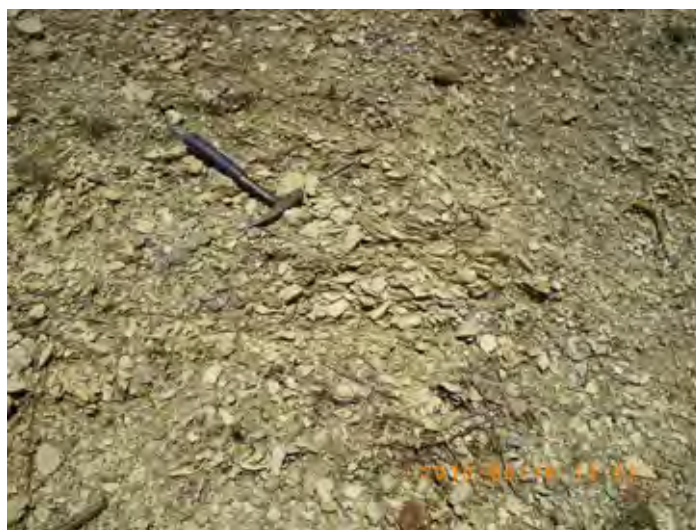
Photo 6 Highly weathered pelite cropped out on the UPH

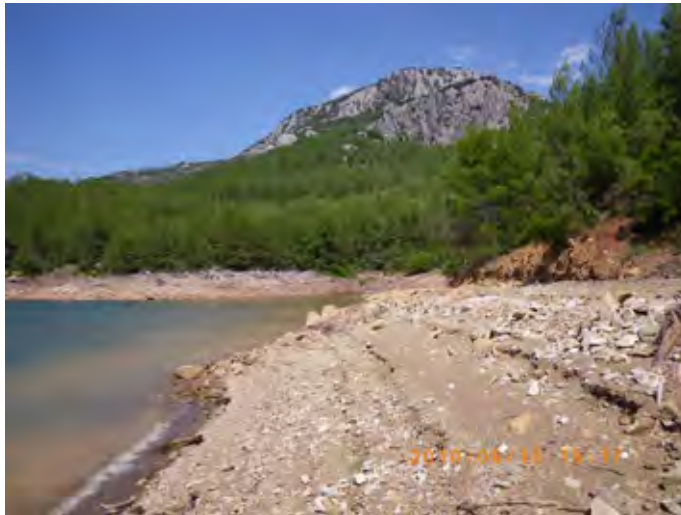
Cohesive soil washed out from clay stone by wave along the lakeside
Photo 8 Tailrace and Outlet site

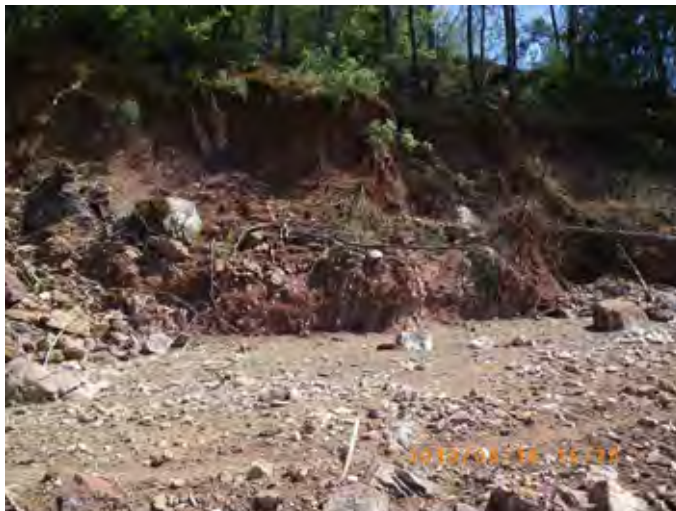
Outcrops of chart eroded by wave
Photo 9 Tailrace and Outlet site

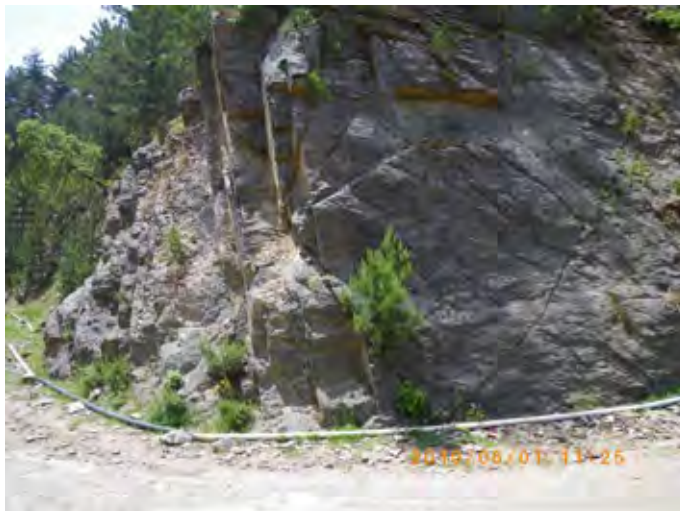
Photo 3 Alternative upper dam site

Schist cropped out in the reservoir (joints are developed)

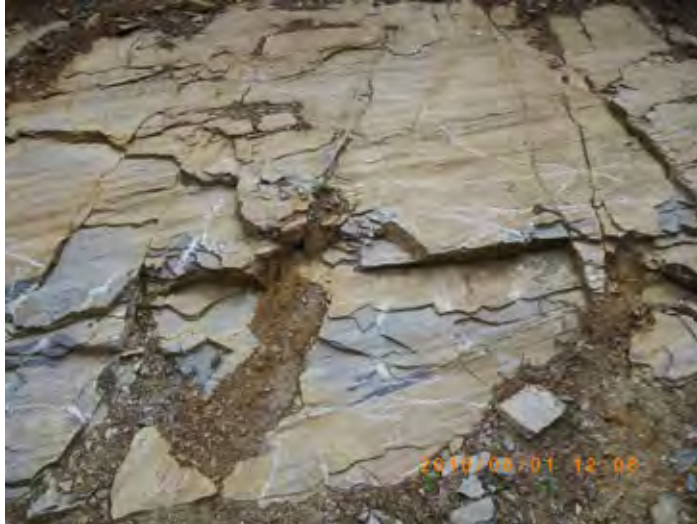
Splitting off in placibus along joints which intersect with schistosityes
Photo 7 Schist distributed on the left bank slope of Gökçekaya reservoir

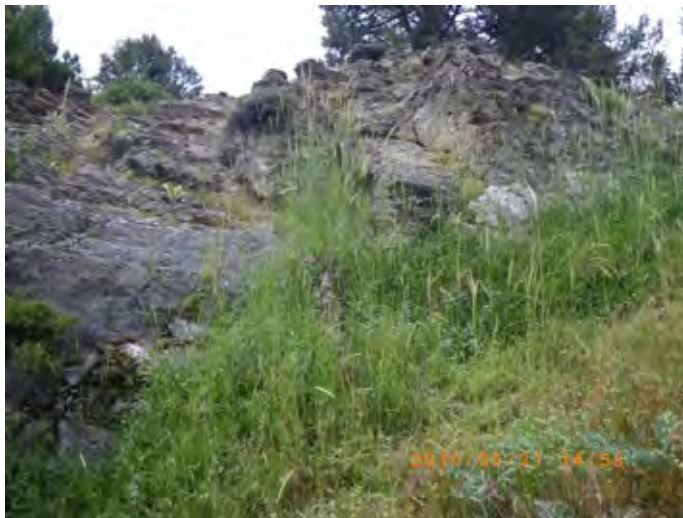
Photo 5 Lime which were dissolved and transferred along joints were deposited on the surface of the outcrop at the dam site

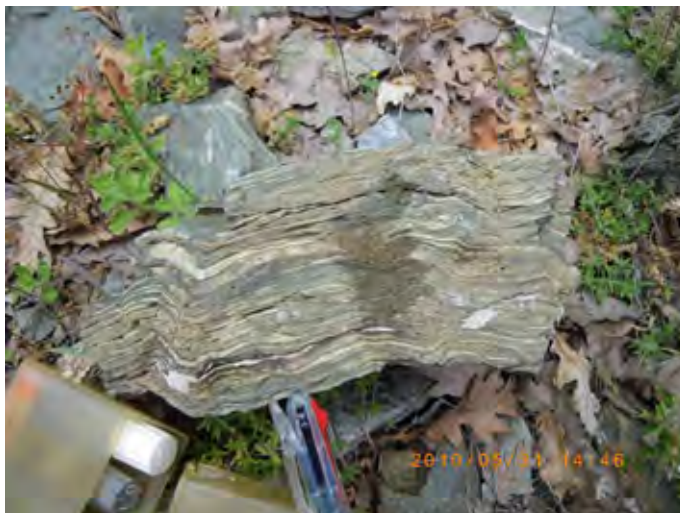
Photo 6 Some parts of the calcareous layer with a few mm thickness were dissolved

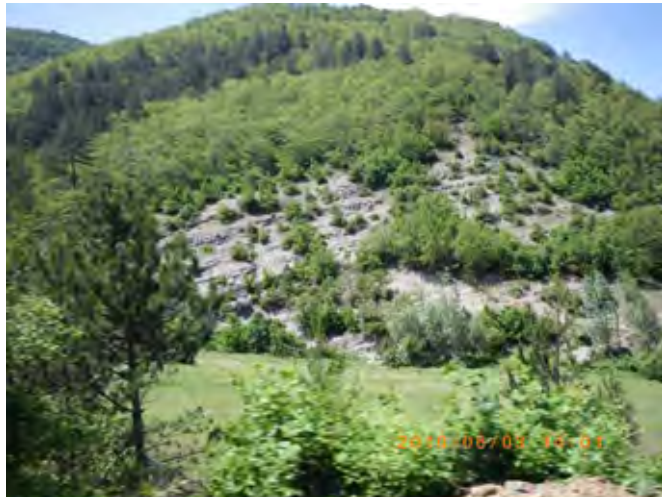
Photo 4 Outcrops at the left bank of the upper dam site

Alternation of sedimentary rocks, most of rocks on the right bank are hard, however, small scale holes were observed in the thick calcareous strata

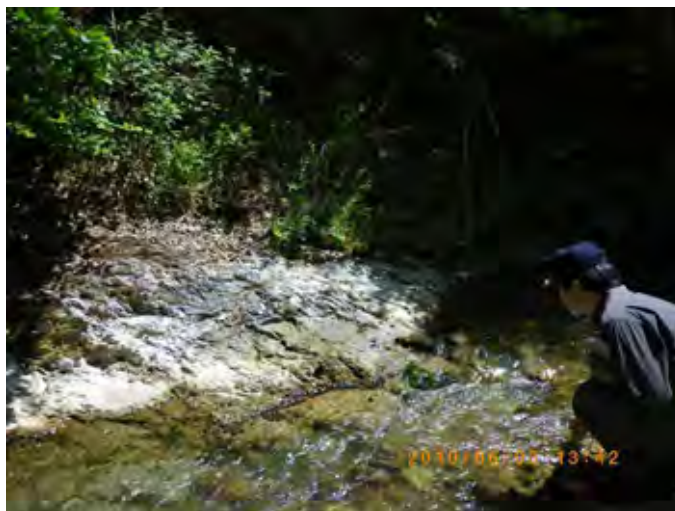
Photo 6 Mudstone cropped out at the riverbed of the upper dam site

Slaking due to weathering at some surface of mudstone

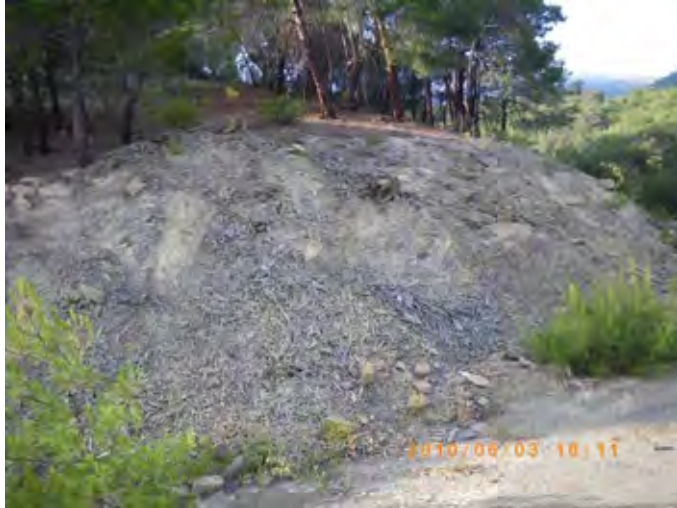
Photo 10 Mudstone cropped out at the outlet site, which is slaked by weathering
