## **11.4 INITIAL ENVIRONMENTAL EXAMINATION**

“The Study on the Rural Water Supply in Tabora Region in the Republic of Tanzania”

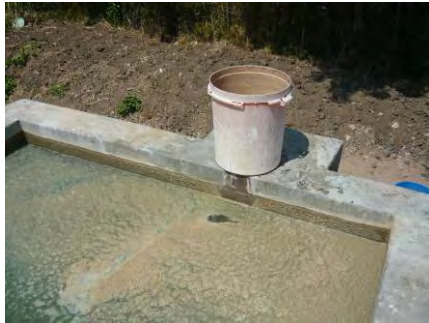
The present point of injection of coagulant

The Study Team establishes a simple improvement plan as follows; to change the injection point of the coagulant from the receiving well to the upper outlet point of the flocculation basin, and to drop the coagulant from above, utilising the turbulence flow of the outlet of the receiving well for mixing the raw water and coagulant. As there are two (2) outlets, the Study Team proposes that another tank of coagulant should be added to the existing one.

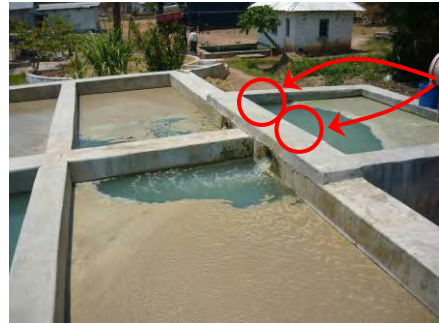
The proposed points of injection

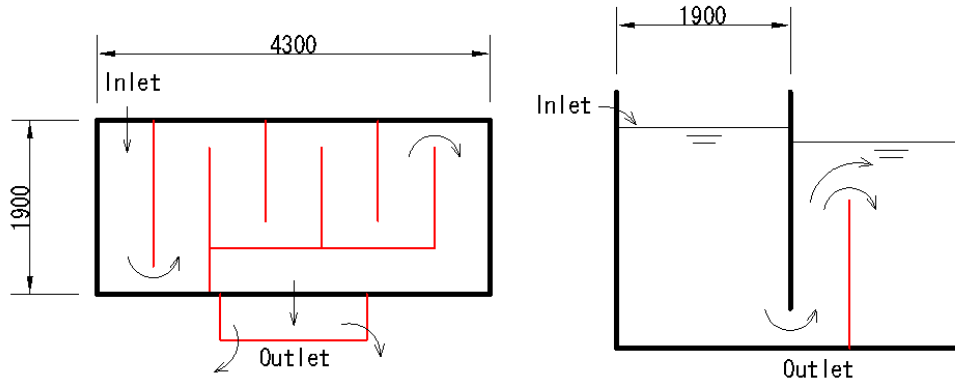
**Figure 14.4.1 Installation of Baffle Plates into Flocculation Basin (Plan and Section)**

The existing flocculation basin is to be improved as it does not match with the mixing function. The plan applies the water flow method for mixing instead of the machinery flocculation such as using a mixing device which is not employed as it needs to install a new machine and electronic device and to operate and maintain them. The plan adopts using wooden boards which are easy to install as baffle plates dividing the basin. As flocks are withdrawn from the bottom of the intake wall, they roll up in the basin. Therefore, a wall shall be installed in the surrounding intake, which makes roll-up flowing until the middle of the basin. The following figure shows the draft plan of the baffle plate installation.

- Type: horizontal baffle type flocculation basin
- Material of Baffle Wall: wooden plate (water proof)

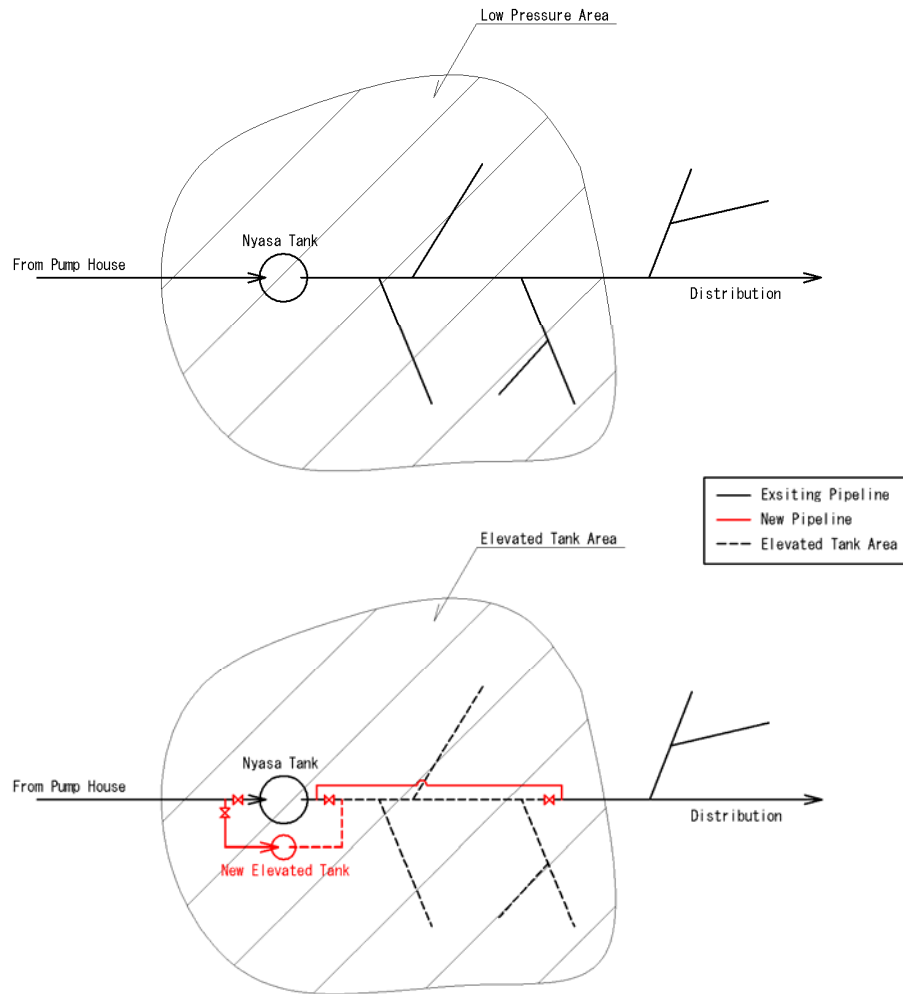
**Figure 14.4.3 Nyasa Tank Distribution Area (Above: Present, Below: After Improvement)**

The present issue on the distribution from the Nyasa Tank is that the surrounding households complain of low water pressure when the water level of the Nyasa Tank becomes low, the problem with low pressure is supposed to be limited to a part of the service area. Therefore, the Study Team estimates that there is no need to construct a new elevated tank which covers all the water of the entire service areas of the present Nyasa Tank, rather, the team proposes that a small scale elevated tank which covers the areas suffering from low pressure. The draft improvement plan is shown in the figure below. The plan aims to divide the service areas into a new elevated tank distribution and the Nyasa Tank distribution, and to install the new connecting pipe for the Nyasa Tank distribution. Basically, though it is necessary to conduct a detailed survey to establish a plan, the plan calculates the draft project budget based on the following assumption.

- Structure of Tank: Elevated Tank with Reinforced Concrete (H=5m)
- Capacity of Tank: 45 m<sup>3</sup> (Necessity is assumed to be about 1/3 of the present capacity)
- Distribution Pipe: it is assumed 4" PVC L = 1,000m
