# CHAPTER 6 ENGINEERING GEOLOGY ON SELECTED STRUCTURAL MEASURE SITES

# 6.1 Oeste Dam

Preparatory Survey for the Project on Disaster Mitigation Measures for the Itajai River Basin Prevention and

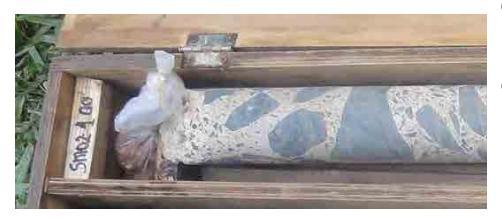
Concrete: CO

Photo (left) shows ordinary portland cement concrete of the existing dam body.

Content of aggregate is approximately 40% in volume and no degradation was found between aggregate and cement.

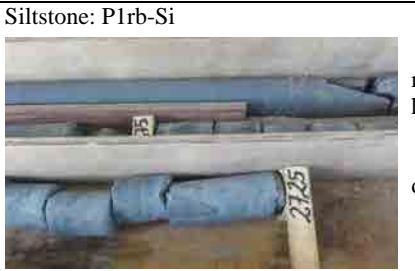
Photo (left) shows siltstone at GL-27m of F-BO-01. Medium strong rock, whose unconfined compression strength is about 20MN/m2 by hammer sounding, was observed.

Low angled cracks for bedding plane are closely adhered with no degradation.

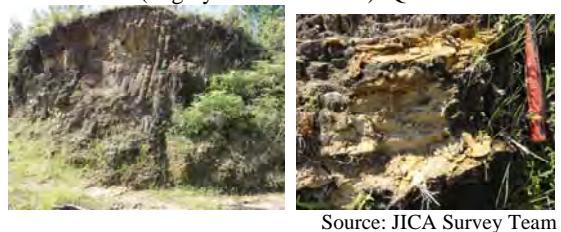
Residual soil (Highly weathered rock): Q2r

Photos (left) show outcrops observed at the right down stream side of dam body. Original is sandstone and structures are remaining. The layer is deeply weathered and easily broken by hammer; therefore excavation by ripper might be easy.

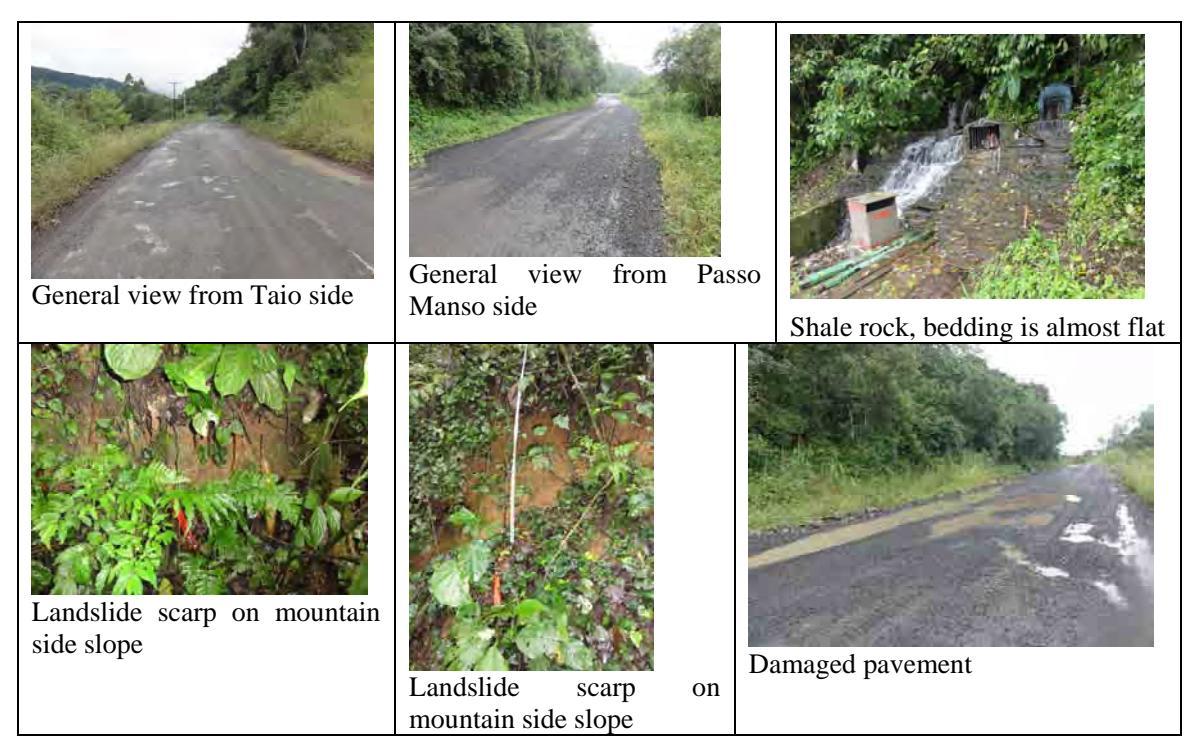
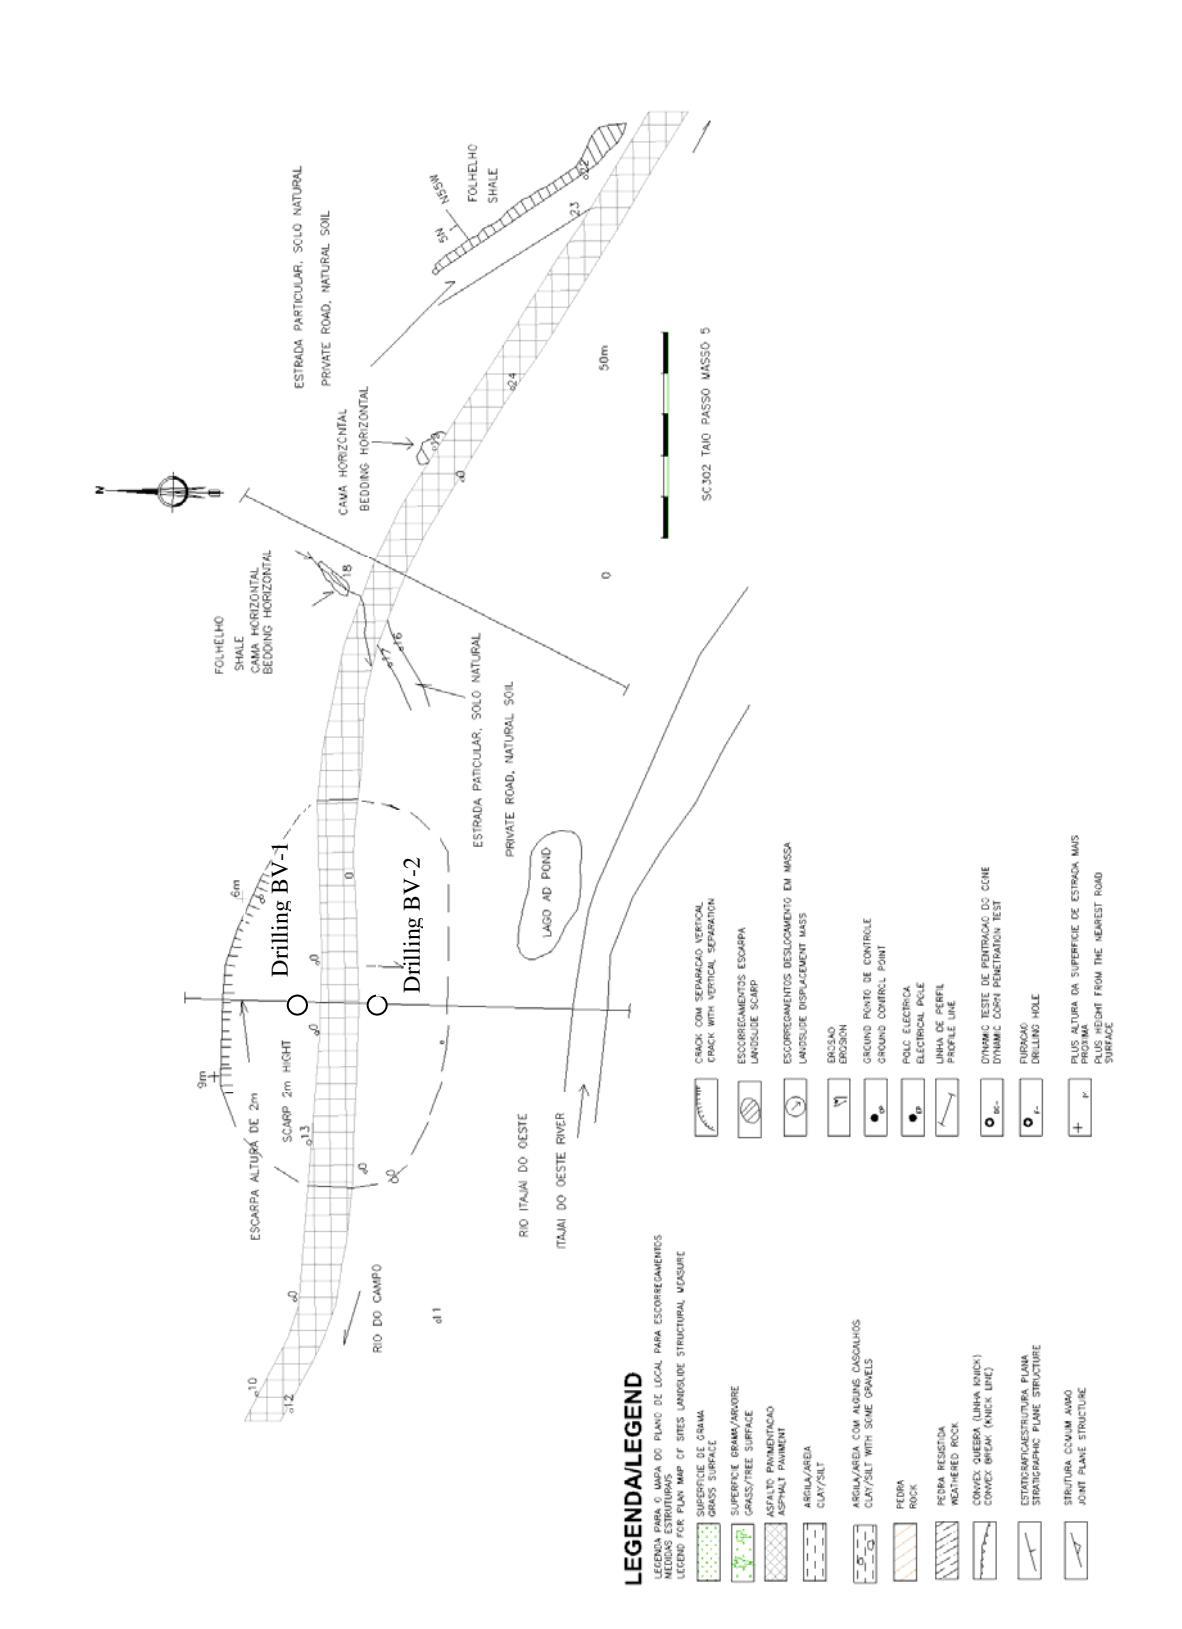
Figure 6.5.4 Engineering Geological Map for SC301 Taio -Passo Manso-5

Active landslide block of 80 m width 60 m length is recognized. Pavement has been broken recurrently due to landslide. Drilling investigation shows that bed rock surface is shallow (2.7 m - 3.0 m depth) and groundwater table is shallow (1.0 m - 2.6 m). Pipe strain gauge monitoring does not indicate sharply-defined slip surface.

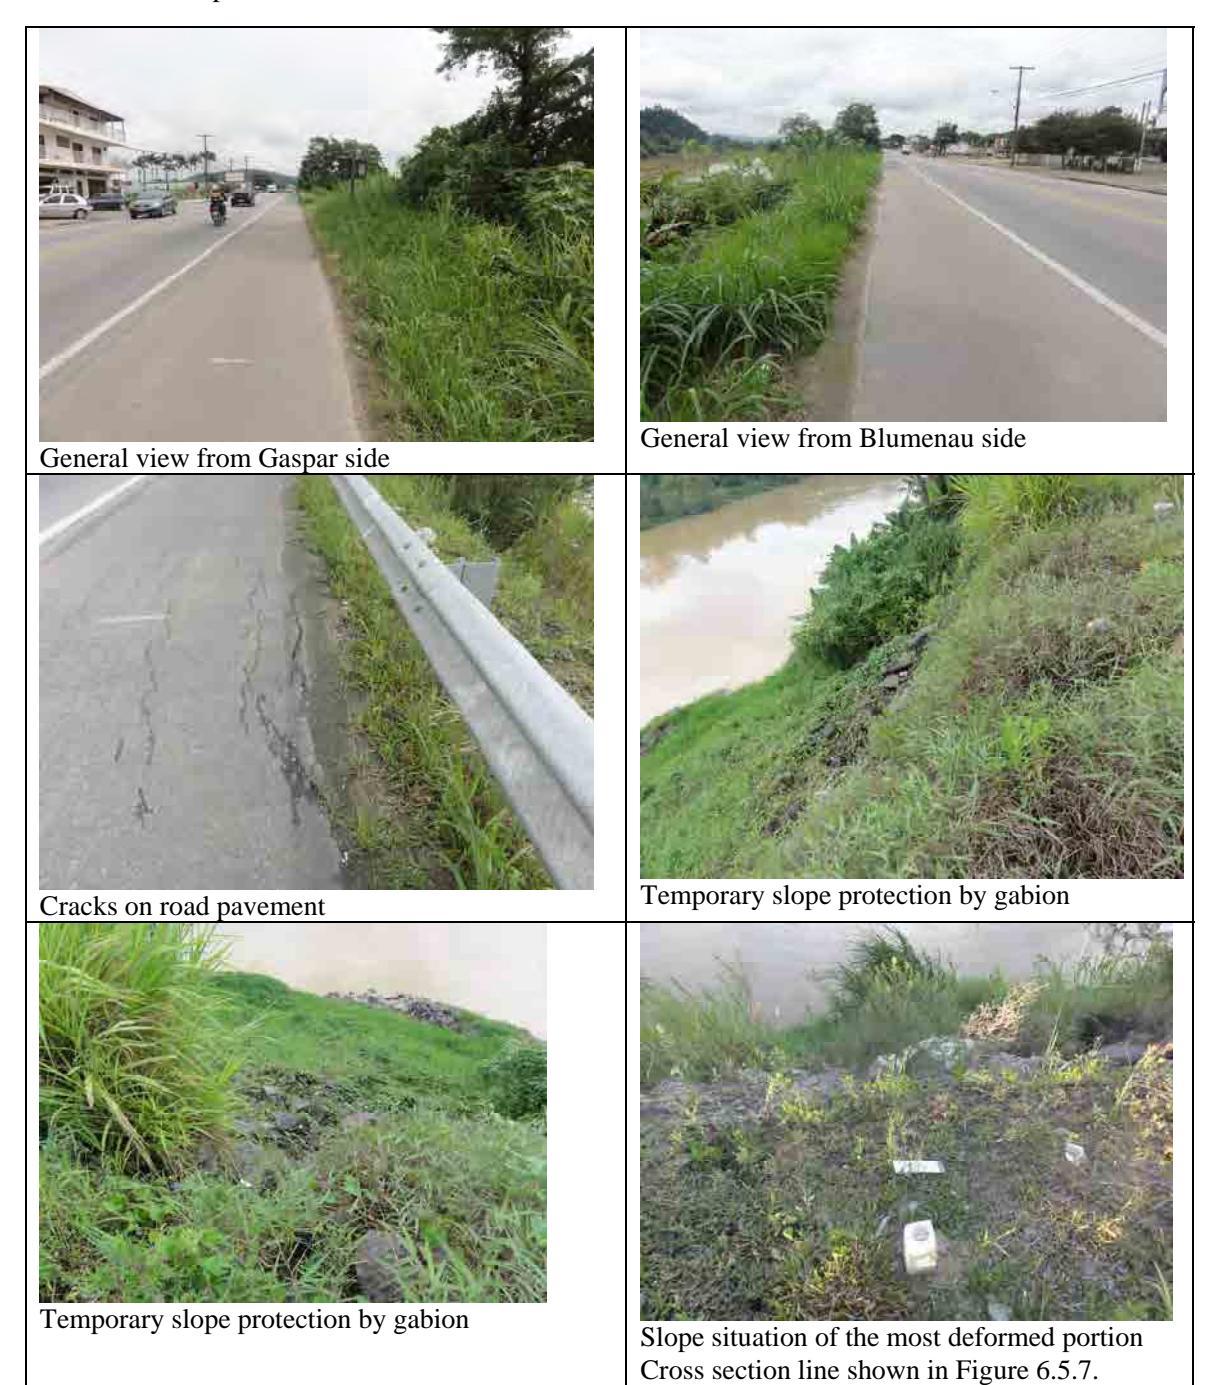
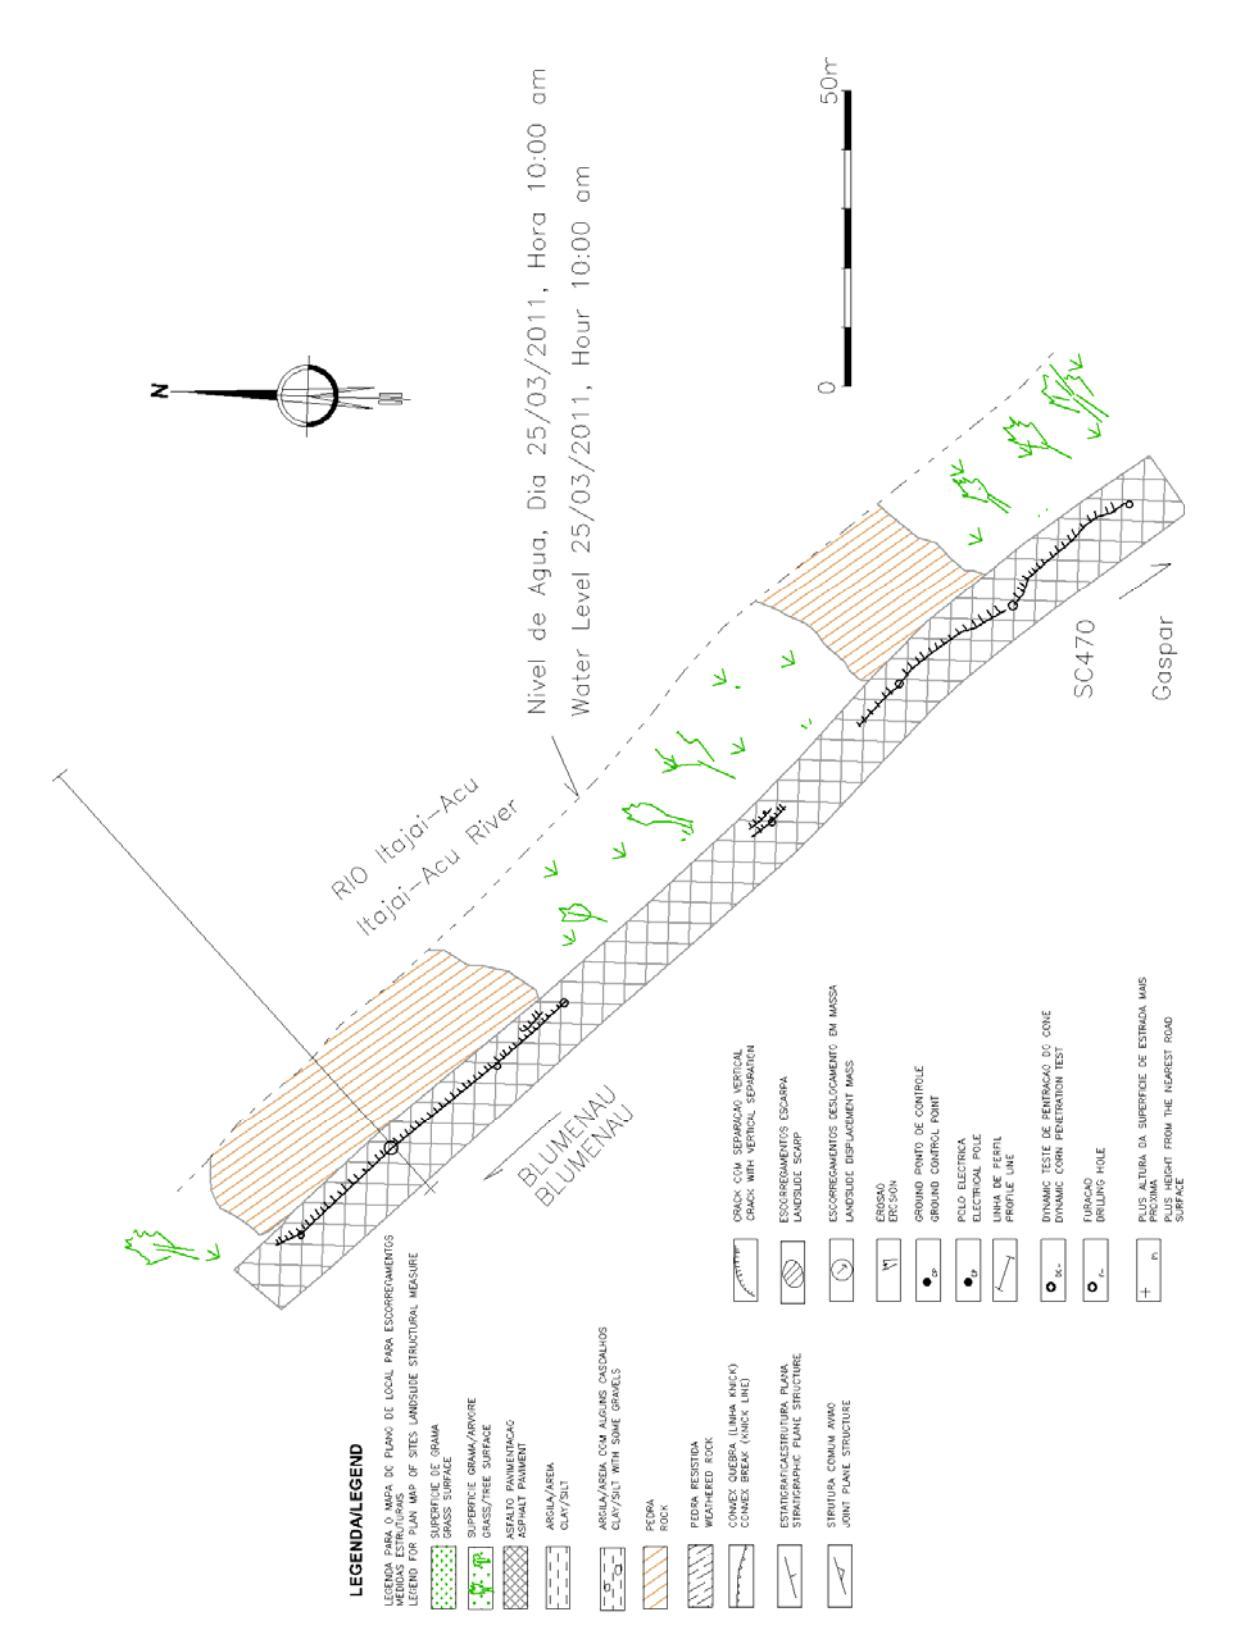
Figure 6.5.7 Engineering Geological Map for SC470 Gaspar River Bank

The slope was collapsed by heavy rain in November 2008. The slope was temporally restored and protected by gabion. But deformation of road shoulder is progressing. It is a possibility of destruction of pipe culverts which go across the road. In that case, the water leakage may cause a further road slope failure.

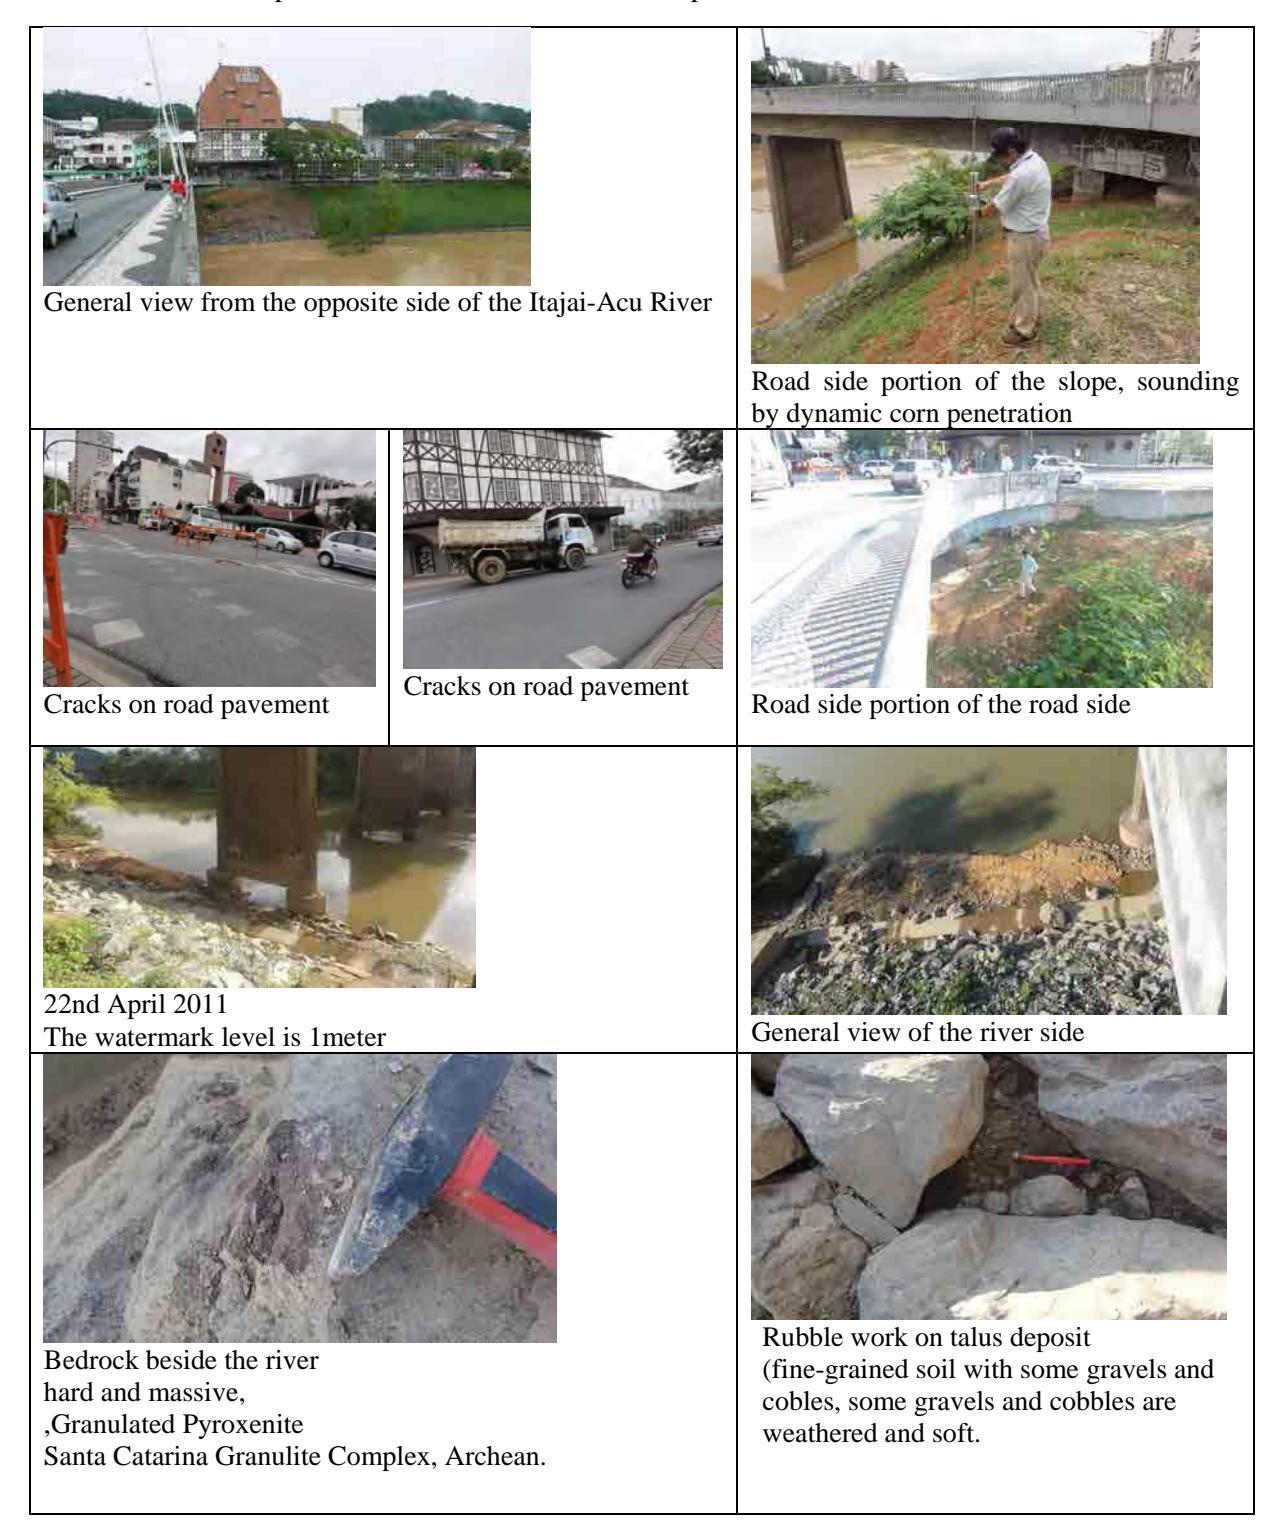
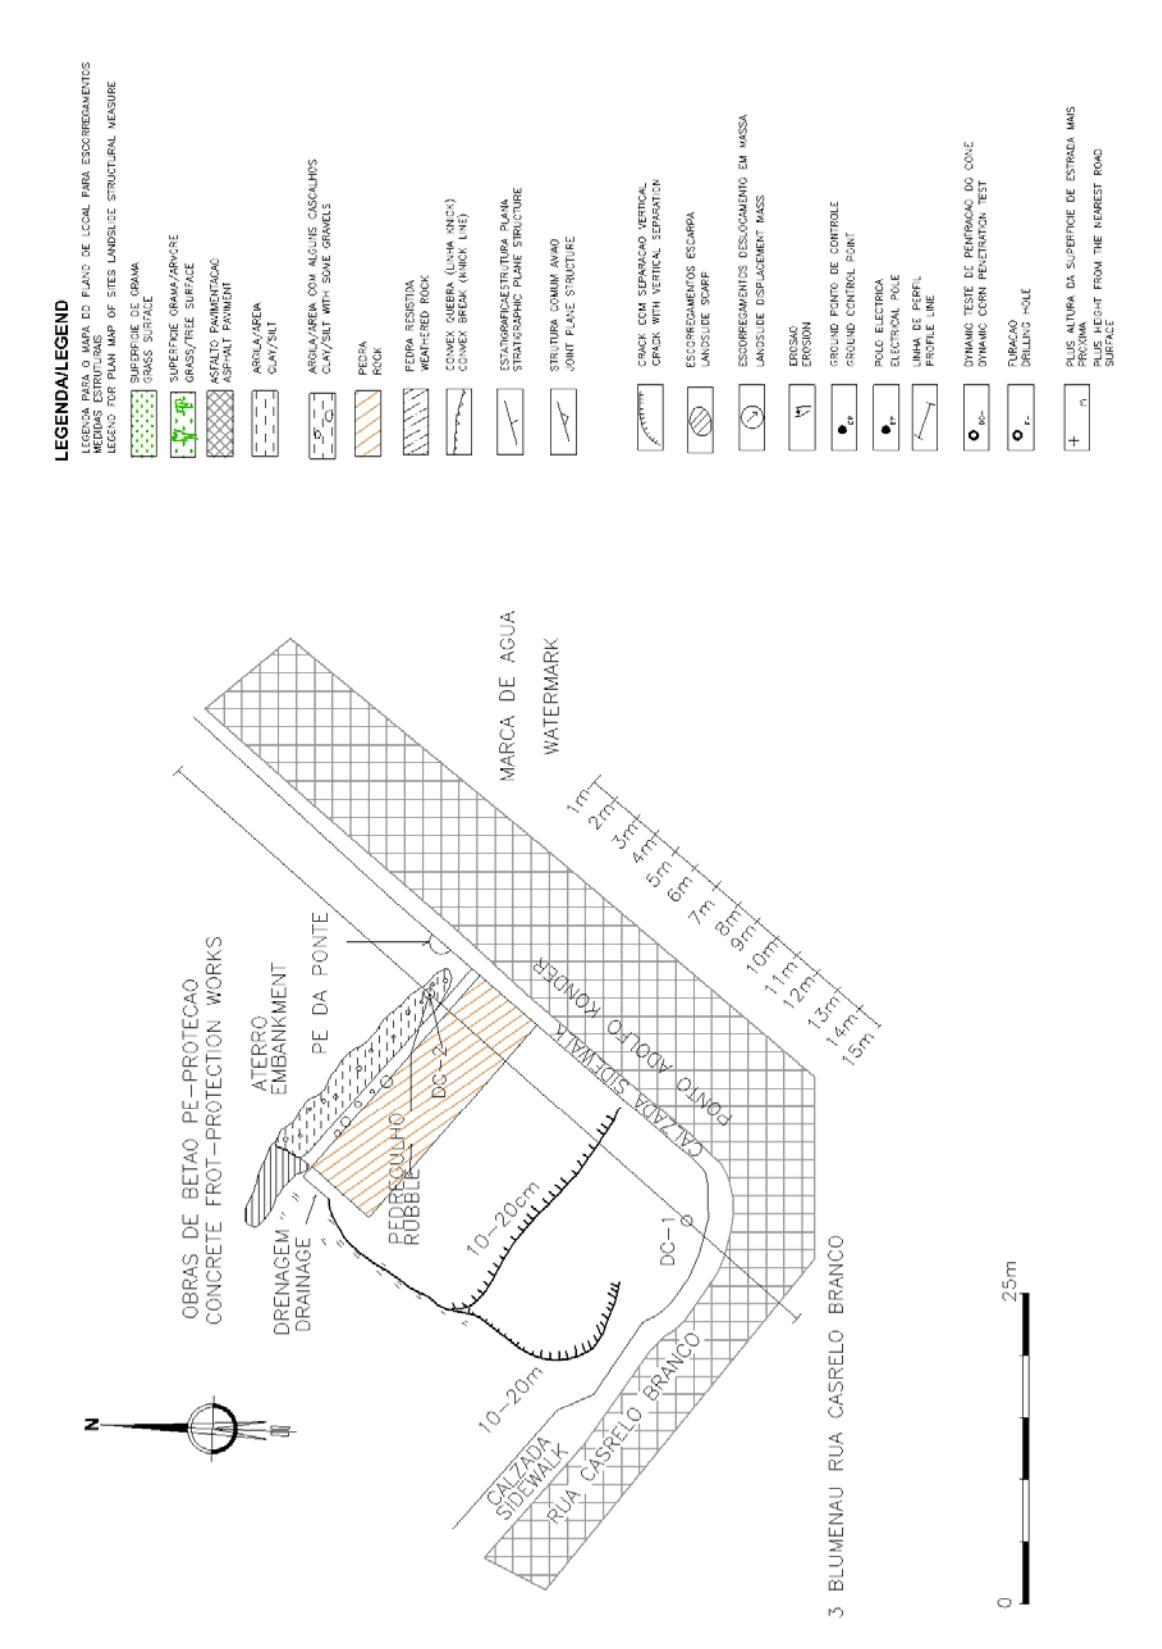
Figure 6.5.8 Engineering Geological Map for SC470 Blumenau-Av Pres Castero Branco

Cracks and deformation is recognized on the road. The slope deformation with 10-20 cm height miner scarps of river bank is also recognized. Dynamic corn penetration test shows that soft clay is distributed of the slope surface with more than 3 meter depth.

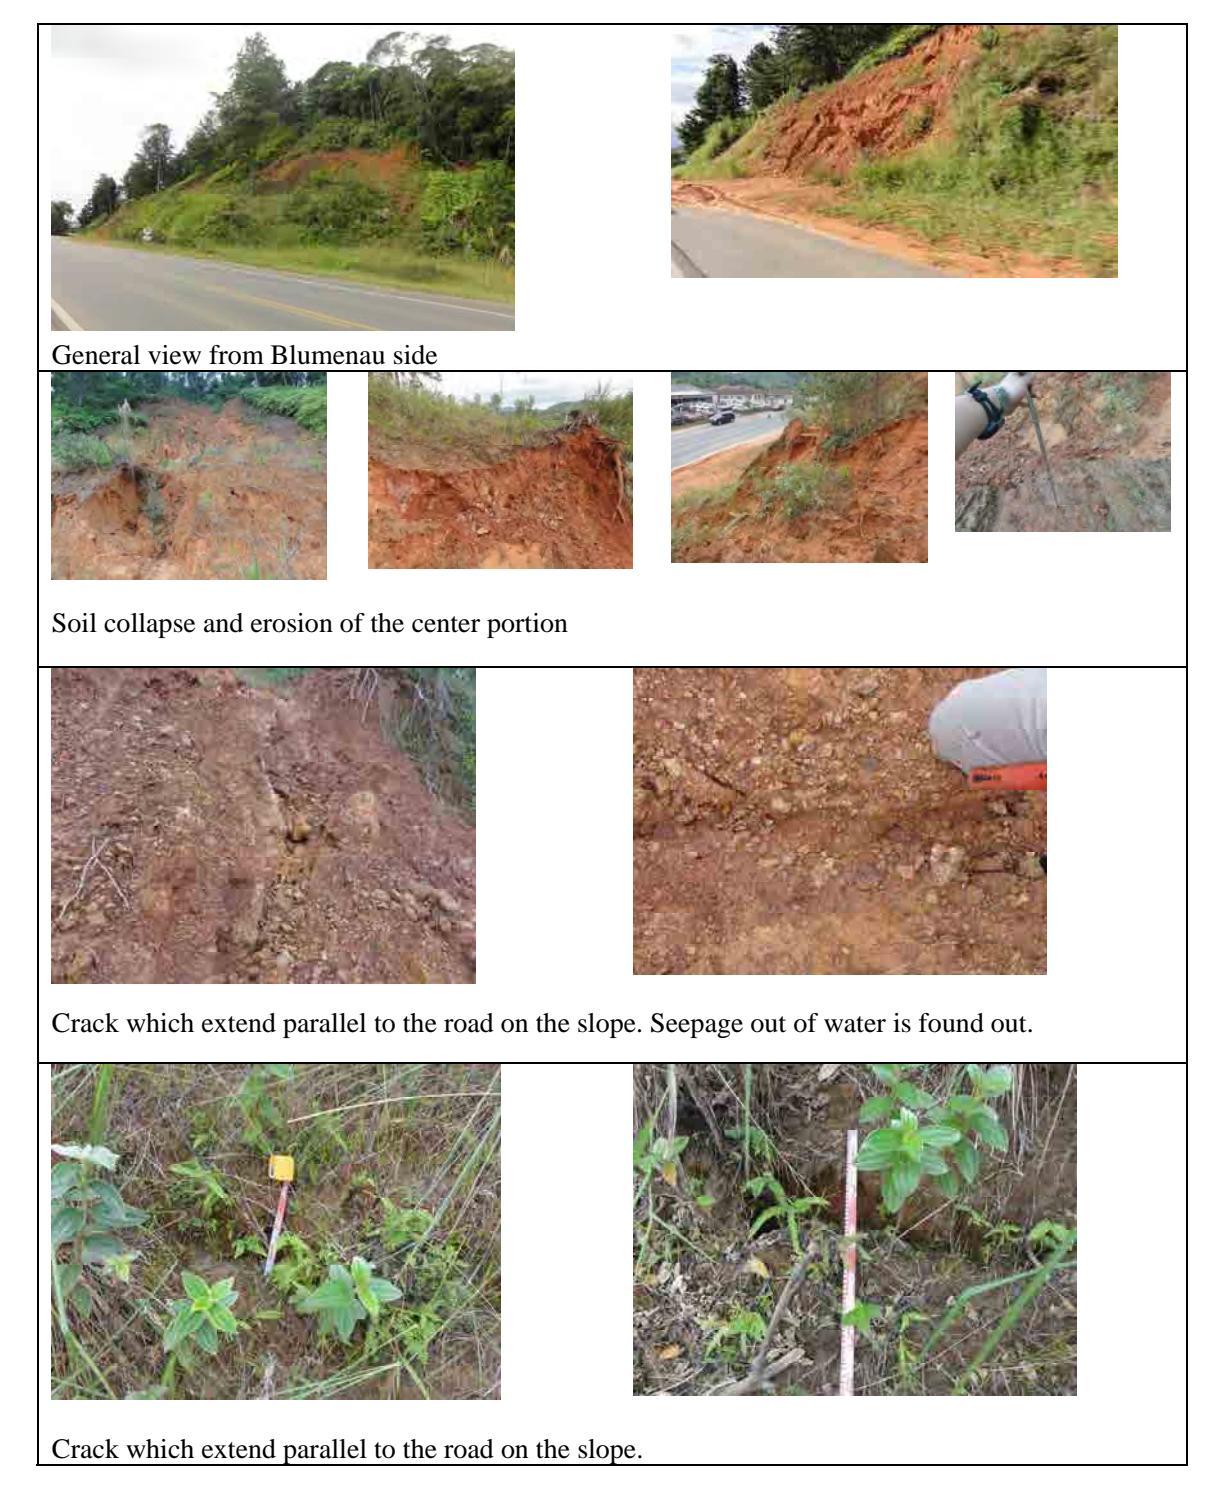
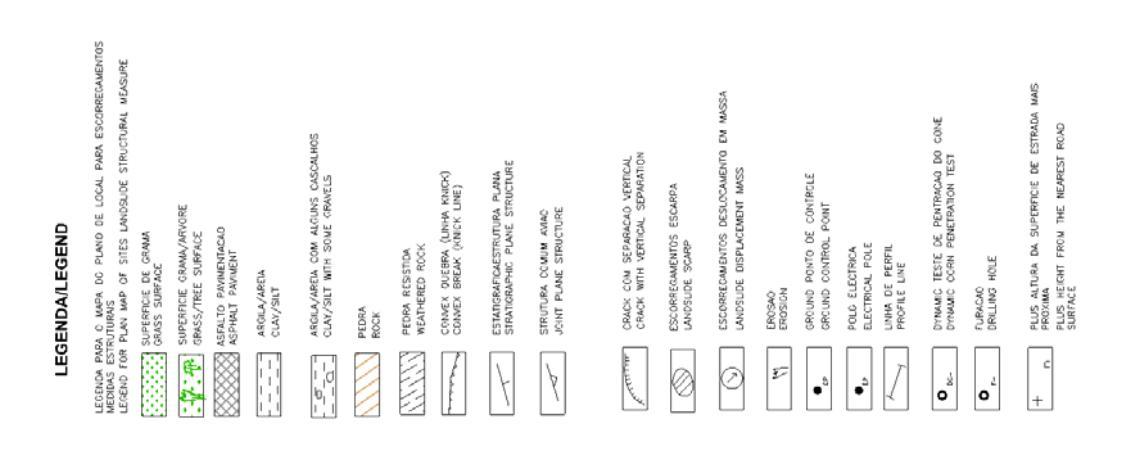
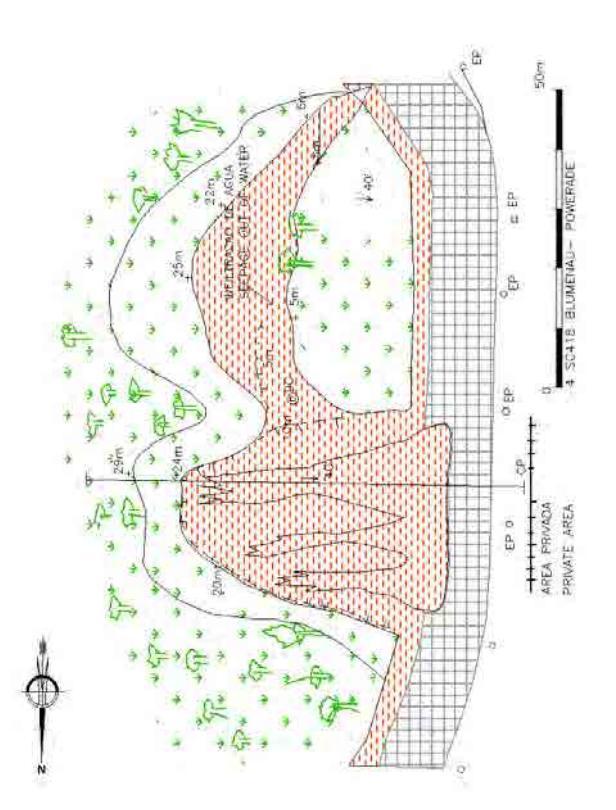
Figure 6.5.9 Engineering Geological Map for SC418 Blumenau-Pomerode

Soil collapses have been occurred intermittently due to heavy rain. Crack which extend parallel to the road on the slope. Seepage out of water is found out.

Dynamic corn penetration test shows that very soft red clay is distributed of the slope surface with more than 3 meter depth.

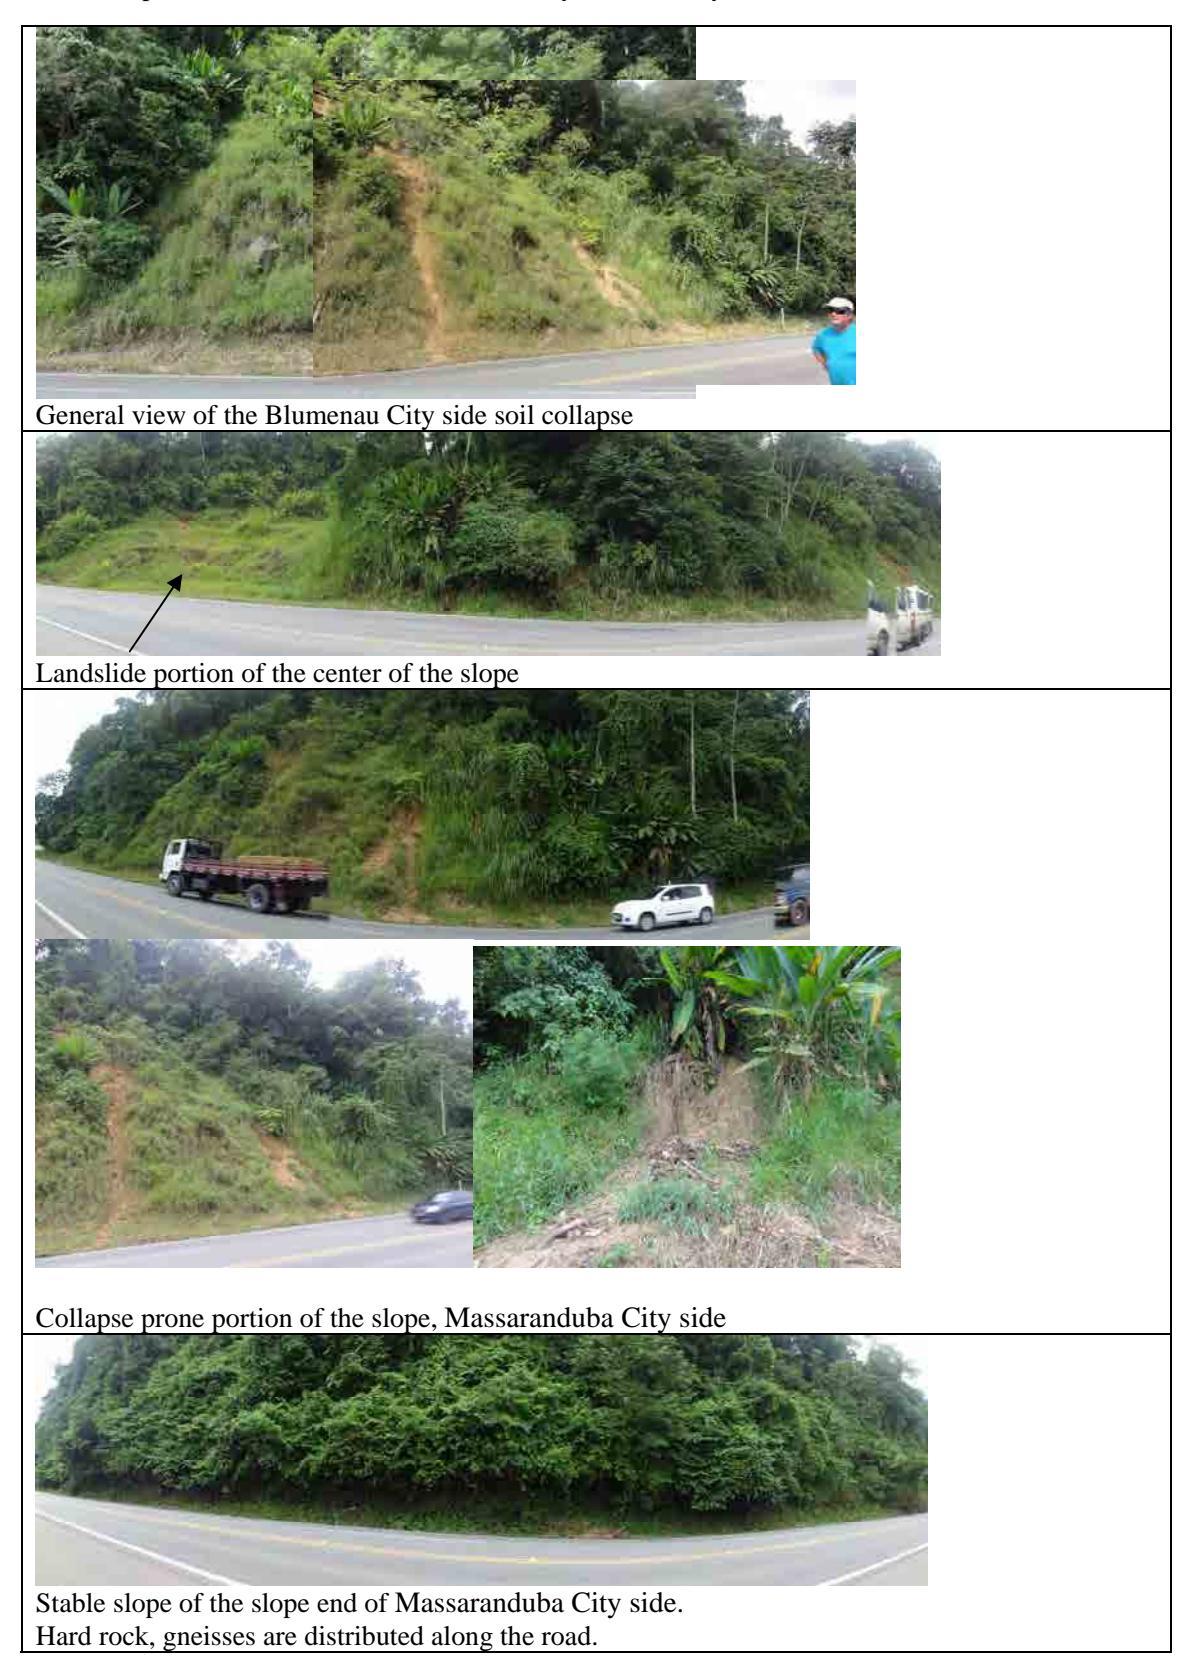
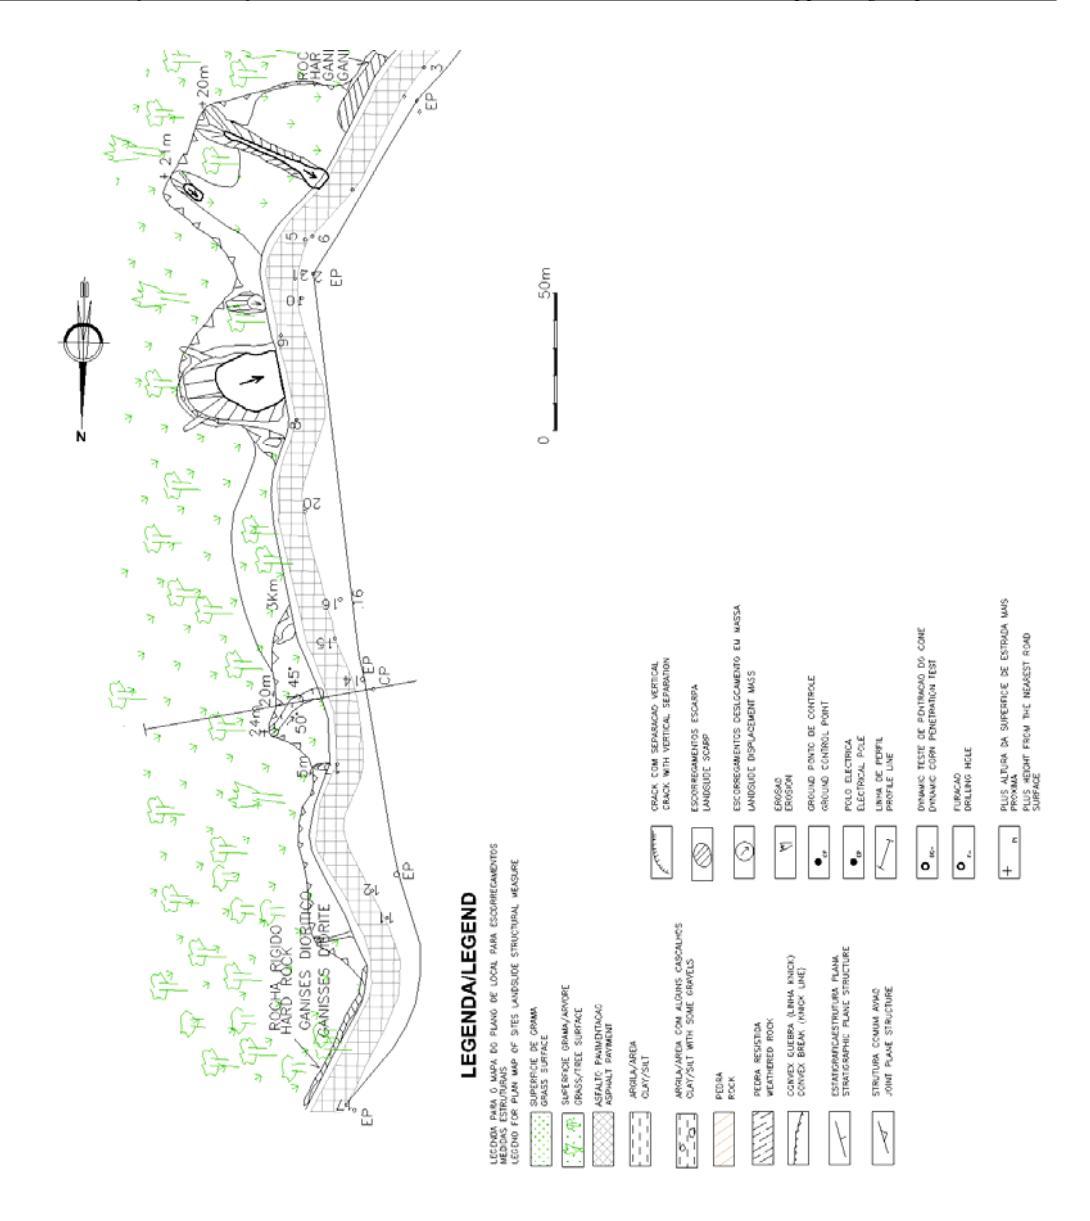
Figure 6.5.10 Engineering Geological Map for SC474 Blumenau – Massaranduba 2

Soil collapses have been occurred intermittently due to heavy rain.

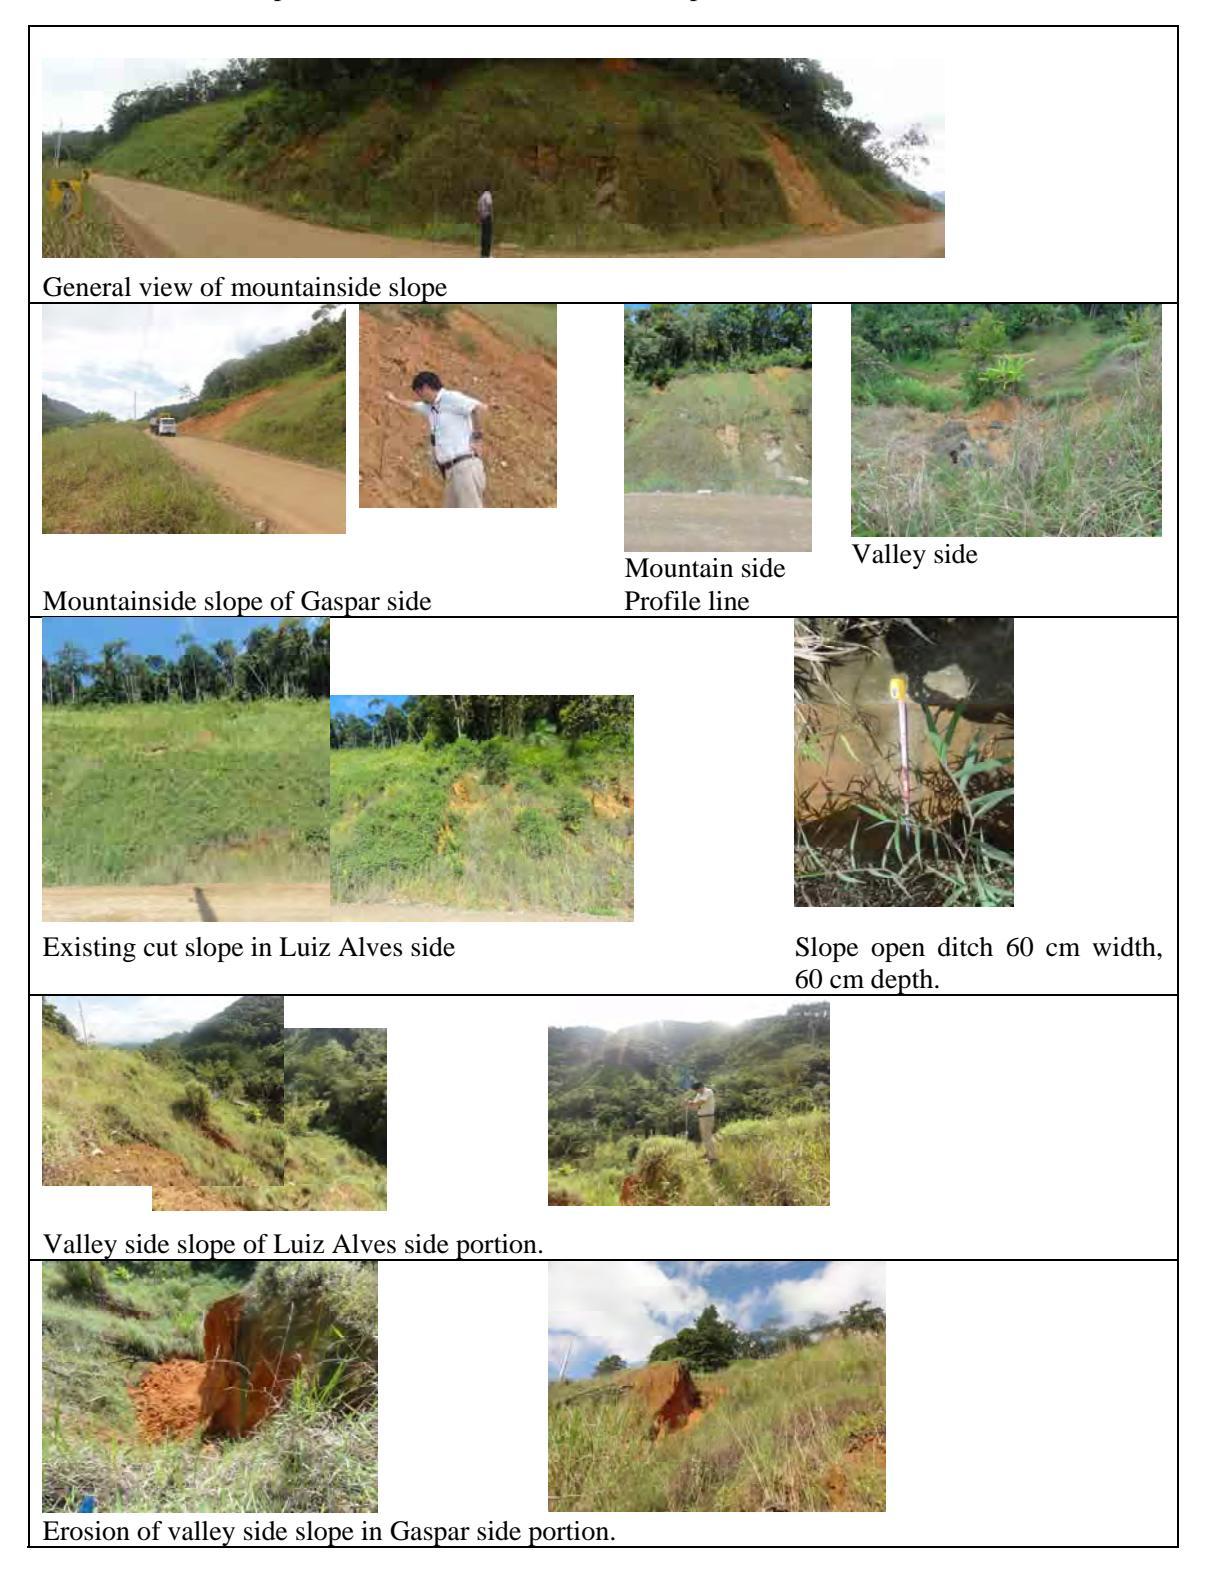
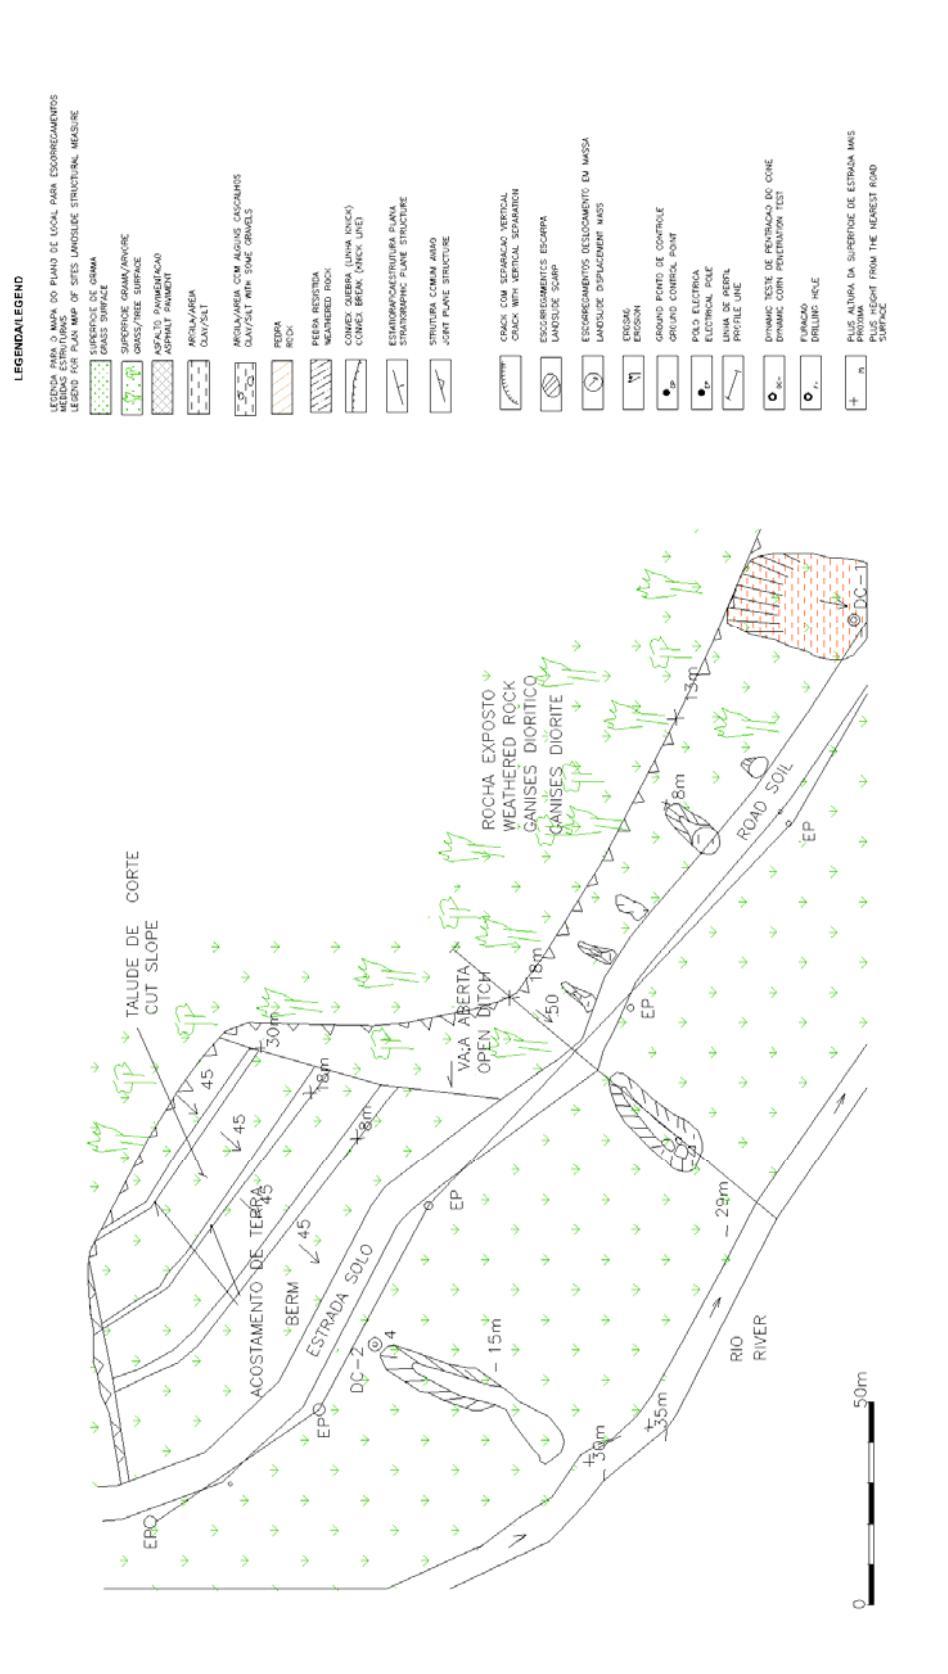
Figure 6.5.11 Engineering Geological Map for Gaspar-Luiz Alves, Gaspar 6

Soil collapses have been occurred intermittently due to heavy rain. Serious erosion is progressing in the side of valley, and Gaspar. Dynamic corn penetration test shows that very soft red clay is distributed of the slope surface with more than 3 meter depth.
