# CHAPTER 6 ENGINEERING GEOLOGY ON SELECTED STRUCTURAL MEASURE SITES

# 6.1 Oeste Dam

Preparatory Survey for the Project on Disaster Mitigation Measures for the Itajai River Basin Prevention and

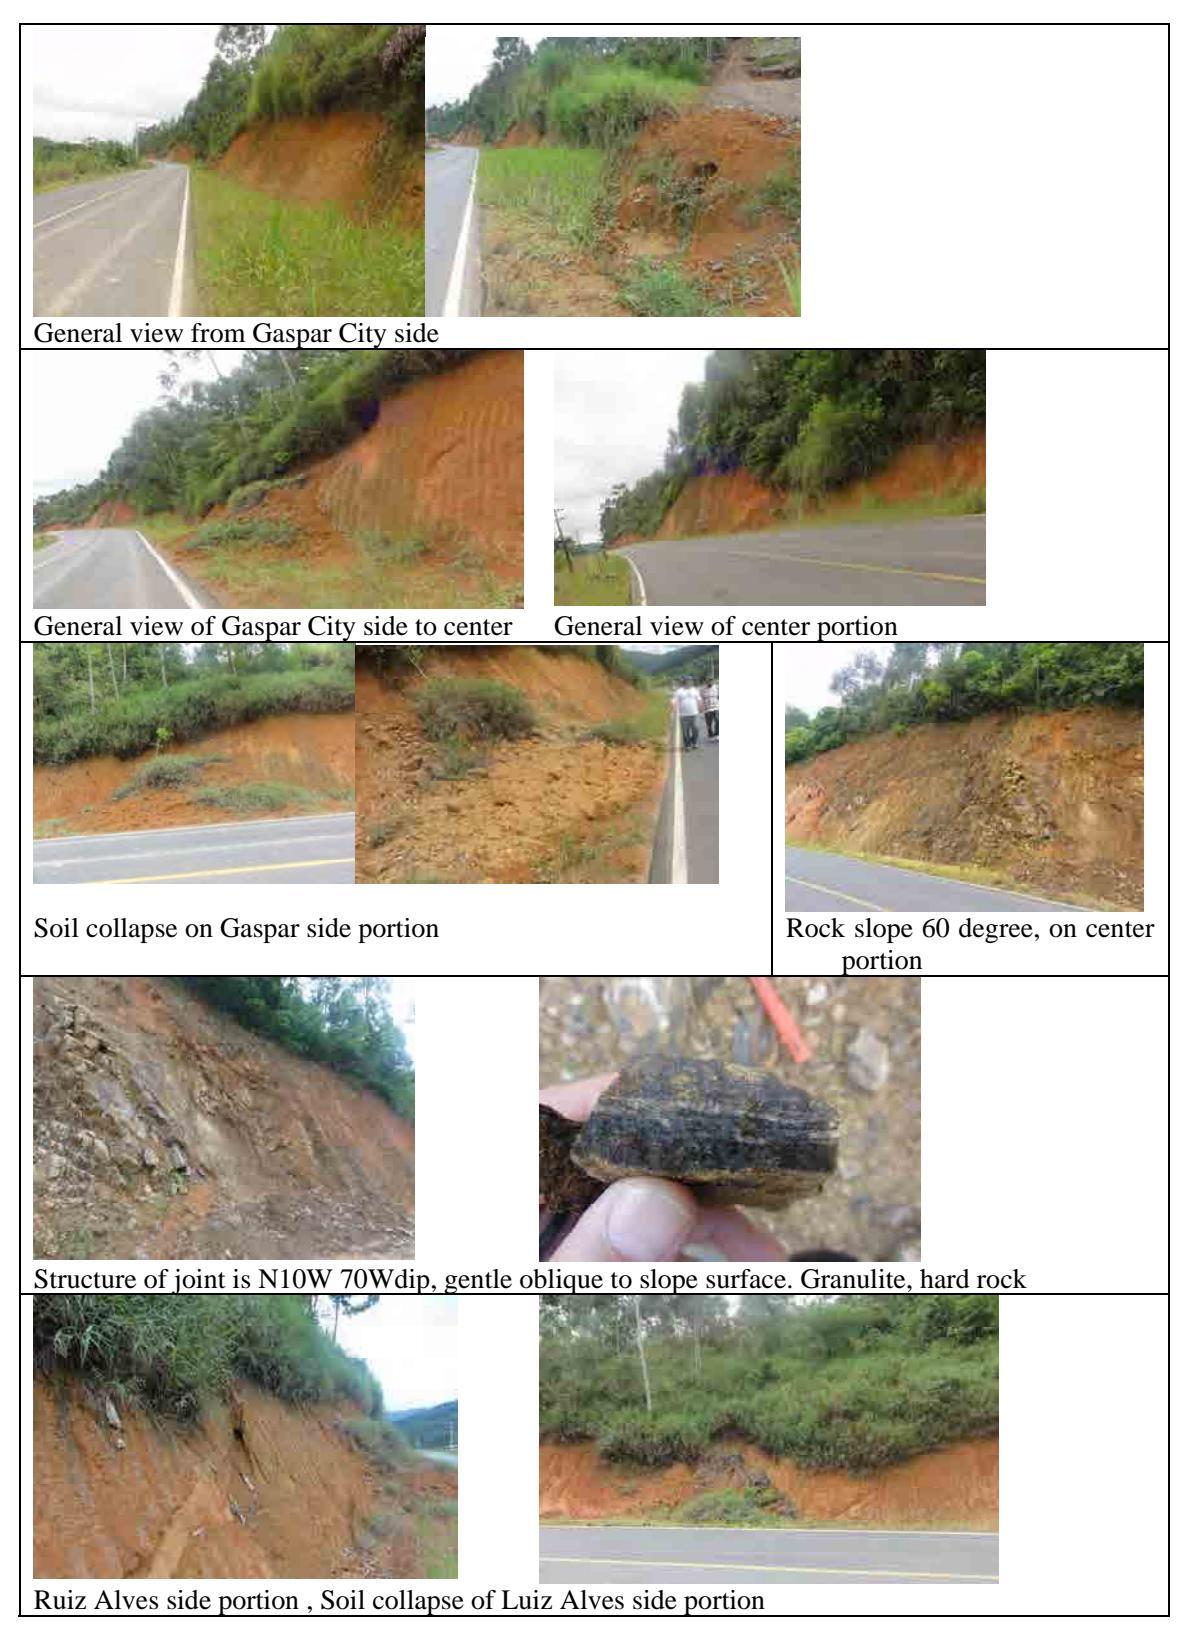
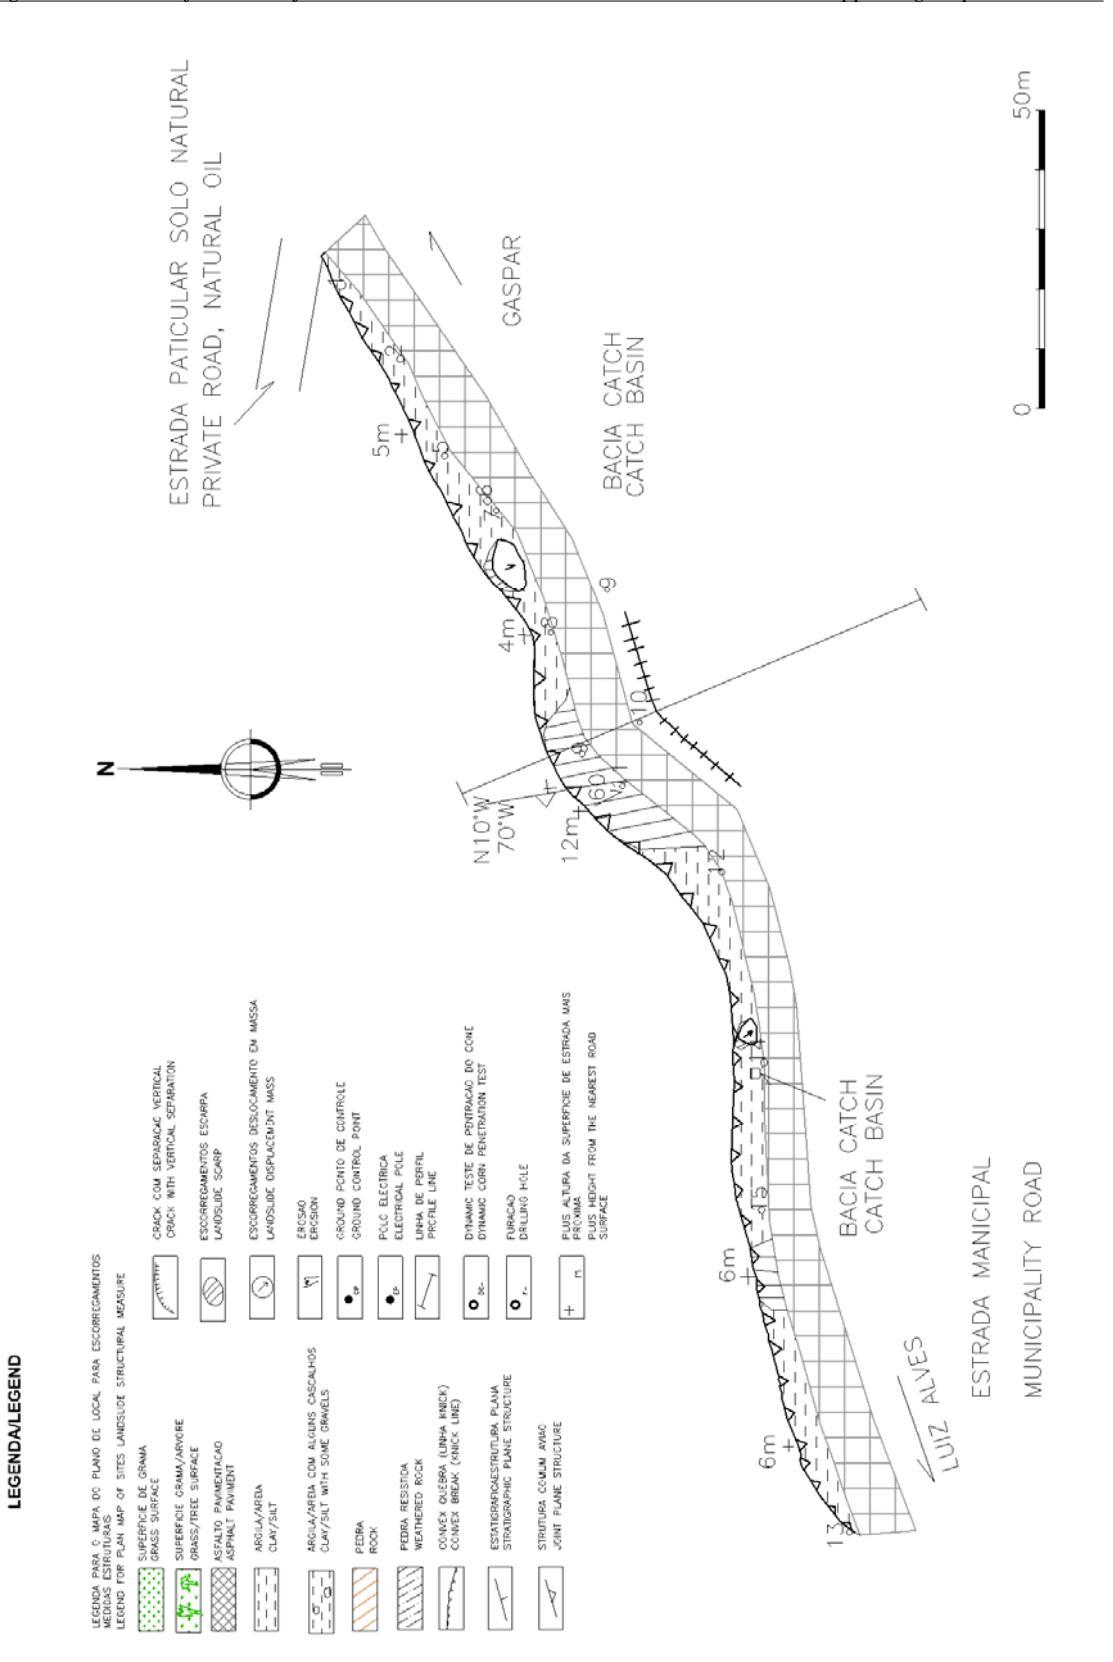
Figure 6.5.12 Engineering Geological Map for Gaspar-Luiz Alves, Luiz Alves 6

Soil collapses have been occurred intermittently due to heavy rain. There is a possibility of rock slope collapse in center portion.

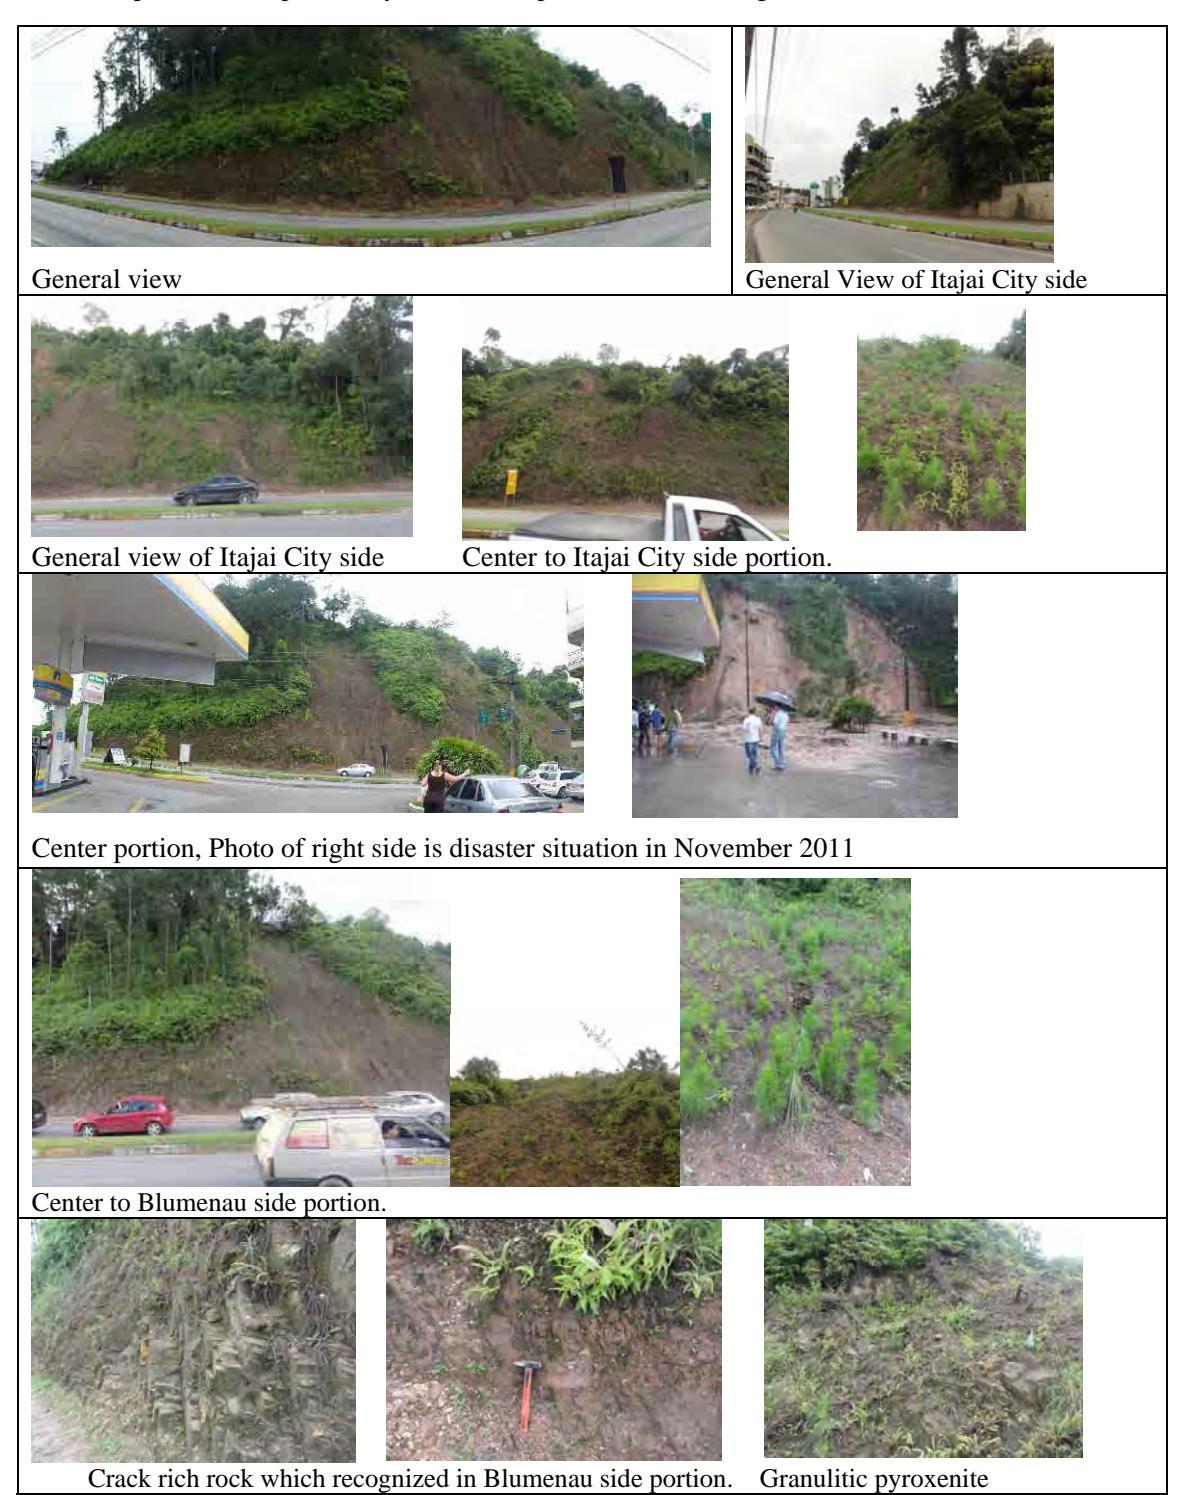
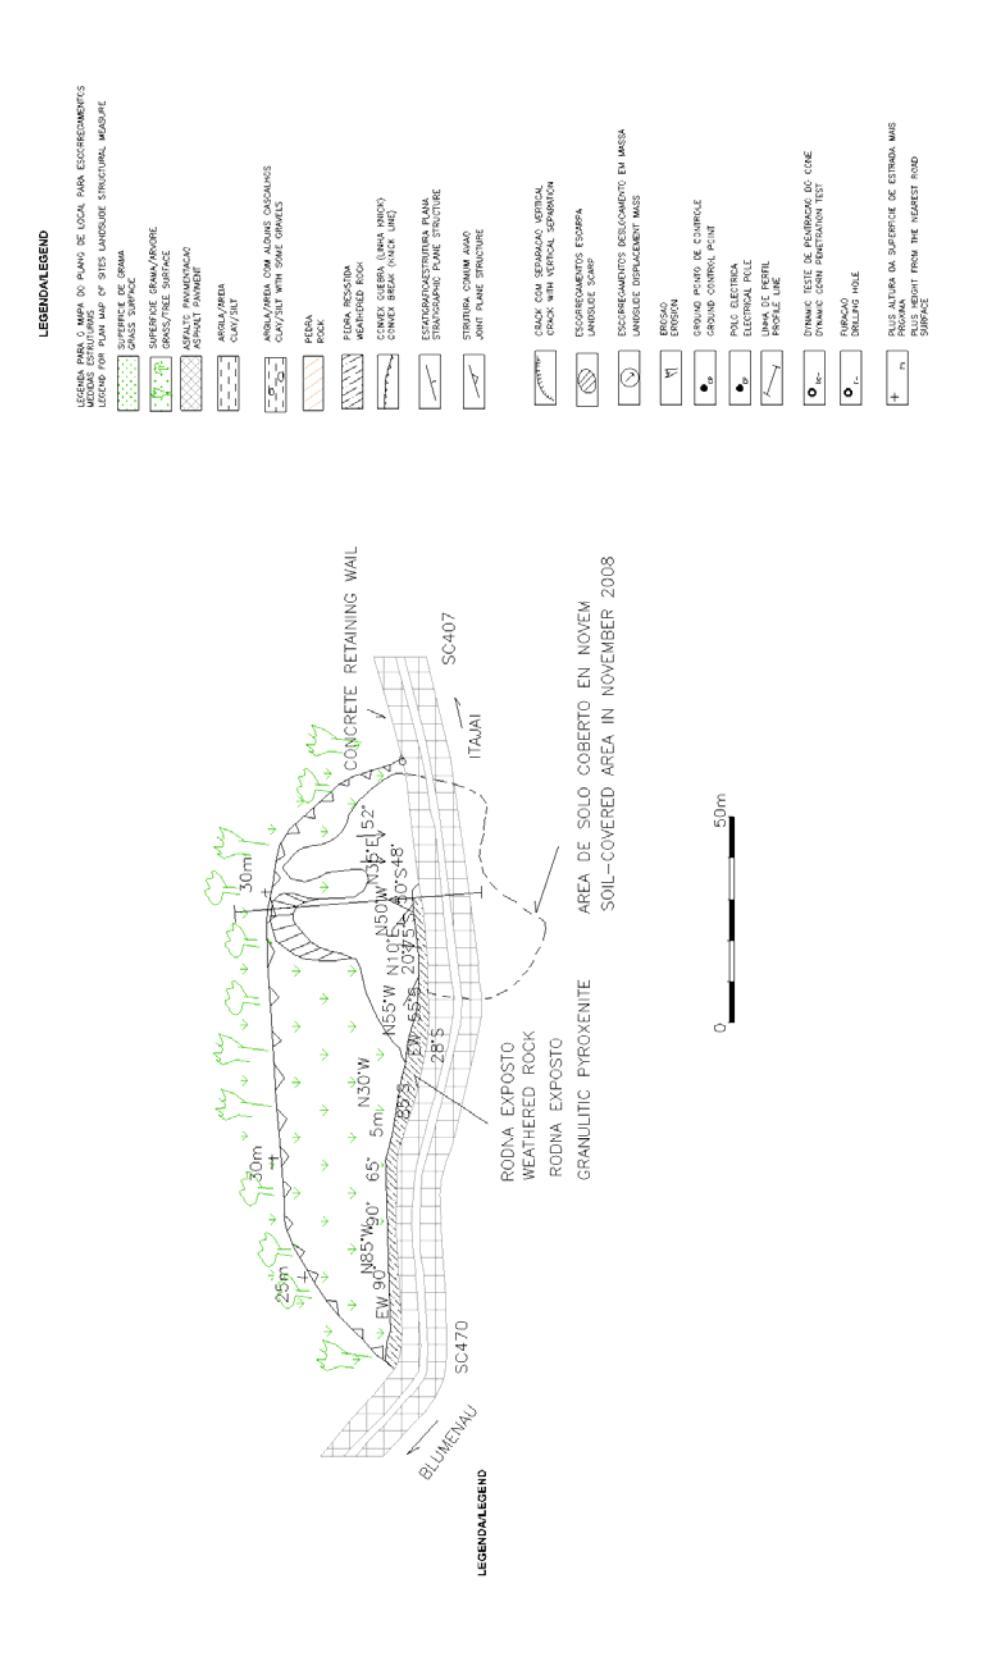
Figure 6.5.13 Engineering Geological Map for SC470 Gaspar Bypass

Under the heavy rain In November 2008, road closure disaster of whole width was occurred due to soil collapse. And the possibility of soil collapse is still remaining.

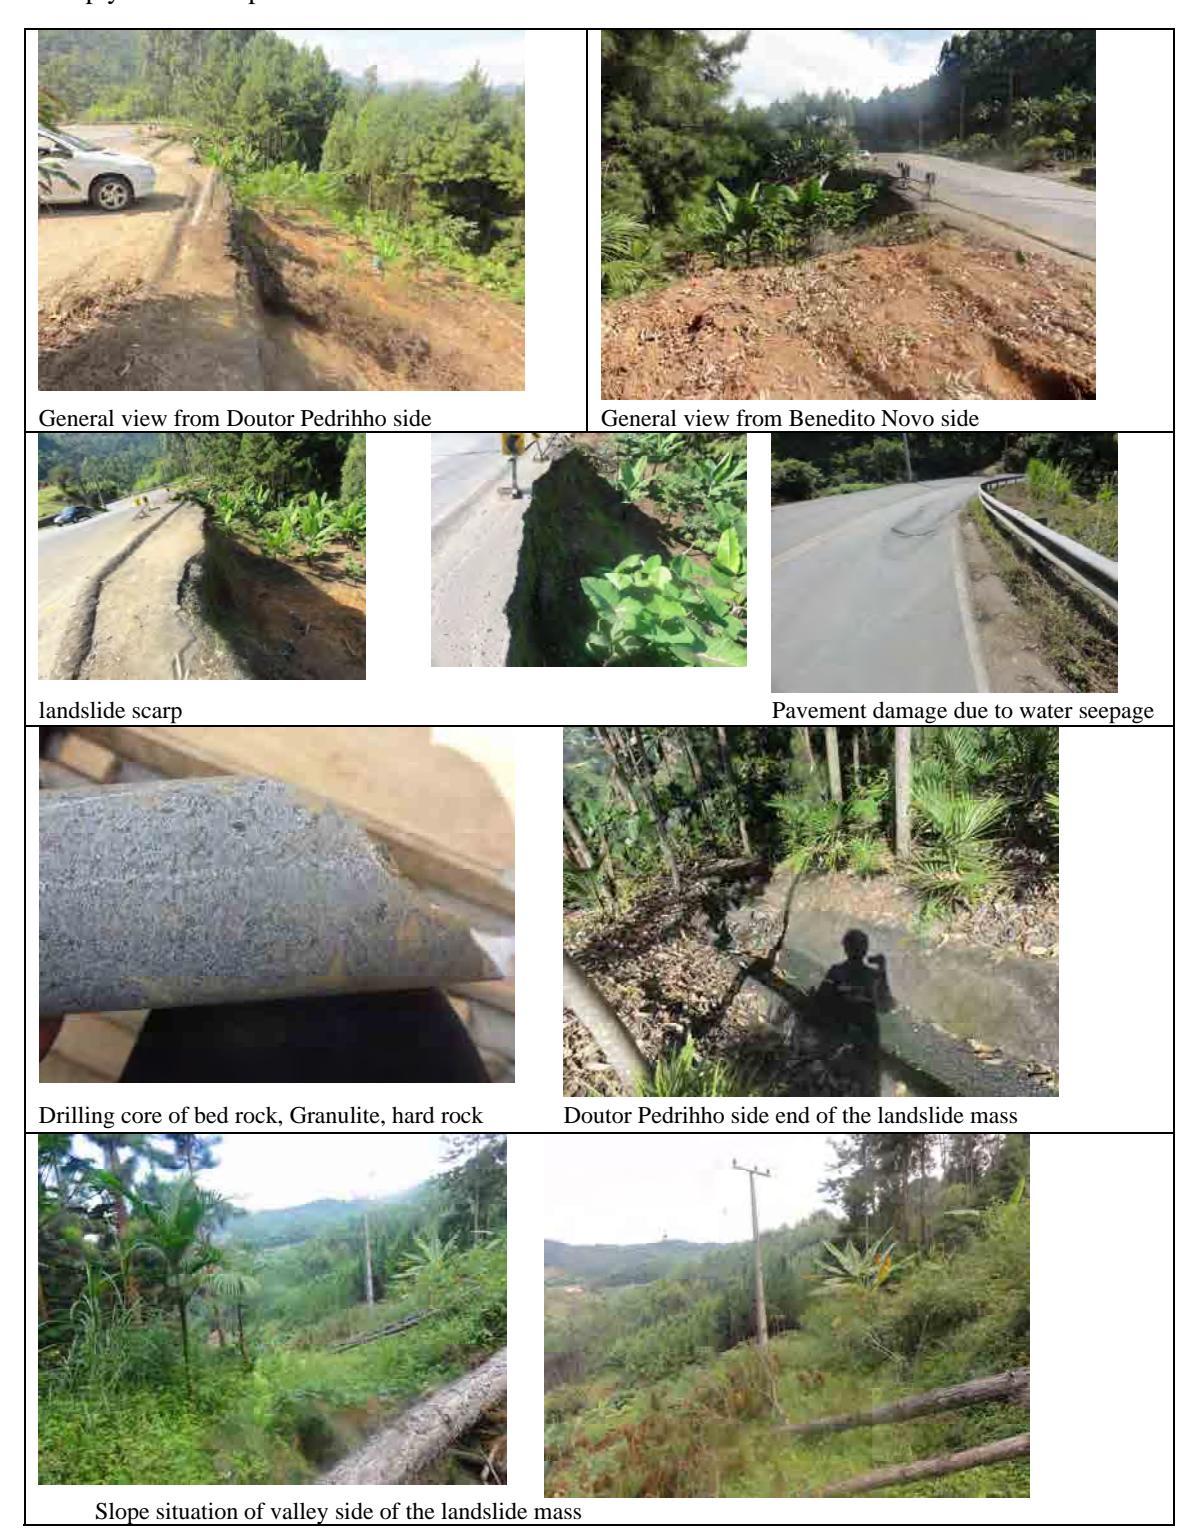
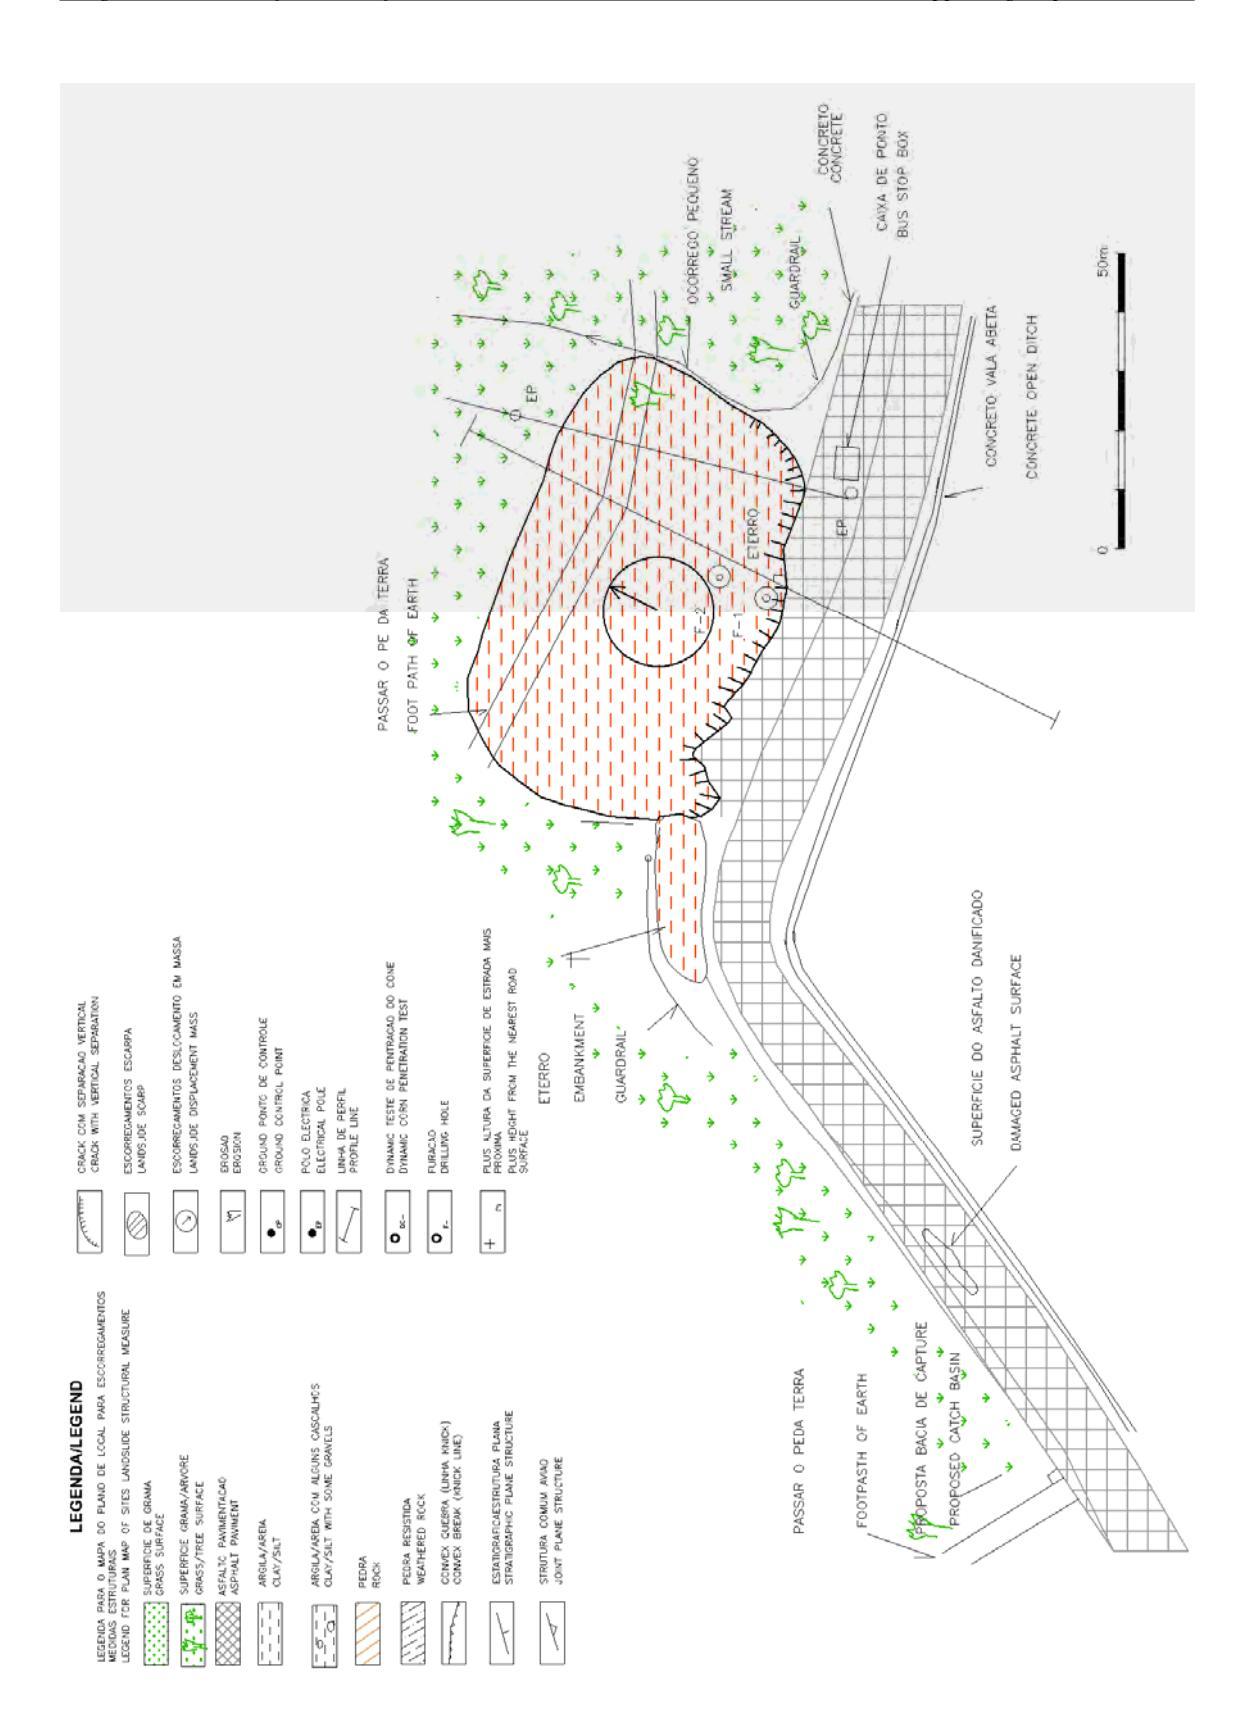
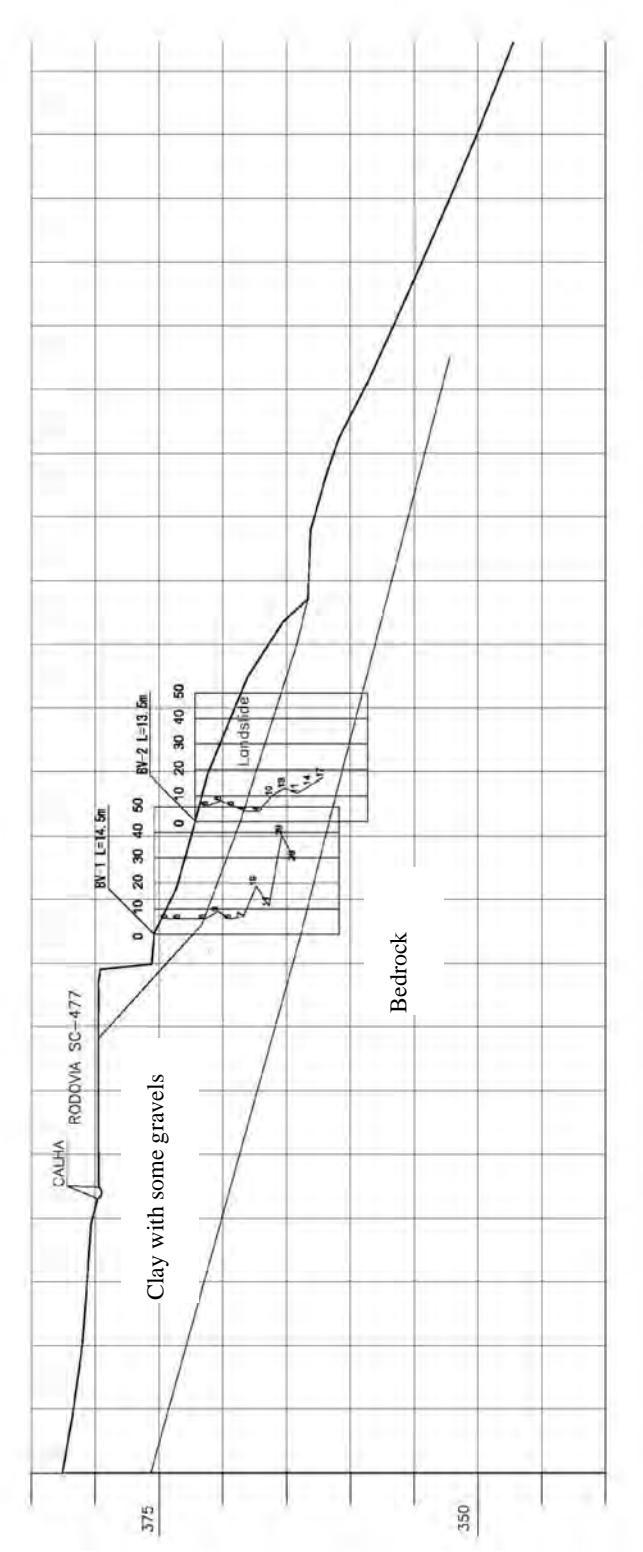
Figure 6.5.14 Engineering Geological Profile for SC 477 Benedito Novo - Doutor Pedrihho 1

Landslide block of 60 m width 50 m length with 2 m height scarp is recognized. Drilling investigation shows that bed rock surface is deep (10 m - 12 m depth) and groundwater table is also deep (9.5m at road side, 3.2m at valley side). Pipe strain gauge monitoring does not indicate sharply-defined slip surface.

For the site of the priority No. 9 SC477 Benedito Novo - Doutor Pedrinho 1, groundwater drainage is not appropriate; because groundwater table is initially low. Light weight embankment by EPS (Expanded polystyrene) is appropriate for the site condition of deep foundation rock and low groundwater.

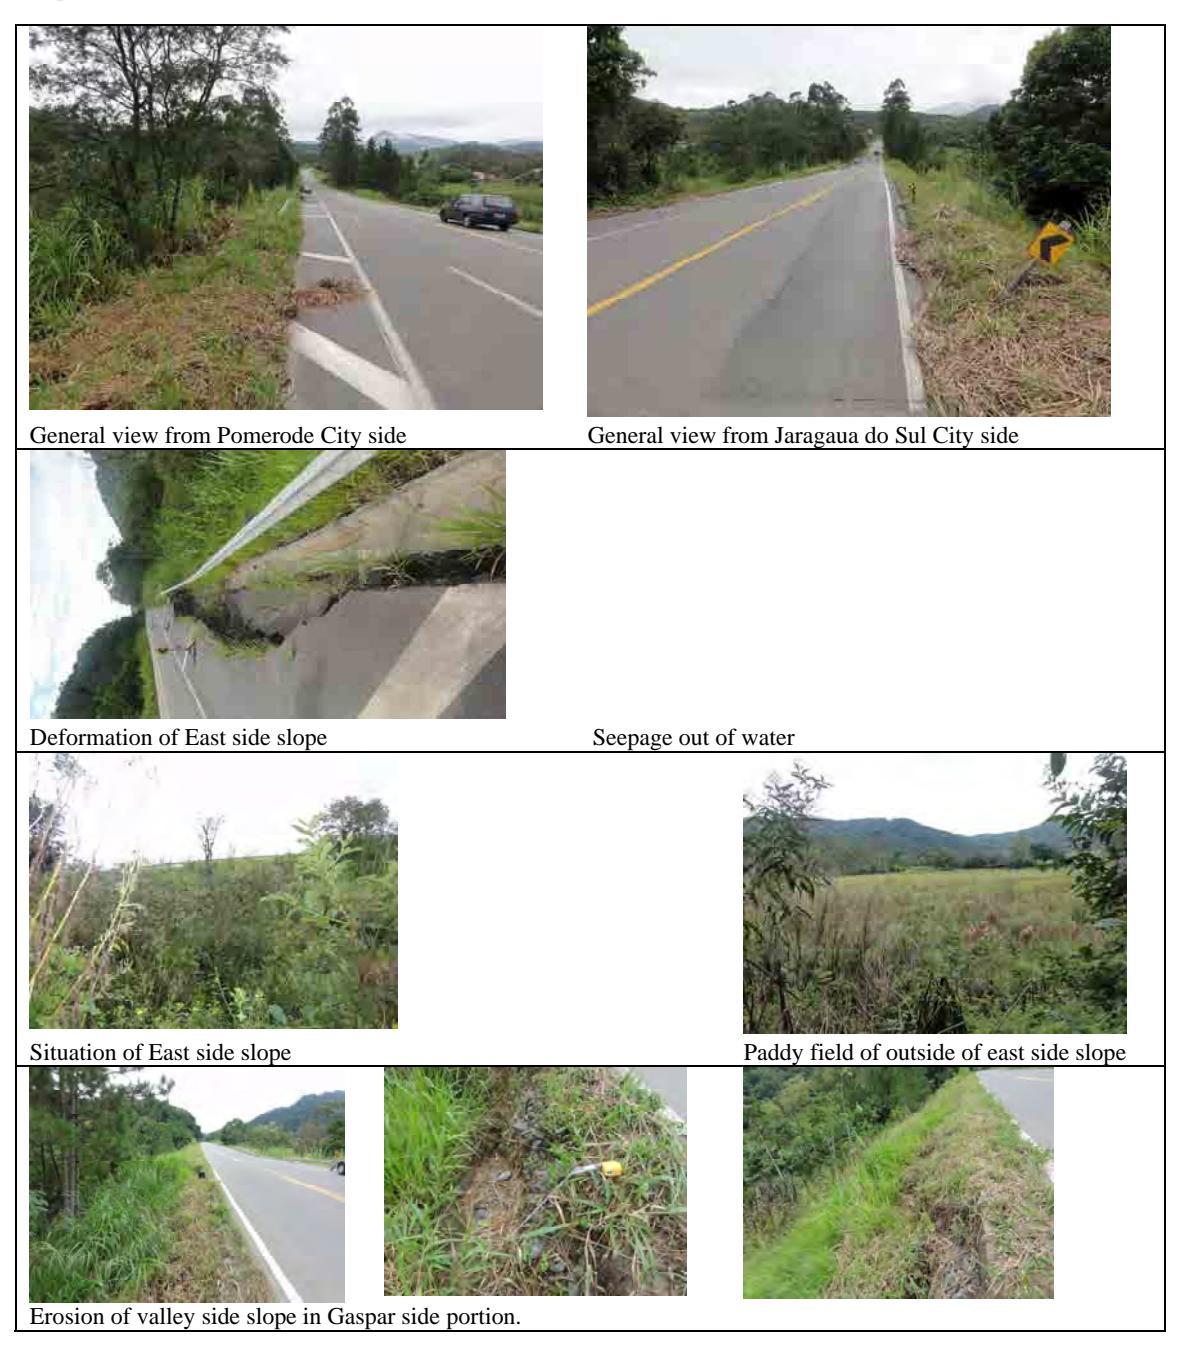
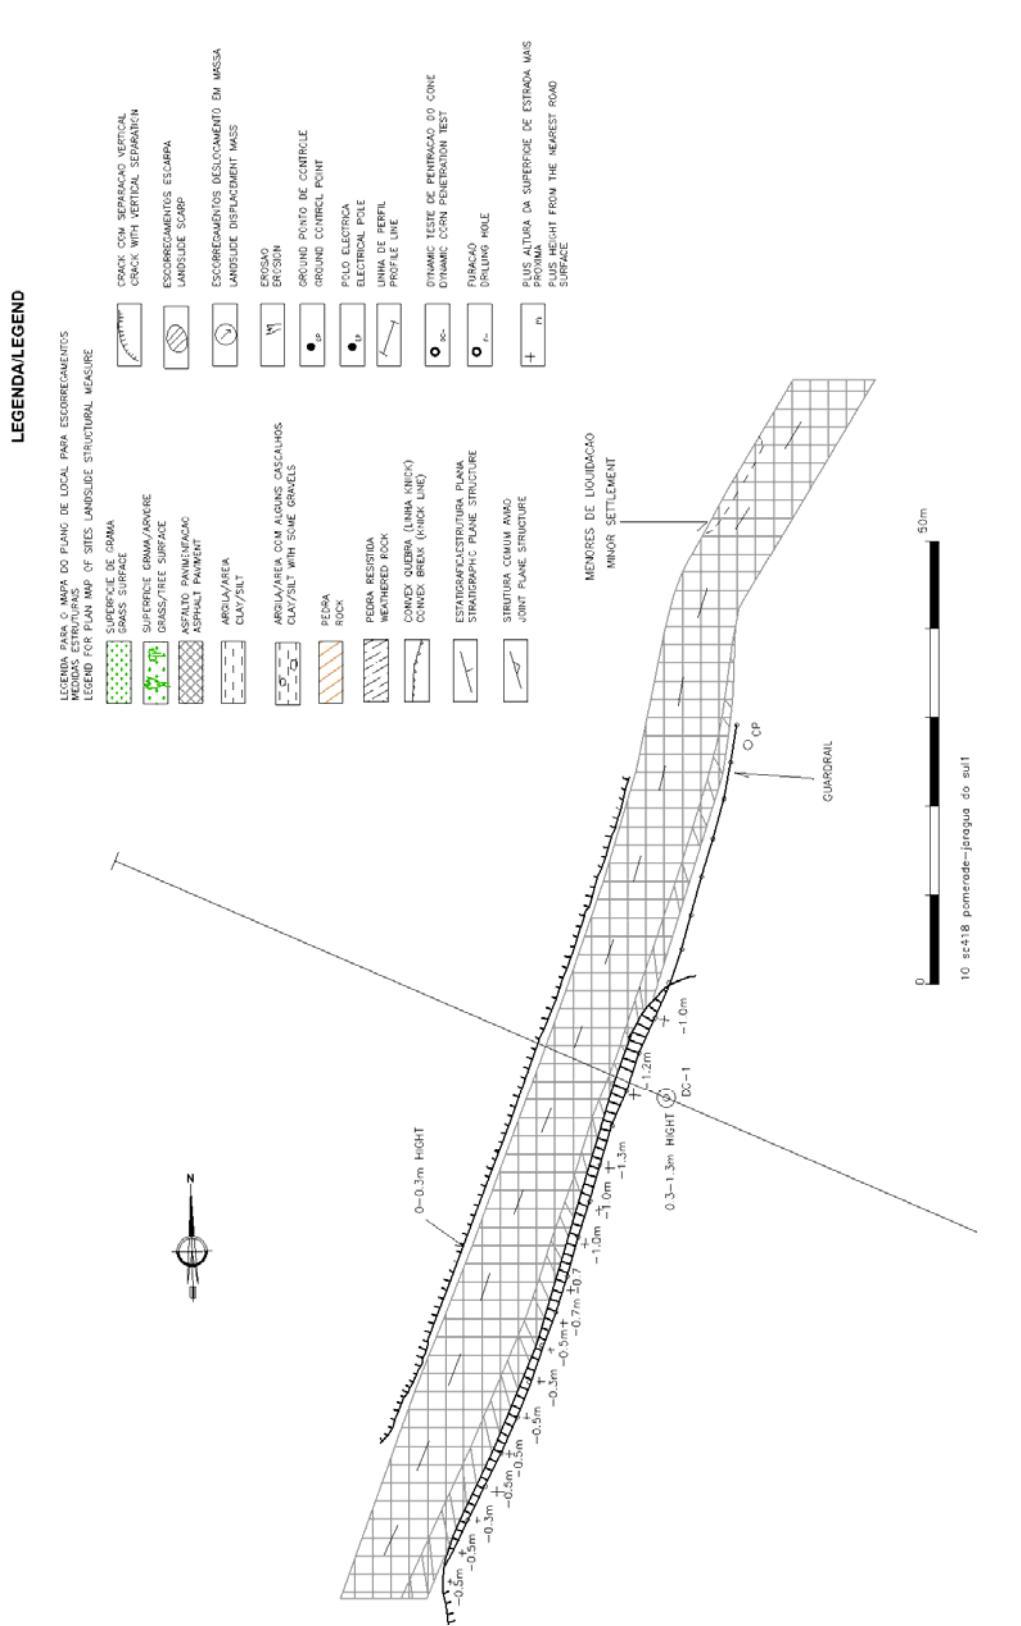
Figure 6.5.16 Engineering Geological Map for SC 418 Pomerode - Jaragaua do Sul 1

Both side of road embankment shoulder is deformed by sliding. Dynamic corn penetration test shows that soft clay with some gravel is distributed of the slope surface with more than 3 meter depth.

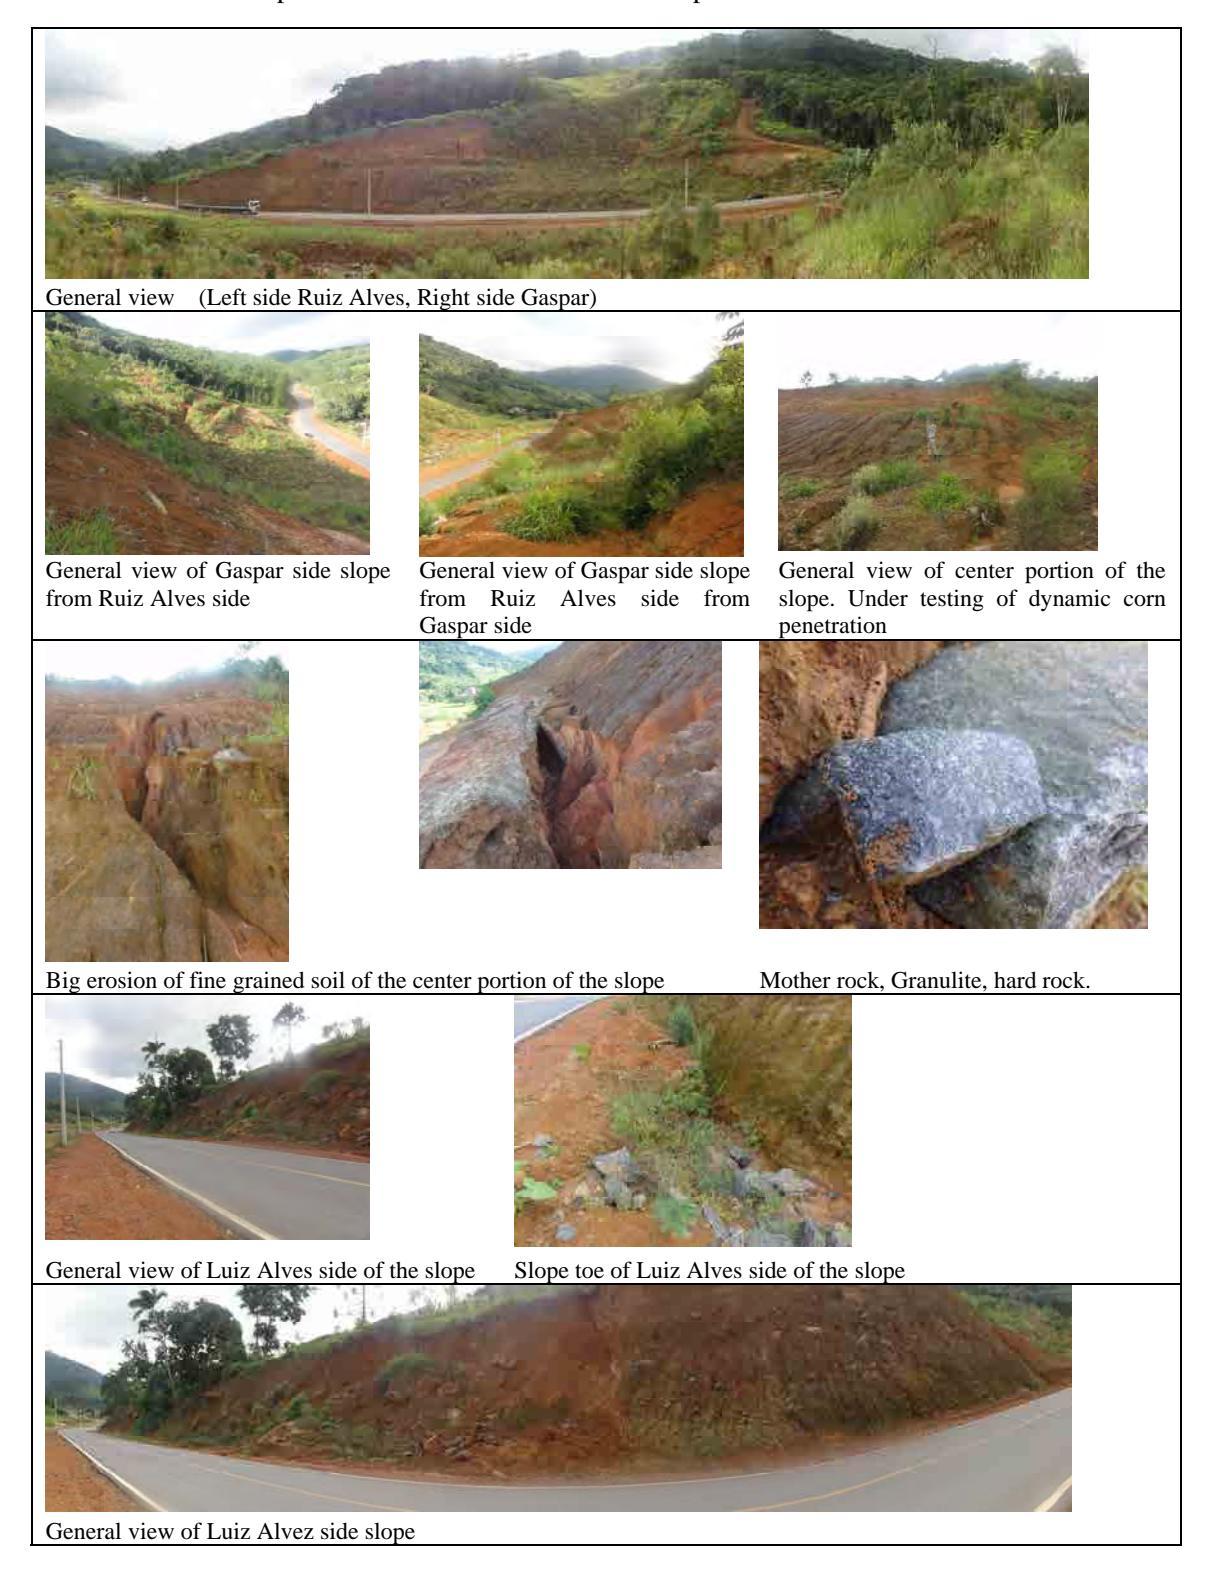
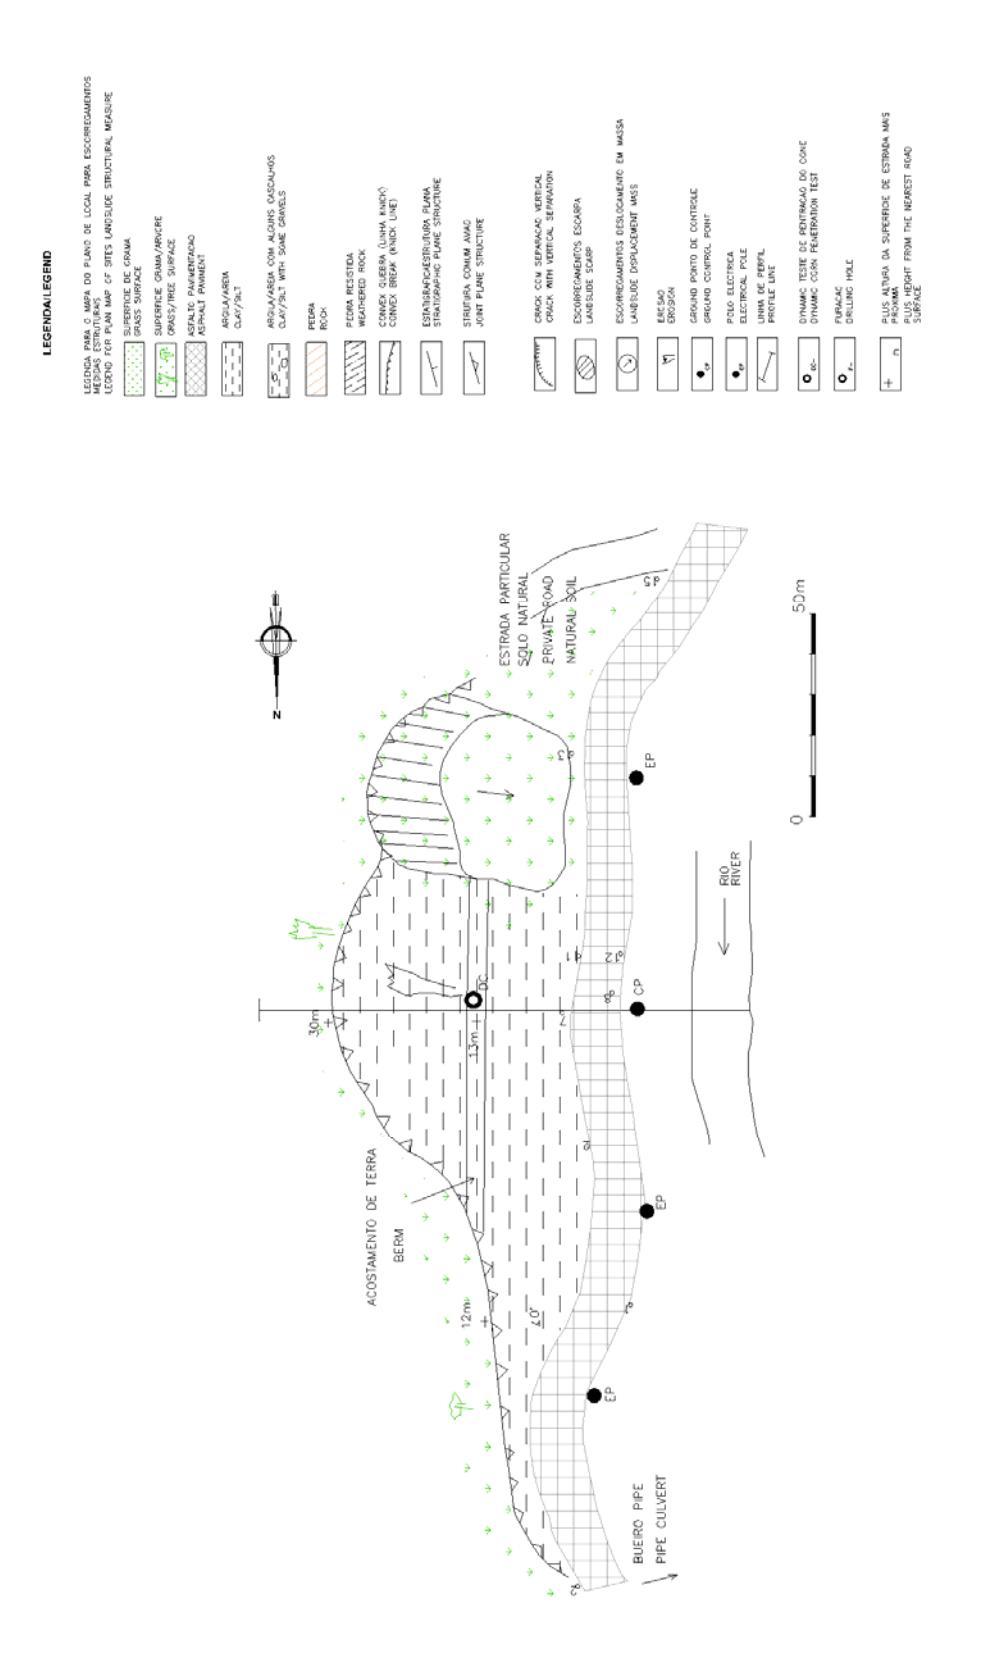
Figure 6.5.17 Engineering Geological Map for Gaspar-Luiz Alves, Luiz Alvez 4

Soil collapses have been occurred intermittently due to heavy rain. Serious erosion is progressing in the mountainside of center portion. Dynamic corn penetration test shows that very soft red clay is distributed of the slope surface with more than 3 meter depth.

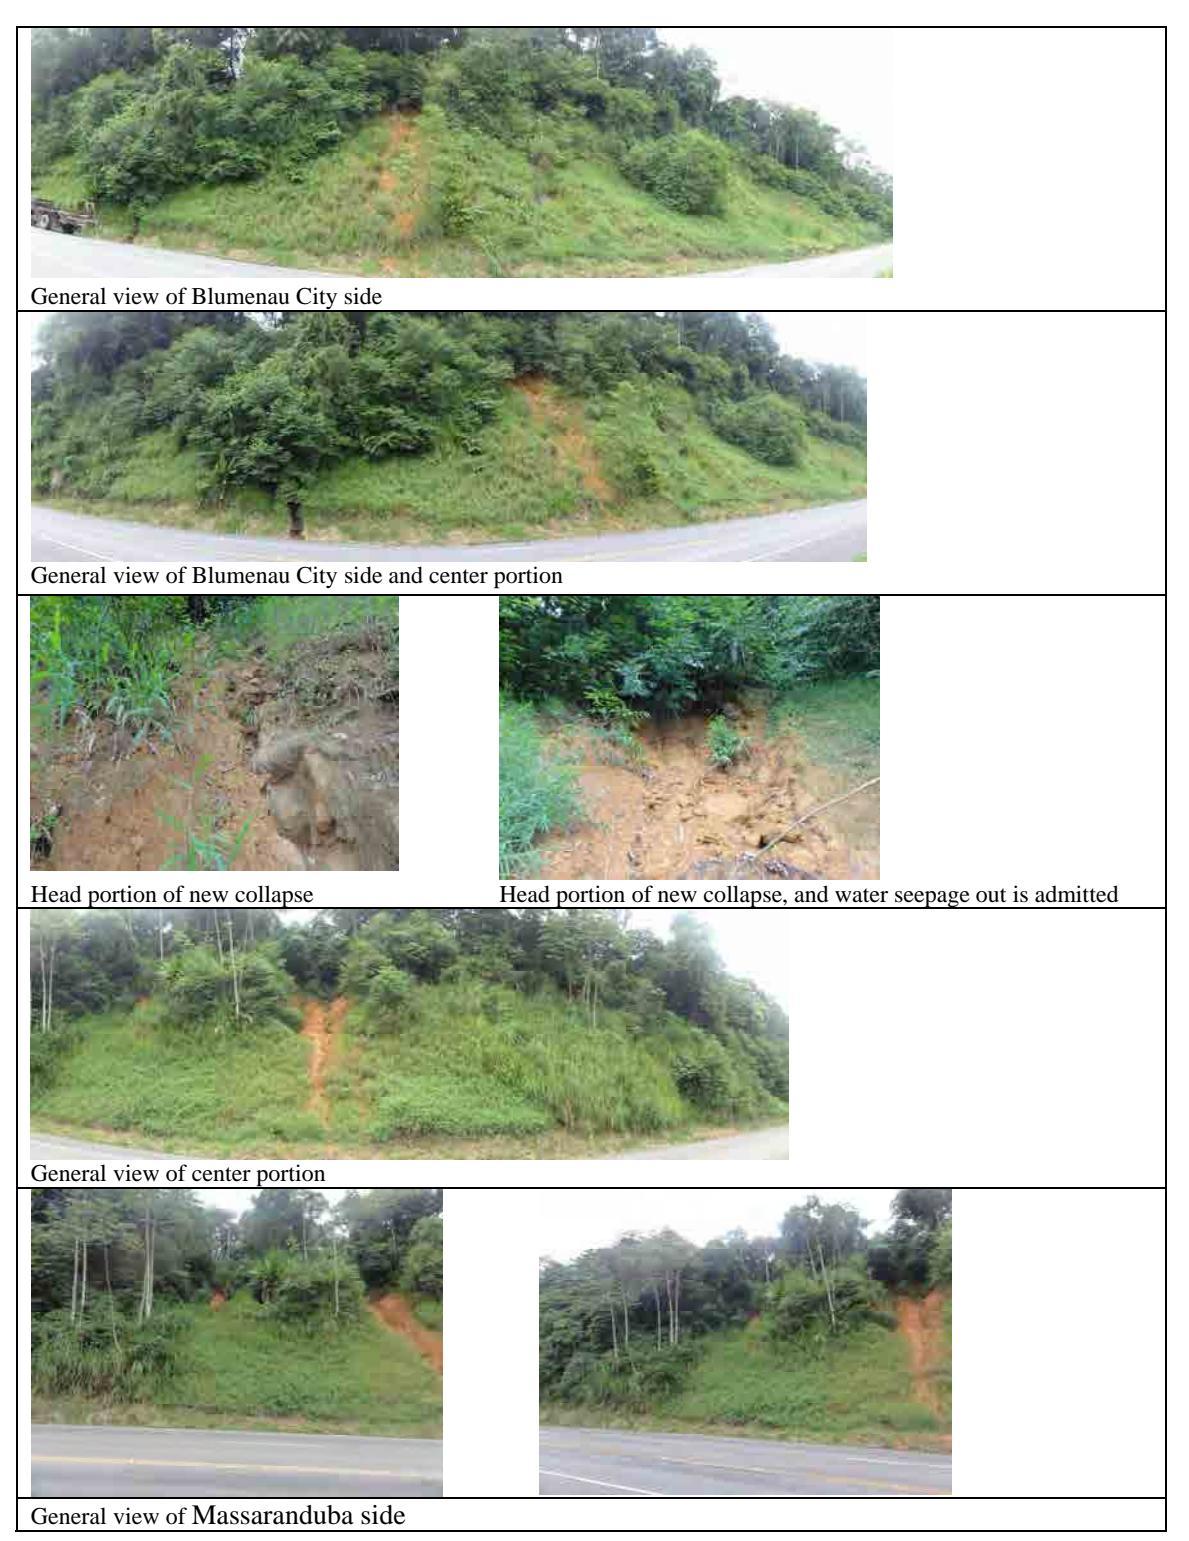
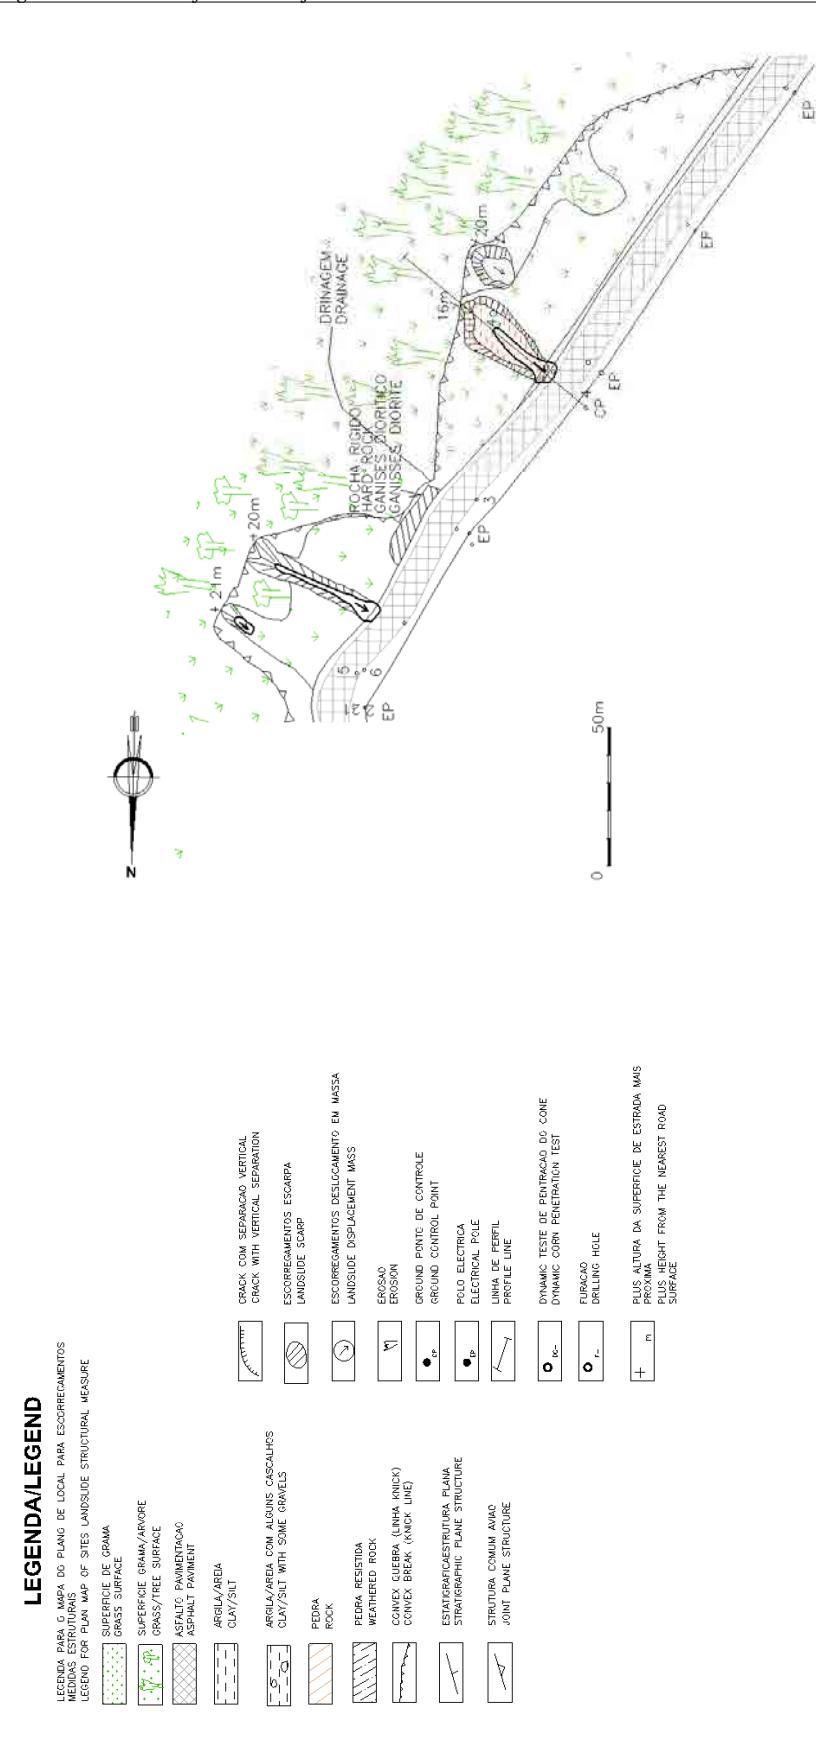
Figure 6.5.18 Engineering Geological Map for SC474 Blumenau-Massaranduba 1

Soil collapses have been occurred intermittently due to heavy rain. Soil is reddish and very soft when it is saturated.
