# CHAPTER 6 ENGINEERING GEOLOGY ON SELECTED STRUCTURAL MEASURE SITES

# 6.1 Oeste Dam

Preparatory Survey for the Project on Disaster Mitigation Measures for the Itajai River Basin Prevention and

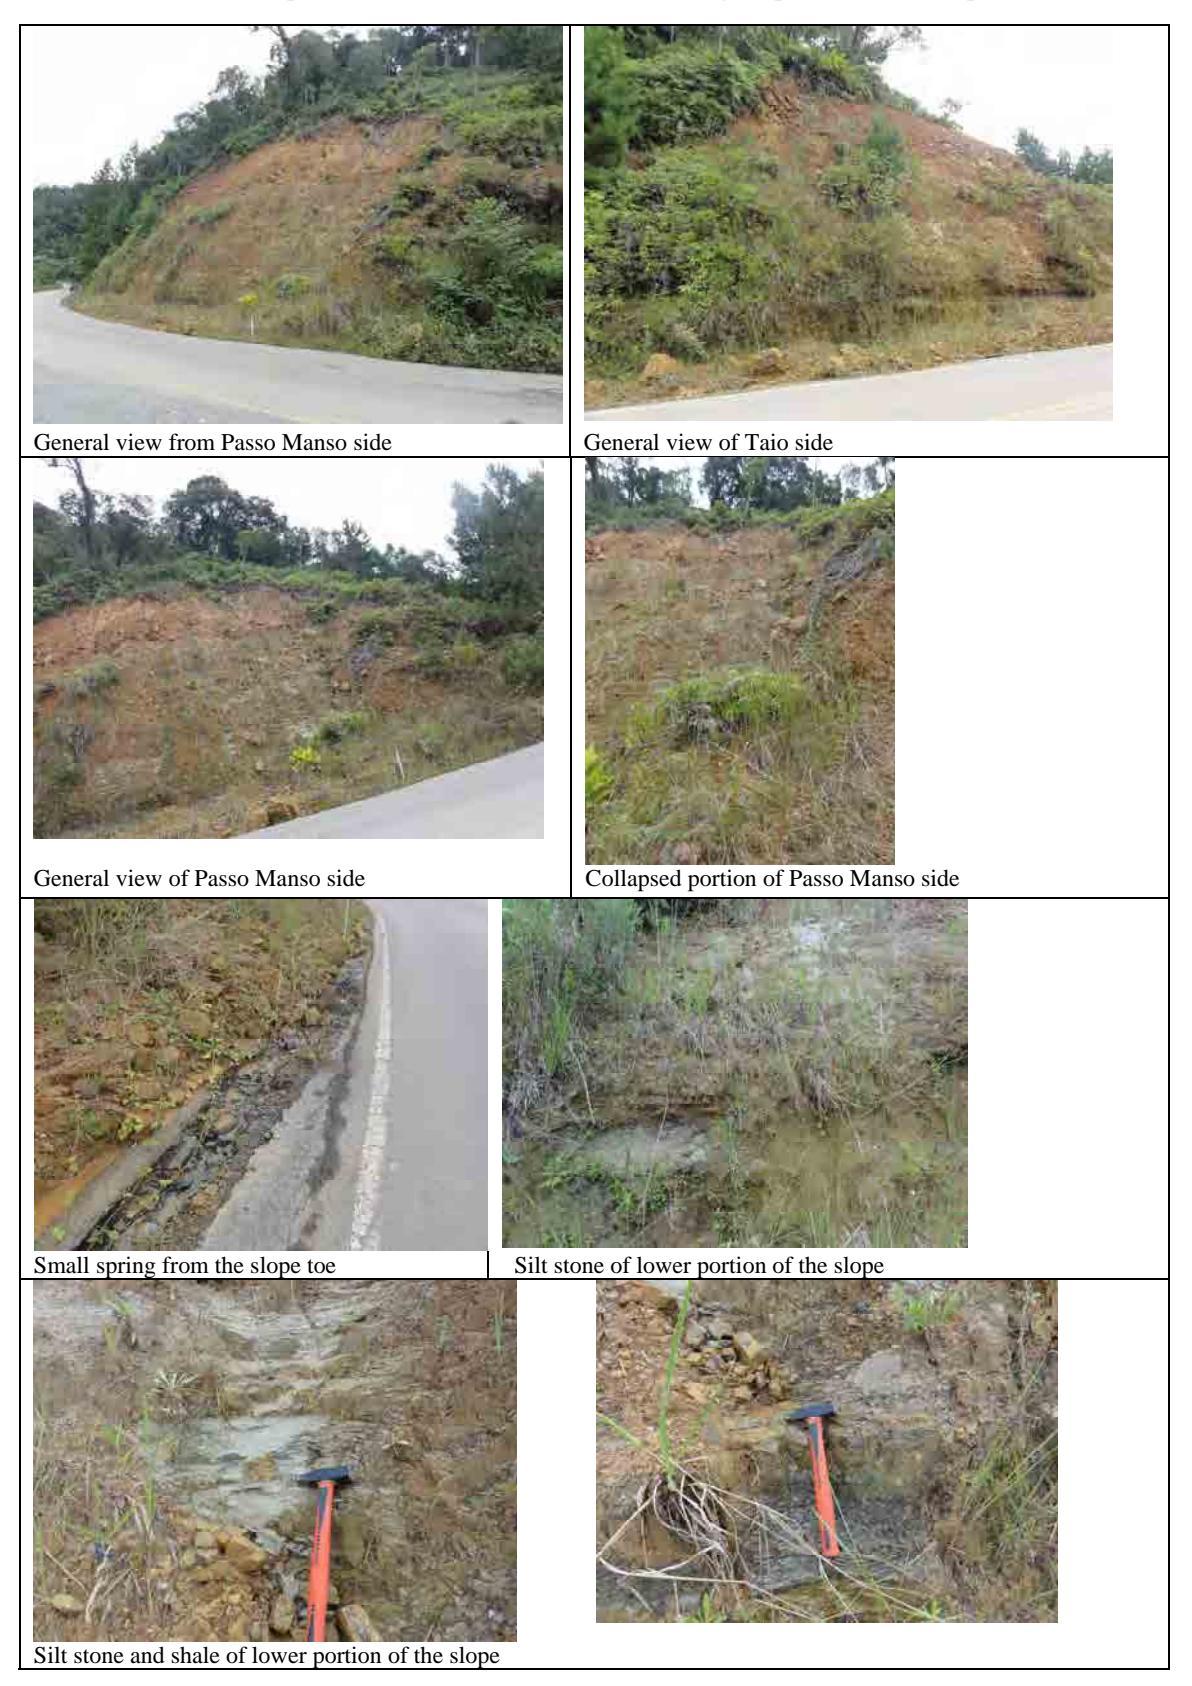
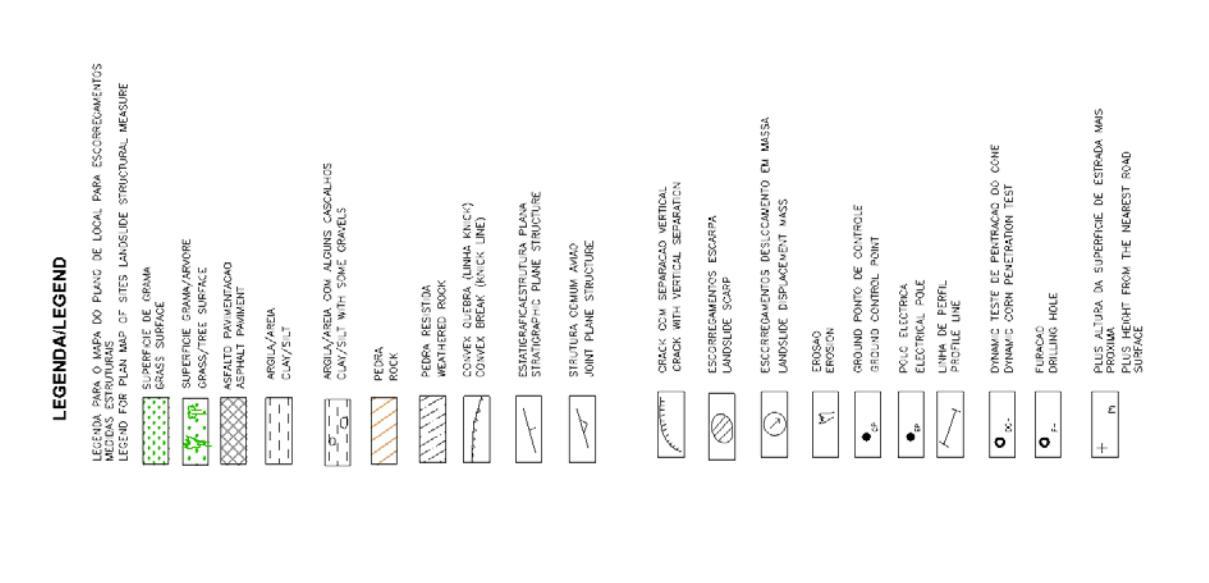
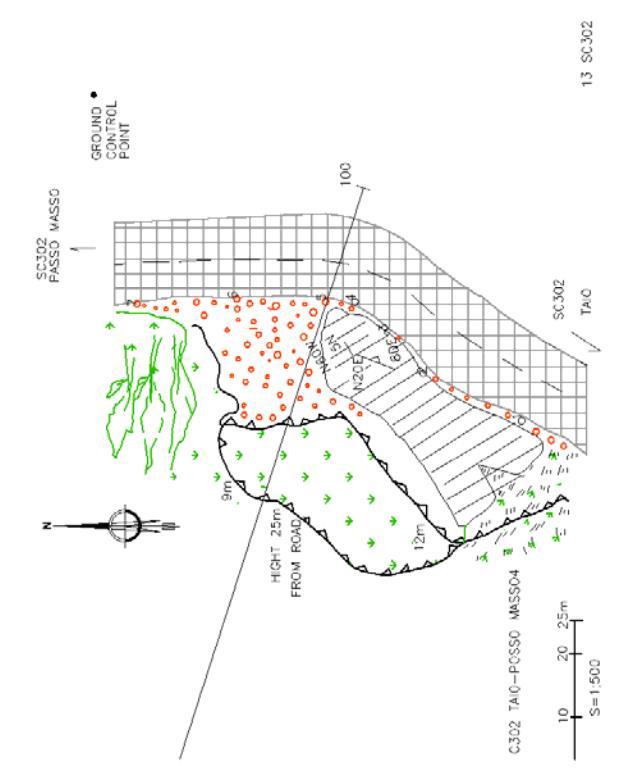
## (13) Taio-Passo Manso 4

Soil collapses have been occurred intermittently due to heavy rain. Depth of soil is mostly shallower than 1 meter on lower portion, and thicker than 3 meter on higher portion of the slope.

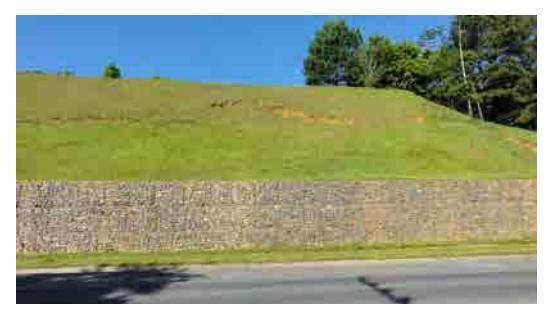
There are many existing gabion retaining walls on slope foots with slope vegetation in the Itajai river basin. It is enough against 60 years heavy rain for the slope less than 7 m height. But in case of slope height is more than 7m, some slopes occurs deformation as shown in following photo.

Slope deformation in cut slopes which higher than 7 m on SC 474 Blumenau - Massaranduba road in Blumenau Municipality.
