sedapal **REPUBLICA DEL PERU** **jica**
SERVICIO DE AGUA POTABLE Y ALCANTARILLADO DE LIMA

FIGURE 2.5.8-14: DISTRIBUTION OF SECONDARY PIPES BY MATERIAL

GRAFICO 2.5.8-15: REDES SECUNDARIAS DE AGUA POTABLE SEGUN ANTIGUEDAD DE TUBERIAS
FIGURE 2.5.8-15: DISTRIBUTION OF SECONDARY PIPES BY AGE

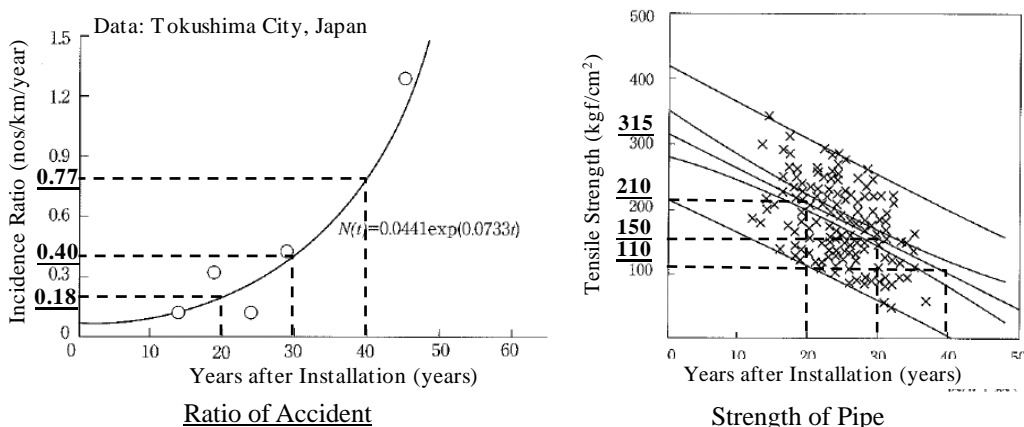
Figure 2.5.8-18: Increase of Accidents and Deterioration of Strength of AC Pipe

- About 50 % of AC pipes were installed more than 20 years ago, but more than 30 %, on the other hand, have been installed in the last 15 years.
- AC pipes are distributed throughout the whole Study Area except in the newly developed area in Puente Piedra.
- Asbestos cement is a kind of cement reinforced by asbestos. According to the Rehabilitation Guideline (2005, Japan Waterworks Association), the strength of asbestos cement deteriorates over time. As shown below, the tensile strength of asbestos cement deteriorates by 30% in 20 years and by 50% in 30 years. Moreover, ratio of accidents of asbestos cement tends to increase, especially 25 years after installation.

In addition to strength of the material, water tightness at the joints also deteriorates because of its inflexible structure and degradation of rubber ring.

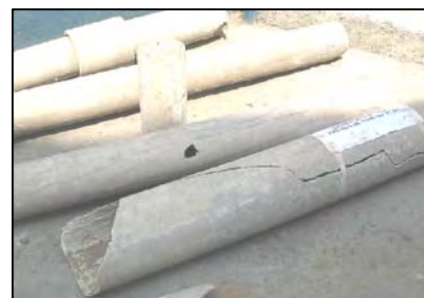
Even in the above situation, it can be said that the old AC pipes have high risk of incident and leakage. At present, AC pipe does not show significant deterioration in the Study Area. Considering its characteristics of material, however, frequency of incidence and water leakage caused by AC pipe can increase year by year, which will raise maintenance cost and water production cost of SEDAPAL.

Photograph No.1: AC Pipe
Broken asbestos-concrete pipes.

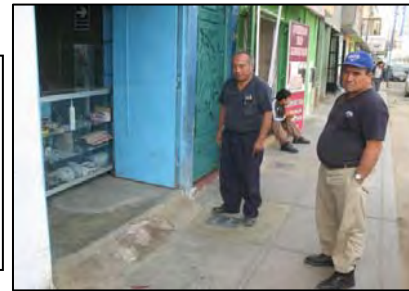
Photograph-5 and 6:

- There are pipelines installed in private property. Although such pipes were originally located in backyards, existing houses were later expanded on the pipes without relocation of the pipes. This situation disturbs proper maintenance works and also can promote illegal water consumption.

Secondary network pipeline inside a property - - Av. Los Alisos Urb. Previ, Los Olivos district.

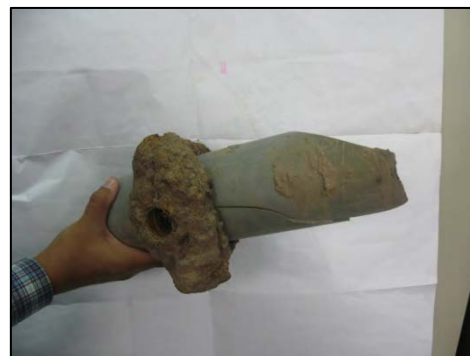
Picture 8:

Many incidences on house connections are caused by oxidized galvanized iron or cast iron connection joints between distribution pipes and house connection pipes, in comparison with existing PVC and polyethylene connection joints. Replacement of all oxidized galvanized iron connection joints is considered.

Broken PVC pipeline with cast iron clamp. Oxide accumulation brought about pressure on the pipeline to the point of breaking it.
