5.3. Required of Port Facilities Development

5.3.3 Repair and Improvement of Existing Facilities

(2) Facility Assessment

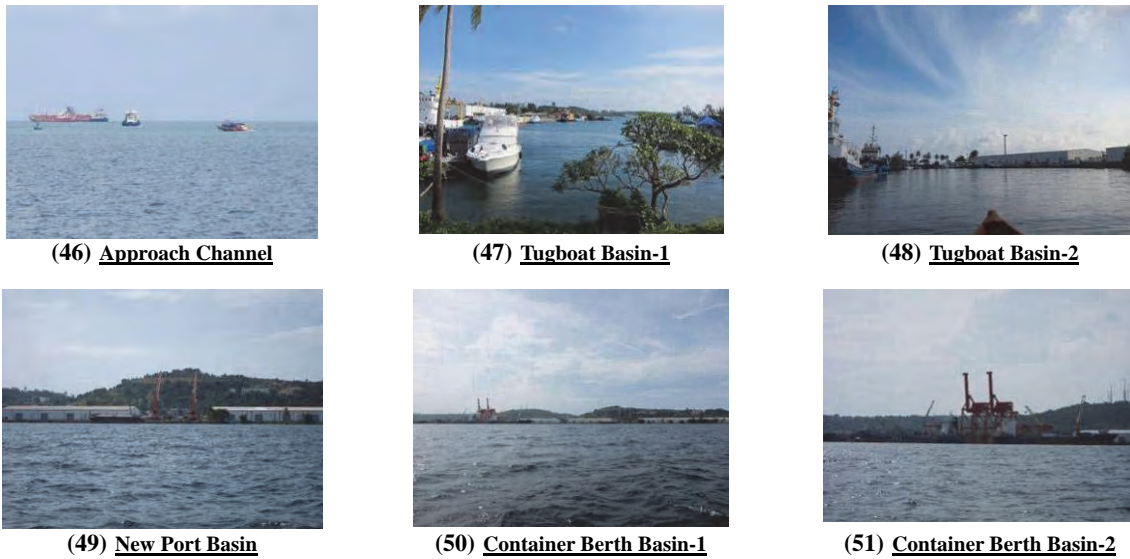
Figure 5.3-2 Site Conditions of Waterways & Basins

Table 5.3-5 shows the results of the facility assessment of waterways & basins for the approach channel, tug basin, new port basin and container berth basin. Figure 5.3-2 provides the actual site conditions of the inspected protective facilities. As seen in the table, the assessment gives a classification "D" which means "satisfactory capacity and performance remained without any defects" to all the facilities, except for the tugboat basin. The tugboat basin is supposed to be maintained at -3 meters deep, but the actual depth is -1.5 to -2.5 meters. It is not a significant problem upon the actual operation because only small-drafted boats and vessels are berthing at the basin and quay. However, in view of maximizing the capacity of the facilities for larger boats and vessels that may berth in the future, it is noted that the tugboat basin does not assure satisfactory capacity and performance as assessed.

Insction Item	Waterways & Basins				Remark
	Approch Channel	Tug Boat Basin	New Port Basin	Container Berth Baisin	
Depth	d	a	d	d	
Condition of Fairway or Basin	d	d	d	d	
Assessment	D	A	D	D

- **Ordinal Maintenance:** All the observations of the tugboat basin, new quay, container berth, internal road and yard for the container terminal belong to this category. Respectively, maintenance dredging, reinstallation of missing items if needed, concrete repair, and re-basing of ILB pavement are commonly required as periodical maintenance activities.

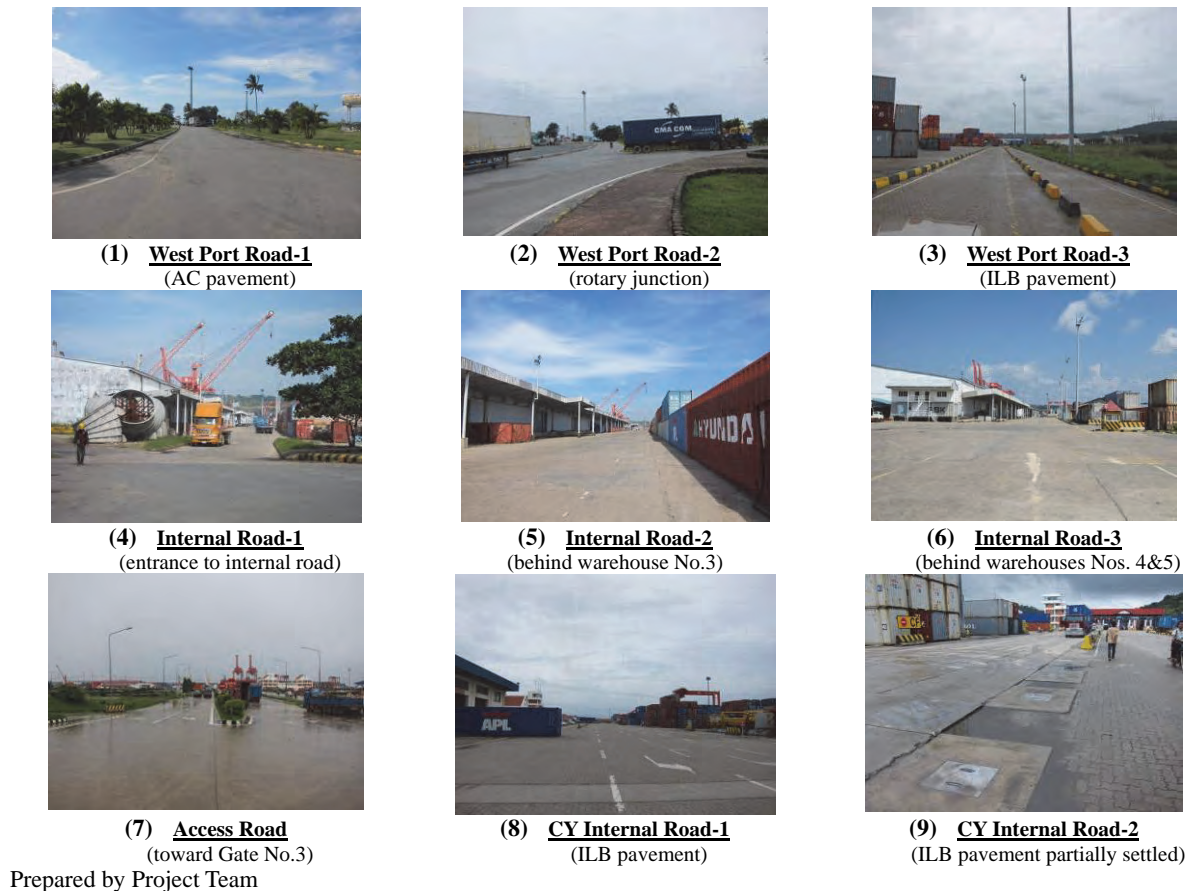
Figure 5.3-6 Site Conditions of Transportation Facilities

Table 5.3-8 presents the results of the facility assessment of transportation facilities such as west port road, internal roads behind warehouses No. 3 and Nos. 4&5, and the access and internal roads for the container terminal. Figure 5.3-6 displays the actual site conditions of the inspected transportation facilities. As shown in the table and figure, all the roads show no significant deterioration levels for each inspected item, except for the internal road for the container terminal. Some settlement of interlocking block pavement was observed on the east side.

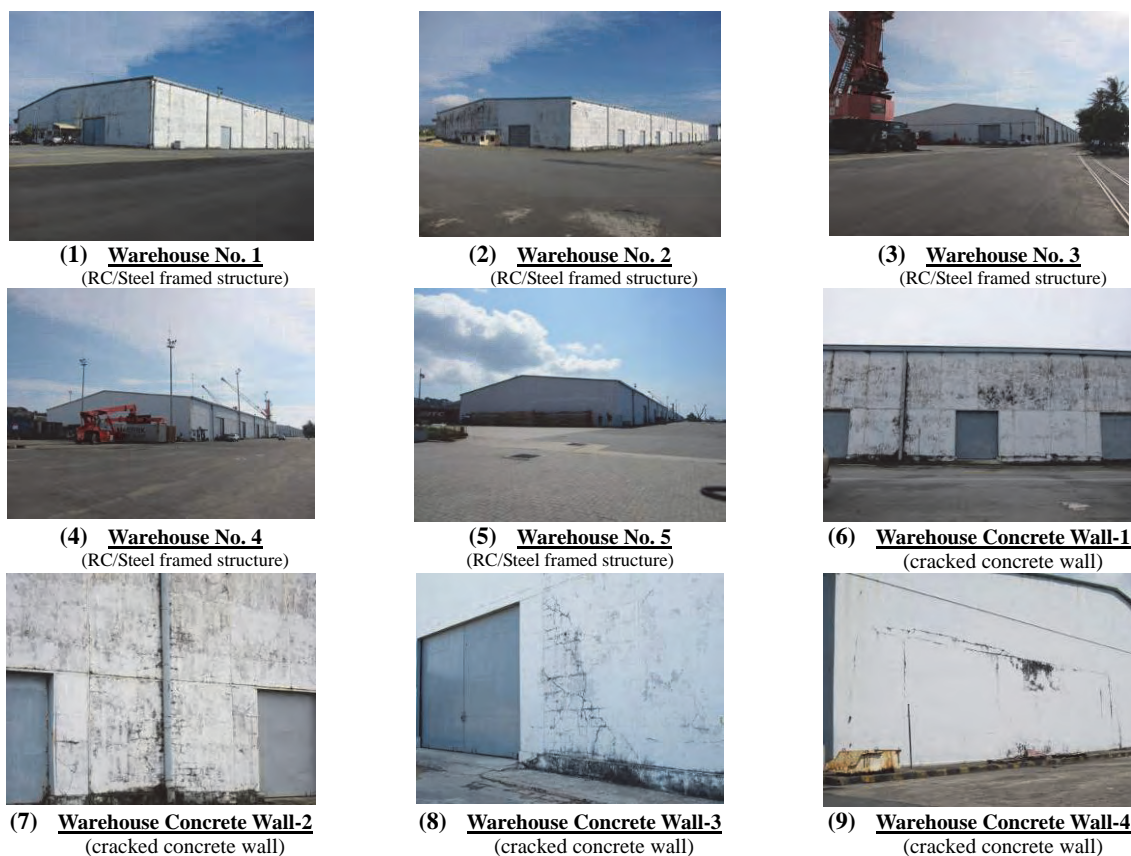
Figure 5.3-9 Site Conditions of Storage Facilities (Warehouse)

Table 5.3-11 describes the results of the facility assessment for warehouses Nos. 1, 2, 3, 4 and 5 of storage faculties. Figure 5.3-9 presents the actual site conditions of the inspected warehouses. As shown in the table and figure, the assessment classifies the concrete structure as “B” with a lowered capacity and performance probably due to neglect, particularly for the concrete walls of all the warehouses. Several cracks are seen on the surfaces of building walls at the installed lines of reinforcement. The roof, floor slab and steel frame structures are not remarkably deteriorated at present.

- ✚ **Storage Facilities:** All the warehouses are becoming superannuated and the concrete walls have many cracks on the installed lines of reinforcement.

- **Rehabilitation:** North Breakwater (north), warehouses and VTMS in the administration building fall under the 'rehabilitation' category. The breakwater requires at least reconditioning of the opened sections where the top materials have been lost by filling with suitable stone materials up to the original elevation. The concrete walls of the warehouses need to have crack repairs such as epoxy injection, concrete filling to v-cut portions, chipping, re-concreting, etc. The fiber optic cables connected to the radar tower and VTMS need to be re-spliced by an experienced technician or be replaced.
