PART 3

SELECTION OF BRIDGES FOR SEISMIC CAPACITY IMPROVEMENT (PACKAGE B AND C)

CHAPTER 11 PROCEDURES FOR SELECTION OF BRIDGES FOR OUTLINE DESIGN

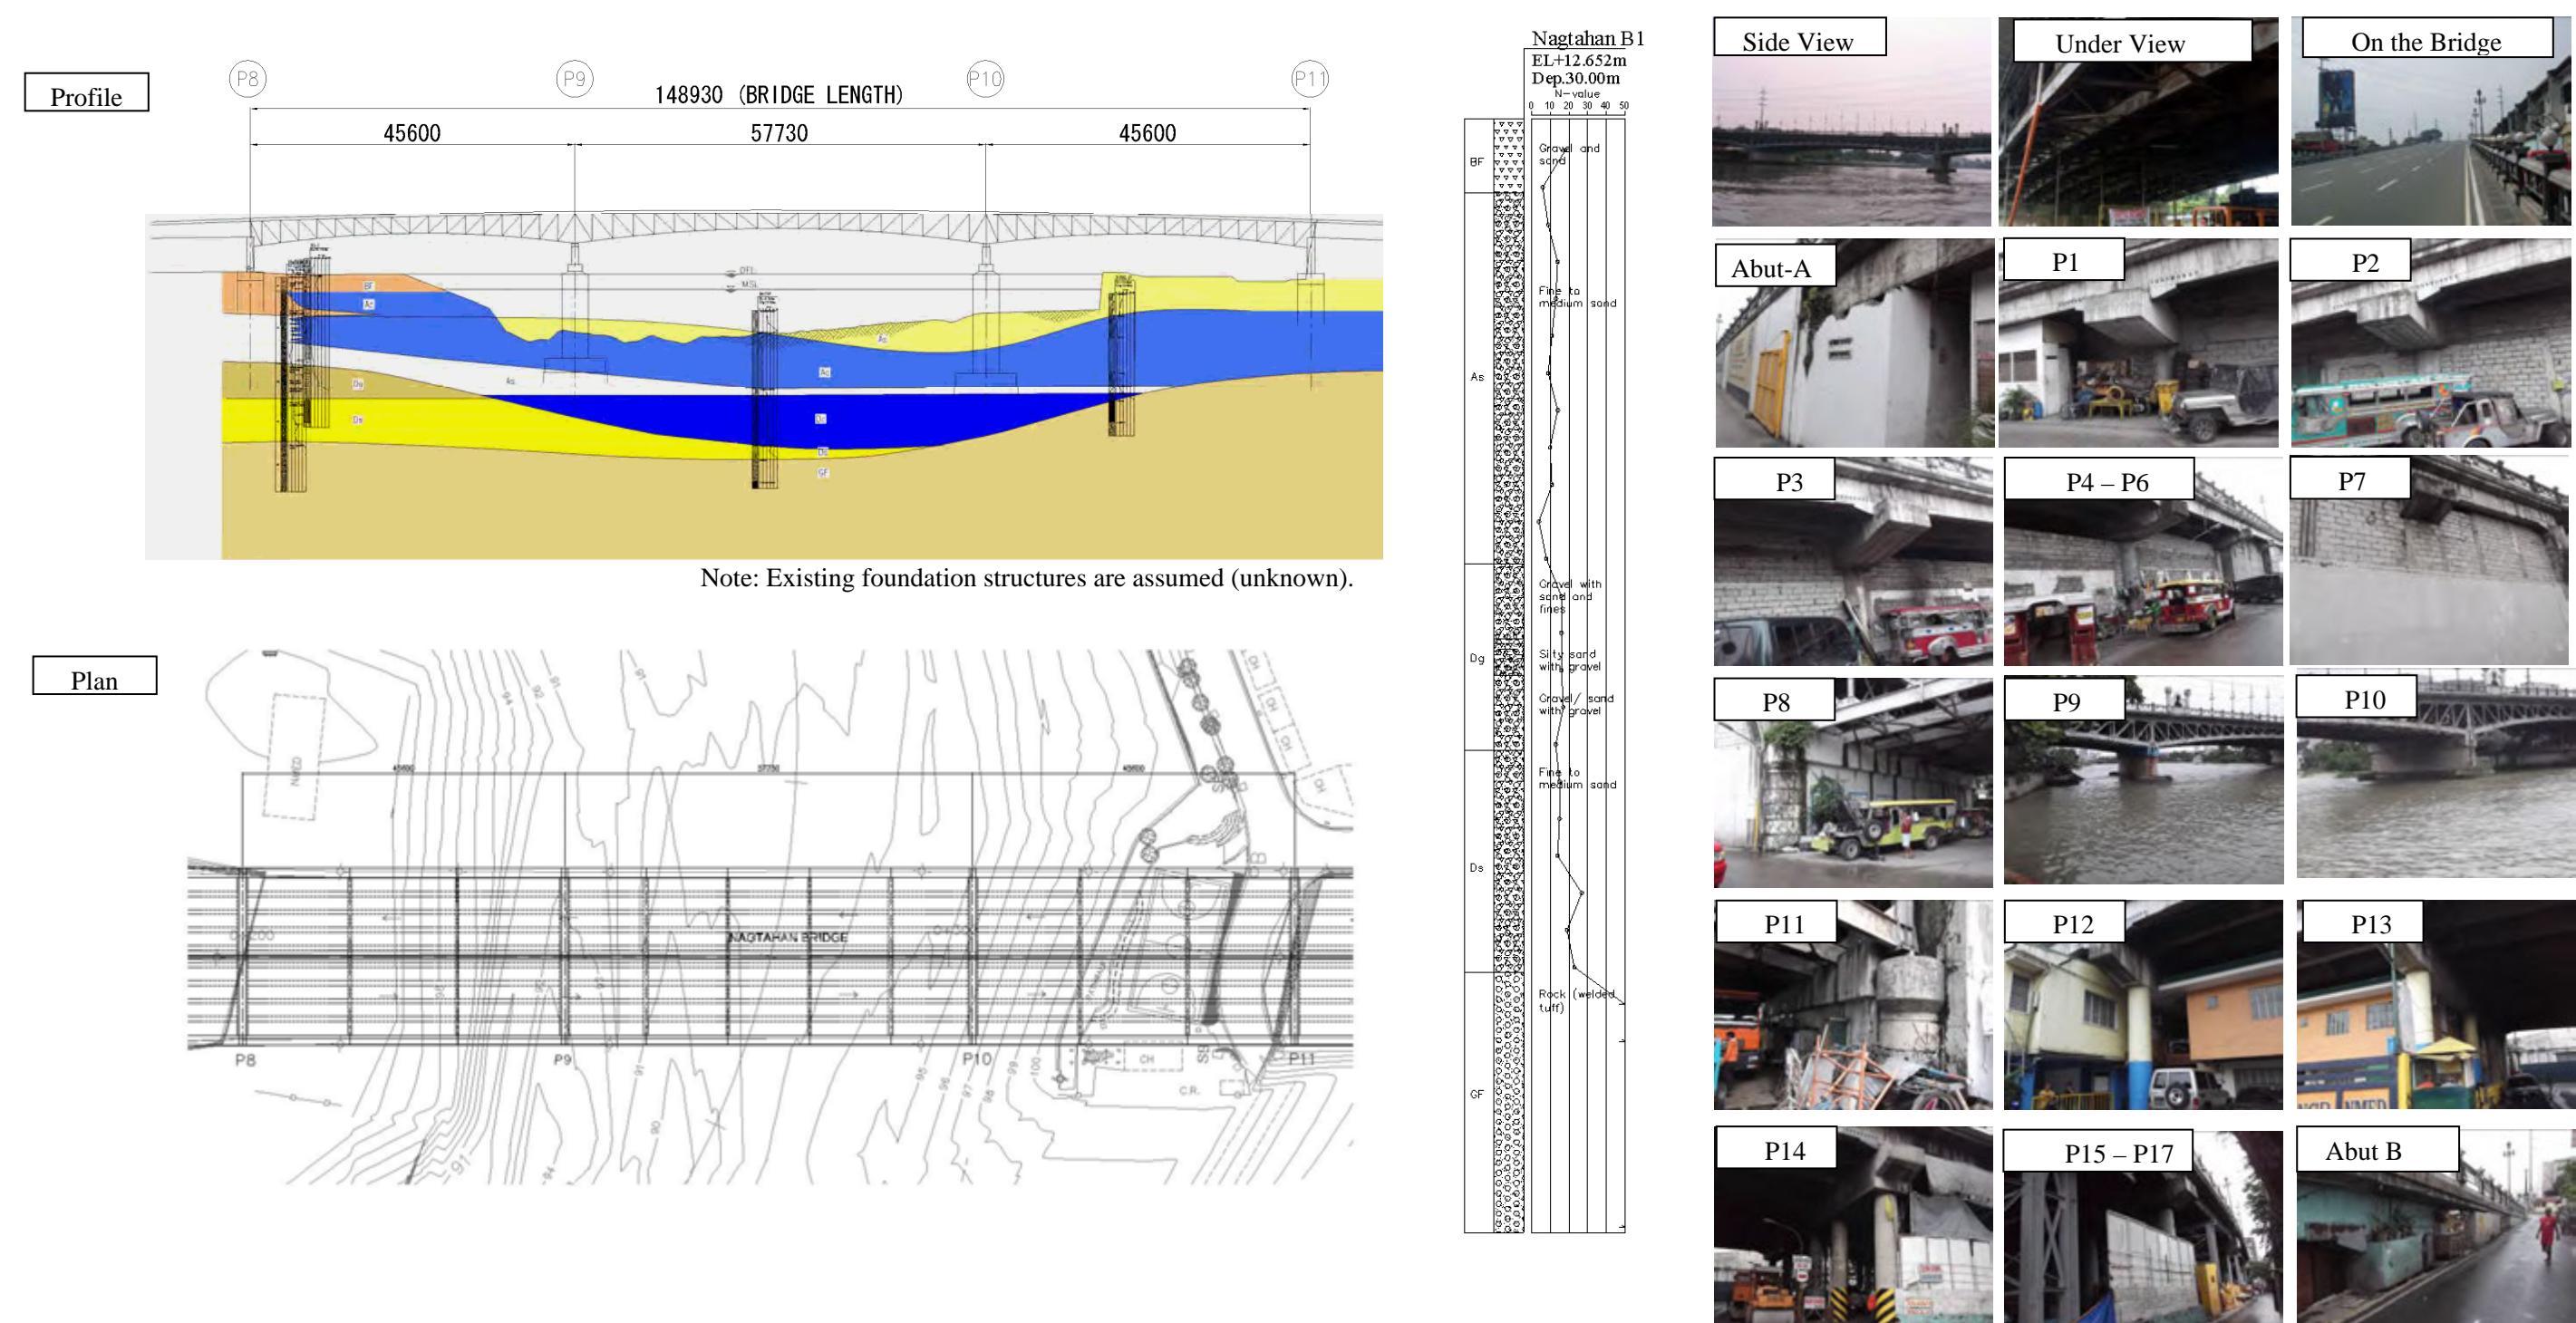
Figure 13.1.1-4 Current Bridge Condition of Nagtahan Bridge

Bridge length/width	L=202.9m, W=20.52m	Traffic Load Regulation	20 tons
Year Built	1965 (1988)	Soil Profile Type (JRA)	Left Bank: Type II, Right Bank: Type II
Bridge Type	CBG (Concrete Box Girder) PCDG (PC Deck Girder)	Liquefaction Potential	High
		As Built Drawing	None

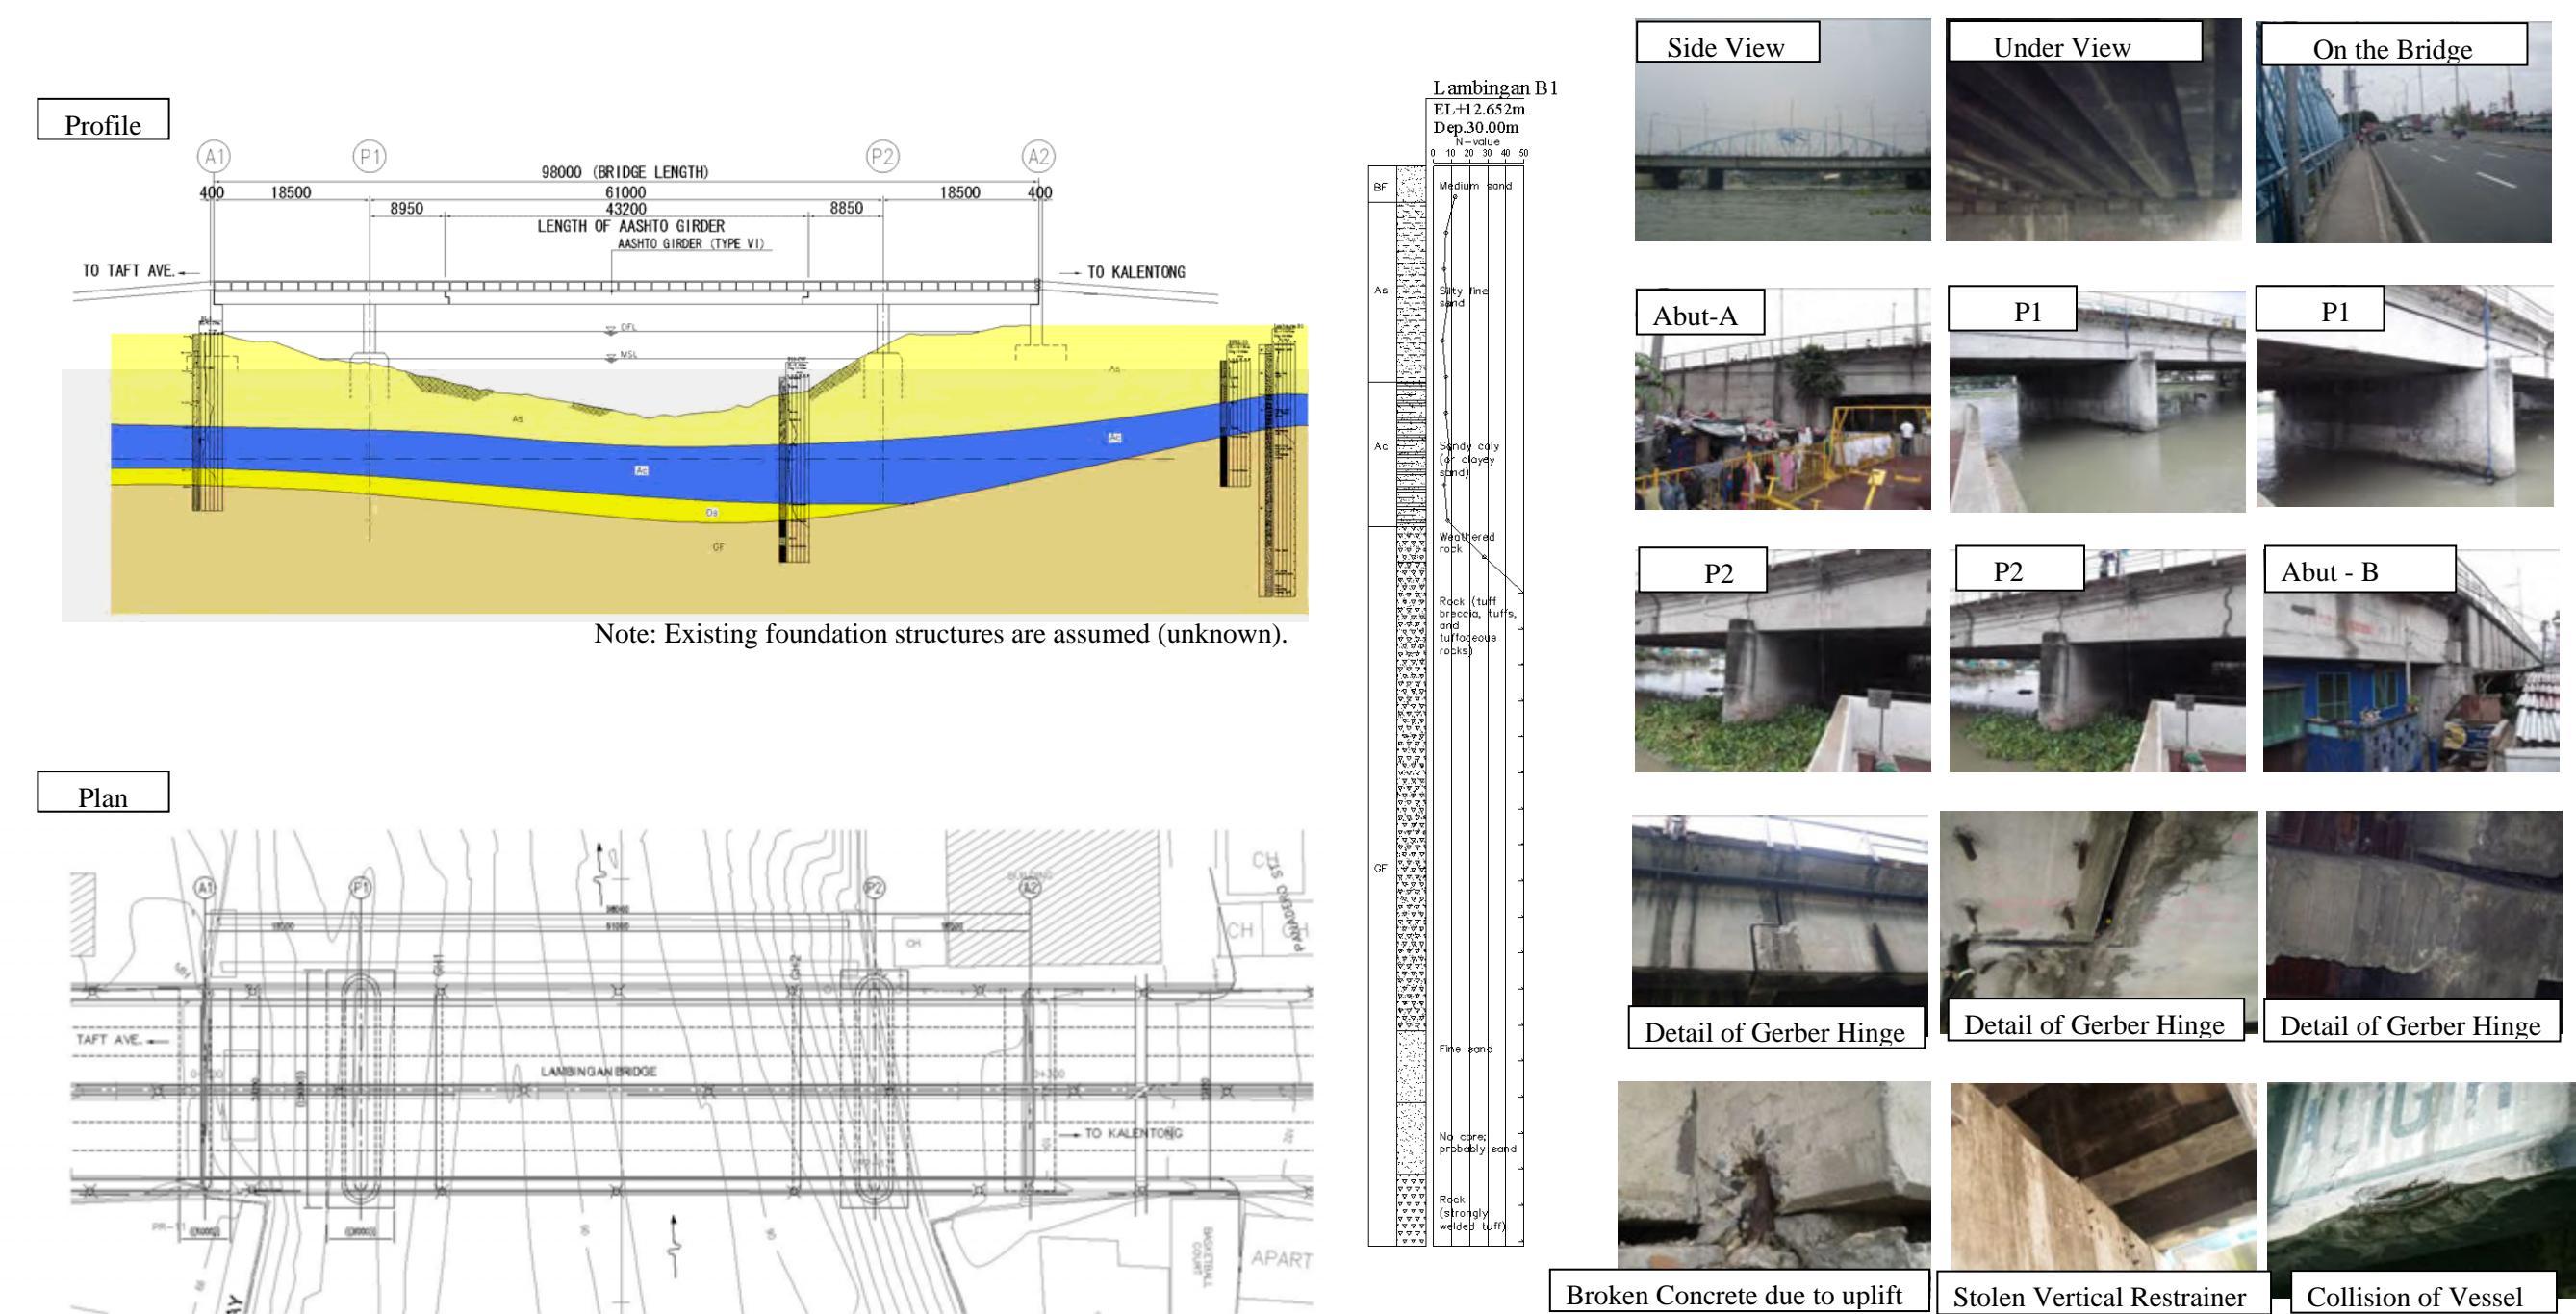
Figure 13.1.1-7 Current Bridge Condition of Lambingan Bridge

Bridge length/width	L=98.1m, W=24m		Traffic Load Regulation	15 tons
Year Built	1979		Soil Profile Type (JRA)	Left Bank: Type II, Rigl
Bridge Type	PCDG (PC Deck Girder) with Gerber Hinge		Liquefaction Potential	High
			As Built Drawing	None

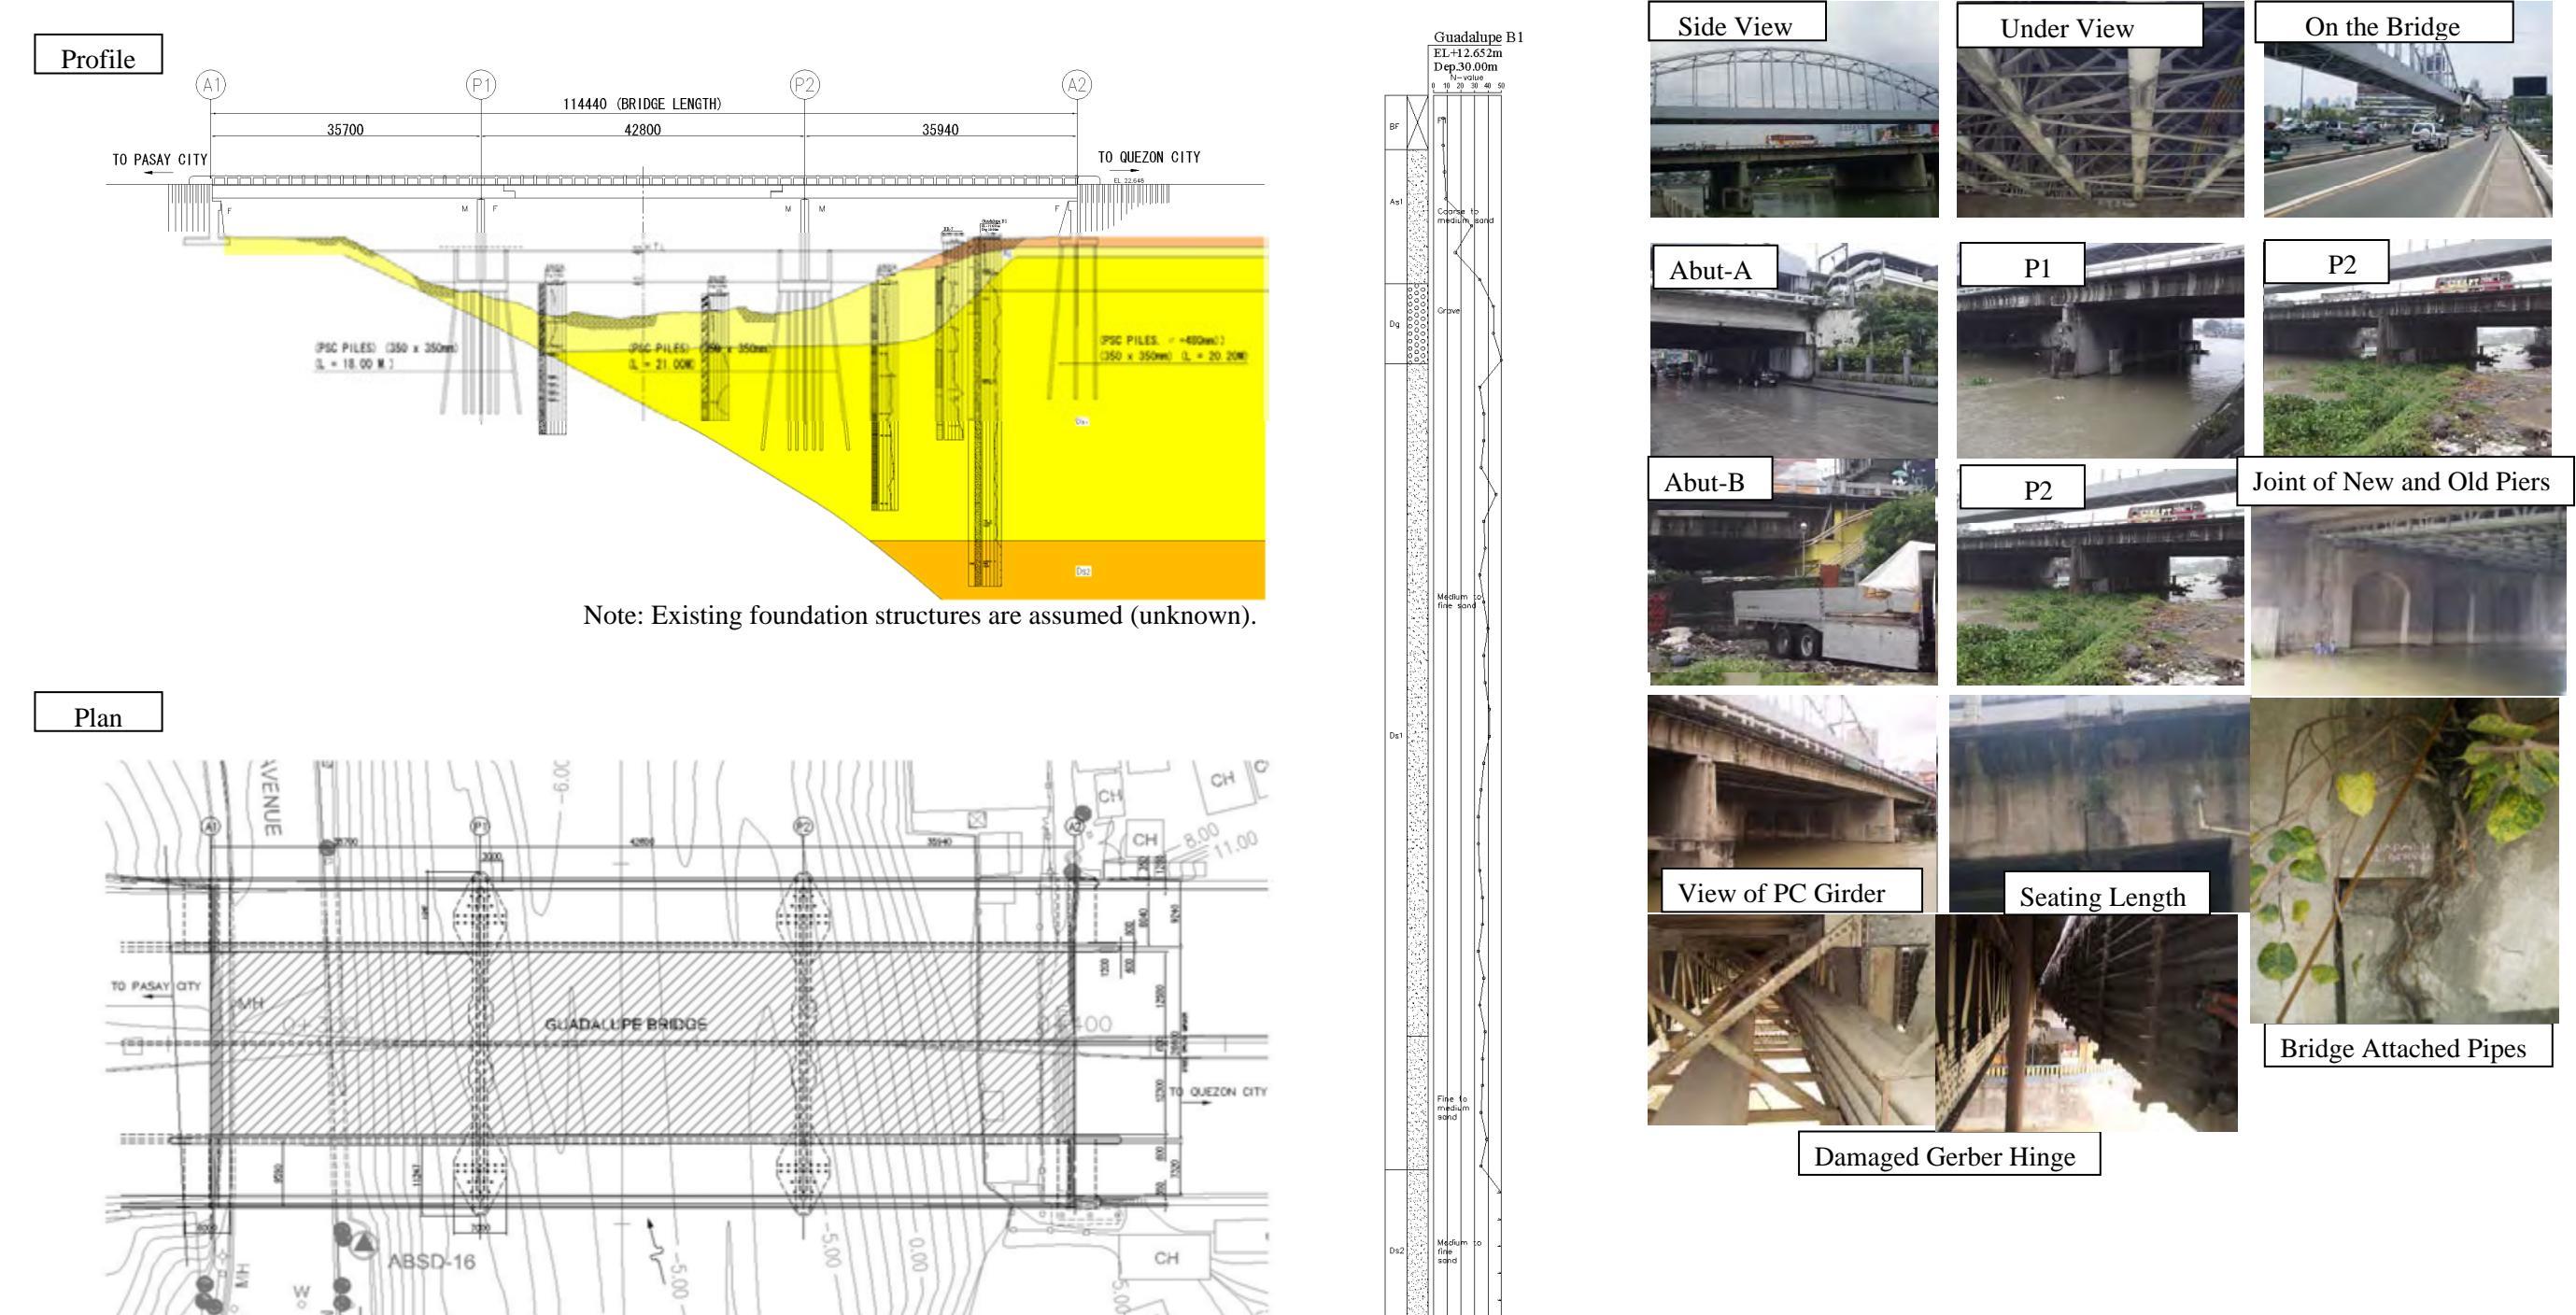
Figure 13.1.1-10 Current Bridge Condition of Guadalupe Bridge

Bridge length/width	L=144.44m, W=25.4m	Traffic Load Regulation	20 tons
Year Built	1962 (Old), 1978 (New)	Soil Profile Type	Left Bank: Type I, Right Bank: Type
Bridge Type	Continuous Steel Truss (Old)	Liquefaction Potential	High
	PC Deck Girder with Gerber Hinge (New)	As Built Drawing	None

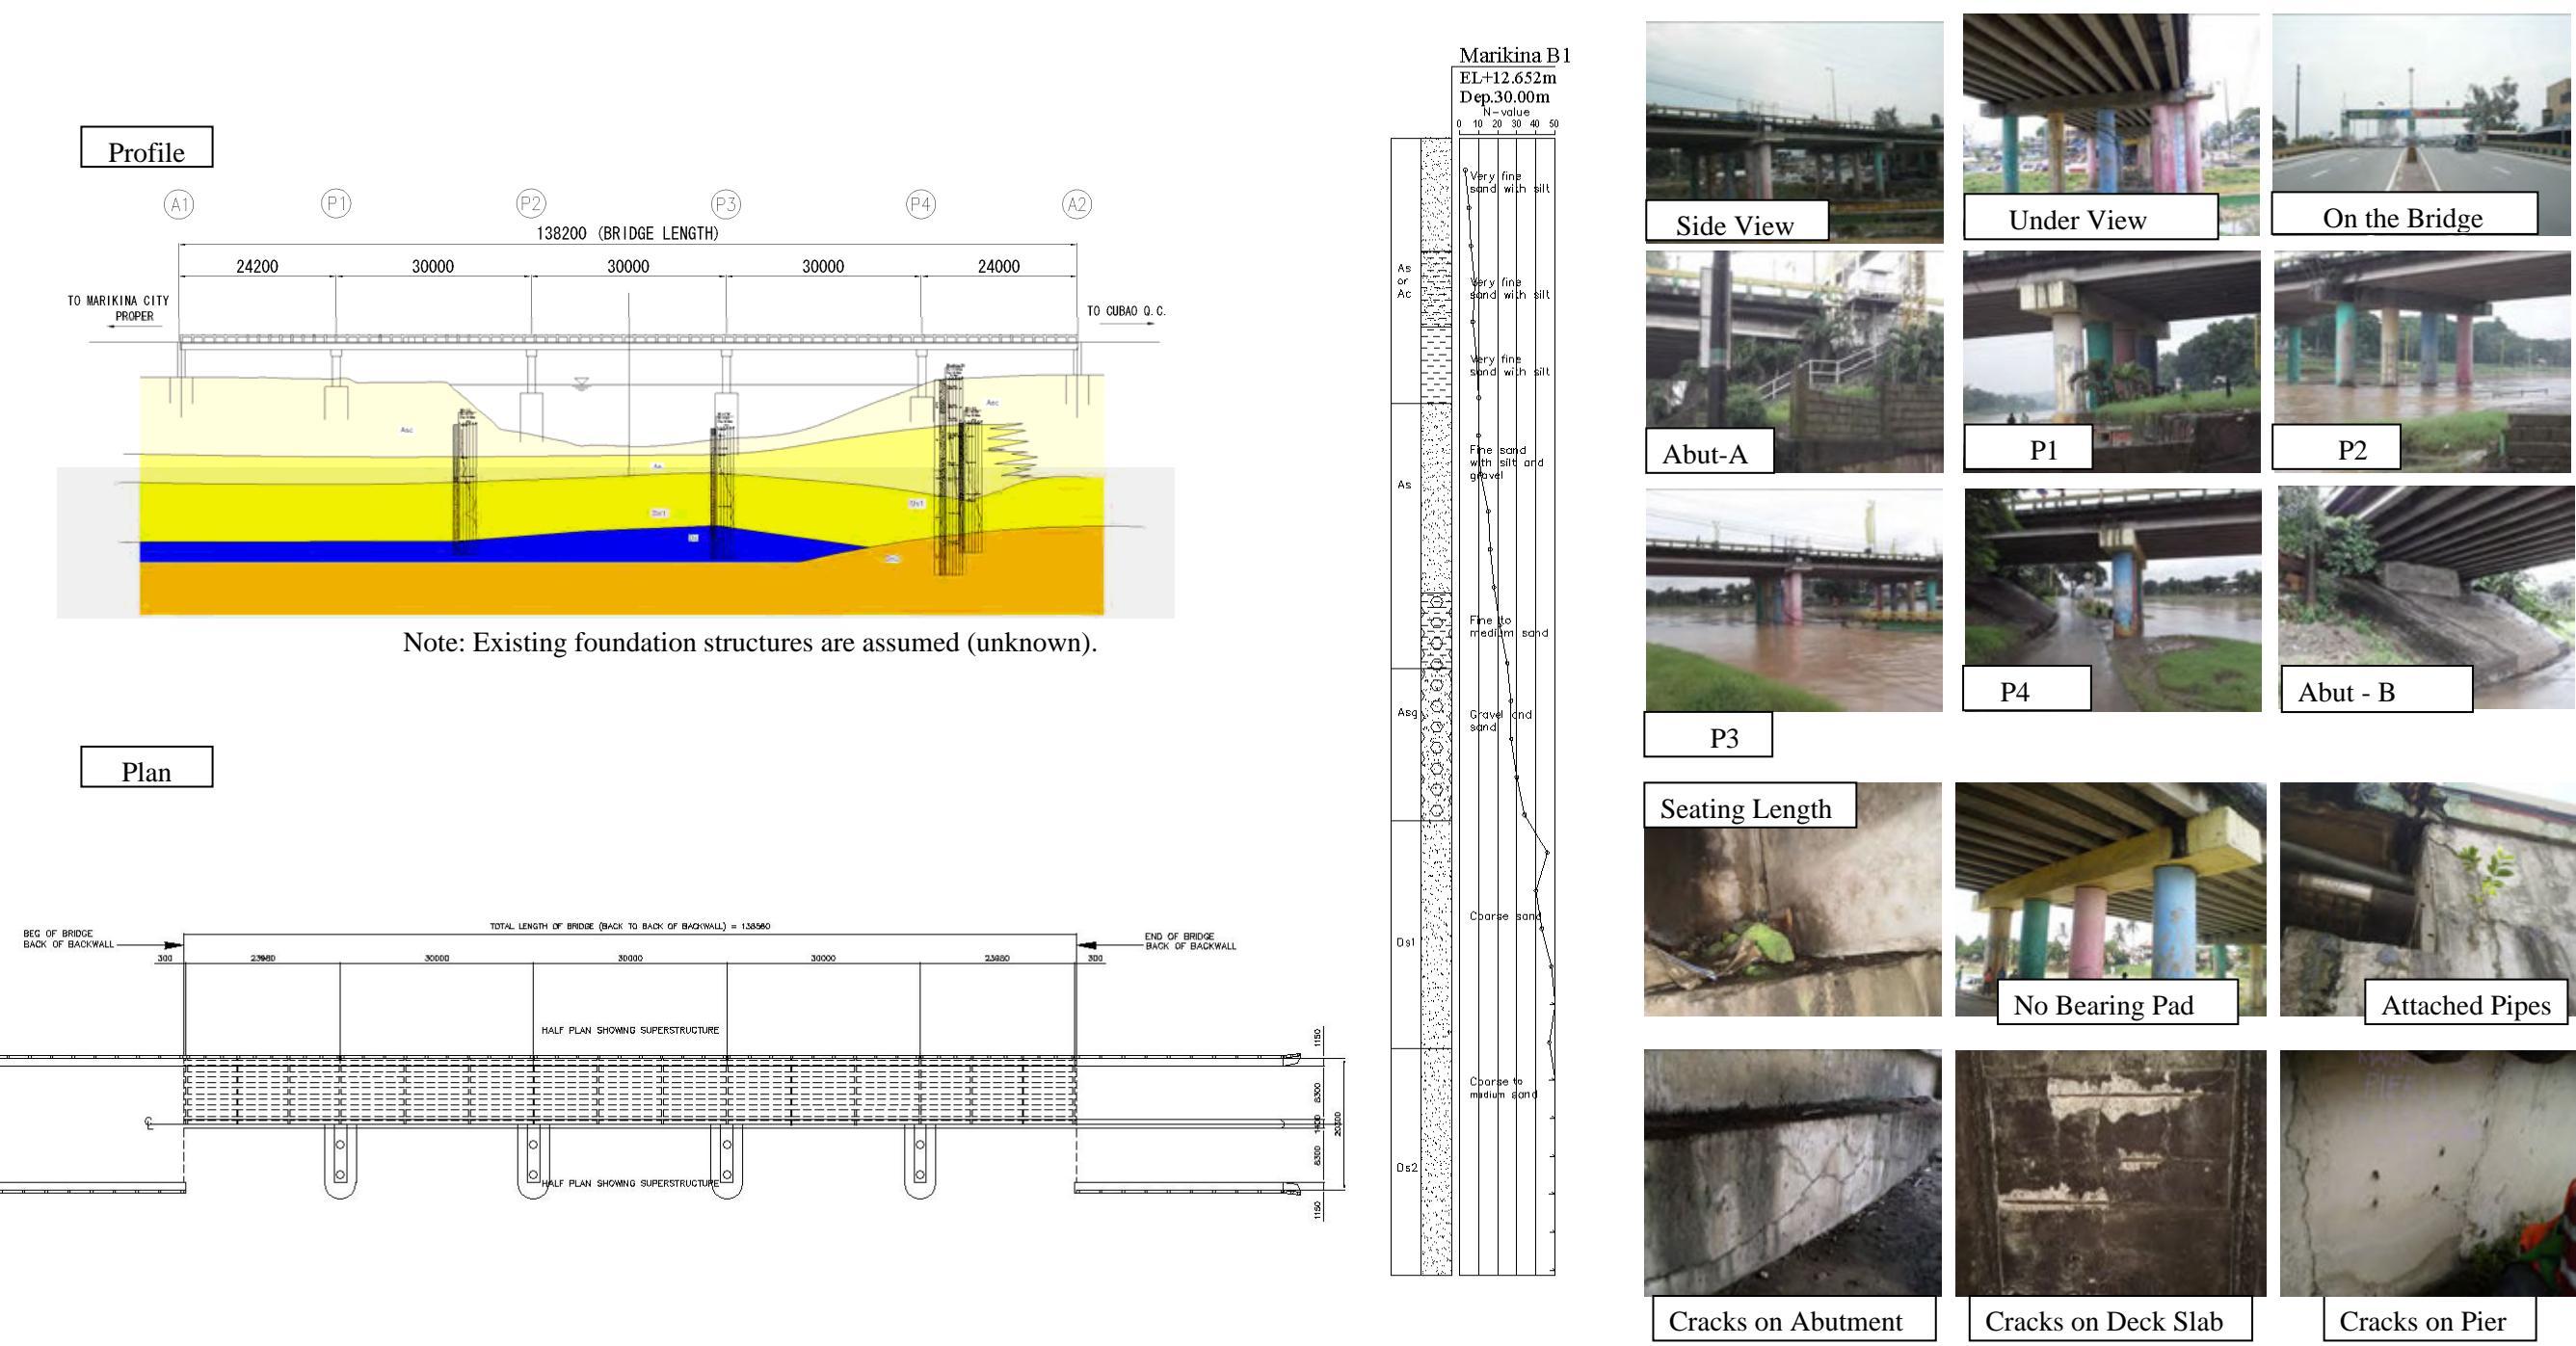
Figure 13.1.1-13 **Current Bridge Condition of Marikina Bridge**

Bridge length/width	L=138.2m, W=20.3m	Traffic Load Regulation	20 tons
Year Built	1980	Soil Profile Type	Left Bank: Type I, Rig
Bridge Type	PCDG (PC Deck Girder)	Liquefaction Potential	High
		As Built Drawing	None

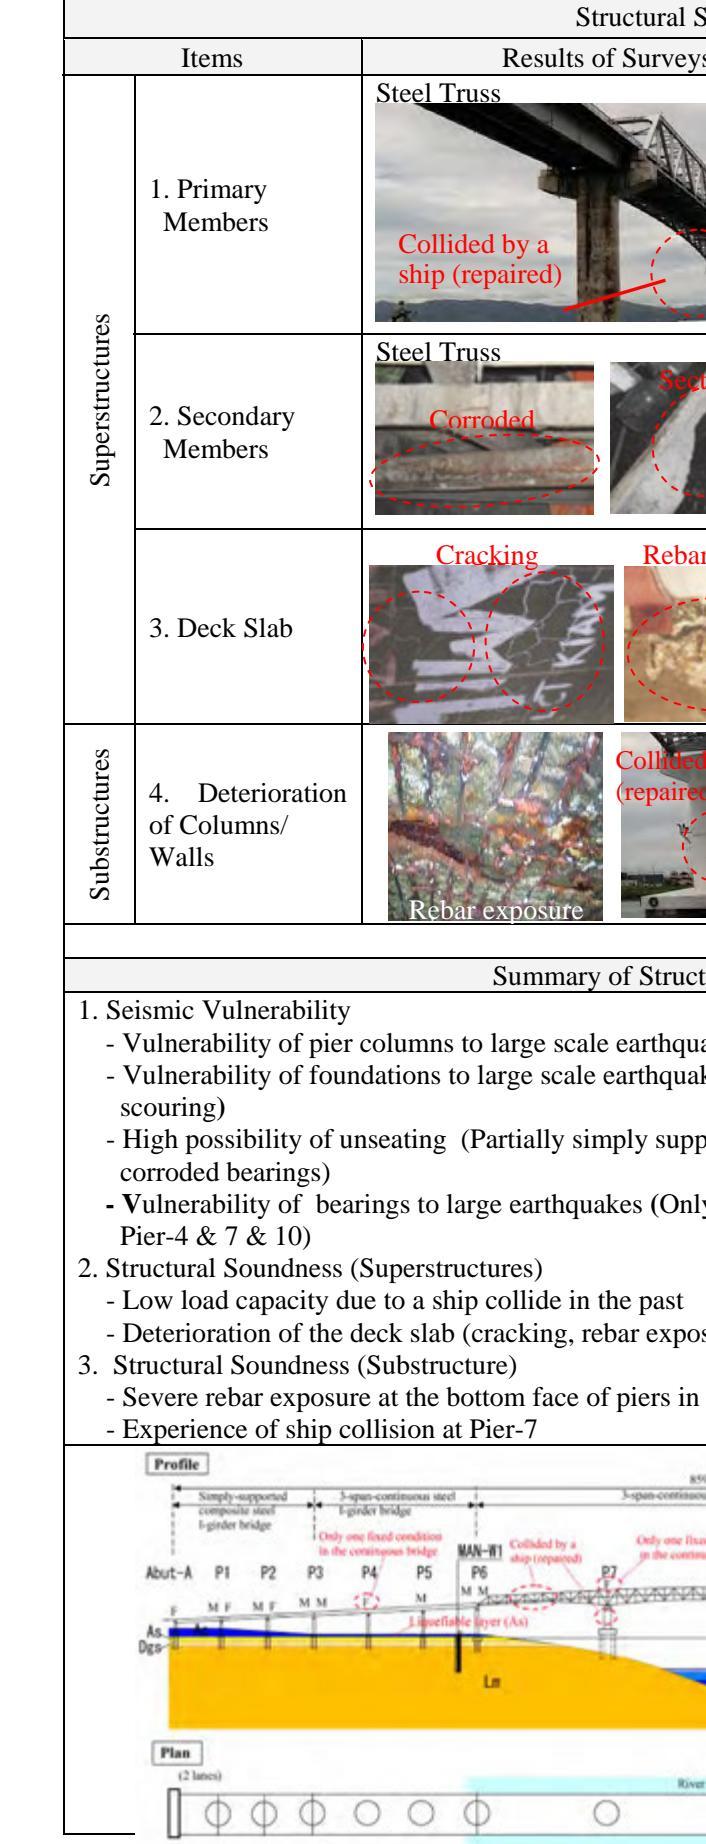
Soundness	
VS	Analyses/Comments
	- Primary steel members are apparently in good condition.
	<ul> <li>The load capacity is considered to be reduced by the damage even though</li> </ul>
	the damage was repaired. - Overall damage degree: Moderate
cion loss	<ul> <li>Heavy corrosion at most of secondary steel members</li> <li>Section loss at some of the secondary steel members</li> <li>Overall damage degree: Serious</li> </ul>
ar exposure	<ul> <li>Minor cracking at the bottom face of deck slab through the entire bridge (Crack width range: 0.1-0.4mm)</li> <li>Rebar exposure at the overhanging deck slabs</li> <li>Overall damage degree: Moderate</li> </ul>
ed by a ship ed) P7	<ul> <li>Severe rebar exposure at the bottom face of piers in the water</li> <li>Pier-7 was collided by a ship in the past.</li> <li>Overall damage degree: Serious</li> </ul>
ctural Deficien	cies
uakes (confine akes (liquefact	ment loss, deterioration) ion potential, unknown structure,

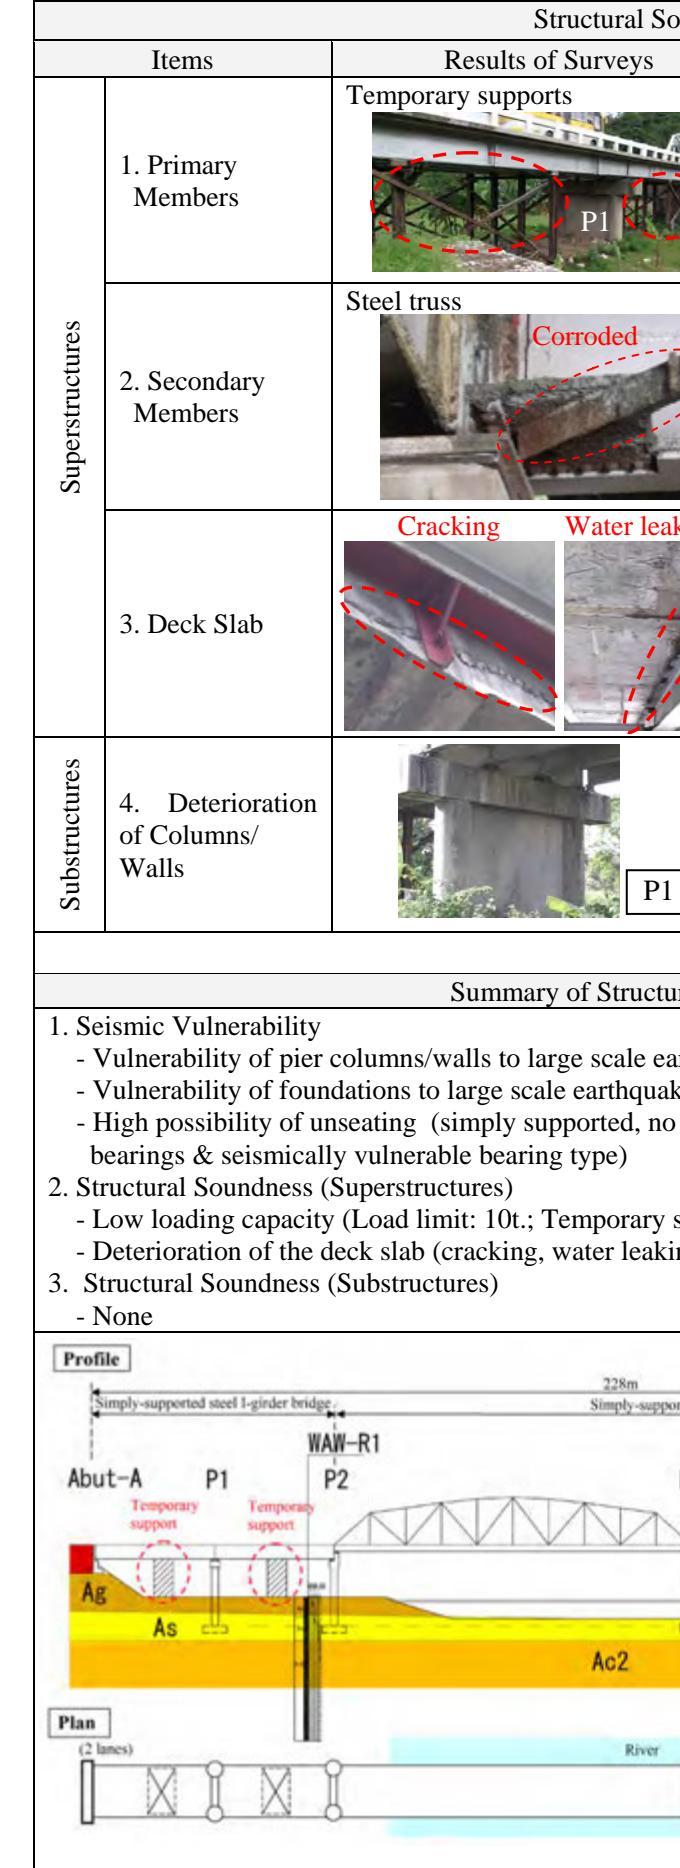
Soundness	3				
	Analyses/Comments				
	<ul> <li>Corrosion at the part of steel members</li> <li>Low load capacity (load limit: 10t)</li> <li>Temporary supports for steel I-girders due to the low load limit</li> <li>Overall damage degree: Serious</li> </ul>				
	<ul> <li>Corrosion at bracing members</li> <li>Overall damage degree: Moderate</li> </ul>				
aking	<ul> <li>Major cracking at the side face of the deck slab</li> <li>Water leaking along the center girder</li> <li>Overall damage degree: Serious</li> </ul>				
	<ul><li>Piers are apparently in good condition.</li><li>Overall damage degree: Good</li></ul>				
1					
ural Defi	ciencies				
earthquak akes (unk o seismic	es (confinement loss) nown structure) restrainers, short seat length, corroded				
v supports cing)	supports are used.) (ing)				
ported steel truss	bridge Simply-supported steel				
P3	P4 Abut-B Temporary support				
I
