**THE PROJECT FOR CAPACITY  
DEVELOPMENT ON COASTAL  
PROTECTION AND REHABILITATION  
IN THE REPUBLIC OF MAURITIUS**

**FINAL REPORT**

**COASTAL CONSERVATION PLAN**

**(Volume 2)**

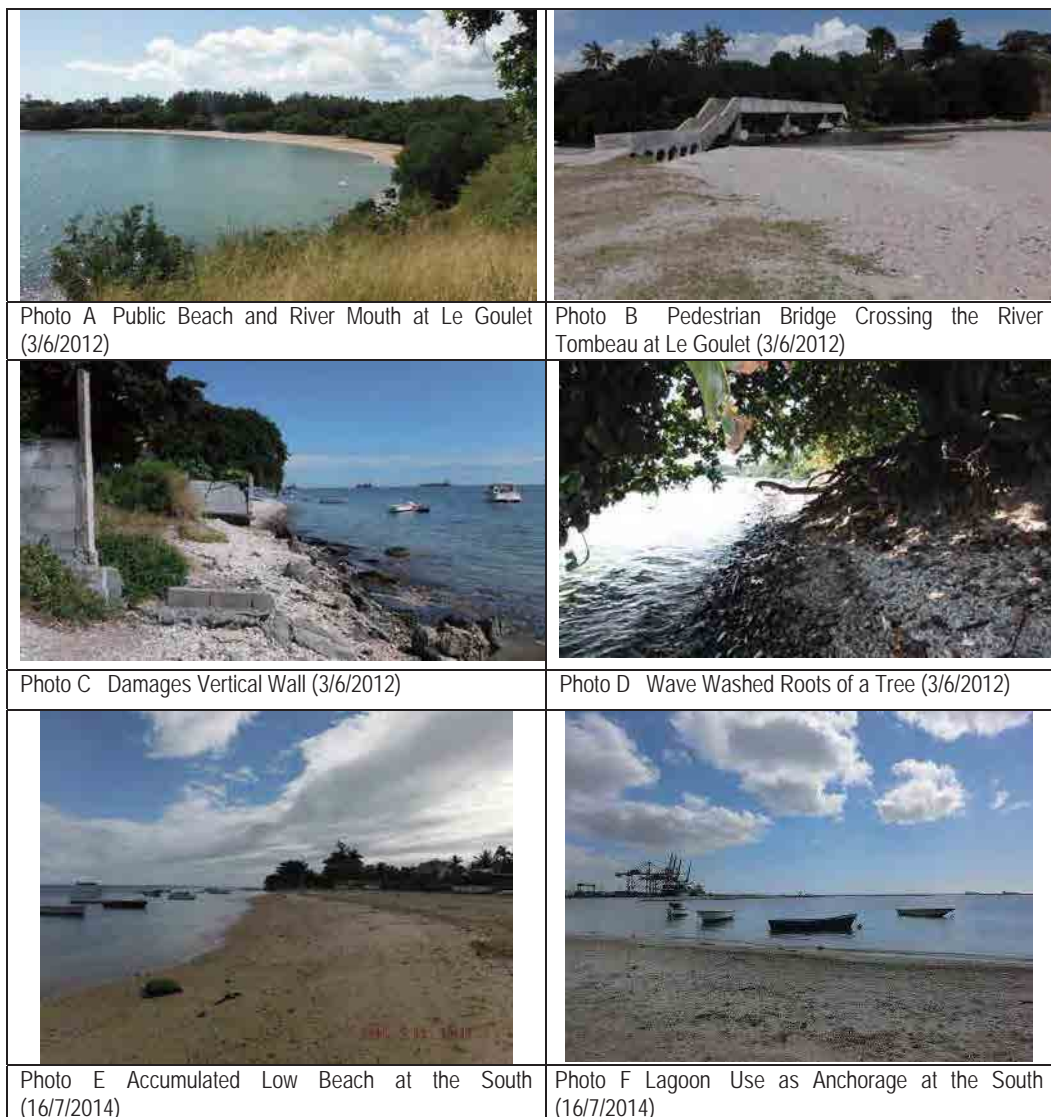
Figure 1.2.2 Coastal Condition at Baie du Tombeau

At the south the vertical walls were constructed within the DBZ (dynamic beach zone) and they were damaged over time by cyclones and storms as shown in the Photo C in the Figure 1.2.2. The remains were scattered in front of the damaged wall. There were also no beaches in front of the vertical walls.

There is presence of a mature tree (Badamier) with exposed roots within the dynamic beach zone in front of leased site of Loretto Institute as shown in the Photo D in the Figure 1.2.2. The roots of the tree were washed by waves and became difficult to support upper parts of the tree. This also disturbs the accumulation of sediment at the beach.

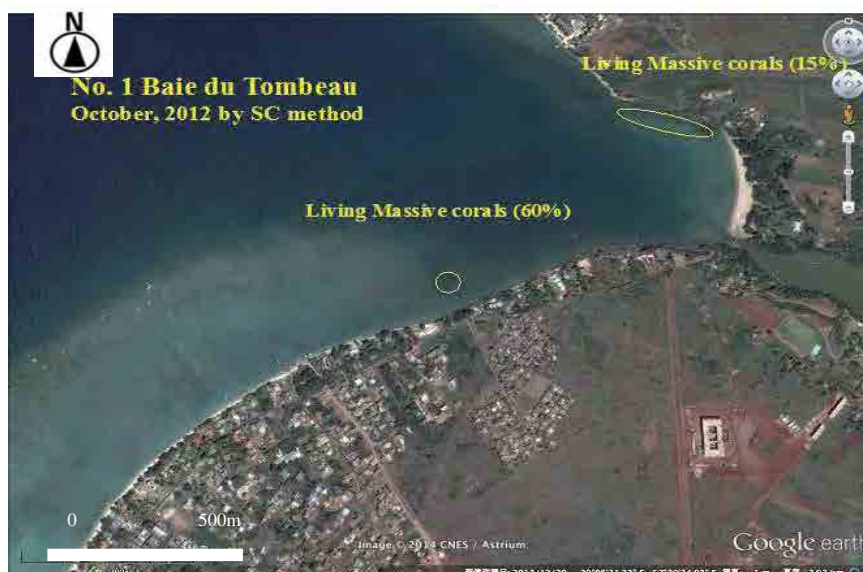
Figure 1.2.4 Coral Condition at Baie du Tombeau and Le Goulet

present most of the living corals seemed to be decreasing.

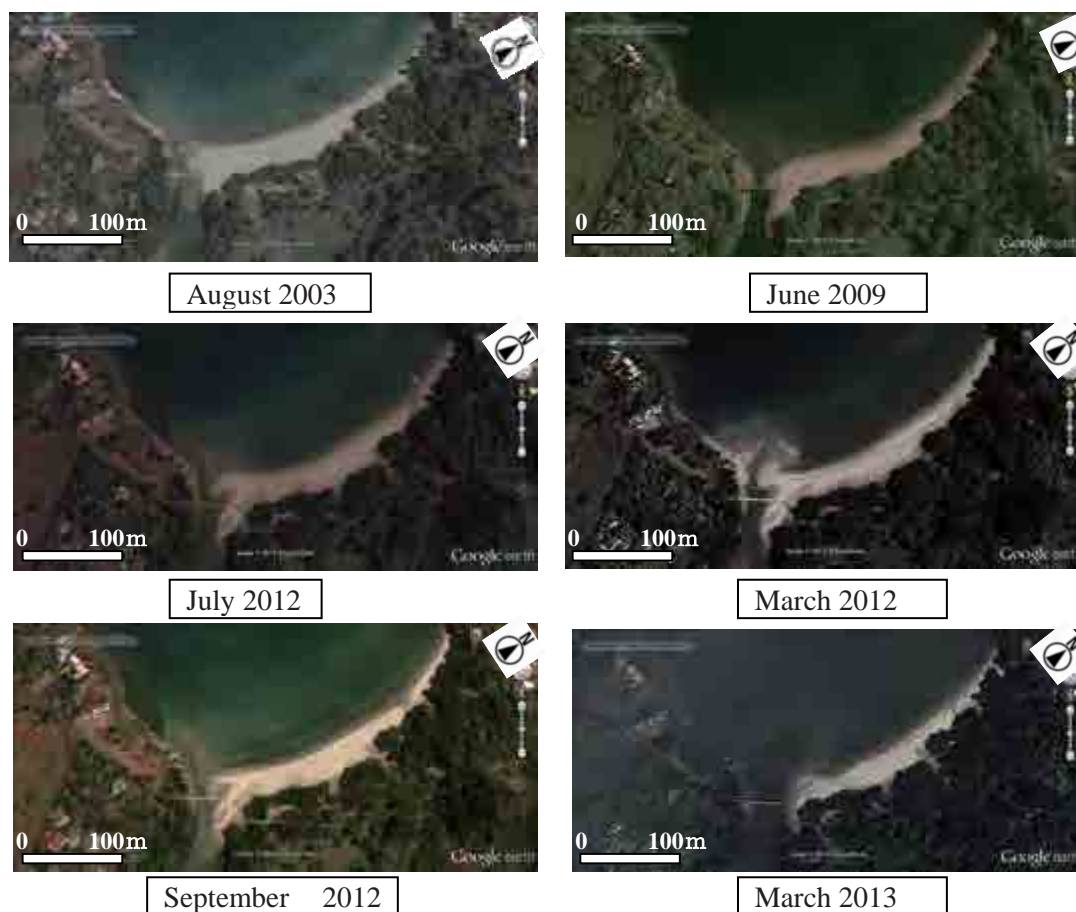
Figure 1.3.6 Change of Sand Bar and Beach at the River Mouth of Le Goulet, Pedestrian Bridge Damaged at March 2013

from Baie du Tombeau to the public beach is one of the problems.

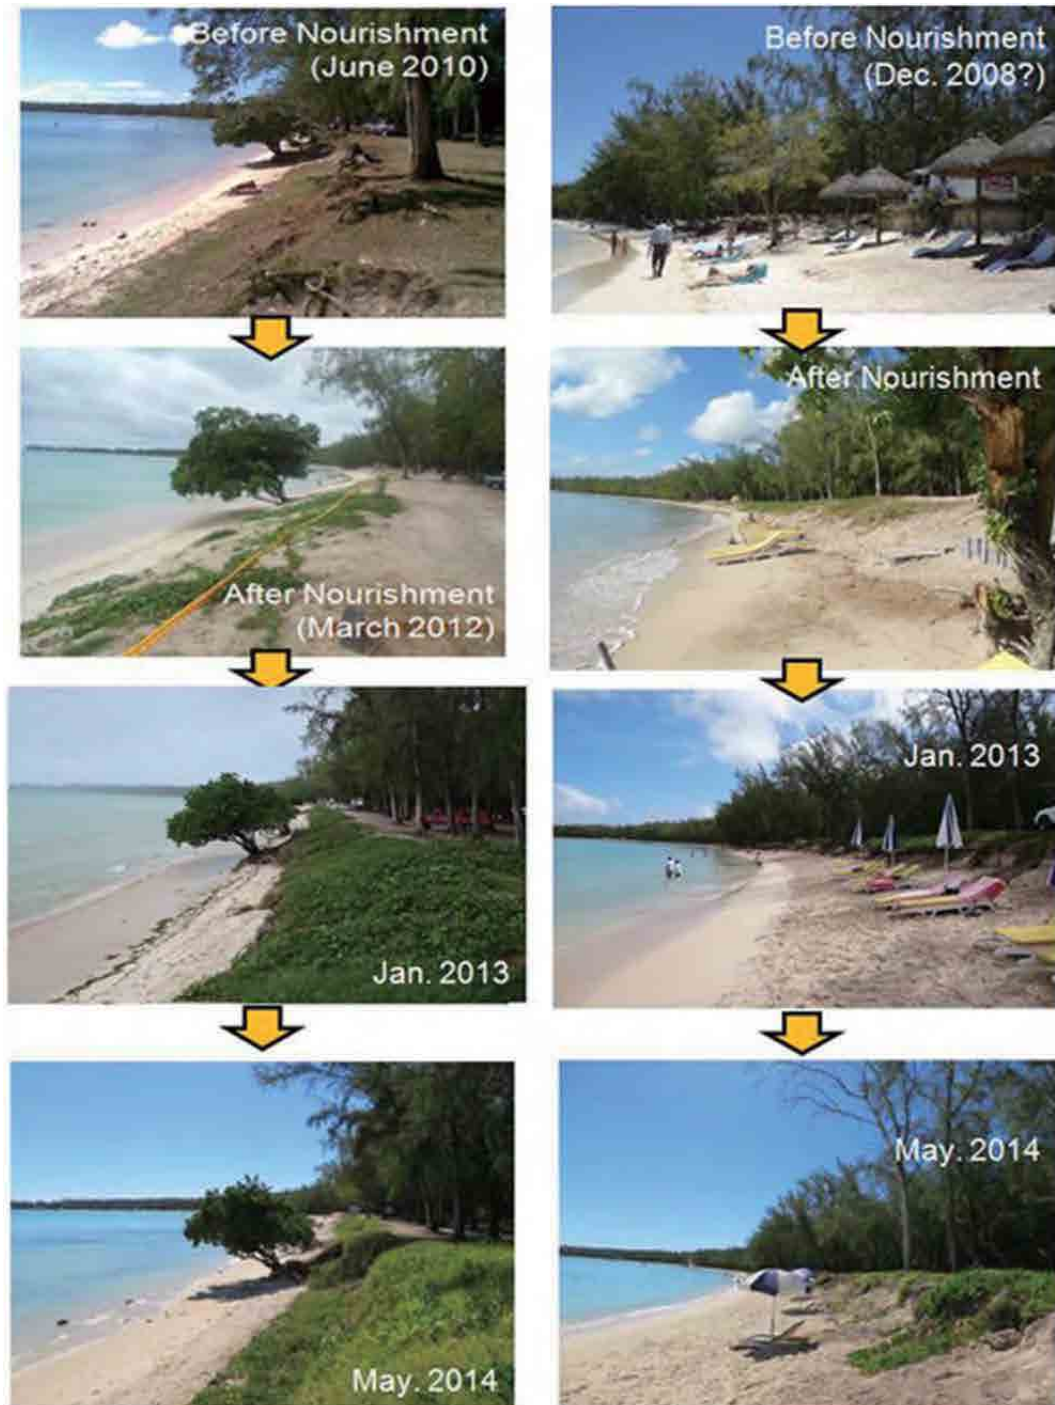
during storm season in 2012, most of the nourishment sand has been scattered and the beach has returned to almost the same condition as previously, as shown in Figure 3.2.3.
