ANNEXES

ANNEX 4

REHABILITATION OF TURBINE AND AUXILIARY EQUIPMENT

- (1) Check List (Baluchaung No.1 Hydropower Plant)
- (2) Check List (Sedawgyi Hydropower Plant)
- (3) Measurement on the Clearance of Mechanical Components (Baluchaung No.1 Hydropower Plant)
- (4) Measurement on the Clearance of Mechanical Components (Sedawgyi Hydropower Plant)

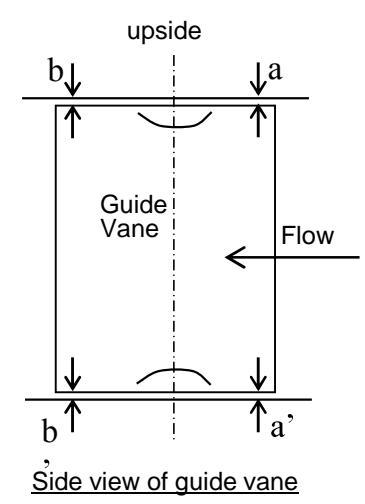
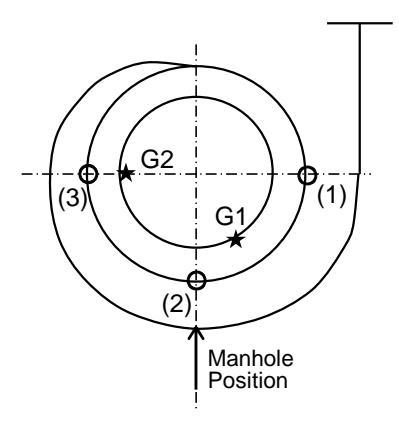
Planar positions of measuring points

(unit: mm)
		Unit #1			Unit #2	
Position		Location			Location	
	(1)	(2)	(3)	(1)	(2)	(3)
а	0.90	0.90	0.90	0.90	0.70	0.90
a'	1.40	1.20	1.40	0.90	0.90	0.90
b	0.15	0.20	0.15	0.10	0.10	0.10
b'	0.70	0.60	0.70	0.70	0.70	0.70

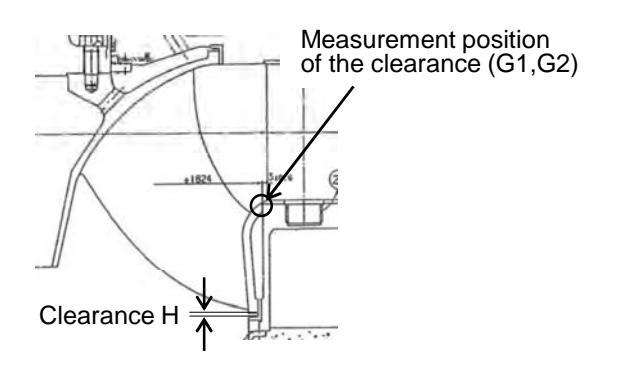
3. Clearance between the runner periphery and the inner surface of discharge ring

(unit: mm)
	Position	Measurement
	G design value	3±0.6
1 10:4 #0	G1	2.5
Unit #2	G2	2.8
	H design value	13
Unit #2	Н	14
Unit #1	Н	15

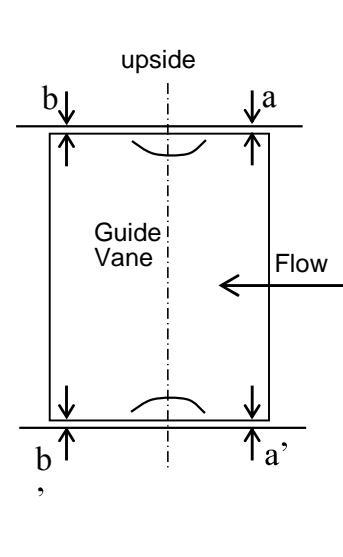
<u>1. Guide vane clearance at the top and bottom portion</u>

No	Wicket Gate No	a	a'	a+a'	b	b,	b+b'
1	l	1.45	1.86	3.31	0.4	2.01	2.41
2	2	1.05	3.28	4.33	0.08	1.5	1.58
3	3	0.75	2.55	3.3	0.75	2.25	3
4	4	1	2.9	3,9	0.18	1.45	1.63
5	5	1.2	2.75	3.95	0.45	2.45	2.9
6	6	1.32	3.25	4.57	0.5	2.4	2.9
7	7	1.28	3,1	4.38	0.6	3.2	3.8
8	8	1.37	3.55	4.92	0.5	3.05	3.55
9	9	1.3	3.05	4.35	0.5	0.8	1.3
10	10	1.1	2.15	3.25	0.55	2.7	3.25
11	11	1.5	1.9	3.4	0.5	0.4	0.9
12	12	1.5	1,4	2.9	0.45	0.2	0.65
13	13	1.65	1.4	3,05	0.38	0.75	1.13
14	14	1.7	1	2.7	0.4	2.85	3.25
15	15	1.96	2.25	4.21	0.3	2.5	2.8
16	16	1.95	2.7	4.65	0.15	2.5	2.65
17	17	1.8	2.71	4.51	0.45	3.1	3.55
18	18	1.5	3.23	4.73	0.38	2.85	3.23
19	19	1,1	3.1	4.2	0.9	2.7	3.6
20	20	1.25	3.35	4.6	0.7	2.4	3.1

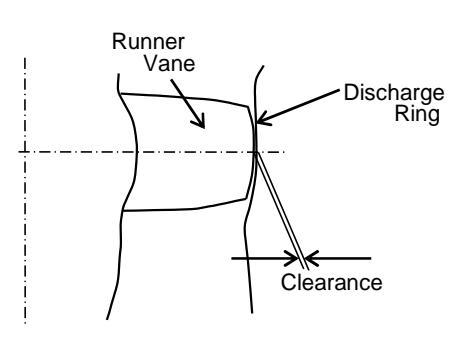
Runner Cone/Hub	Surface	Visual Condition	Crack, Deformation, Erosion and Corrosion, Defects, etc.	Visual Inspection	I	0	0	to damage and defect
			Runner Liner	Surface	Visual Condition	Crack, Deformation, Erosion and Corrosion, Defects, etc.	Visual Inspection	1	n.a	ı	
			Seal Rings	Surface, Seal Gaps	Visual Condition	Gap Condition, Crack, Deformation, Erosion and Corrosion, Defects, etc.	Visual Inspection	I	n.a	1	
		Draft Tube	Upper Draft Tube	Surface	Visual Condition	Crack, Deformation, Erosion and Corrosion, Defects, etc.	Visual Inspection	I	0	0	to damage and defect
			Air Admi. Pipes	Surface	Visual Condition	Crack, Deformation, Erosion and Corrosion, Defects, etc.	Visual Inspection	n.a	n.a	1	
			Discharge Ring	Surface	Visual Condition	Peripheral Gap, Crack, Deformation, Erosion and Corrosion, Defects, etc.	Visual Inspection	I	*	0	some abration signatures on the surface facing the runner vane outer periphery were found. The measuring results of <u>gaps between runner vane peripheries and the</u> corresponding surface of discharge ring were scattered between 0.55–5.34mm <u>.</u>

No	Runner	Clearance
1	B1-3	3.4 mm
2	B2-3	2.15 mm
3	B3-3	0.55 mm
4	B4-3	2.15 mm
5	B5-3	5.34 mm
6	B6-3	3.4 mm
