CHAPTER 5 REPAIR OF CONCRETE STRUCTURE

5.1 Planning of Concrete structure repair

5.2 Case of Concrete structure repair

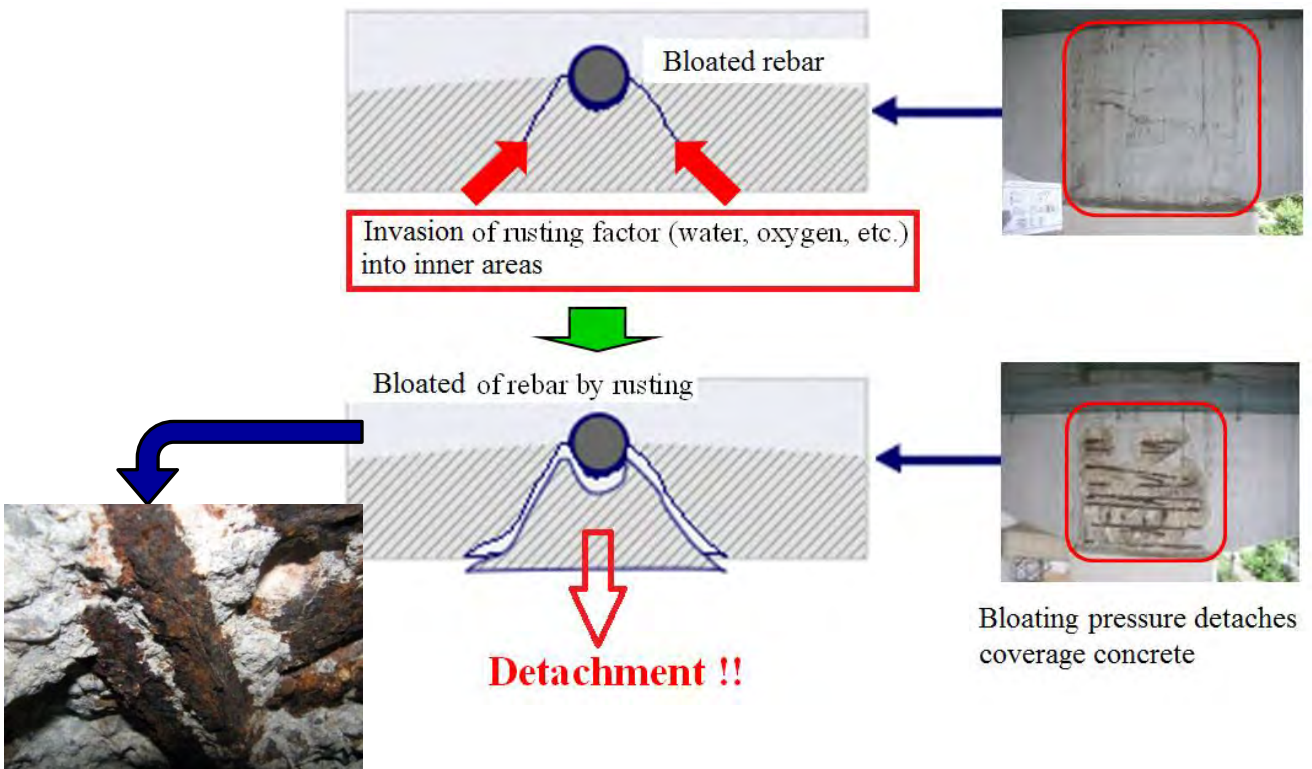
Photo 5.2.1.1 Concrete crack on pier

There are alligator cracks or multiple numbers of linear cracks on the sides of concrete piers, and their width is more than 0.3mm (Photo 5.2.1.1). If this situation remains untreated, corrosion of reinforcements is in danger of progressing. As a result, spalling and decrease of concrete strength might occur in the future (Fig. 5.2.1.1).

Though there are some possible causes of the damage such as dry shrinkage during construction, it is difficult to identify to the one.

However, since many similar cracks exist in multiple directions and locations, the excessive external load from overloading vehicles can be excluded.

Concrete cracks are filled with epoxy resin injection (**Photo 5.2.1.2**).

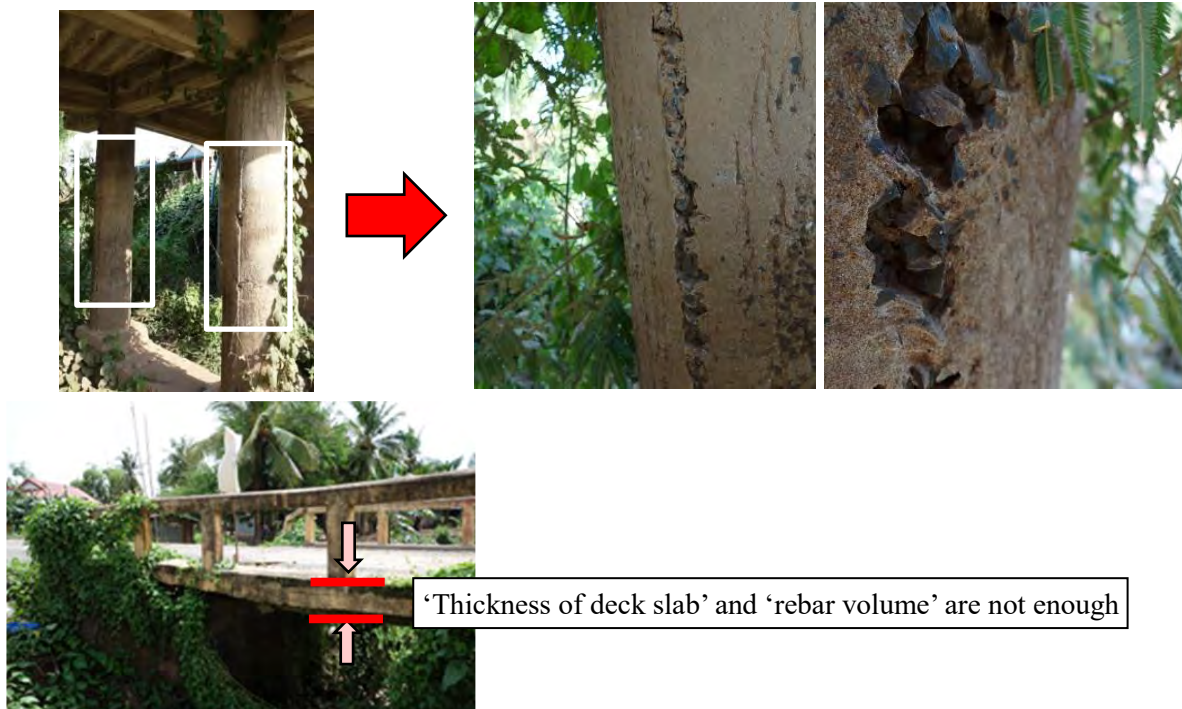
Photo 5.2.2.1 Insufficient strength capacity

Case1: Insufficient strength capacity due to non-conforming work or design deficiency (**Photo 5.2.2.1**)

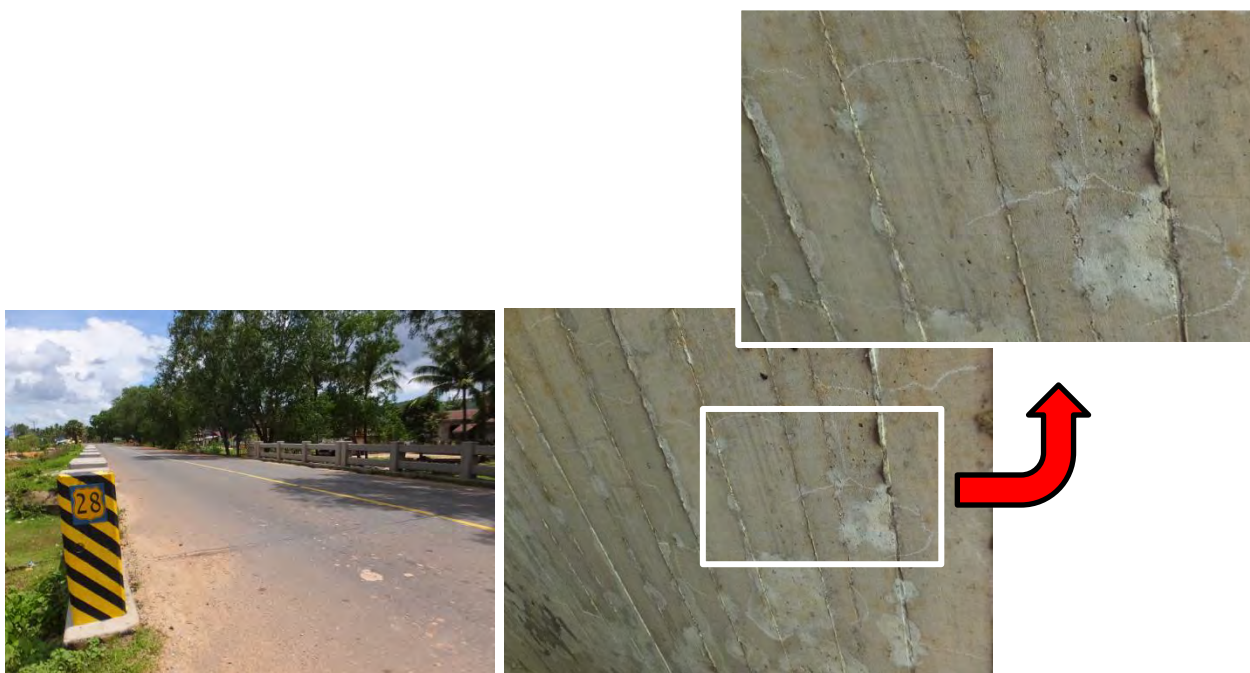
Photo 5.2.2.4 Concrete crack on slab

There are numbers of cracks on the slab, and their width is more than 0.6mm. If this situation remains untreated, this crack will progress. As a result, spalling and decrease of concrete strength might occur and this bridge will collapse in the future (**Photo 5.2.2.5**).

It is a possibility of fatigue crack by overloading from the following reasons.

- These cracks occur in transverse direction.
- When overloaded vehicles pass, the vibration of the slab is large.
- There are many cracks near axle of vehicle.

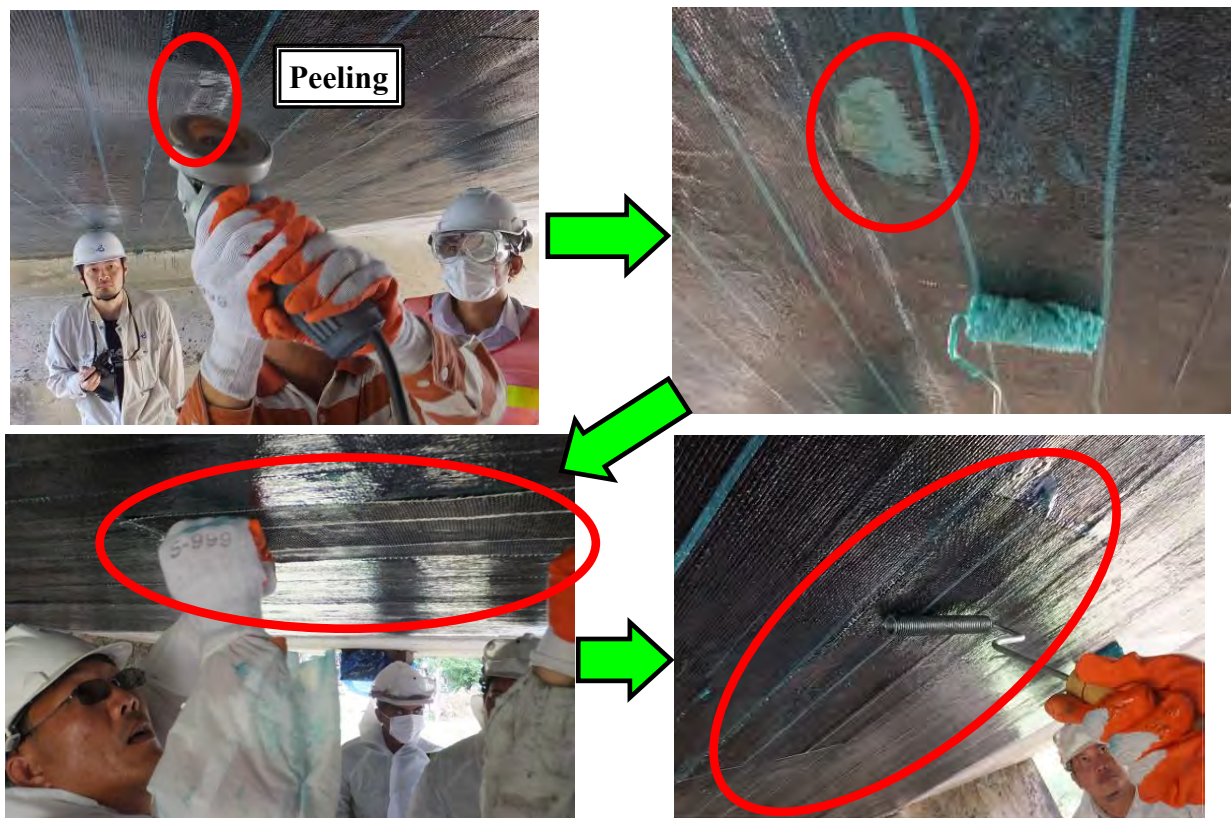
Photo 5.2.2.35 Repairing after completely cured impregnating resin

If the peeling is found from 4-1) work, it is necessary to repair this part (**Photo 5.2.2.35**).

- 1) The failure part is removed carefully by using disk grinder.
- 2) It is backfilled by impregnation resin.
- 3) CFC patch is overlapped with impregnation resin.

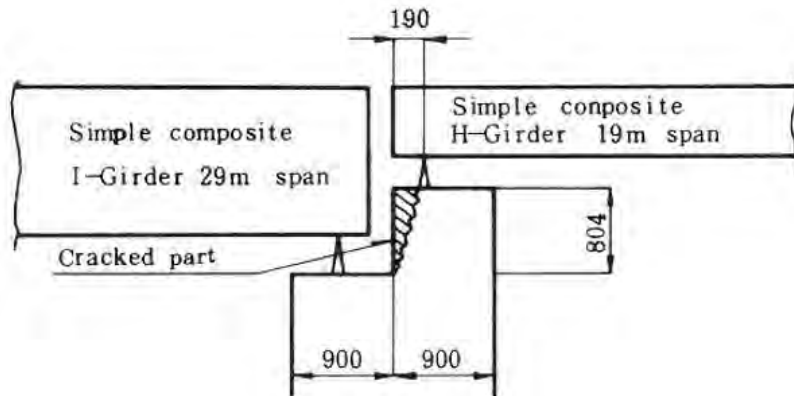
Fig. 5.2.4.1 Damaged position of concrete pier

The pier was designed to support the simple composite steel I-girder bridge (29m in span) on one side and another simple composite steel H-girder (19m in span) on the other, making 804mm level difference on the pier to top (Fig. 5.2.4.1).

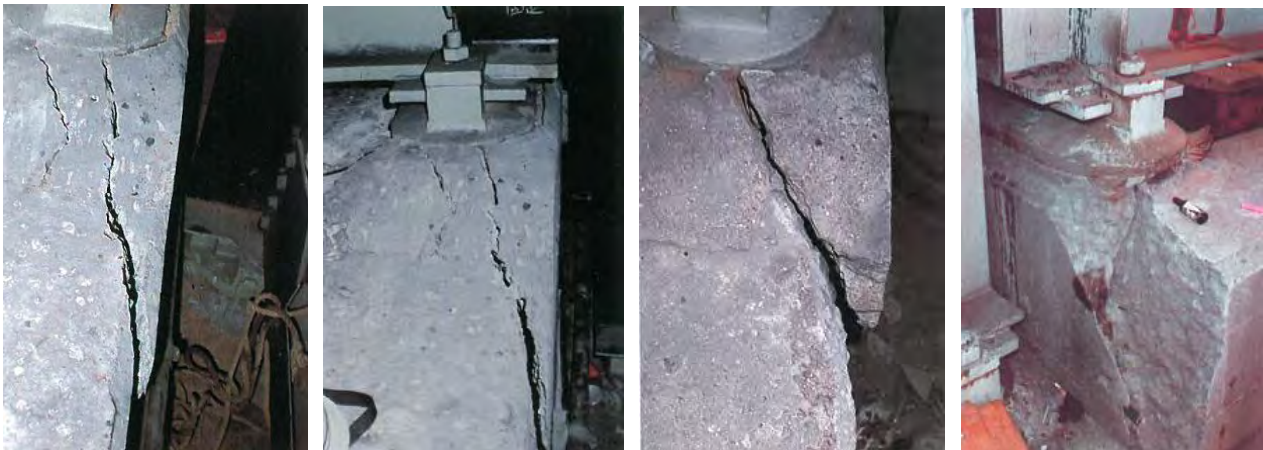
Photo 5.2.4.1 Damages on concrete base

Cracking initiated near the bearing and the partial concrete spalling took place in the pier top (Photo 5.2.4.1).

- (1) The girder seat length was only 190mm from the bearing center. This length was insufficient for supporting the horizontal forces in the longitudinal direction. It was assumed, therefore, the shear force fractured the concrete base.
- (2) With too much reinforcement clustered in the concrete base, concrete strength was not sufficient:
 - (a) Insufficient compaction during the concrete placement.
 - (b) Irregular arrangement of the reinforcement because of the presence of anchor bolts.

(3) The current design standard requires the seat length not to be less than 200mm for the staggered beam (Fig.5.2.4.2). In this condition, the staggered beam exhibits strong enough against the shearing force.

Fig.5.2.4.3 shows the repairing method of the damaged part of concrete base, with attaching steel plate. The steel plate serves dual purpose, reinforcement and form for concrete. The procedures taken in this repair is as follows.

- (1) Install L-shape steel member to the girder web at the jacking position, reinforcing the temporary support for the bearing (Fig. 5.2.4.4).
- (2) Install jacks (two sets of 100 ton hydraulic jacks) as temporary support.

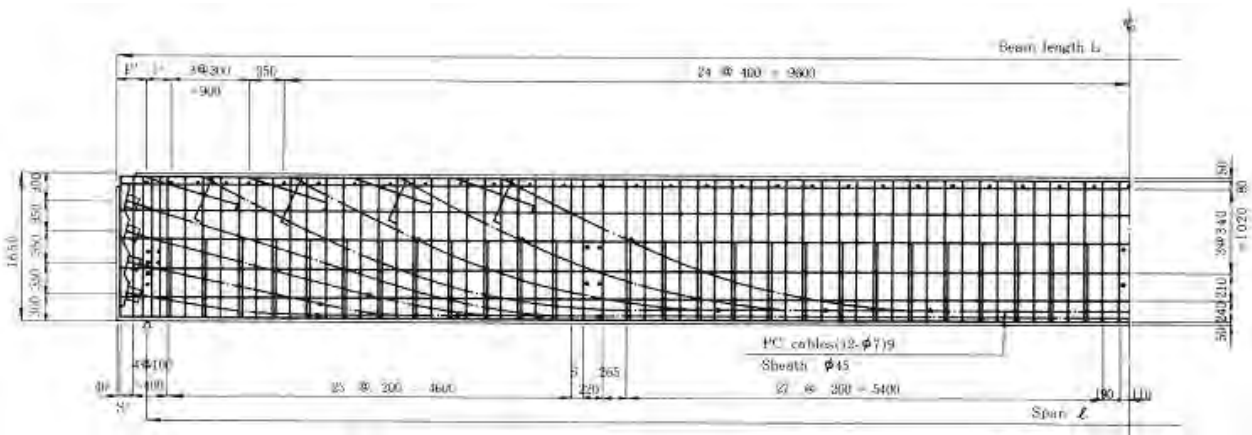
Fig. 5.2.6.1 Side view of main girder

- (1) In search of cause, from the road surface fluorescent paint material was poured over the damaged area. The paint flowed out from the damaged position of the lower flange of the girder, evidencing that the rainwater of road surface was penetrating into the girder.
- (2) The leakage was located about 8.5m to the mid-span from the girder end (**Fig. 5.2.6.1**). It was judged it originated from C3 and C4 sheaths (**Fig. 5.2.6.2**).

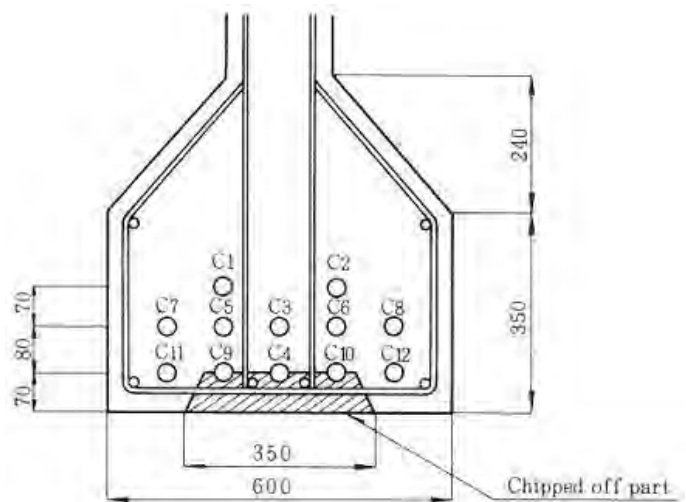
Fig. 5.2.6.2 Chipped part and arrangement of sheaths

- (3) To confirm the grouting workmanship, soffit concrete portion was removed (**Fig. 5.2.6.2**). The sheath was easily broken when it was hammered.
- (4) The site investigation revealed corrosion of PC steel wire and seepage of a small amount of water from the C4 sheath. It was assumed the rainwater came in from the girder end, penetrated the C4 sheath, and came out from the damage position.

(5) The cause for the damage was insufficient grouting work of sheath at the construction stage and subsequent rainwater.

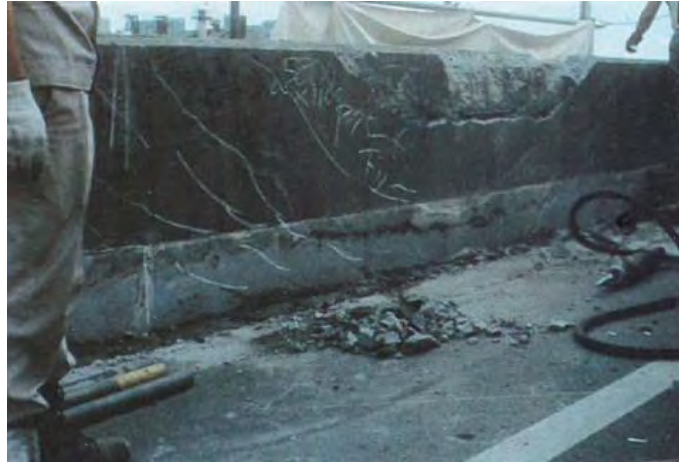
Photo 5.2.10.3 Damage condition (Case 2)

Running at speed of 70km/h, a 14 tons trailer truck lost control due to improper wheel operation and hit the median guardrail, then colliding against the concrete railing. The railing was damaged (**Photo 5.2.10.3**) and concrete pieces dropped down.

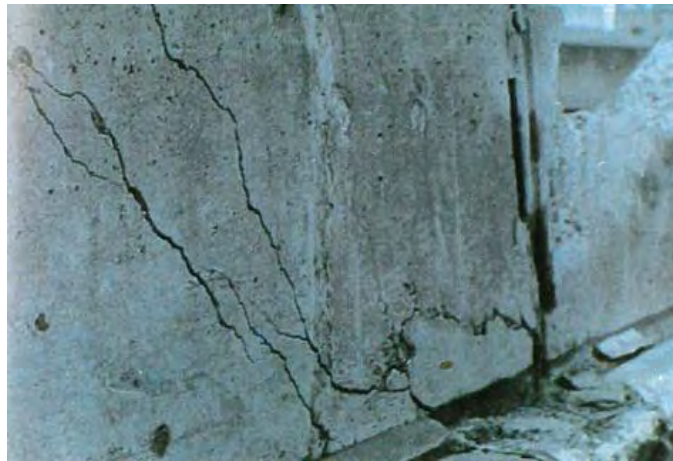
Photo 5.2.10.5 Damage railing (Case 3)

In design and construction of construction of concrete railing of the curves with radius 200m and less, design load is 2t /m, 2 times railing collision load as that on the standard (straight) section. But this section of damage had no reinforcement and concrete block fell down.

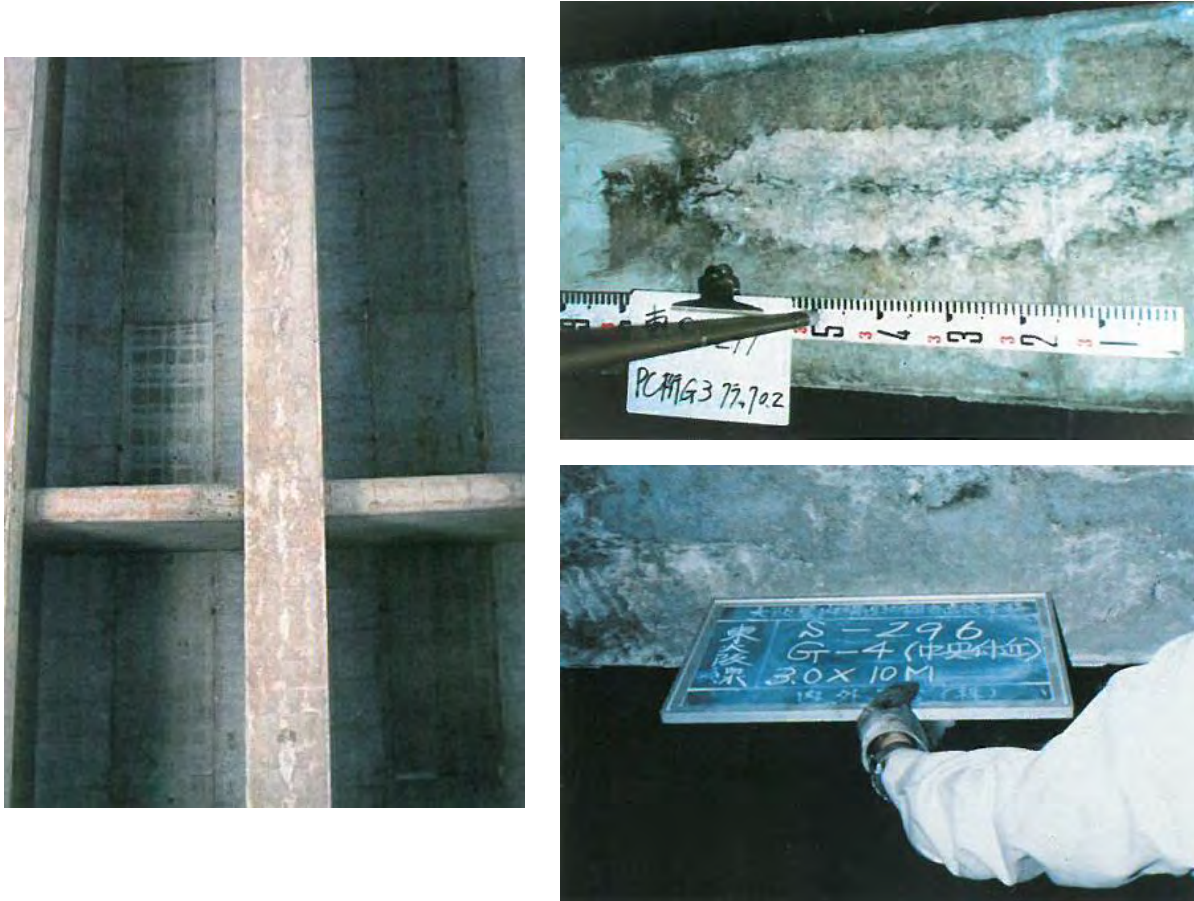
Photo 5.2.11.1 Crack on low flange

A longitudinal crack was found along the sheaths on the lower flange of PC girder (Photo 5.2.11.1).

Two cracks spread in the longitudinal direction, dividing 60cm-wide lower flange into trisections and trace of efflorescence at places. The ultrasonic detector measured the estimated crack depth as 6cm to 10cm.

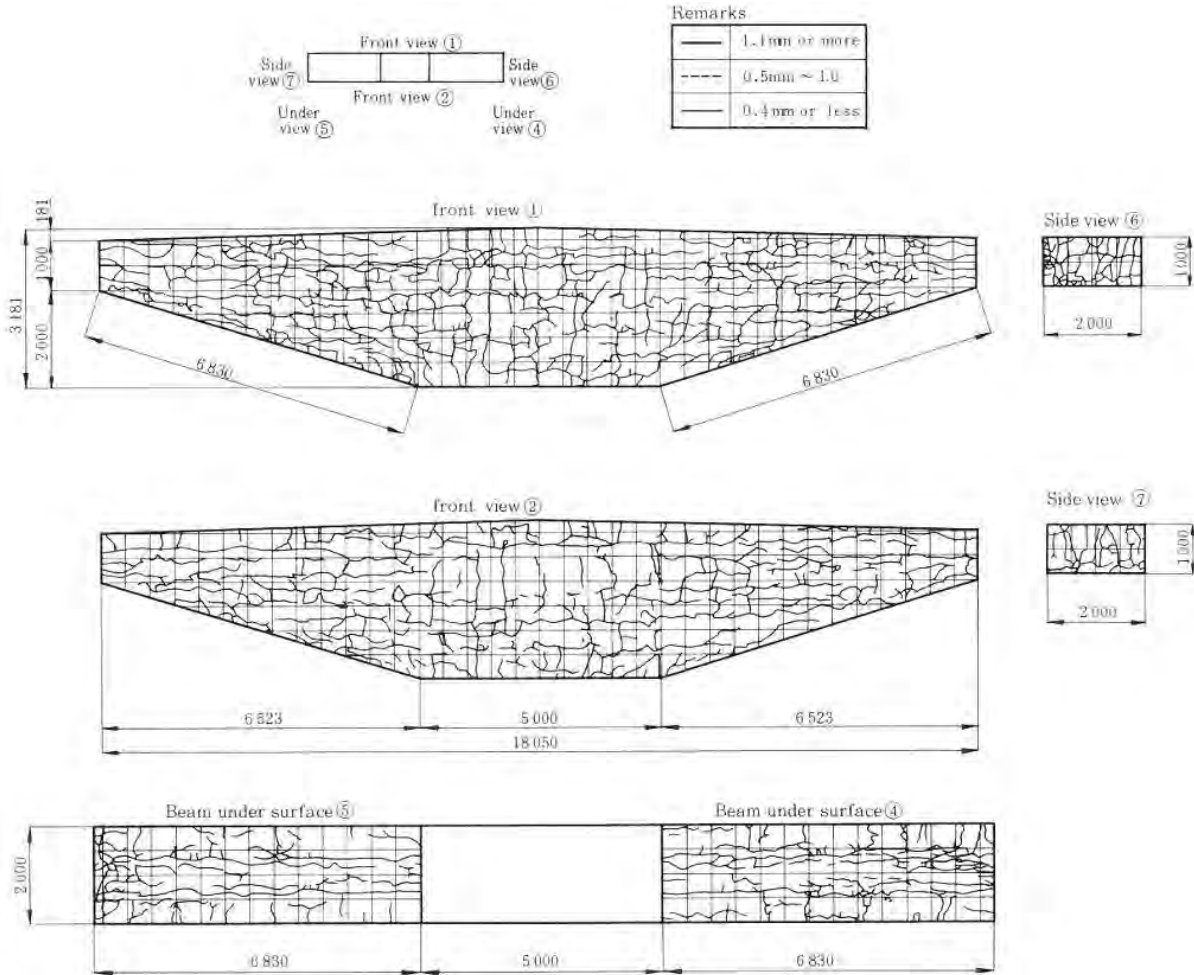
Fig. 5.2.12.1 Crack on the concrete pier beam

Fig.5.2.12.1 shows typical crack pattern in the column head caused by Alkali-Aggregate Reaction, illustrating wide cracks extending in horizontal direction.

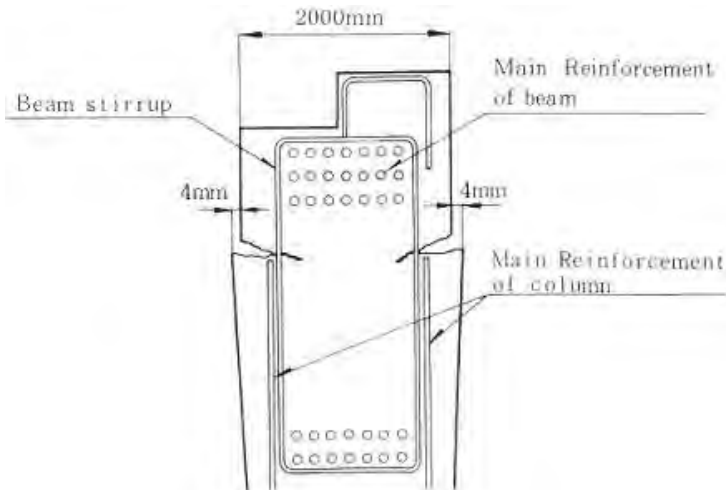
Fig. 5.2.12.2 Detail Crack on the concrete pier beam

As **Fig. 5.2.12.2** shows, each side of cracks of the beam surface had about 4mm dislocation. Except for this cracks, other cracks were not deep and stayed within the cover concrete according to the random core sampling. This type of cracking was found out also in the abutment and its core samples are shown in **Photo 5.2.12.1**.

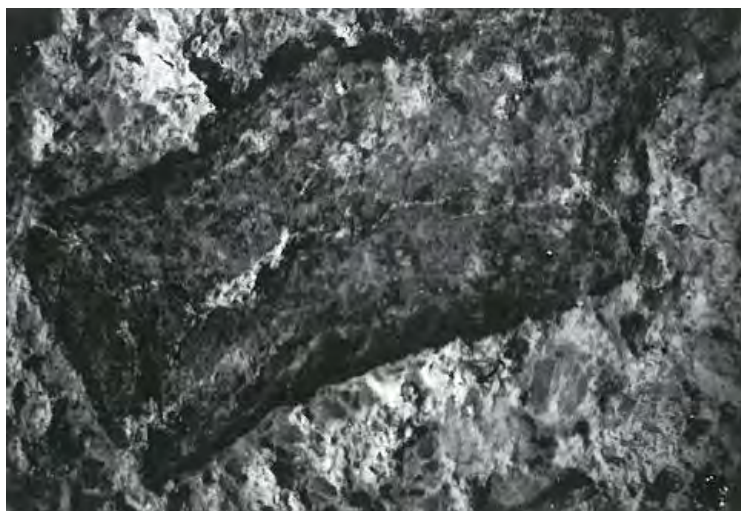
Photo 5.2.12.3 Reaction ring and crack inside of aggregate

The investigation confirmed aggregate reaction rings (**Photo 5.2.12.3**), and also revealed exudation of gel around each ring (**Photo 5.2.12.4**).

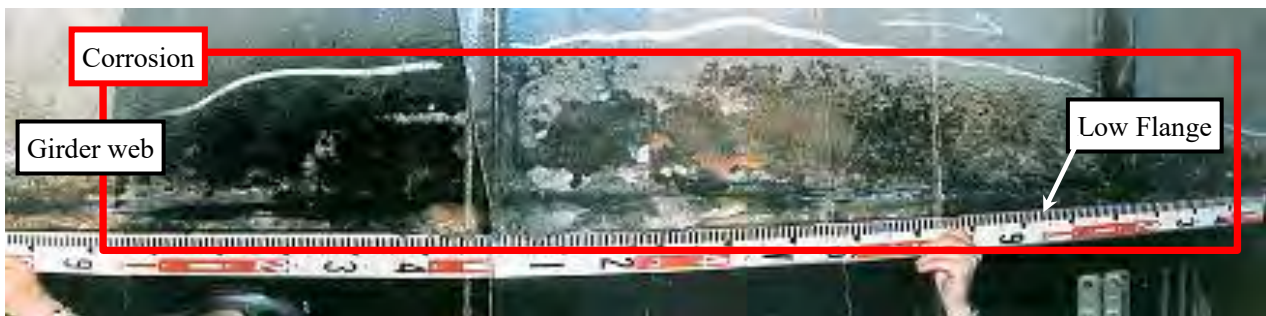
Photo 6.2.1.1 Steel girder corrosion condition

Corrosion was found at web, lower edge of the vertical stiffener and lower flange of the steel girder as shown in **Photo 6.2.1.1**.

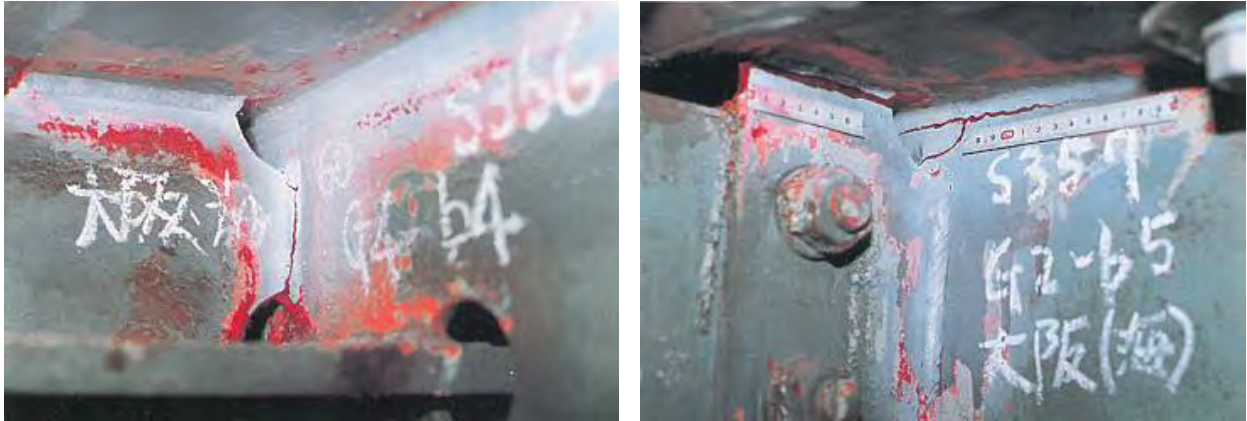
Photo 6.2.2.1 Cracks the jammed part connection cross beam and vertical stiffener of I-girder

A crack was found at jammed part where so many members, such as cross beam sway bracing and main girder on the nearby upper flange and web, are connected by welding to the simple composite steel I-girder, as shown in Photos 6.2.2.1 and Fig.6.2.2.1.

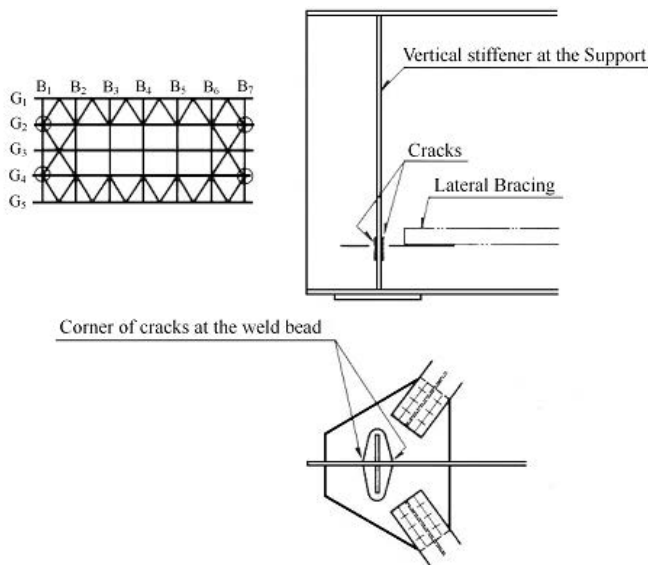
Photo 6.2.3.1 Condition of crack

The cracks shown in Fig.6.2.3.1 and Photo 6.2.3.1 were found on both welded parts of the main girder web and vertical stiffener connected with gusset for a lateral bracing at the end of the main girder, around the support, in the simple steel girder bridge.

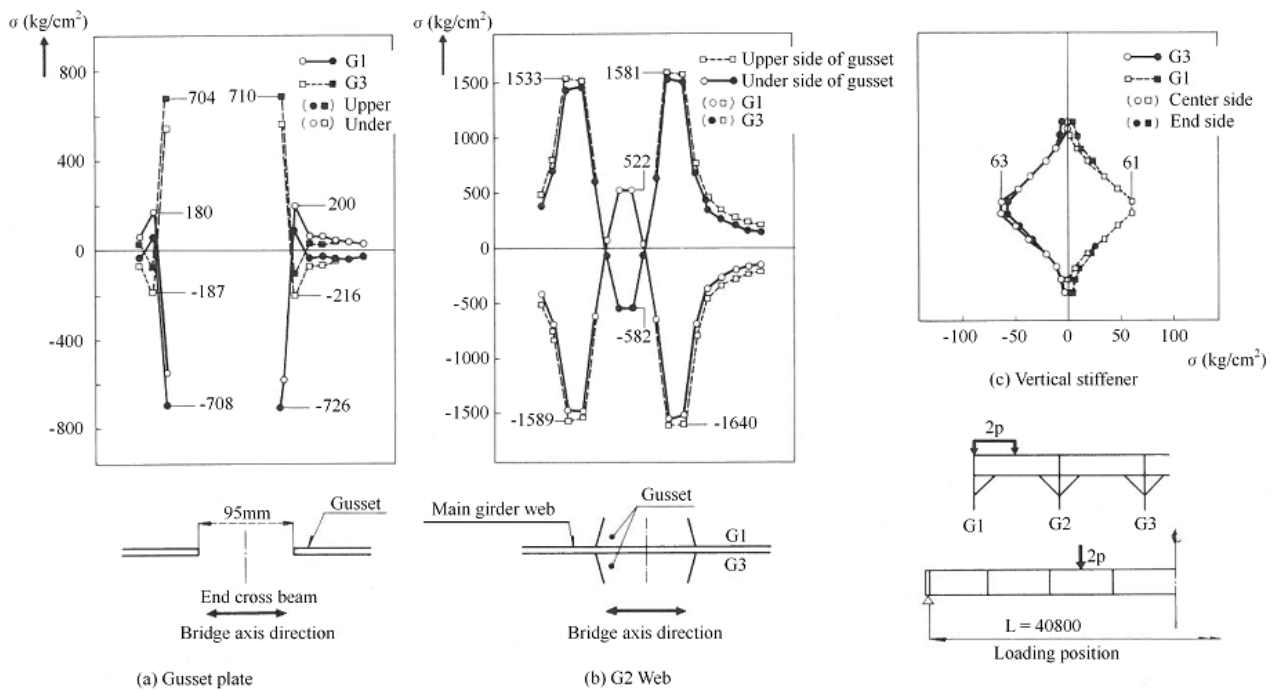
Fig. 6.2.3.2 Stress nearly gusset

- 2) A large axial force is introduced on the web of the inner main girder from both sides of the lateral bracing by a live load.
- 3) Stress generated by the axial force is in disorder at the position of the scallop on the gusset plate and makes a local deformation on the web of the main girder (**Fig.6.2.3.2**).
- 4) Repetition of the deformation develops cracks at the toe of welding near the scallop of the gusset.
- 5) As the deformation becomes larger, the cracks grow on the welded part of the vertical stiffener on the support, too.
