Bridge Condition Survey Rout 13N in Vientiane Province

The Project of Improvement of Road Management Capability in Lao PDR Report

## Appendix 2-17 Concept Design Report for Rehabilitation Project of National Road No. 9

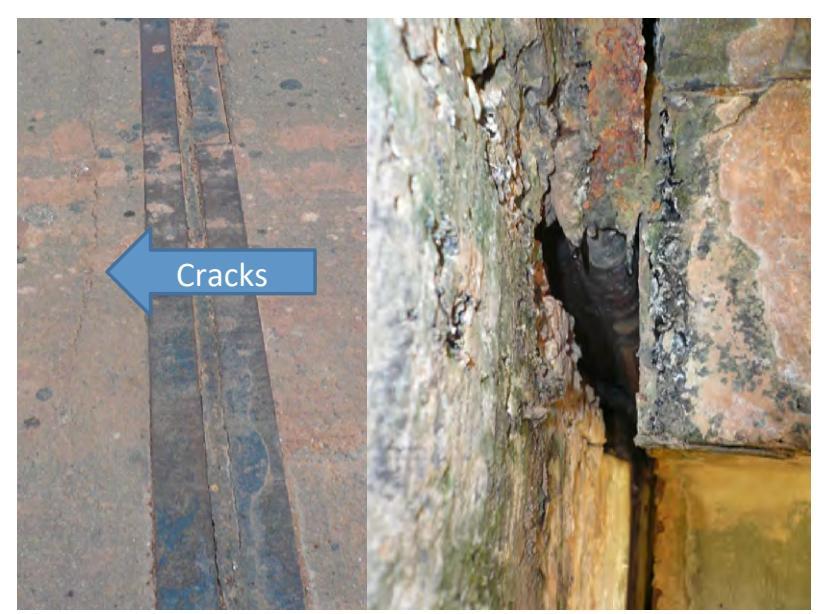
Problems-and-Causes-

Cracks:-No-gapallowed-for-thetemperaturemovement.-

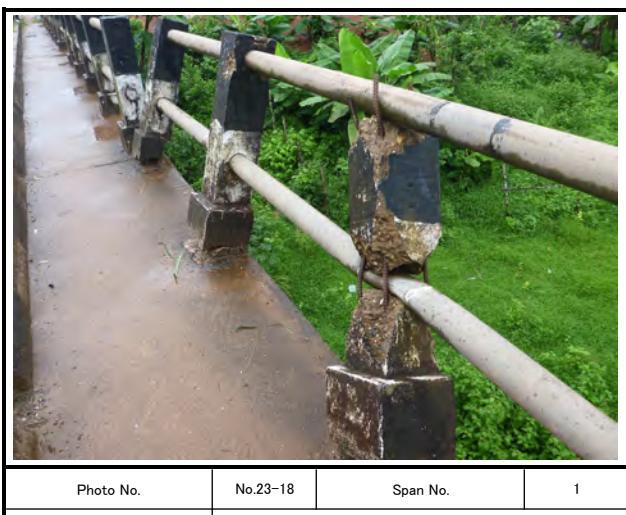
Parapets on Bridge

Damage, Progess of Corrosion

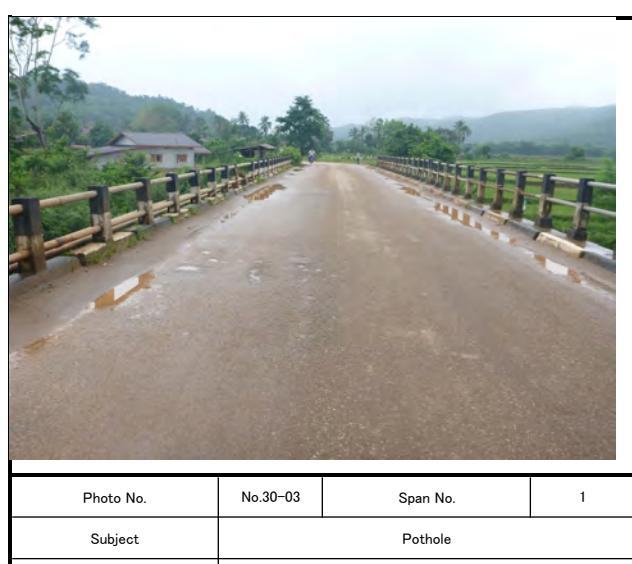
Minor Damage

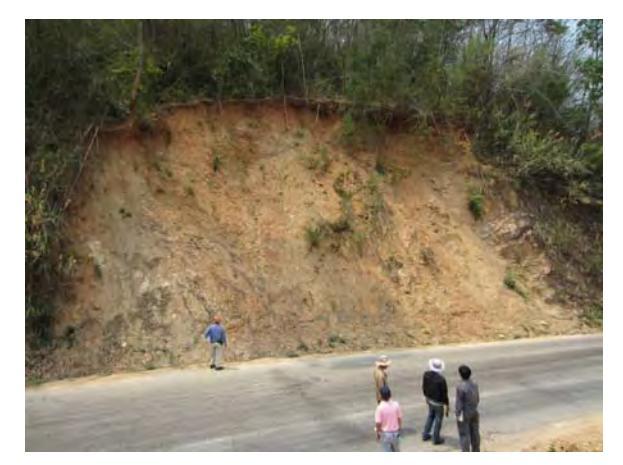
Shallow failure

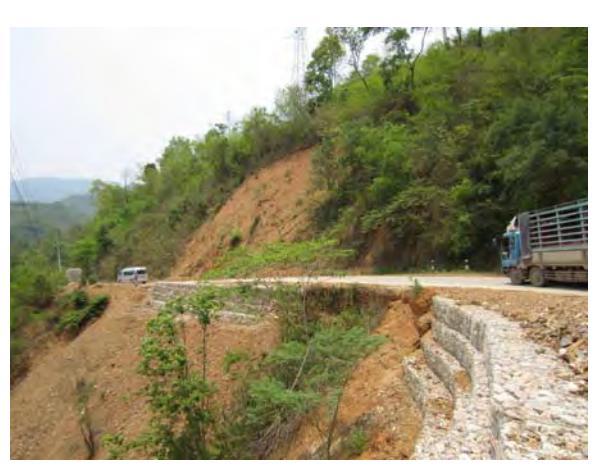
Gabions have been installed after fill slope failure.

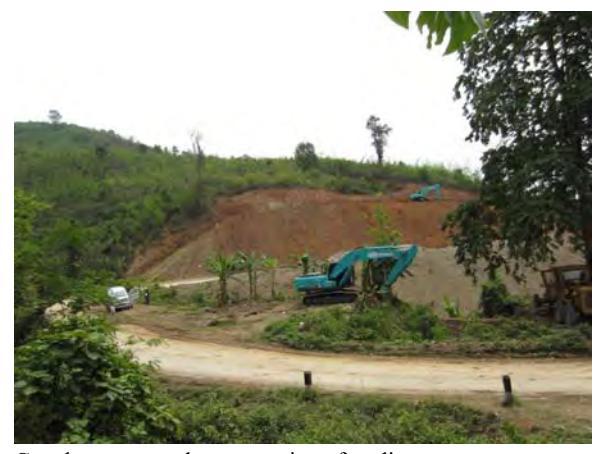
Cut slope was under excavating after disaster.

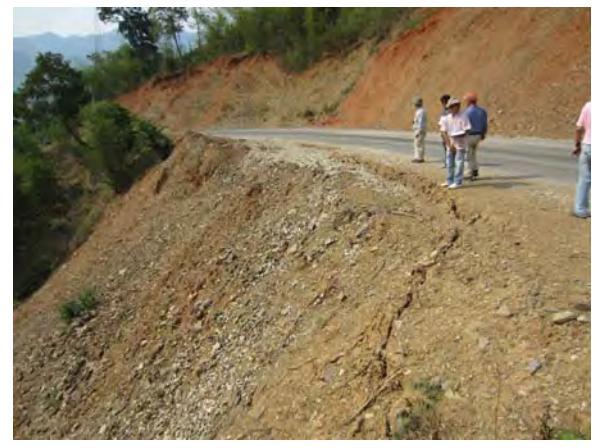
Crack was occurred on fill slope. This area would be There were many slope failures on NR13N. collapsed after heavy rain.

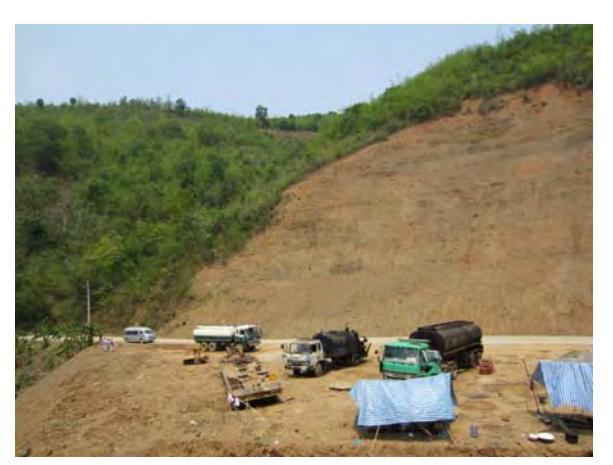
The slope gradient (1:0.5) would be too steep for such large cut slope.

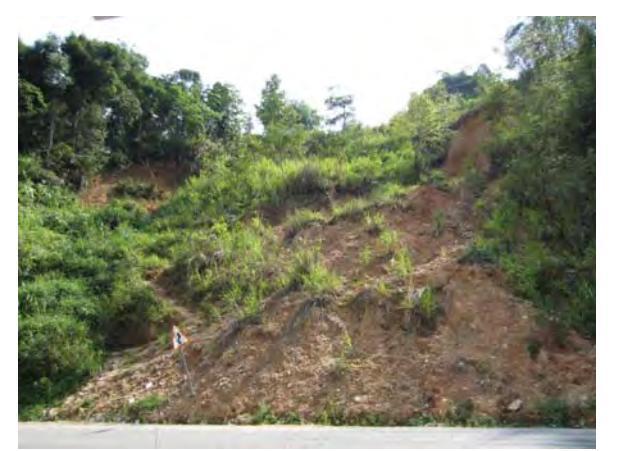
All of the debris of shallow failure was not removed so that secondary failure would be caused after heavy rain.

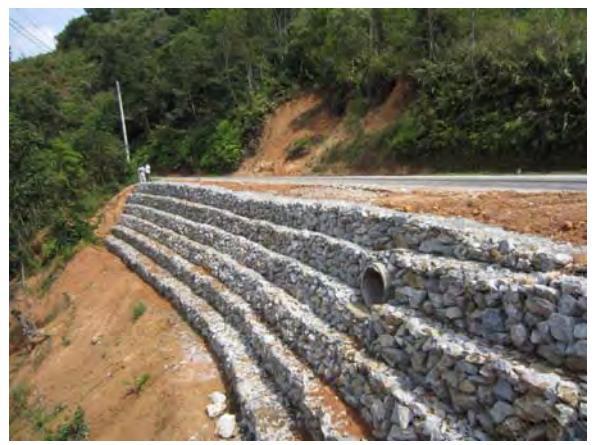
Gabion boxes were often used for protection of fill slope on NR13N. The basements of the gabions were not properly supported by rock or compacted soil so that many erosions under gabion were observed.

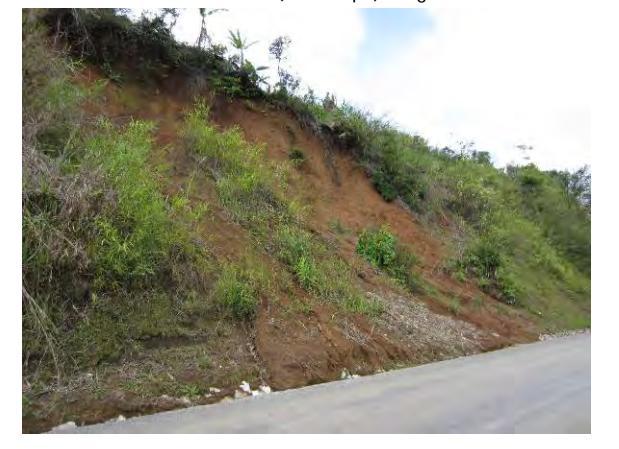
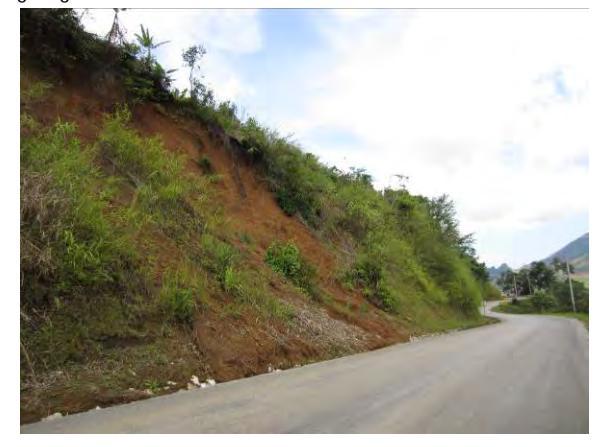
Slope failure type: Possible countermeasures: (Backslope) Shallow failure (Volcanic Rock, some gullies) (Backslope) Mitigate erosion with rounding, vegetation and check dam

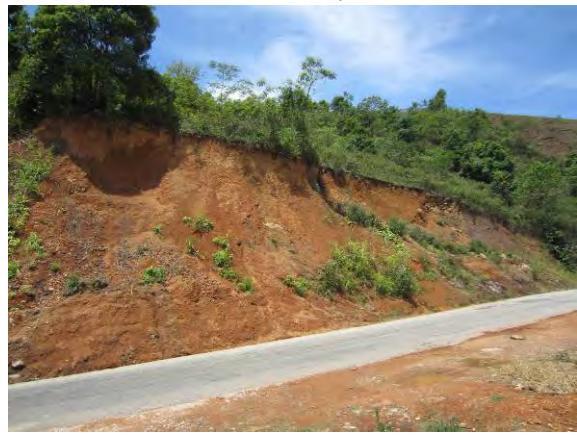
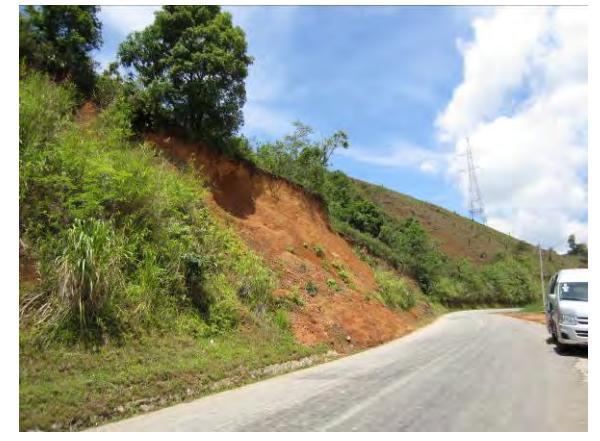
#### SITE-5: KM275-276 (WP-598)

Slope failure type: Possible countermeasures: (Backslope) Shallow failure (Volcanic Rock, some cracks) (Backslope) Removal of cracked surface soil

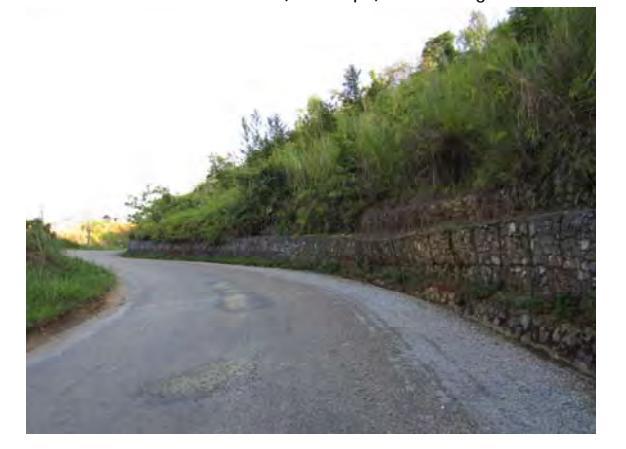
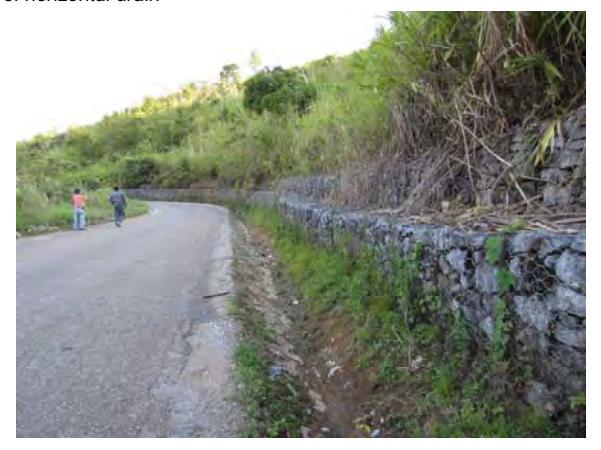
#### SITE-6: KM240 (WP-696)

Slope failure type: Possible countermeasures: (Foreslope) Swelling of backslope (Foreslope) Dewatering with installation of horizontal drain

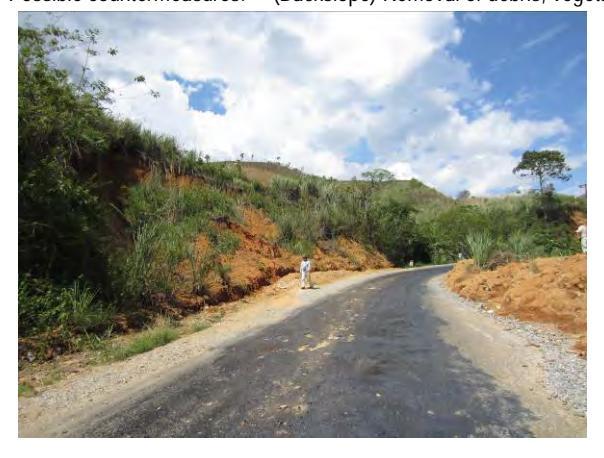
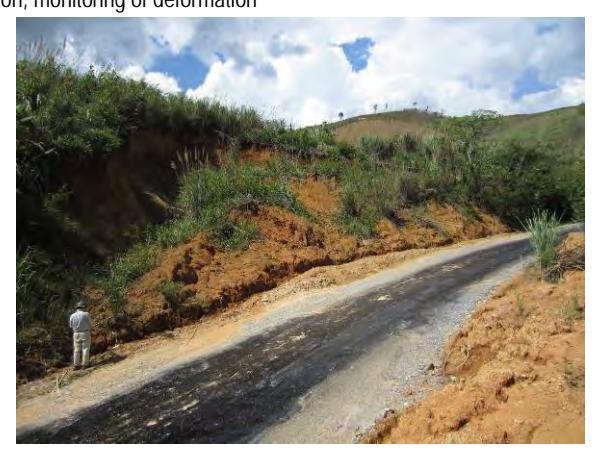
#### SITE-7: KM235 (WP-801)

Slope failure type: Possible countermeasures: (Backslope) Circular failure (unstable) (Backslope) Removal of debris, vegetation, monitoring of deformation
