# FOLLOW-UP COOPERATION ON THE PROJECT FOR FLOOD FORECASTING AND WARNING SYSTEM IN HIGH ATLAS AREA

# FOLLOW-UP COOPERATION REPORT

JULY 2015

JAPAN INTERNATIONAL COOPERATION AGENCY (JICA) CTI ENGINEERING INTERNATIONAL CO., LTD.

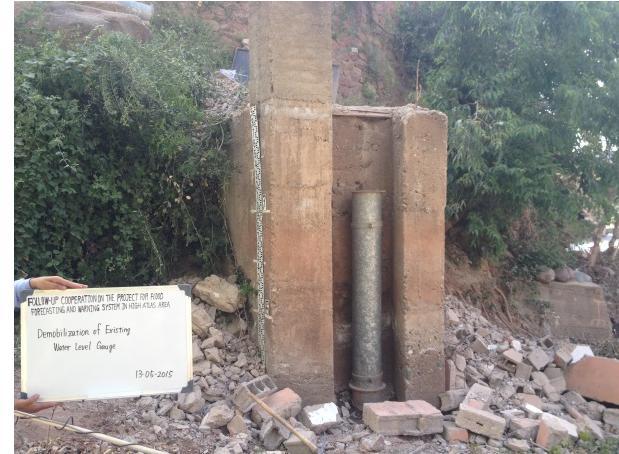
13<sup>th</sup>-May Demobilization of Existing Facilities

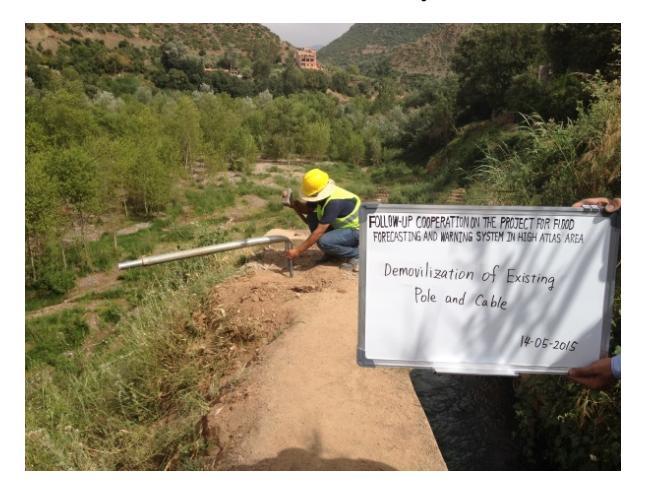
14th May Removal of the destroyed steel poles for overhead wiring

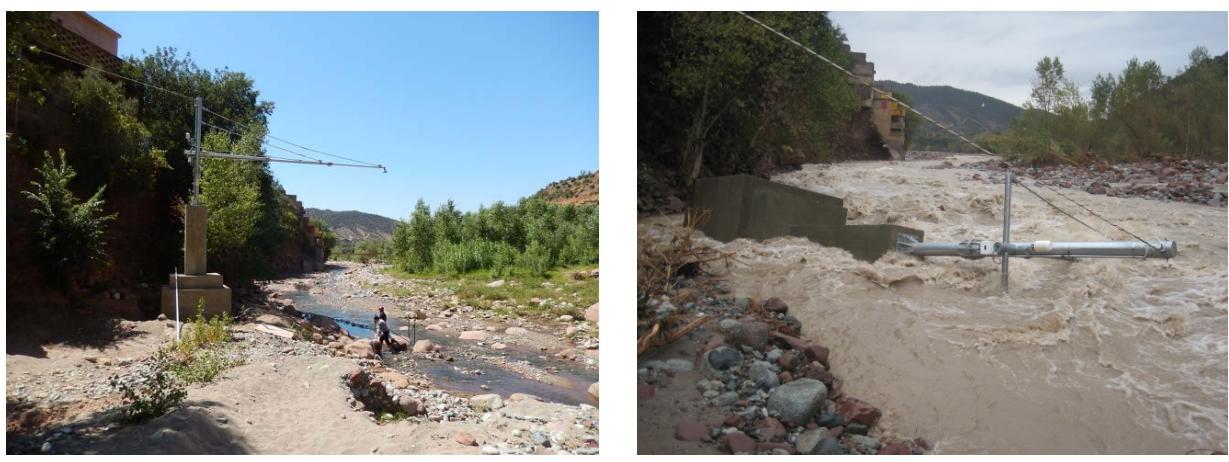
Photo 1.1.1 Water Level Gauge (July 2013)

Photo 1.1.2 Collapsed Water Level Gauge (Nov. 2014)

In November 2014 a large-scale flood hit the southern regions of Morocco and killed over 30 people. In the Ourika River Basin the road and houses along the river were heavily damaged, and the water level gauge at the Aghbalou Station that was constructed under the Japanese grant-aid project was totally collapsed by the flood.

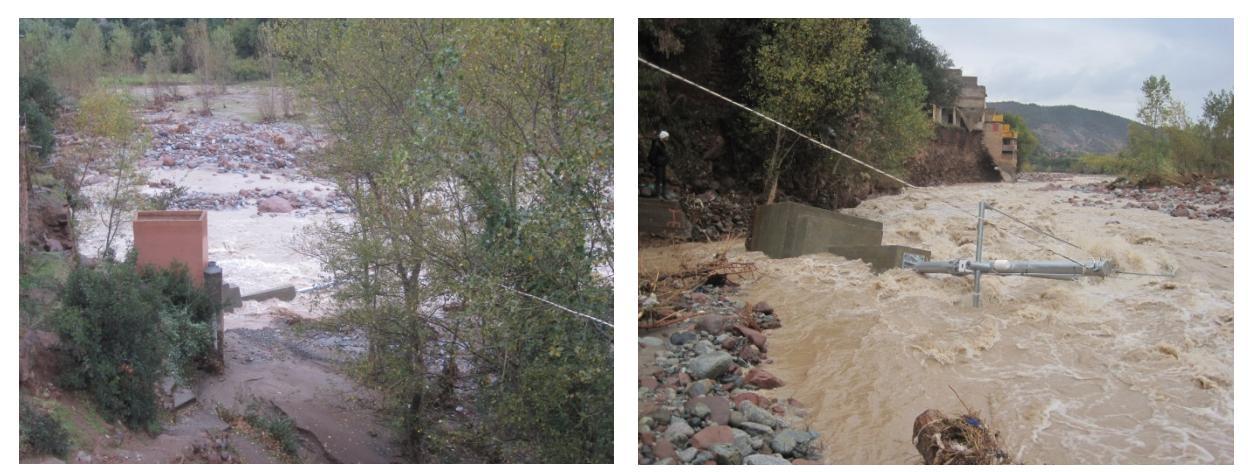
Photo 2.1.1 Photographs taken on November 24, 2014

near the left bank while the flood was high as shown in Photo 2.1.1, but moved toward the middle of the wide river channel due to sedimentation as the flood receded.

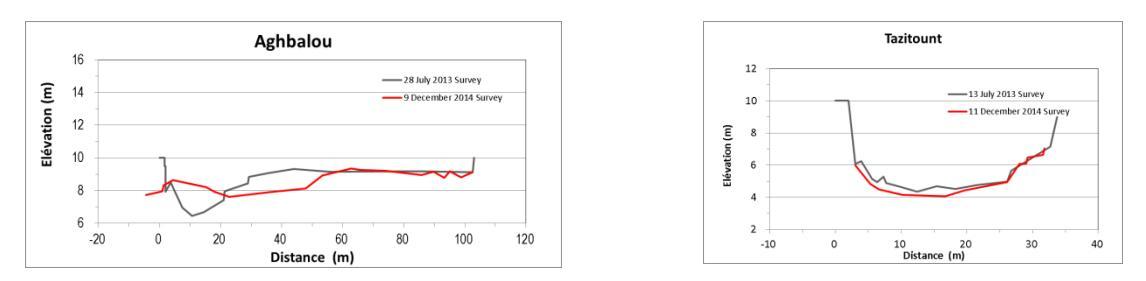
Figure 2.1.3 compares cross sections before and after the flood at the Aghbalou and Tazzitount Stations. At Tazzitount, which is some 10 km upstream of Aghbalou, the river channel is narrow and straight, and the river bed was only lowered slightly but did not changed horizontally at all. As for Aghbalou, the change of the river bed was more dynamic, and the mainstream was flowing

Figure 2.1.3 Comparison of Cross Sections before and after the Flood

• ABHT should conduct riverbed excavation for guiding water from the main stream of the Ourika River to the restored water level gauge as soon as possible. Consequently ABHT should conduct river cross-section survey for the excavated river bed to modify the pre-alert and alert levels, the water level-discharge conversion table and the cross section coordinates.

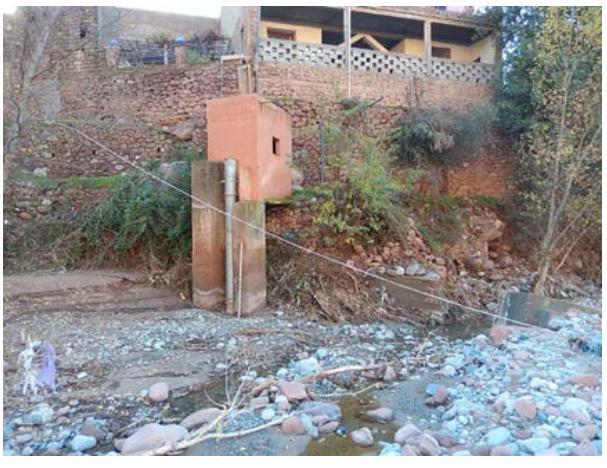
The abandoned structure would be dismantled and removed, and the new foundation/substructure would be constructed at the same site. The Consultant proposed this plan to ABHT, and then it was approved as final plan. Cable wiring is also possible by following the same route as the destroyed one.

Photo 2.3.2 Abandoned Water Level Gauge
