**THE PROJECT  
FOR  
PILOT GRAVEL BEACH NOURISHMENT  
AGAINST  
COASTAL DISASTER  
ON  
FONGFALE ISLAND  
IN  
TUVALU**

**FINAL REPORT  
(MAIN REPORT)**

**April 2018**

**JAPAN INTERNATIONAL COOPERATION AGENCY**

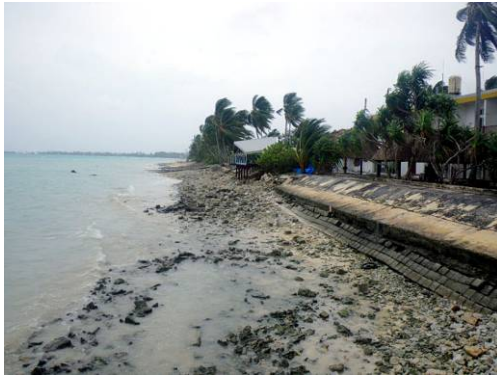
Figure 1.3.1 Damaged Revetment in front of Vaiaku Lagi Hotel

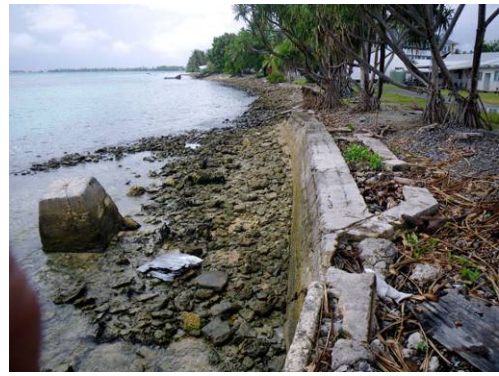
Figure 1.3.2 Damaged Revetment at the North Side of Vaiaku Pier

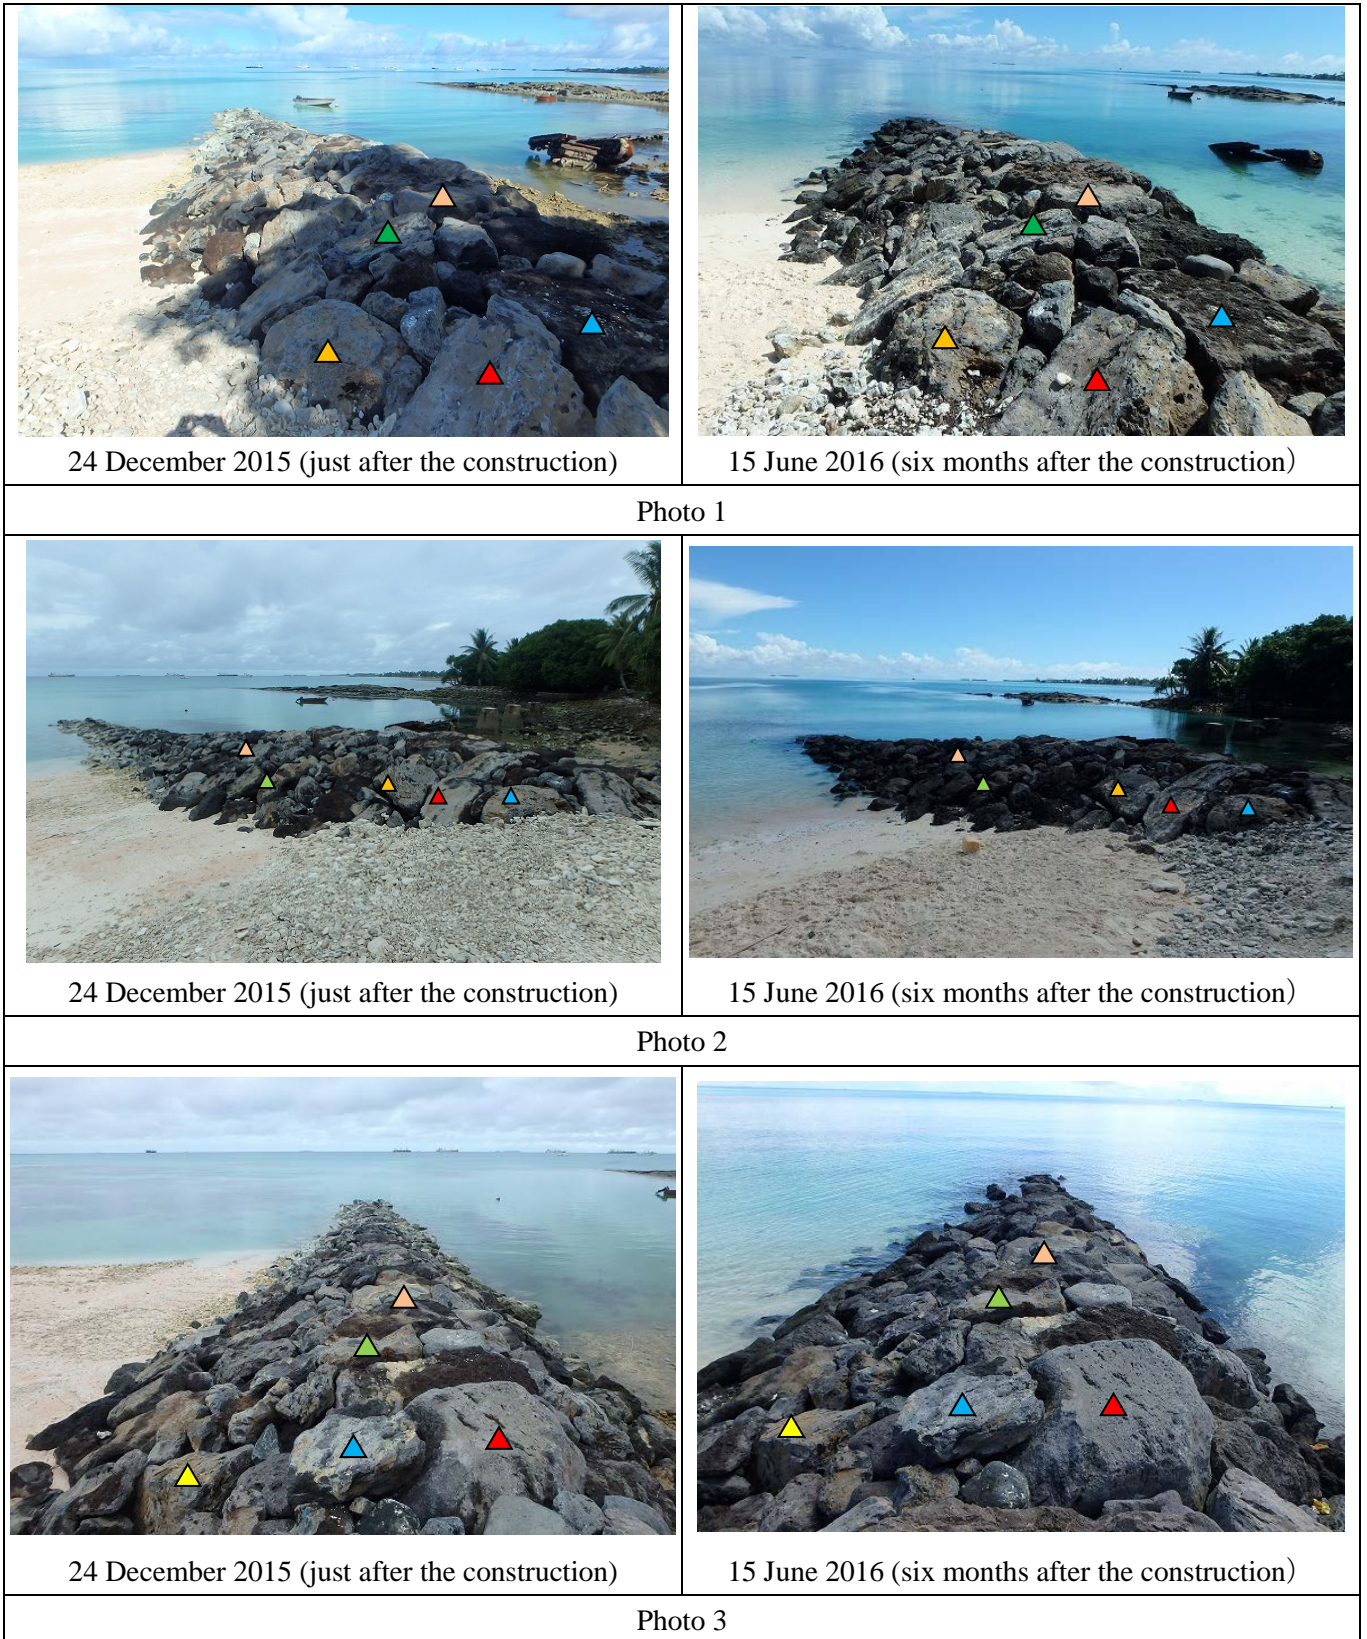
Figure 9.6.2 Comparison of the North Groin

south groins. In addition, no major changes on the cross section profile was recognized. Thus, it was confirmed that both north and south groins have remained stable since its construction.

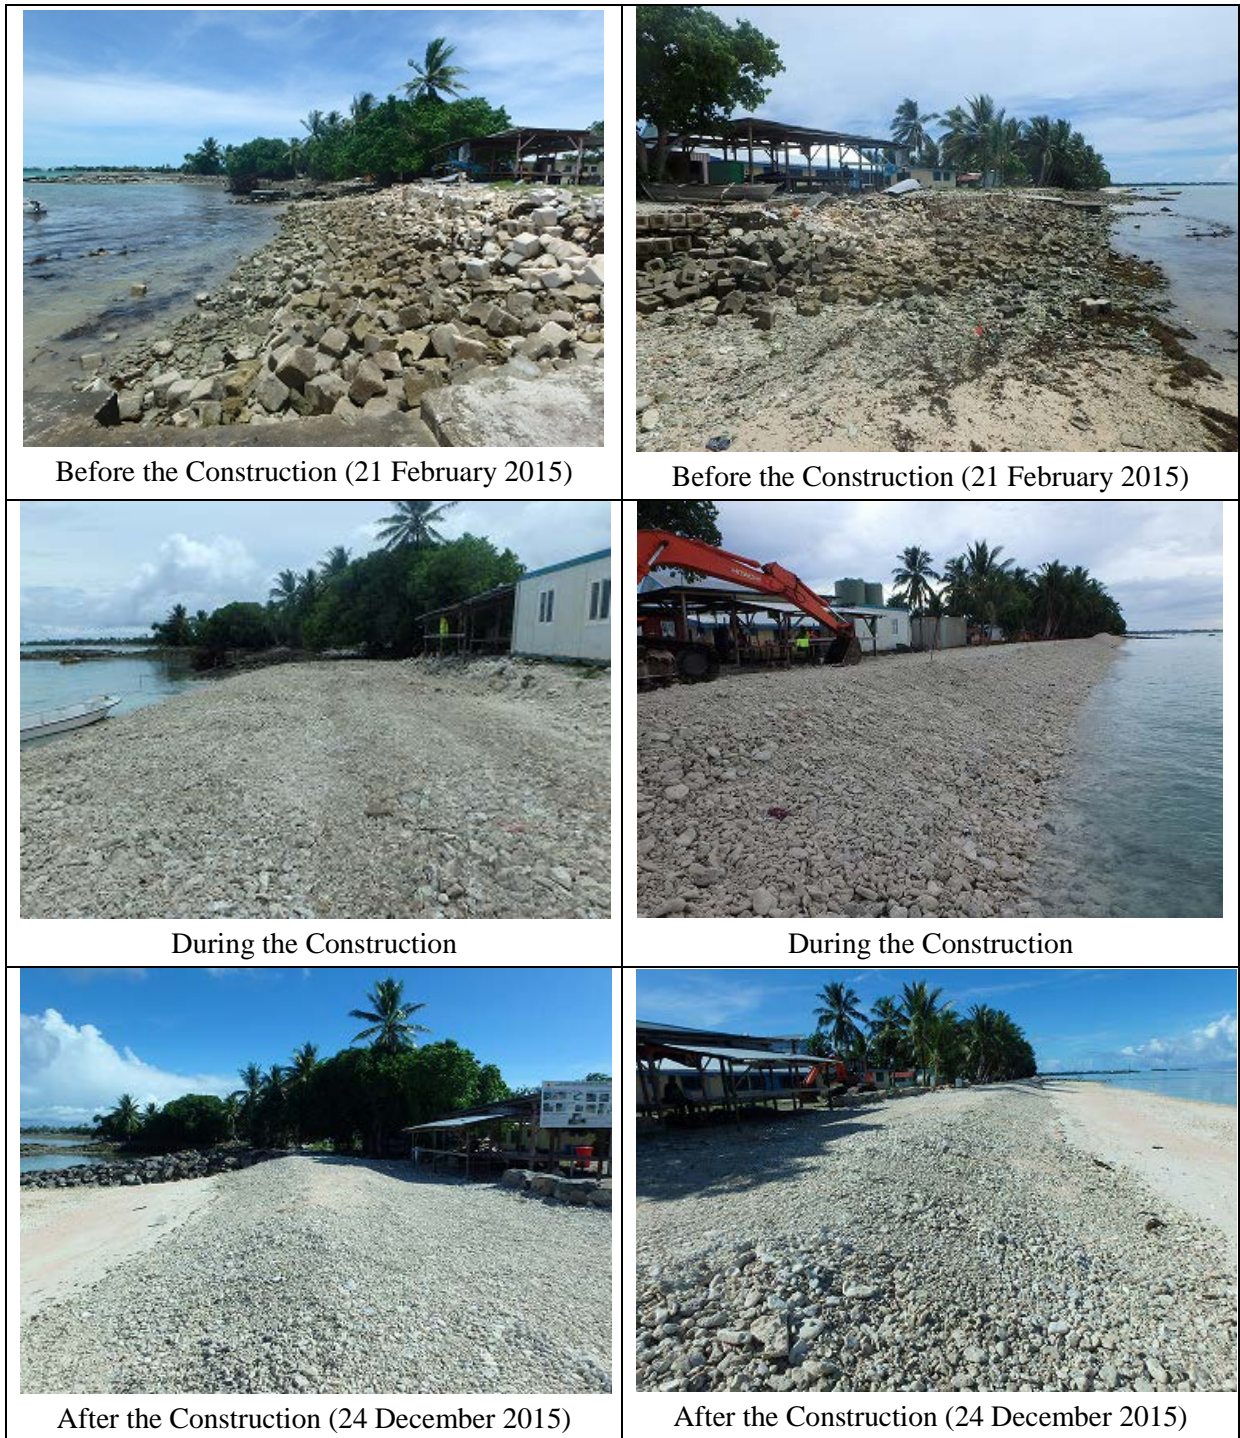
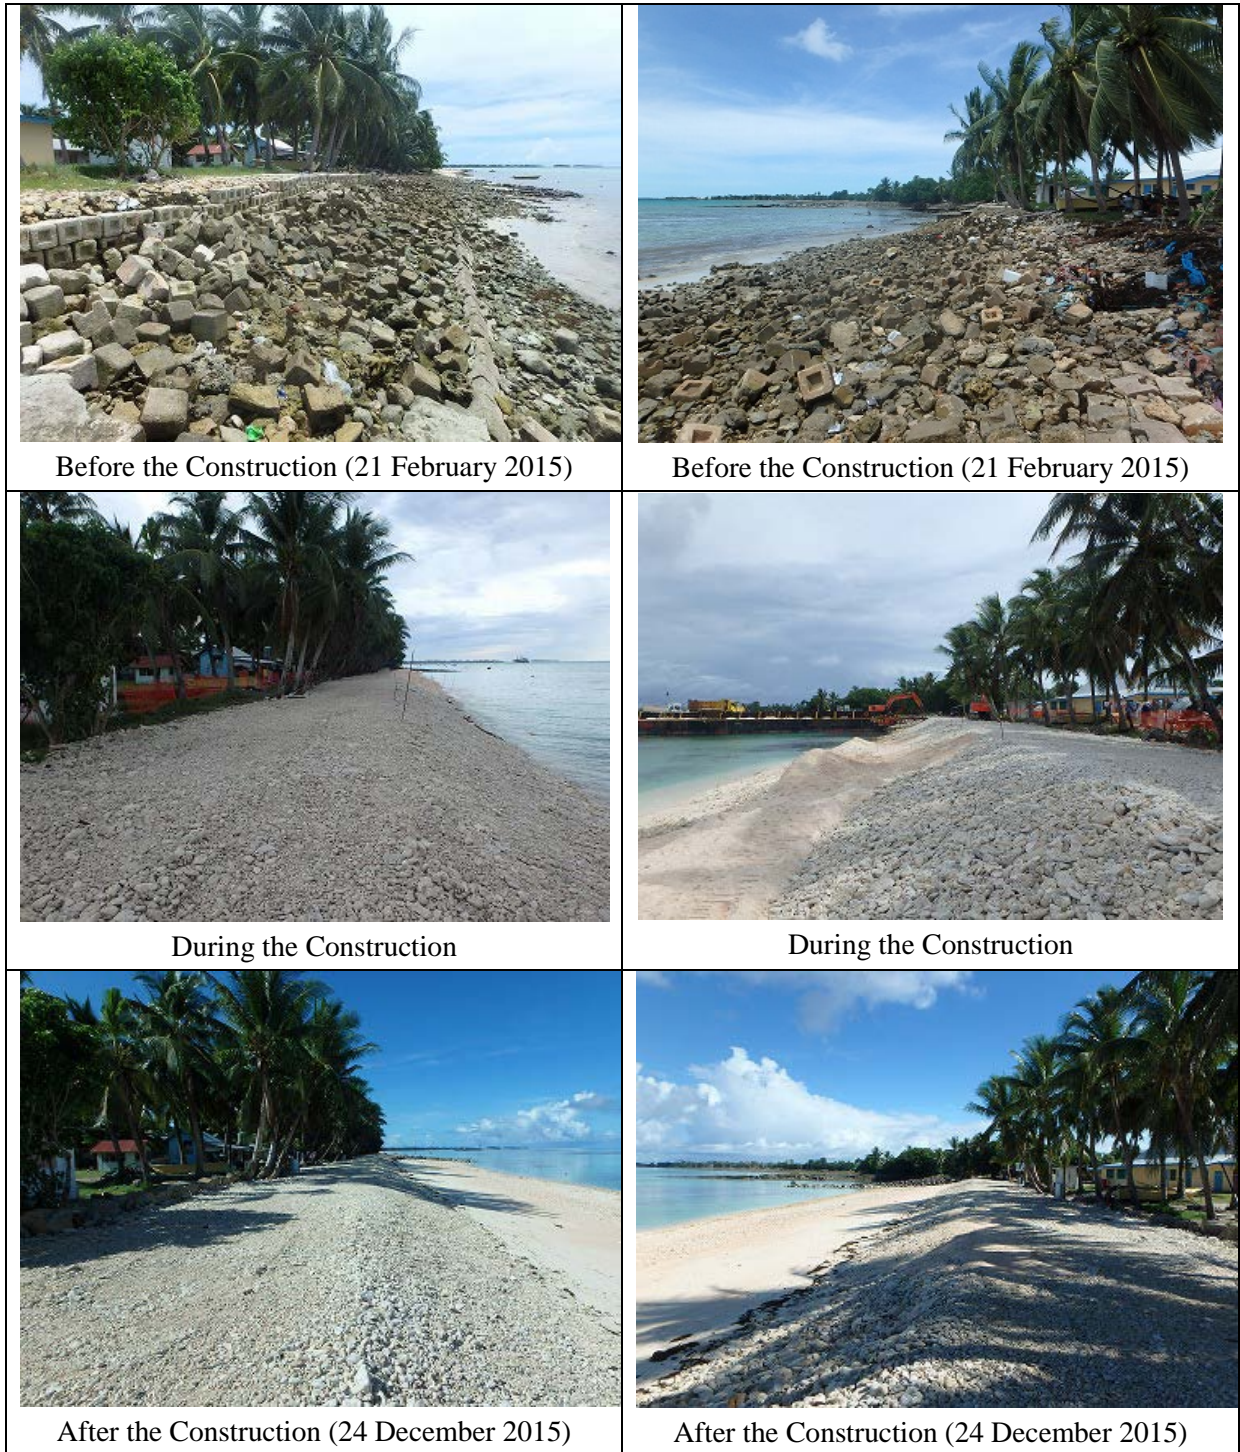
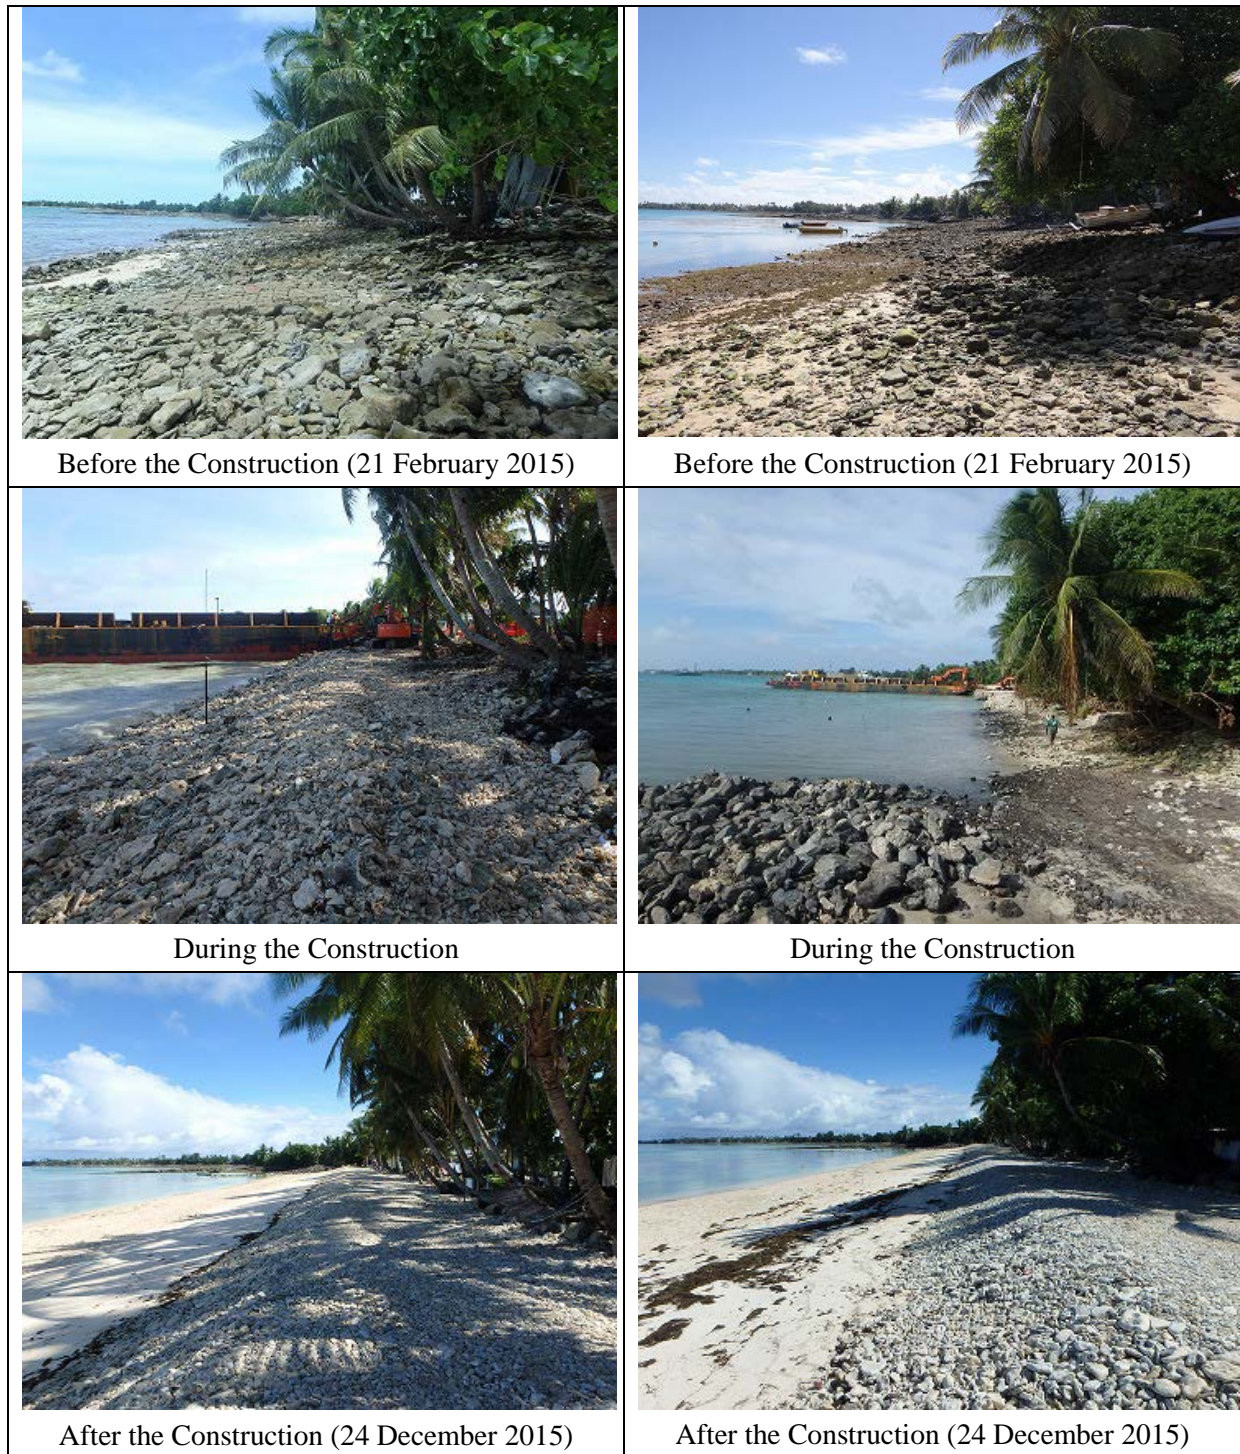
Figures 9.8.1 to 9.8.3 show the comparison photos before, during, and after the construction from the same position. The previous beach condition changes drastically; and a beautiful beach space with gravel and sand is formed.

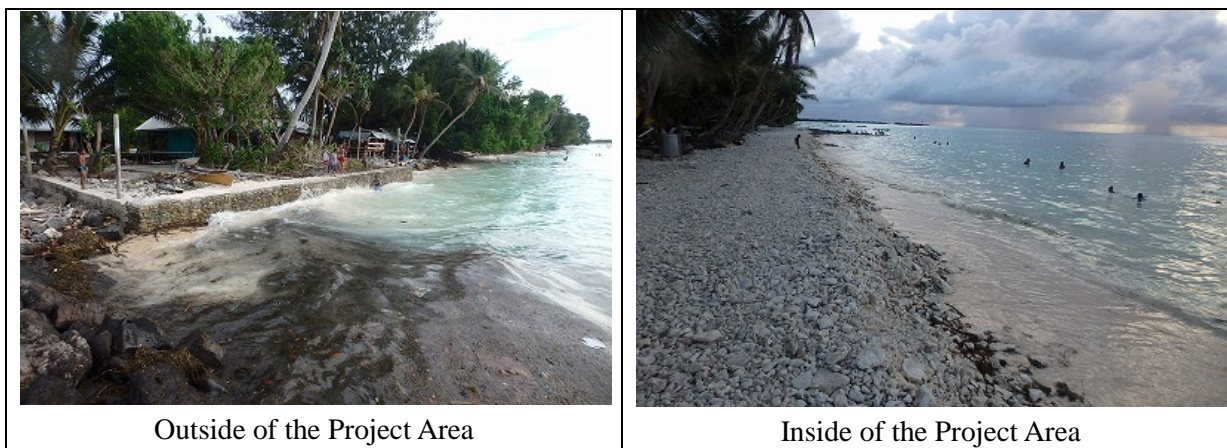
Figure 9.8.5 shows the wave condition in both areas inside and outside of the Project area during the king tide at 5:30 PM on 9 February 2016. At that time, the tide condition was +3.18 m according to the tide table. The land area at the Project site seems safer than the outside of the Project area.

Figure 9.8.5 Comparison of Wave Condition Inside and Outside of the Project Area during the King Tide (9 February 2016, 5:30 PM, +3.18 m from Tide Prediction)
