KILU'UFI HOSPITAL GEOTECHNICAL INVESTIGATION REPORT

Report No: KH202205_GI_001
Report Status: FINAL

July 29, 2022

Kilu'ufi Hospital Improvement Project Geotechnical Investigation

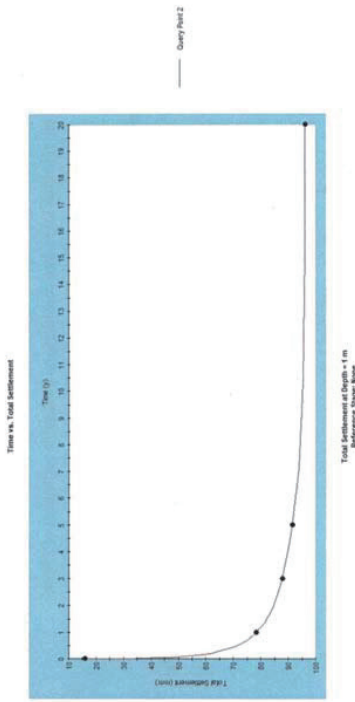
Figure 5. Graph of time vs consolidation settlement

- Immediate Settlement – 16mm -20mm
- Consolidation Settlement – 16mm to 96mm after year 10 of building service life

Final settlement estimates will be evaluated once building loads are determined.

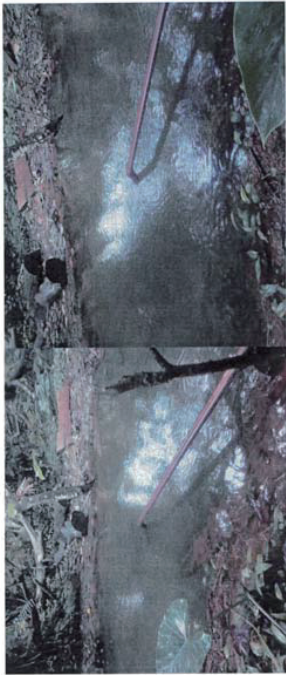
❖ Water Source

It should be noted that contamination of the water source is very likely considering that there are residential homes and villages close to the water source less than 100m away.

The microbiology test results indicate that the presence of E.Coli at the water source and in the taps is considerably higher than the recommended guideline of the WHO and is deemed unsafe for consumption. Contamination of the water source is also possible from human activities in close proximity to the water source as houses and dwellings are built around the area of the water source.

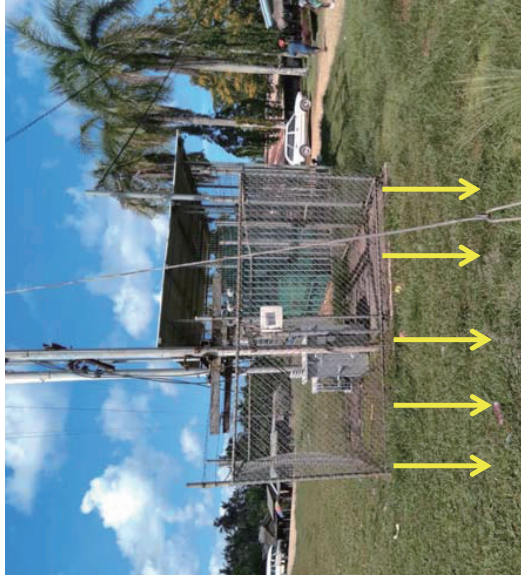
Heavy interferences from overhead power lines and the existing generator fencing

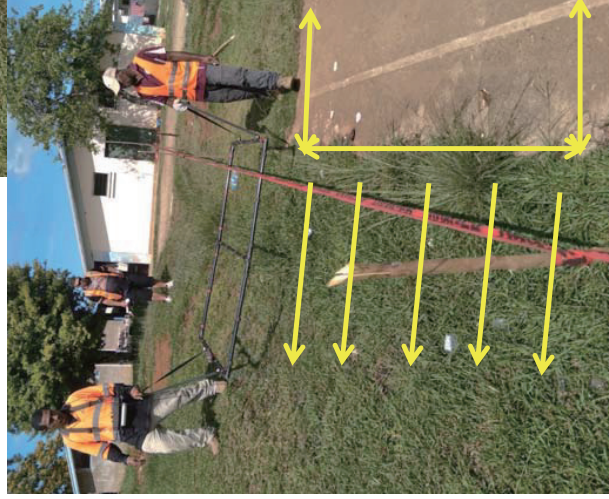
Heavy interferences from steel rods in the concrete slab
