DATA 3
HYDROGEOLOGICAL SURVEY

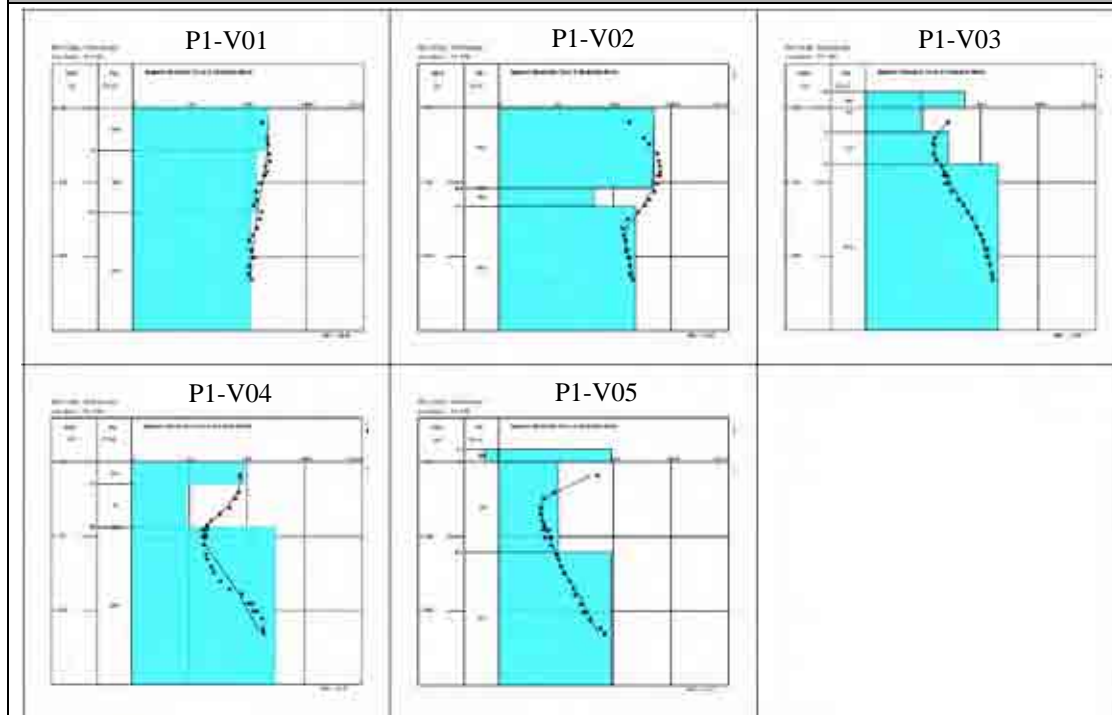
Results of the VES

- V01: Apparent resistivity becomes low value following the deeper part of strata.
- V02: Apparent resistivity around 10 m and 30 m in depth shows the maximum and the minimum value, respectively. The fitting curve shows inverse-S shape.
- V03, V04, V05: Apparent resistivity from ground surface to around 10 m in depth and the below becomes low value and high value following the deeper part of strata, respectively. V05 generally shows low value of apparent resistivity.

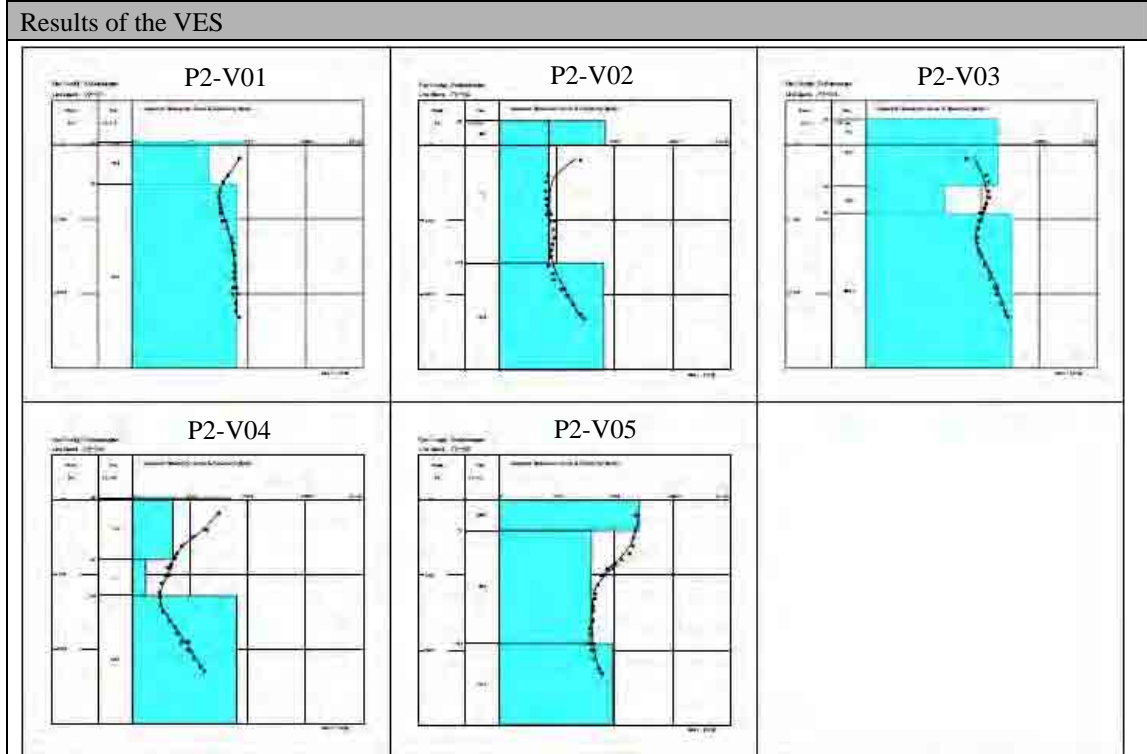
- V01: Apparent resistivity change with depth is less and its value generally shows low.
- V02: Apparent resistivity by 40 m in depth and below it shows less change and becomes high value following the deeper part of strata. Its value generally shows low.
- V03: Apparent resistivity around 20 m in depth shows the minimum value. The fitting curve shows inverse-S shape. Its value shows relatively high.
- V04: Apparent resistivity from ground surface to around 20 m in depth and the below becomes low value and high value following the deeper part of strata, respectively. Its value generally shows low.
- V05: Apparent resistivity from ground surface to 10 m in depth and the below becomes low value and less change. Its value generally shows low.

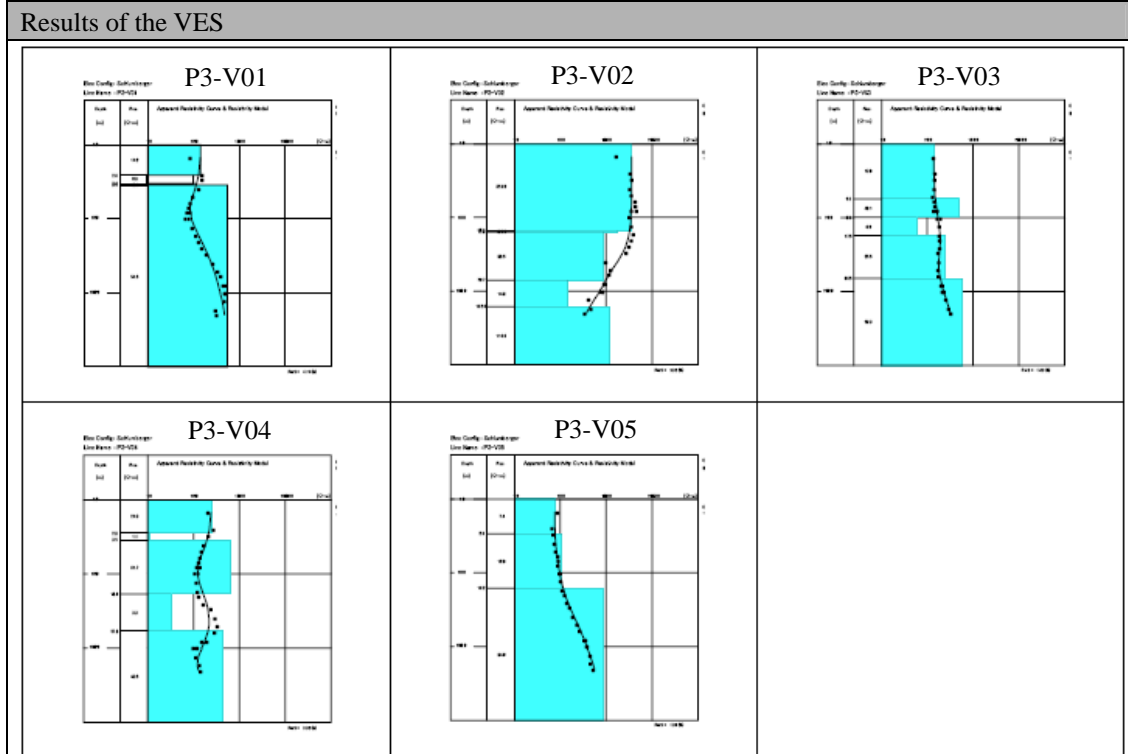
- V01: Apparent resistivity around 10 m in depth, by 100 m in depth and the below shows the minimum value, becomes high value following the deeper part of strata and low value, respectively. Its value generally shows low.
- V02: Apparent resistivity by 20 m in depth and the below shows less change and becomes low value, respectively.
- V03: Apparent resistivity change with depth is less and its value generally shows low.
- V04: Apparent resistivity from 10 m to 50 m in depth and the below becomes high value and low value following the deeper part of strata, respectively. Its value generally shows low.
- V05: Apparent resistivity becomes high value following the deeper depth of strata. Its value generally shows low.

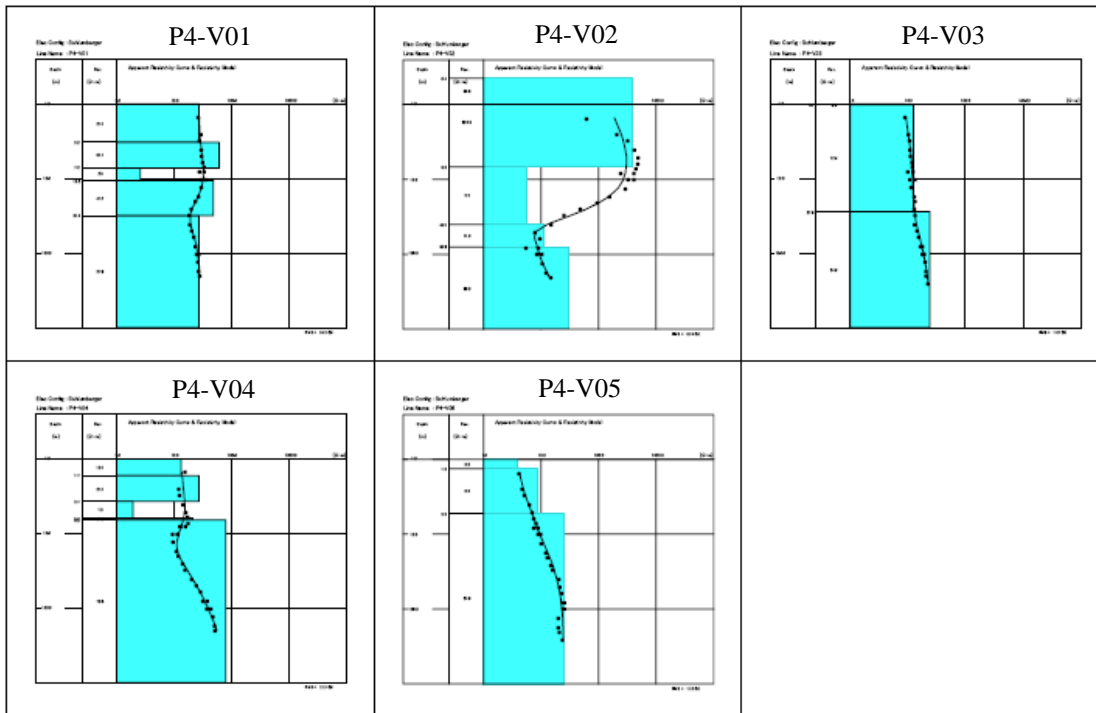
Results of the VES

- V01: Apparent resistivity change with depth is less and the fitting curve shows inverse-S shape. Its value generally shows low.
- V02: Apparent resistivity by 6 m and the below shows relatively high value and becomes low value following the deeper depth of strata, respectively.
- V03: Apparent resistivity becomes slightly high value following the deeper depth of strata. Its value generally shows low.
- V04: Apparent resistivity below 10 m in depth becomes high value following the deeper depth of strata. Its value generally shows low.
- V05: Apparent resistivity by 100 m in depth and the below becomes high value following the deeper depth of strata and shows less change, respectively.

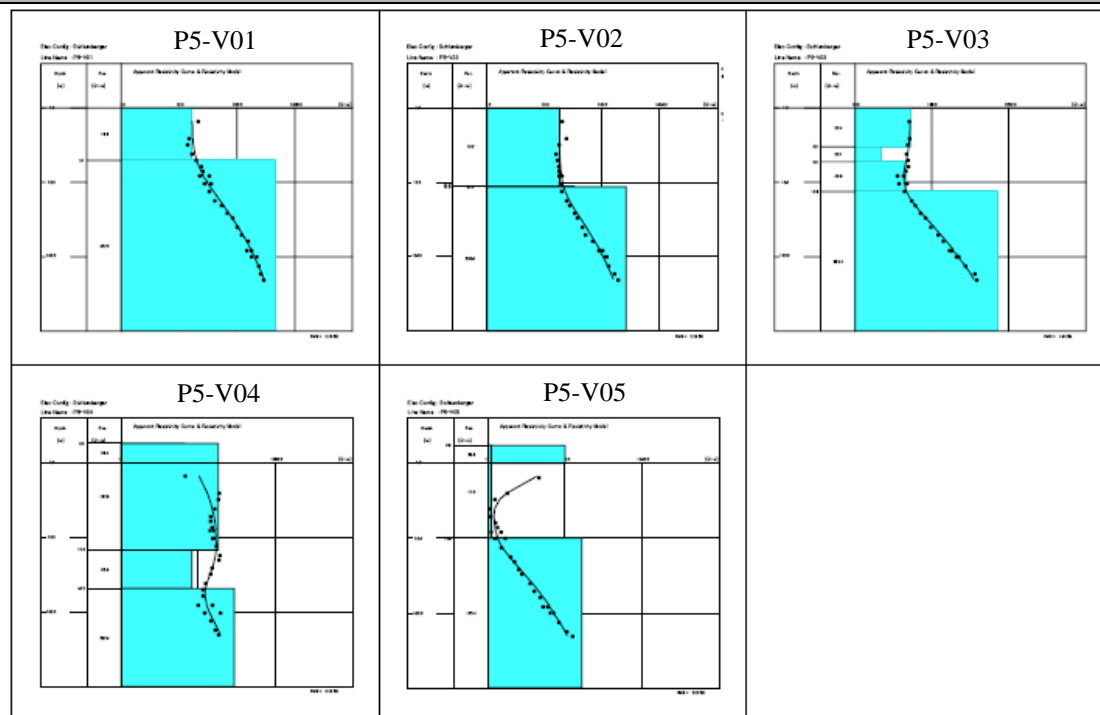
Results of the VES

- V01, V02, V03: Apparent resistivity from ground surface to around 10 m in depth and the below shows less change and becomes high value following the deeper depth of strata.
- V04: Apparent resistivity change with depth is less.
- V05: Apparent resistivity by 10 m in depth and the below shows quite low value and becomes high value following the deeper depth of strata.

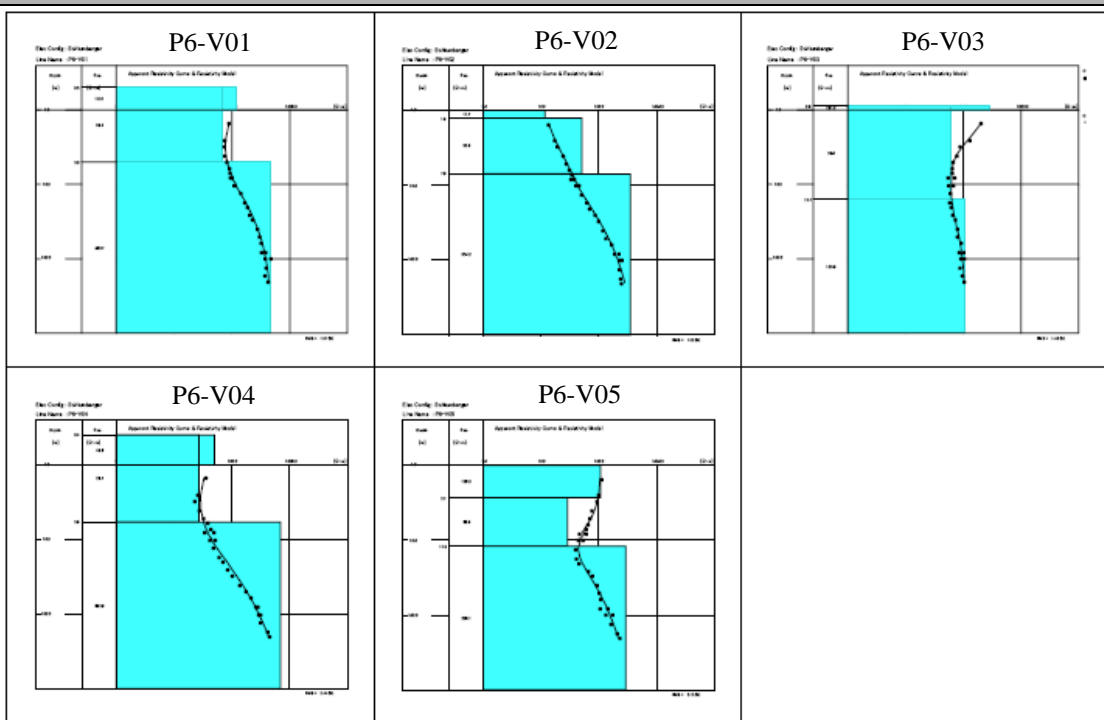
Results of the VES

- V01, V04: Apparent resistivity by 5 m in depth and the below shows less change and becomes high value following the deeper depth of strata, respectively.
- V02: Apparent resistivity becomes high value following the deeper depth of strata.
- V03: Apparent resistivity below 5 m in depth shows less change.
- V05: Apparent resistivity around 10 m in depth and the below shows the minimum value and becomes high value following the deeper depth of strata.

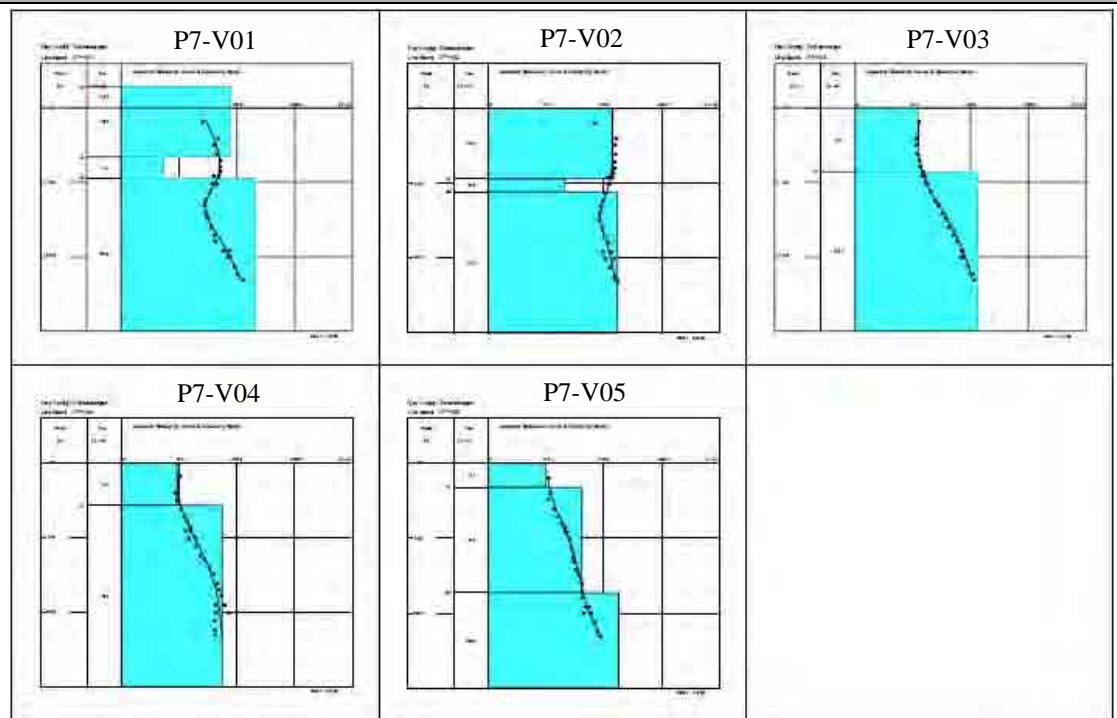
Results of the VES

- V01: Apparent resistivity below 20 m in depth becomes high value following the deeper depth of strata, and the fitting curve shows inverse-S shape.
- V03, V05: Apparent resistivity becomes high value following the deeper depth of strata.
- V04: Apparent resistivity by 80 m in depth and the below becomes high value following the deeper depth of strata and shows less change, respectively.

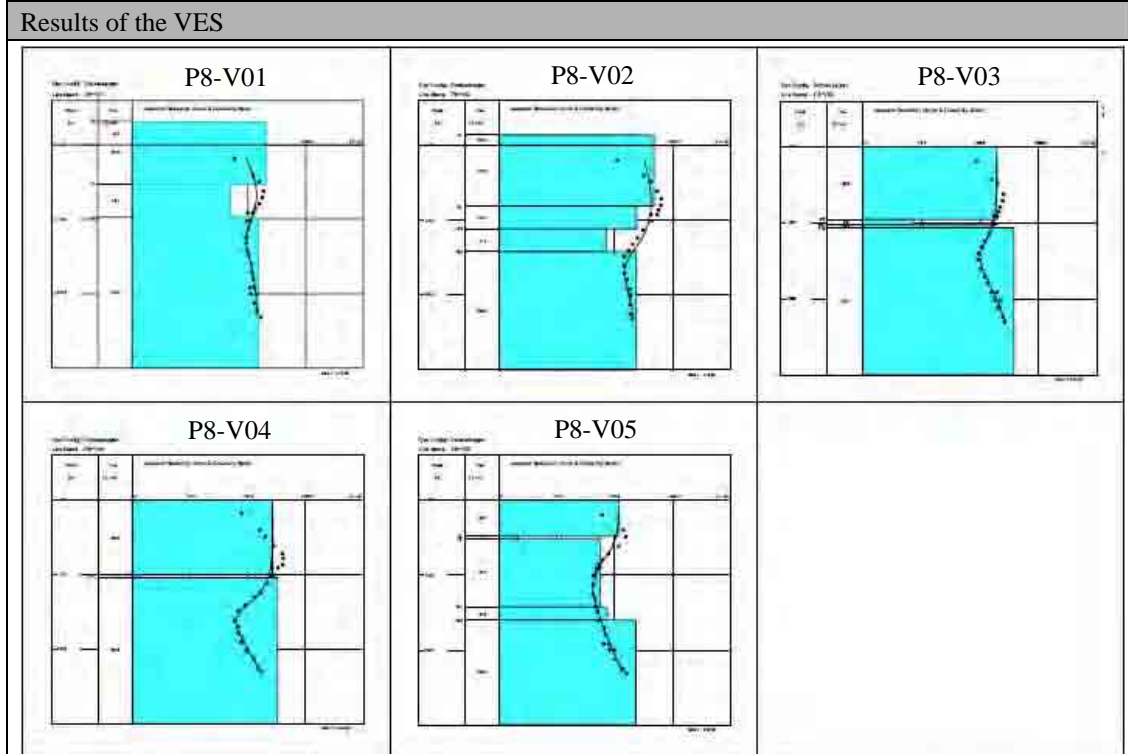
- V01: Apparent resistivity change with depth is less and the fitting curve shows inverse-S shape.
- V02: Apparent resistivity below 30 m in depth shows less change.
- V03, V04: Apparent resistivity below 30 m to 40 m in depth becomes high value following the deeper depth of strata and the fitting curve shows inverse-S shape.
- V05: Apparent resistivity around 20 m in depth and the below shows the minimum value and becomes high value following the deeper depth of strata, respectively.

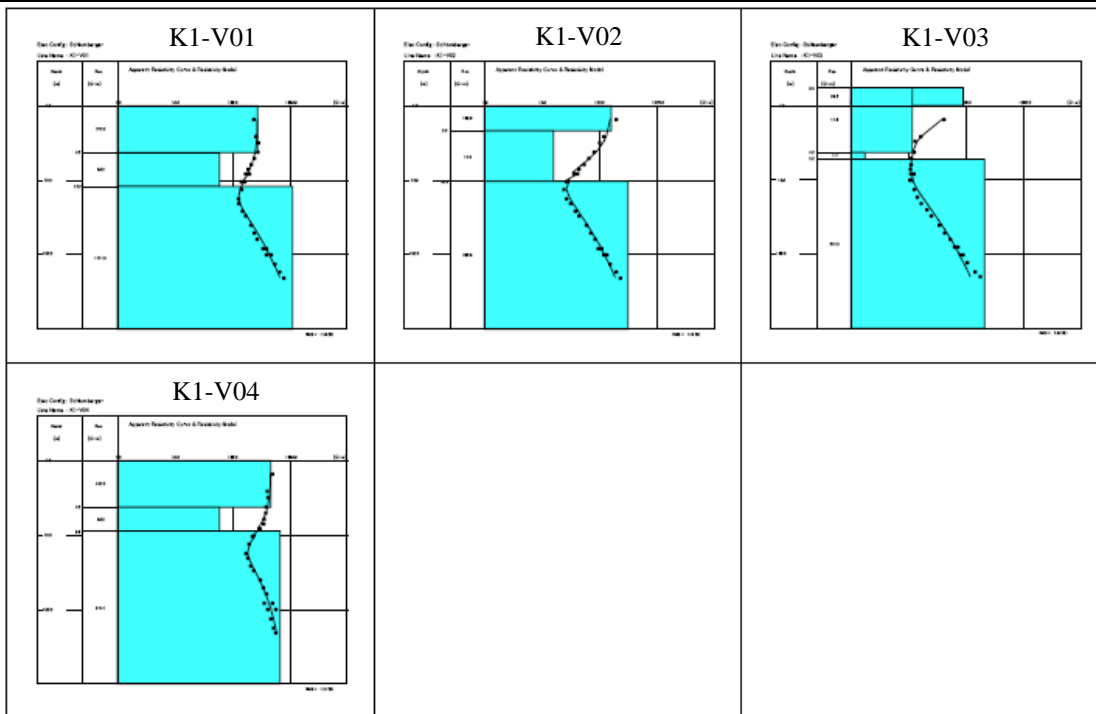
Results of the VES

- V01, V04: Apparent resistivity from ground surface to 15 m in depth and the below shows the minimum value and becomes high value following the deeper depth of strata.
- V02: Apparent resistivity change is similar to V01 and V02, and its value shows relatively low in comparison with the same.
- V03: Apparent resistivity from 1 m to 10 m in depth and the below shows less change and becomes high following the deeper depth of strata.

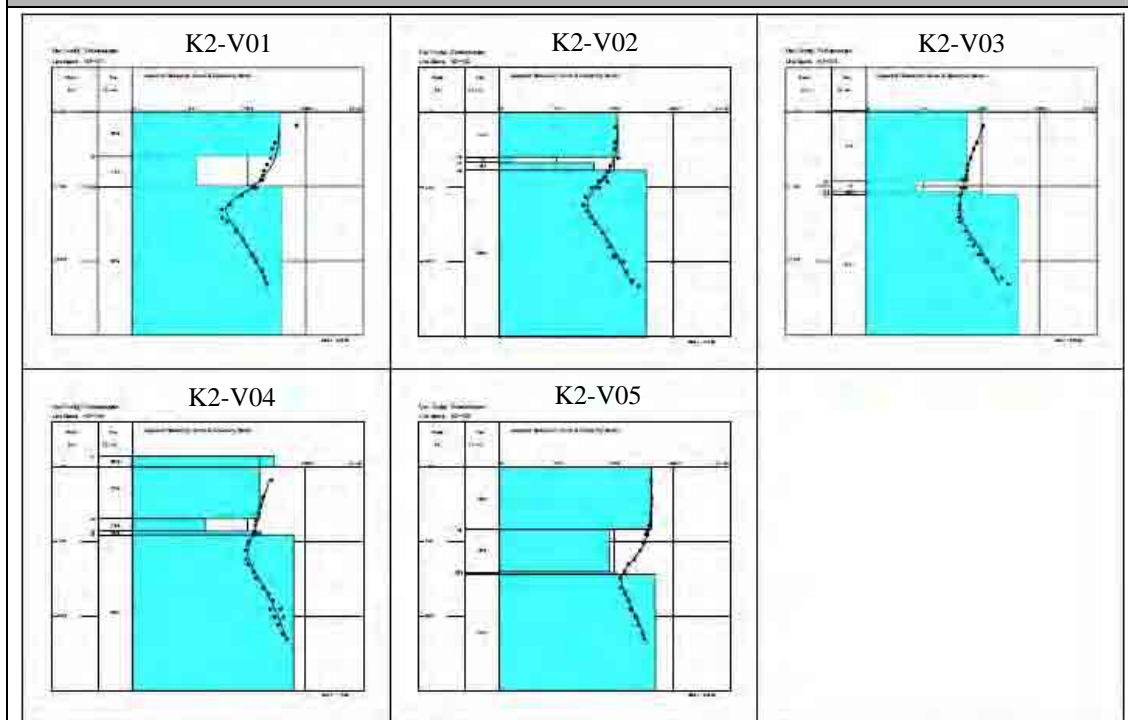
Results of the VES

- V01, V02, V03, V04: Apparent resistivity from ground surface to 20m in depth and the below becomes low value and high value following the deeper depth of strata, respectively.
- V05: Apparent resistivity change from ground surface to 30m in depth and the below becomes low value and high value following the deeper depth of strata, respectively.
