**Ex-Post Monitoring Report of Japanese ODA Loan
Projects 2010: Package III
(Jamaica, Ecuador, Morocco, China)**

December 2011

**JAPAN INTERNATIONAL COOPERATION AGENCY
INGEROSEC CORPORATION**

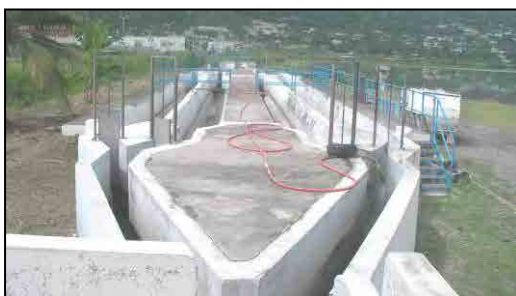
No damage to the present facilities was observed and none of the functions of the facilities had been lost. Thus, problems such as drastic decline in the sewage treatment volume and etc. have not emerged.

Photo 1 Treatment Facility
(Sewage Inlet)

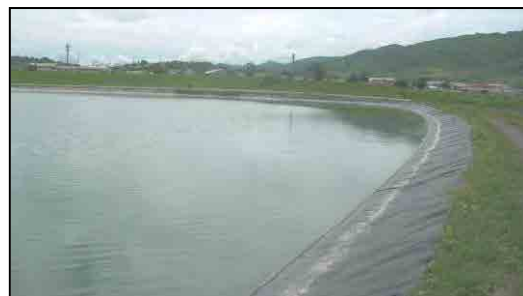
Photo 2 Treatment Facility
(Settling Pond for Treatment)

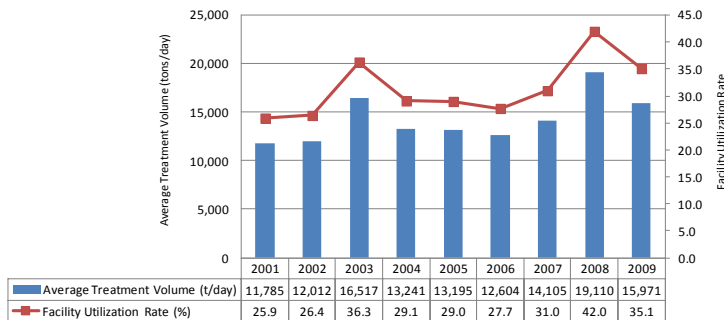
As shown in Figure 1, since the maximum sewage treatment volume is 19,110 t/day (2008) and the facility capacity is 45,500 t/day (facility utilization rate¹: approximately 42%), there is ample spare treatment capacity.

Figure 1 Sewage Treatment Volume and Facility Utilization Rate (Sources: Ex-Post Evaluation Report and Preceding Survey)

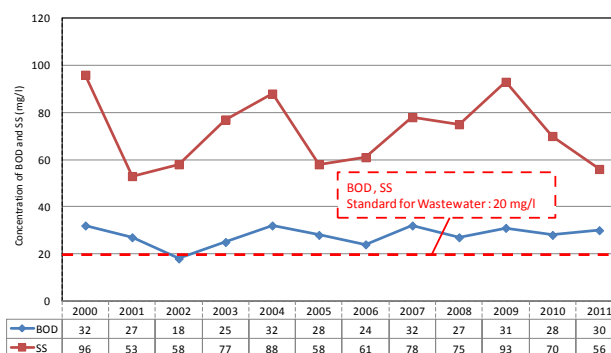
As shown in Figure 2, the changes in the concentrations of BOD and SS show that they have not fallen below the 20mg/l effluent standard. In particular, the concentration of SS reached a rather high level but it has recently declined.

Figure 2 Changes in BOD and SS (Source: NWC materials)

Since the sewage is basically treated by natural purification process with microorganisms such as algae in a huge pond, treatment largely relies on natural conditions such as the weather. Thus, it is highly probable that the concentration of BOD and SS becomes unstable.

Since the purifying method at this plant is natural purification by algae and aquatic plants, treatment largely relies on natural conditions such as the weather. Thus, it is considered that it may be possible to improve the effluent quality if growth of algae and aquatic plants is well taken care of as a maintenance method.

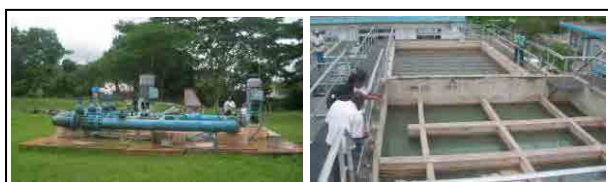
No damage to the present facilities was observed and none of the functions of the facilities had been lost. Thus, problems such as drastic decline in the water supply volume and etc. have not emerged.

Photo 3 Logwood Water Purification Plant

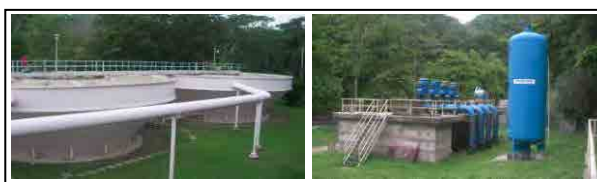
Photo 4 Great River Water Purification Plant

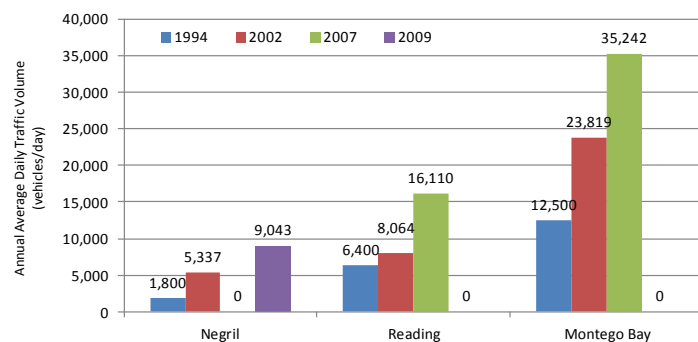
Figure 4 Changes in Annual Average Daily Traffic Volume (Source: Preceding Survey)

² In order to grasp the present traffic volume, the traffic volume of one side of the road (Montego Bay to Negril) was measured for 10 minutes (around 13:00, June 2) while driving along the road concerned (between Negril and Reading) during the field survey; the volume was 109 vehicles/10minutes. From that figure and taking the traffic volume on both sides as 218 vehicles/10 minutes, the traffic volume per hour (60 minutes) was estimated at approximately 1,300 vehicles/hour; and assuming a day-to-night ratio of 1.1 from the traffic conditions in the area concerned, the traffic volume was estimated at approximately 14,000 vehicles per day (1,300 vehicles/hour × 12 hours ÷ 1.1).

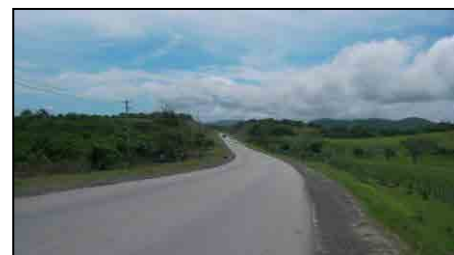
The required driving time from Negril to Montego Bay was about one hour, the same as at the time of the preceding survey, and it was possible to drive at the legal speed at 50km/h (in the city) and 80km/h (between cities). Regarding the road surface condition, some cracks, potholes and exfoliation (see Photo 7 to 9) were observed in the pavement of the road and the shoulder but most had been repaired.

Photo 6 General Condition of Road

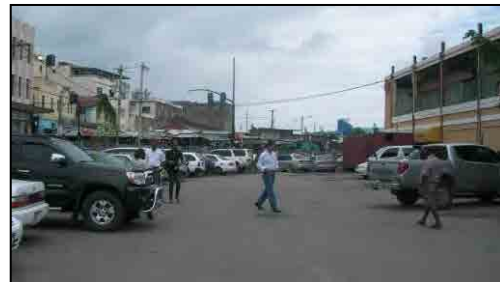
No major damage to the facilities as a whole was observed and none of the functions of the facilities had been lost. The top of the facilities was effectively utilized, for instance, as parking lots, by constructing some sections in a box culvert structure, and they were also used as drain ditches for rainwater in the neighboring area of the facilities. Looking at the conditions in Montego Bay City, no prominent flood damage was observed, indicating that no major flood had occurred due to these facilities.

Photo 11 Utilization of Top of Facilities (as Parking Lot)

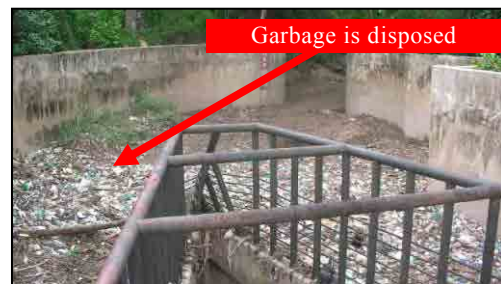
Photo 12 Upper Stream Inlet on Mountainside

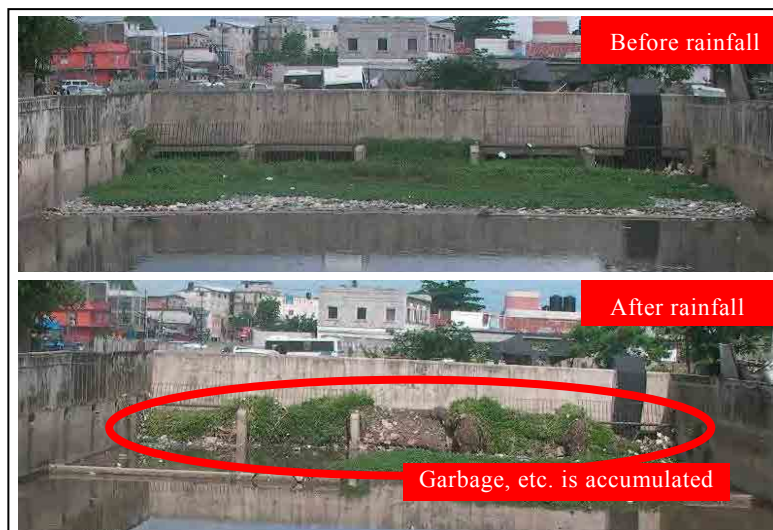
Regarding the condition of the facilities, it was observed that a lot of garbage had been dumped in the facilities. This may lead to accumulating garbage in the culverts and then clogging the inlets of the culverts if the water flow volume increases when it rains. In that case the water-flow cross-section of the culverts may not be secured and thus the original capacity may not be ensured.

Photo 13 Conditions of Culvert Inlet Before and After Rainfall

- Regarding the drainage and flood control facilities, efforts should be made not only to reduce garbage dumping through educational activities for the residents but also to clean the facilities on a regular basis. A lot of garbage thrown into the facilities probably by residents along the river was observed. The discarded garbage may narrow or clog the cross-sectional flow area, preventing the facilities from serving their original functions.

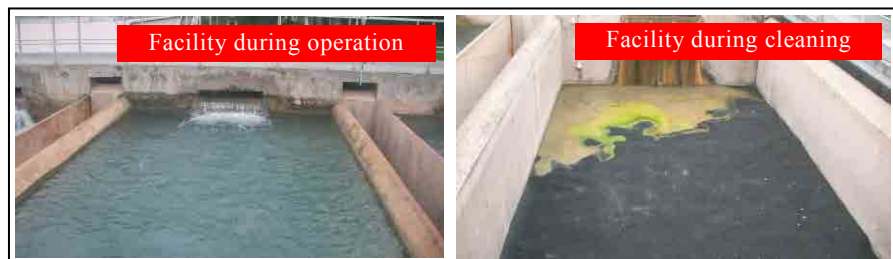
Photo 15 Maintenance of Water Supply Facility

The water supply facilities are cleaned on a regular basis.

Regarding the sewage treatment facility (wastewater stabilization pond),

accumulated garbage in the pond is cleaned up on a regular basis. While nearly ten years have passed since the completion of the wastewater stabilization pond, the sludge which had accumulated since then had not been removed. We were informed that the NWC planned to

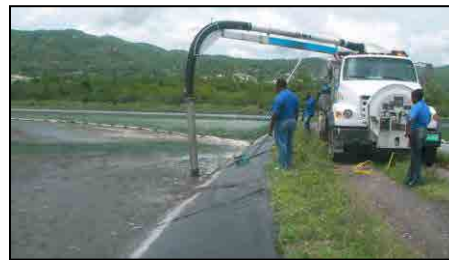
Since inhabitation by these plants and microorganisms is deemed to reduce concentrations of BOD and SS, growth of plants and microorganisms should be taken into account from the viewpoint of maintenance. Neither special techniques nor costly investment is required for growth of plants and microorganisms, thus it is considered that a local agency is able to handle it. As nearly ten years have passed since the completion of the wastewater stabilization pond, a lot of sludge is assumed to have settled at the bottom of the pond. If a lot of wastewater flows into the facility due to heavy rainfall, the settled sludge may swirl up and be discharged into the river at an early stage. Since this may cause an increase in the concentration of SS, the sludge should be removed at certain intervals of period. This sludge removal is large-scale maintenance work and should be generally conducted in approximately ten-year cycles. As ten years have passed since this facility started operation, it is about time to remove the sludge. We were informed that there was a plan to remove the sludge in the near future.

Photo 16 Cleaning of Wastewater Stabilization Pond

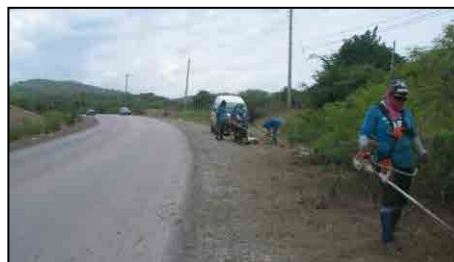
Photo 17 Road Cleaning

Potholes were observed in some sections of the roads (pavement) but there was little major damage such as to impair trafficability and repairs had been carried out. Regarding routine maintenance work such as road cleaning, vegetation removal and garbage cleaning were taken care of by NSWMA. Regarding the problem that the roads and the bridges connecting the areas were not on the same level, reinforcement work had been already carried out for 6 bridges in order to eliminate the height difference using the geotextile method (earthwork reinforcement). Thus, it is considered that the trafficability and safety of the roads have been secured and the necessary technical capabilities and implementation abilities were available for adequate maintenance.

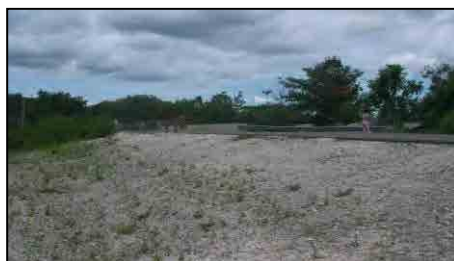
Photo 18 Road after Reinforcement

It was pointed out at the ex-post evaluation that there were bumps between the main roads and access roads for the bridges. In response to it, repair work to eliminate the difference in level is being carried out by repaving roads and earthwork reinforcement.

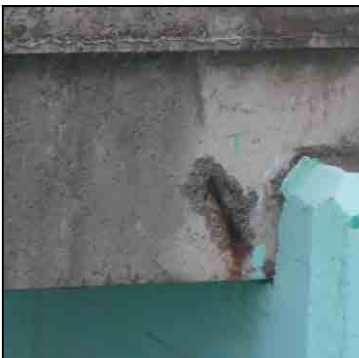
Since nearly ten years have passed since the completion of the facilities, some concrete exfoliation due to brine damage, etc. was observed. We were informed that it was planned to carry out an investigation of the piles supporting the piers and study the possibility of performing maintenance based on the results of the investigation. As nearly 10 years have passed and the piles are located under the sea, erosion by seawater is a concern. It is desirable that PAJ will carry out the investigation and study and implement a maintenance plan.

Photo 19 Concrete Exfoliation

- Regarding the port facilities, as nearly ten years have passed since the completion of the facilities, inspection of the piles supporting the facilities as well as the maritime facilities itself should be conducted to grasp the condition of the facilities. The concrete or other building materials may deteriorate quickly due to brine damage.

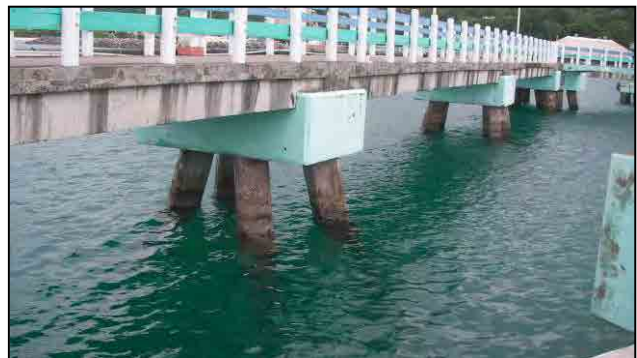
Photo 21 Piles

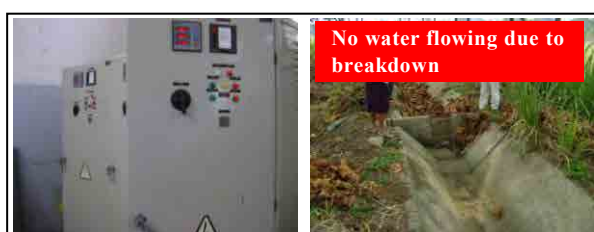
The operating hours of the pump station, which is the main facility in the Catarama Area, are limited due to operation panel trouble, causing damage such as totally destroying rice which was planted as a dry-season crop. There are also other problems; for instance, the big figures in the upstream areas exclusively exploit the scarce irrigation water.

Photo 1 Switchboard (broken down) and Tertiary Channel

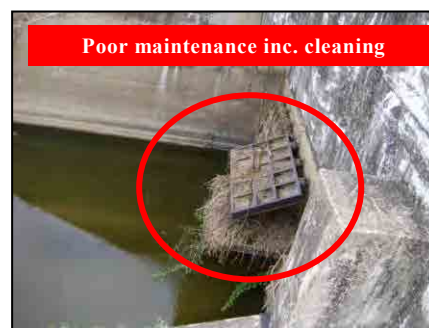
This happens because a lot of dried grass is tangled in the flap gate and causes the trouble that the gate cannot be closed. The daily maintenance of the main facilities such as the flap gate is particularly important.

Photo 2 Flap Gate

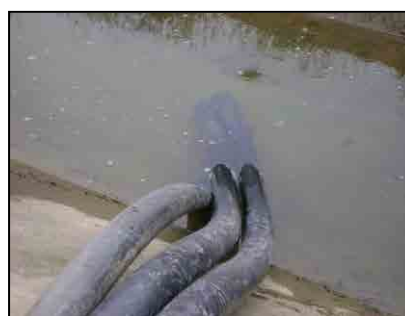
Until mid-2008 the problem often happened that farmers broke part of the concrete wall to take the water into their dry fields without permission because construction of tertiary canals did not make progress. In response to that, CEDEGE performed educational activities, for instance, they toured the regional groups to teach how to use the irrigation water without breaking the concrete wall of the canals. Owing to this, breaking of the irrigation canals has never happened again afterward. However, the instructions for the use of irrigation

Photo 3 Direct Water Intake

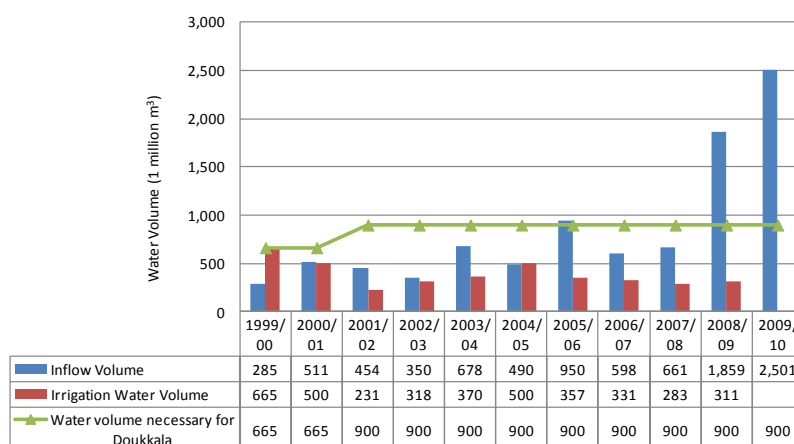
As shown in Fig. 1, the irrigation water has never exceeded the necessary volume in Doukkala Region since the construction had been implemented (2002), and it has been on the decline since the time of the ex-post evaluation (2005). Only 25% - 55% of the necessary water volume has

Fig. 1 Changes in Annual Irrigation

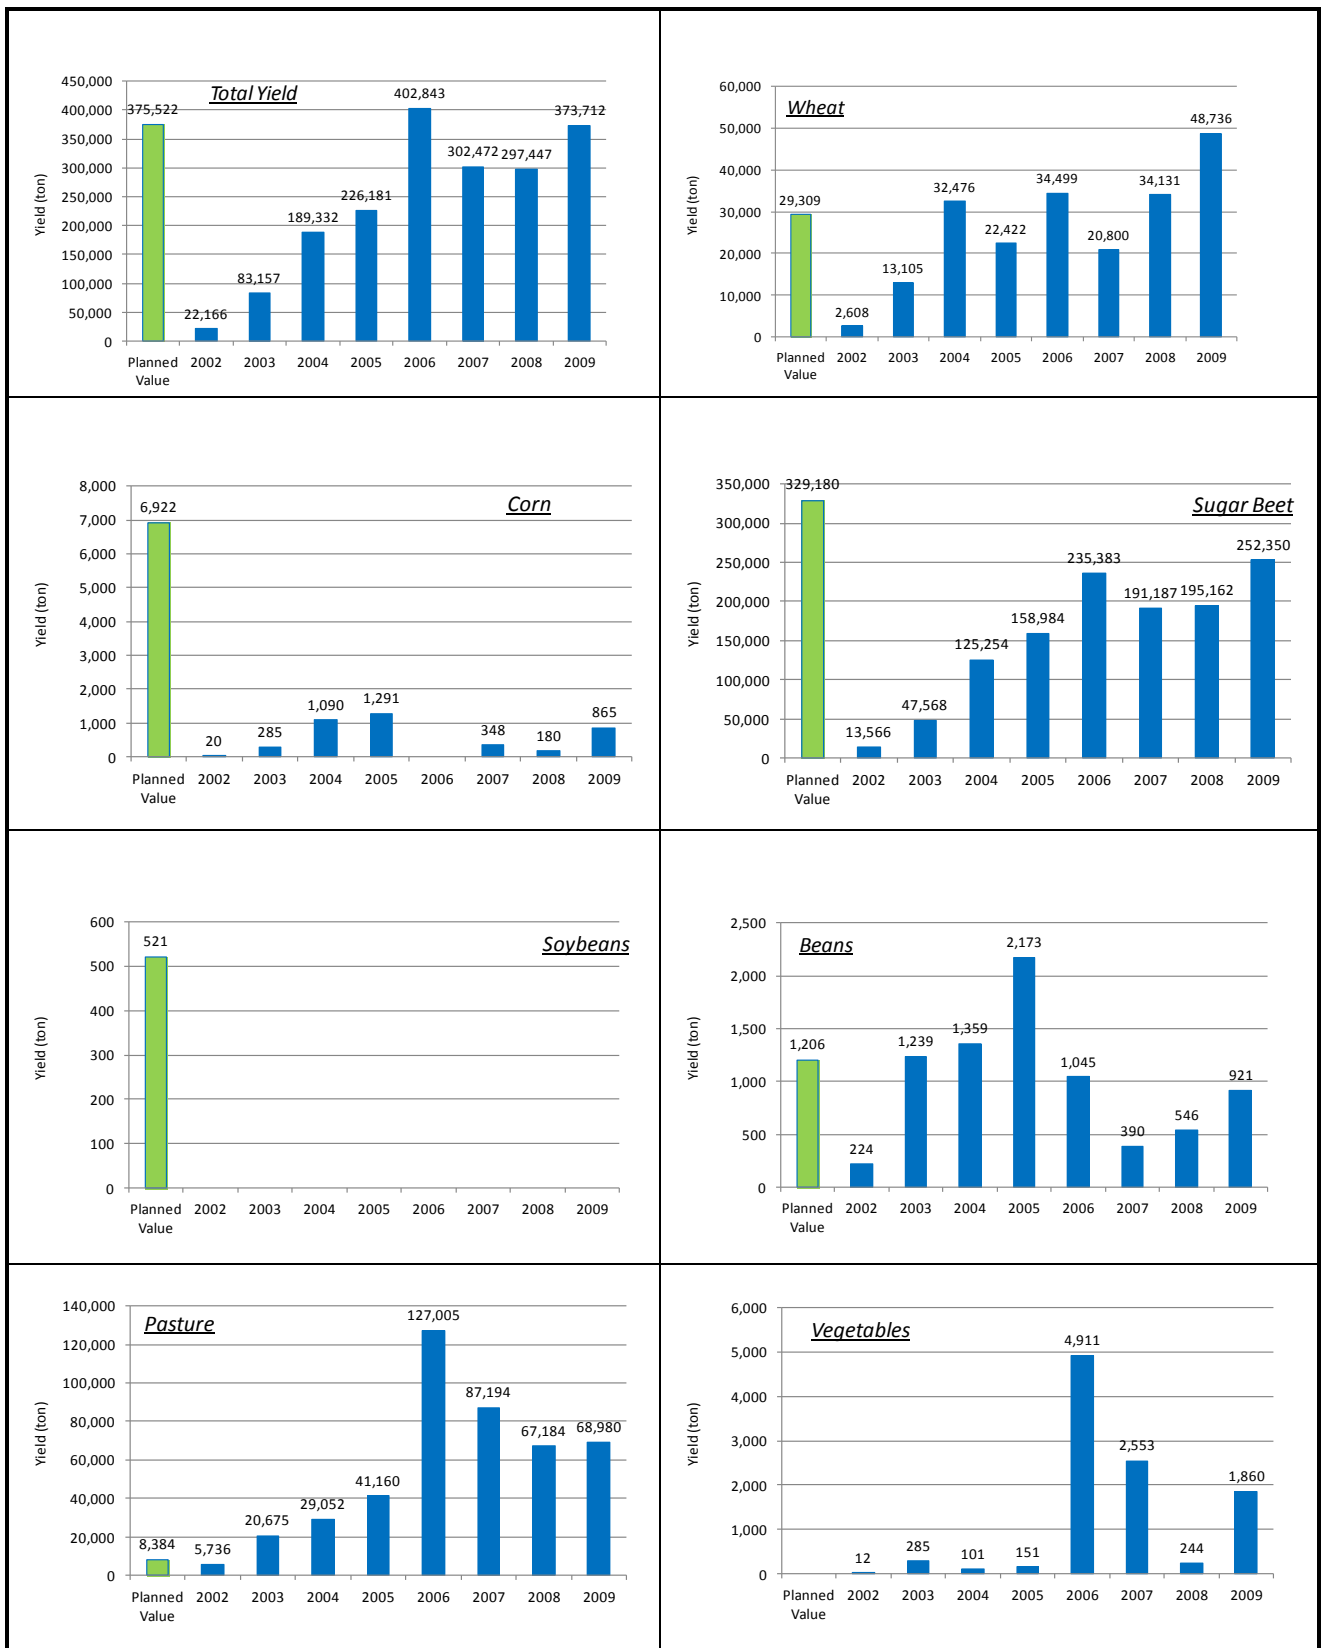
Fig. 3 Shifts in Annual Yields of Main Crops

The total yield of the main crops increased until 2006 after the construction (2002) as shown in Fig. 3. However, it has fluctuated between 300,000 and 400,000 t/year since 2007.

Although there was a plan to cultivate soybeans, there are no records of any soybean harvests. The actual yield of corn is less than the planned value. The possible reasons for such low yields are that soybeans and corn require a lot of irrigation water; ORMVD prioritizes the crops for cultivation in an environment where irrigation water is insufficient; and in particular it is difficult to obtain soybean seeds.

While the original target for pasture was not high, the actual yields are much higher than the planned values. Vegetables, which were not included in the original plan, had high yields especially in 2006, 2007 and 2009.

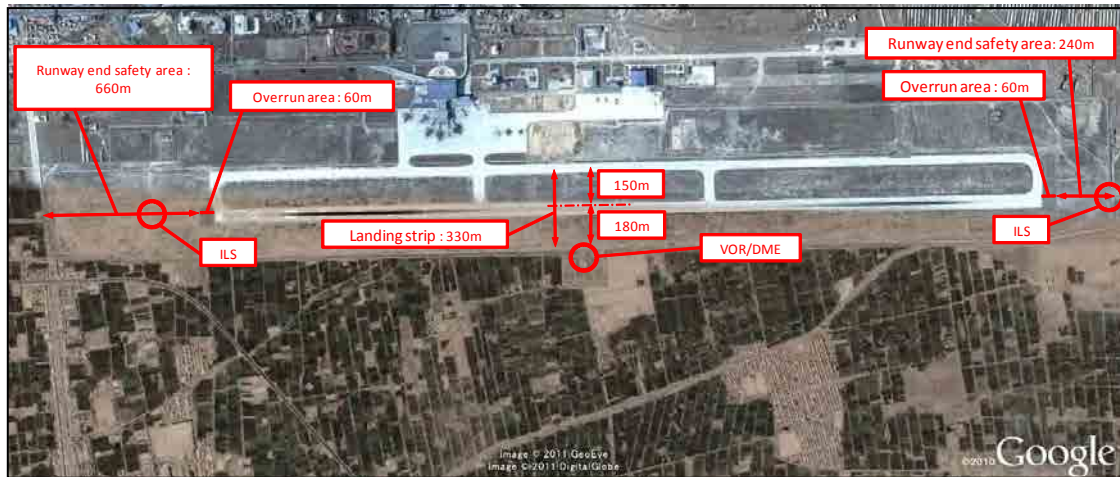
Based on the above, it is considered that the situation at the airport does not pose a threat to the safety of aircraft takeoff or landing or of aircraft services.

Figure-4 Status of Airport Facilities (created based on data from Google Earth)
