CHAPTER 3
PRESENT SITUATION OF
TRANSPORT SYSTEM
IN THE STUDY AREA

3.1 Present Situation of Road Sub-sector

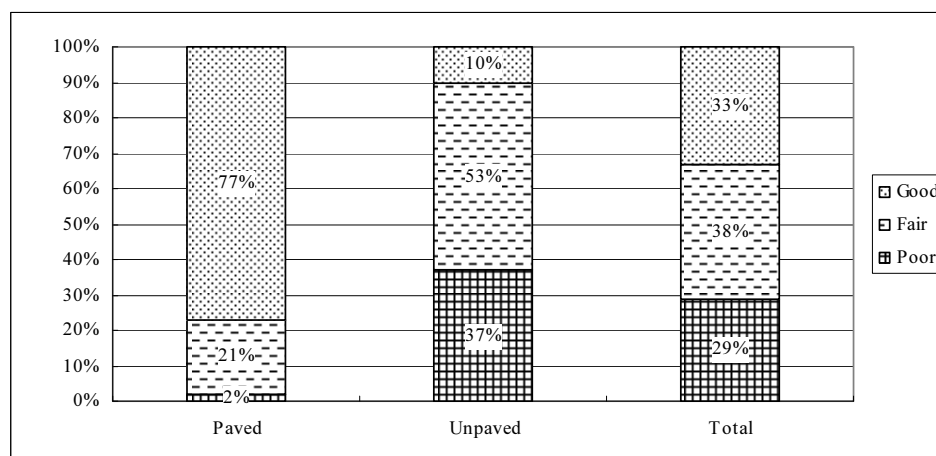
Figure 3-3 Road Condition by Surface in 2009

Table 3-4 and Figure 3-3 show that the paved network is generally in good to fair condition, partly as a consequence of the backlog maintenance programme for urban roads and upgrading programmes for Main roads funded by the EU. The unpaved network is generally in worse shape, with 37% in poor condition. The condition of unpaved roads is influenced by the environment, weather, and changes in traffic levels.

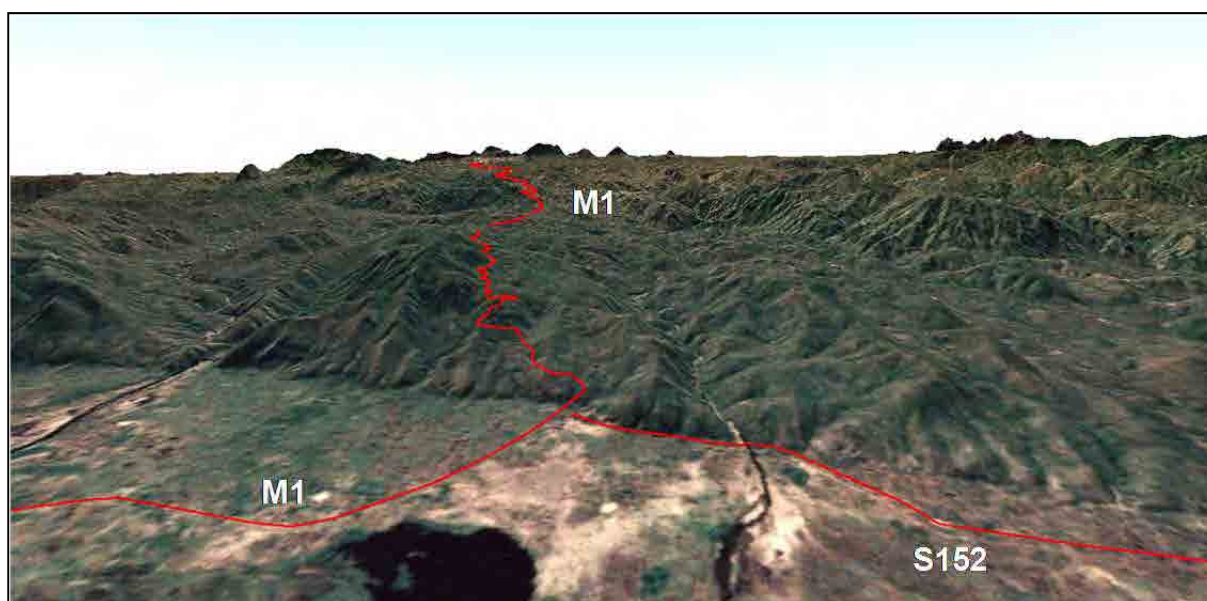
Figure 3-5 3D Image of M1 Alignment at the Rift Valley Escarpment

The Lower Shire Valley in the Southern Region of Malawi is at an elevation of 30 m and lies on the floor of the Rift Valley. The Rift Valley escarpment has a difference in altitude of approximately 800 m. It includes the zone of steep-sloping land of the Thyolo escarpment. In terms of geography, parts of M1 and S151 have steep sections, which cause bottlenecks for industries and transport logistics on M1. The steep section near Thabwa on M1 ranges in vertical grade from 3% to 9%, and the steep section near Seven on S151 ranges in vertical grade from 1% to 5% (see Table 3-9 and Figure 3-5).

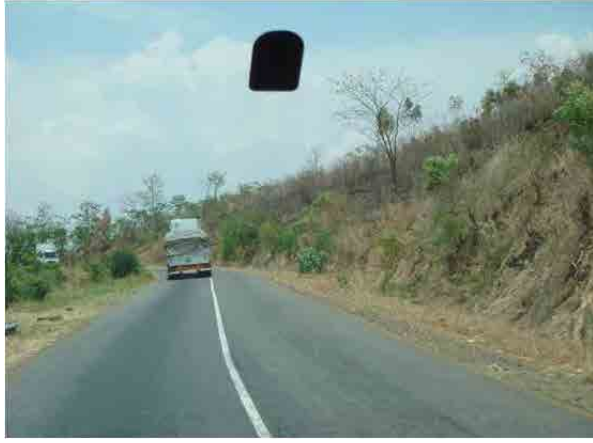
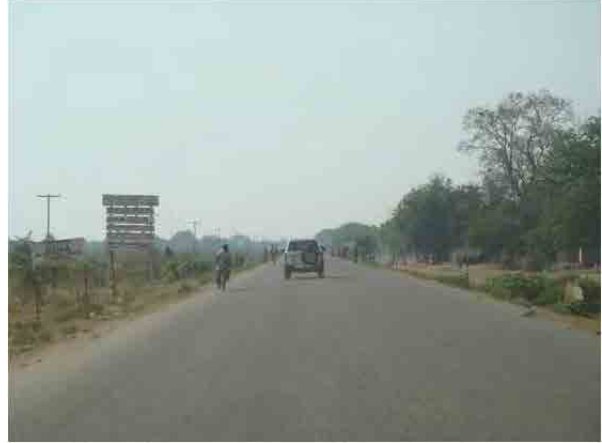
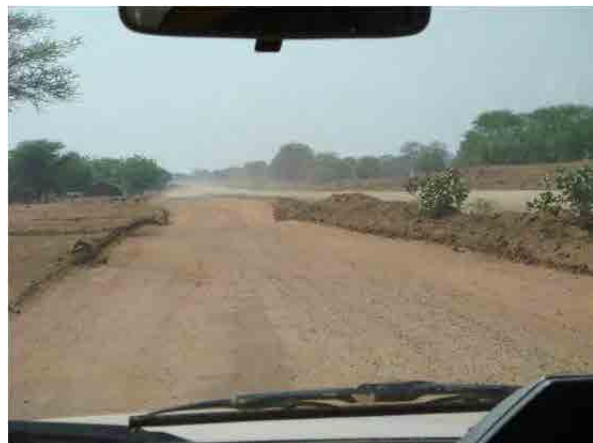
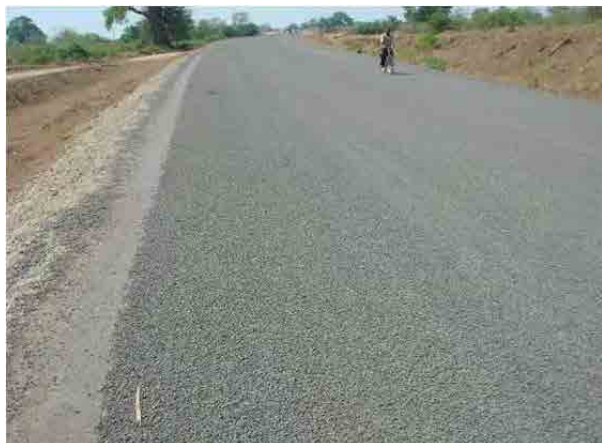
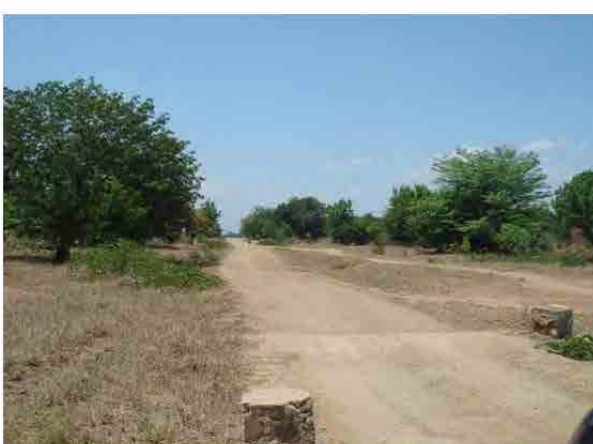
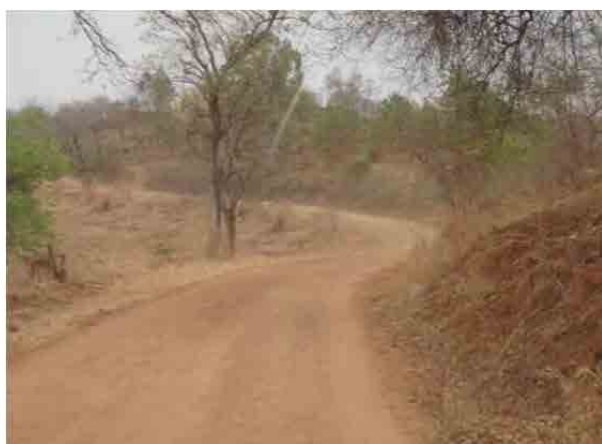
Photos 3-1 Conditions of M1 and S151 in the Dry Season

<p>M1, Blantyre–Chikwawa Paved</p>	<p>M1, Chikwawa–Bangula Paved (under rehabilitation)</p>

<p>M1, Bangula–Nsanje Unpaved (Detour)</p>	<p>M1, Bangula–Nsanje Base Course (Under construction)</p>

<p>M1, Nsanje–Marka Unpaved</p>	<p>S151, Seven–Thyolo Unpaved</p>

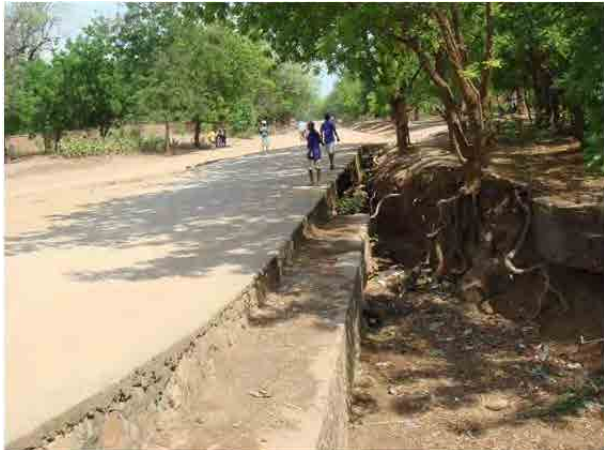
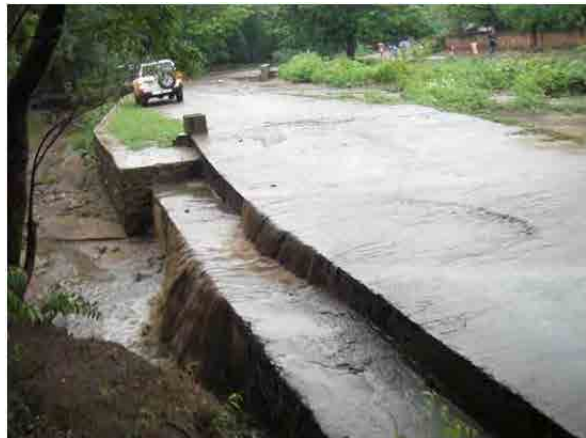
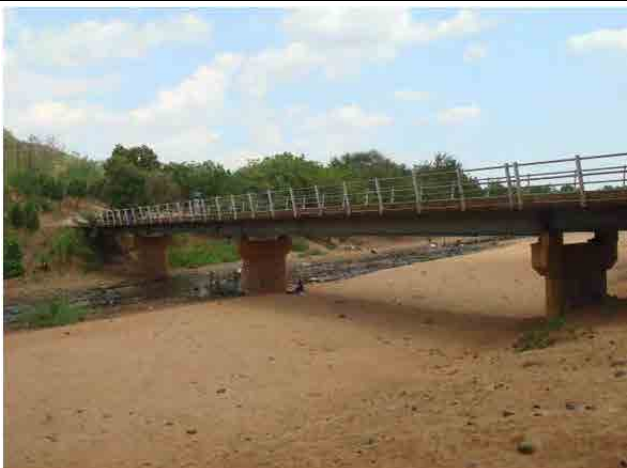
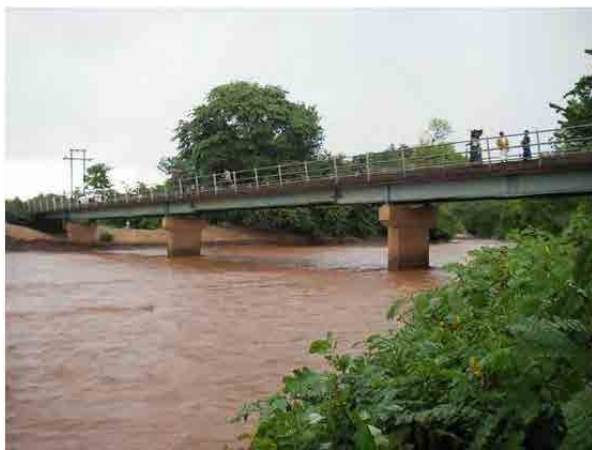
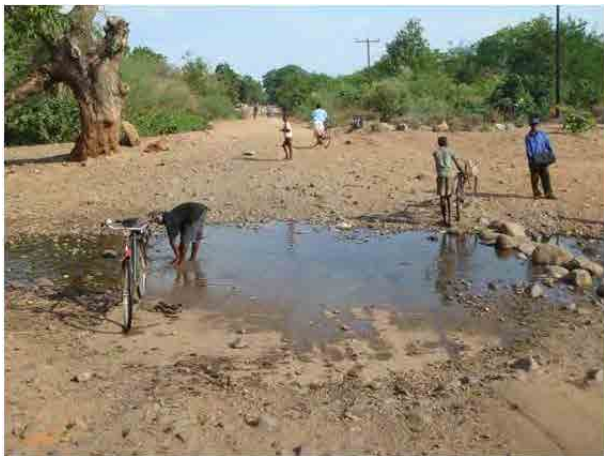
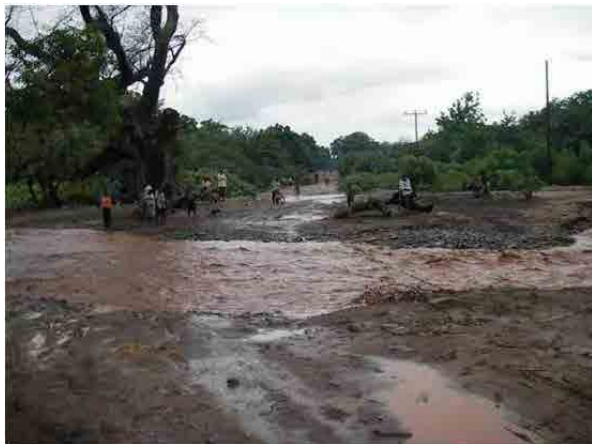
Photos 3-2 Conditions of S152 in the Dry Season and Rainy Season

A photograph showing a dry, sandy riverbed with a concrete curb on the right side. A few people are walking on the path next to the river.

A photograph showing the same riverbed filled with water, with a white vehicle driving on the road above it.
<p>Dry Season, November 2010 Chinolo River (S152)</p>	<p>Rain Season, February 2011 Chinolo River (S152)</p>

A photograph of a bridge over a dry riverbed. The ground is sandy and there is very little water.

A photograph of the same bridge over a river with high, muddy water levels.
<p>Dry Season, November 2010 Thangaozi River (S152)</p>	<p>Rain Season, February 2011 Thangaozi River (S152)</p>

A photograph of a dry riverbed with a small pool of water. A person is standing near the water, and a bicycle is parked nearby.

A photograph of the same riverbed filled with water, with people and bicycles crossing it.
<p>Dry Season, November 2010 Milola River (S152)</p>	<p>Rain Season, February 2011 Milola River (S152)</p>

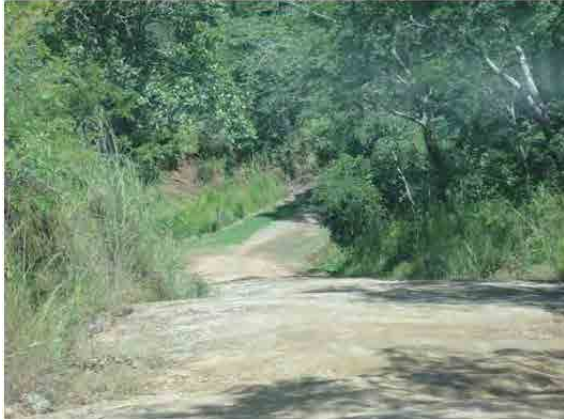
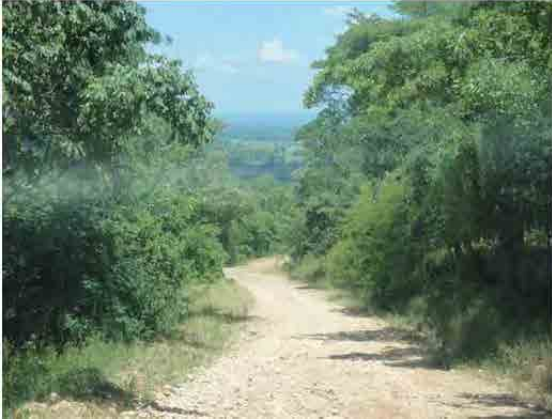
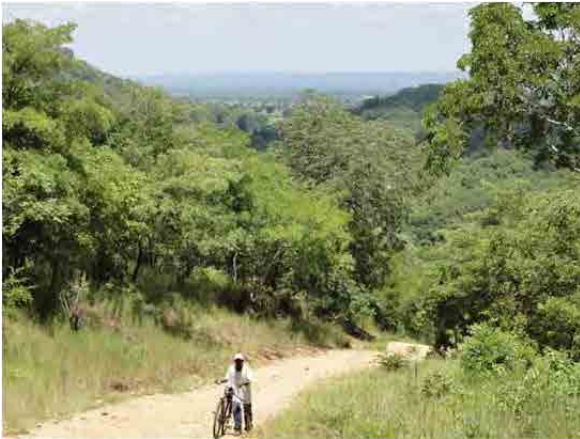
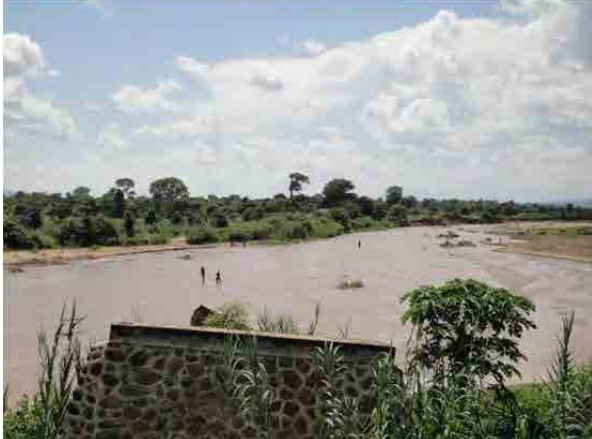
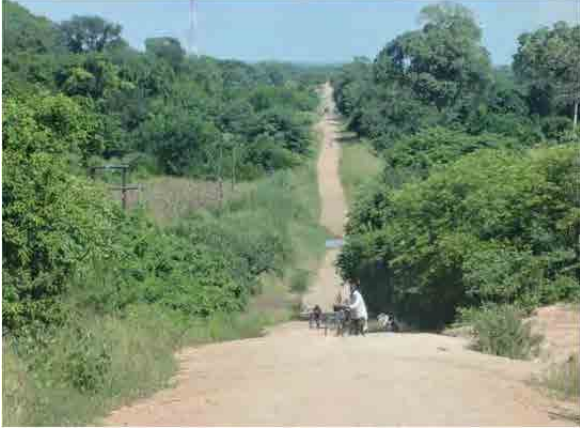
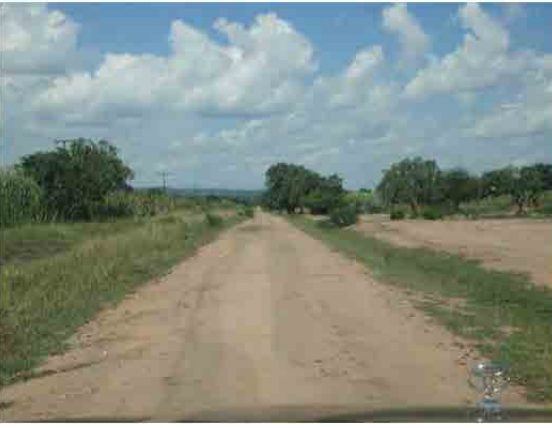
Photos 3-3 Road Conditions of S136

<p>Rift Valley Scalp Zone (1/3) (within 50 km from Mwanza)</p>	<p>Rift Valley Scalp Zone (2/3) (within 50 km from Mwanza)</p>

<p>Rift Valley Scalp Zone (3/3) (within 50 km from Mwanza)</p>	<p>Mwanza River (Washaway section)</p>

<p>Depositional Rift Valley Floor (1/2) (within 50 km from Chikwawa)</p>	<p>Depositional Rift Valley Floor (2/2) (within 50 km from Chikwawa)</p>

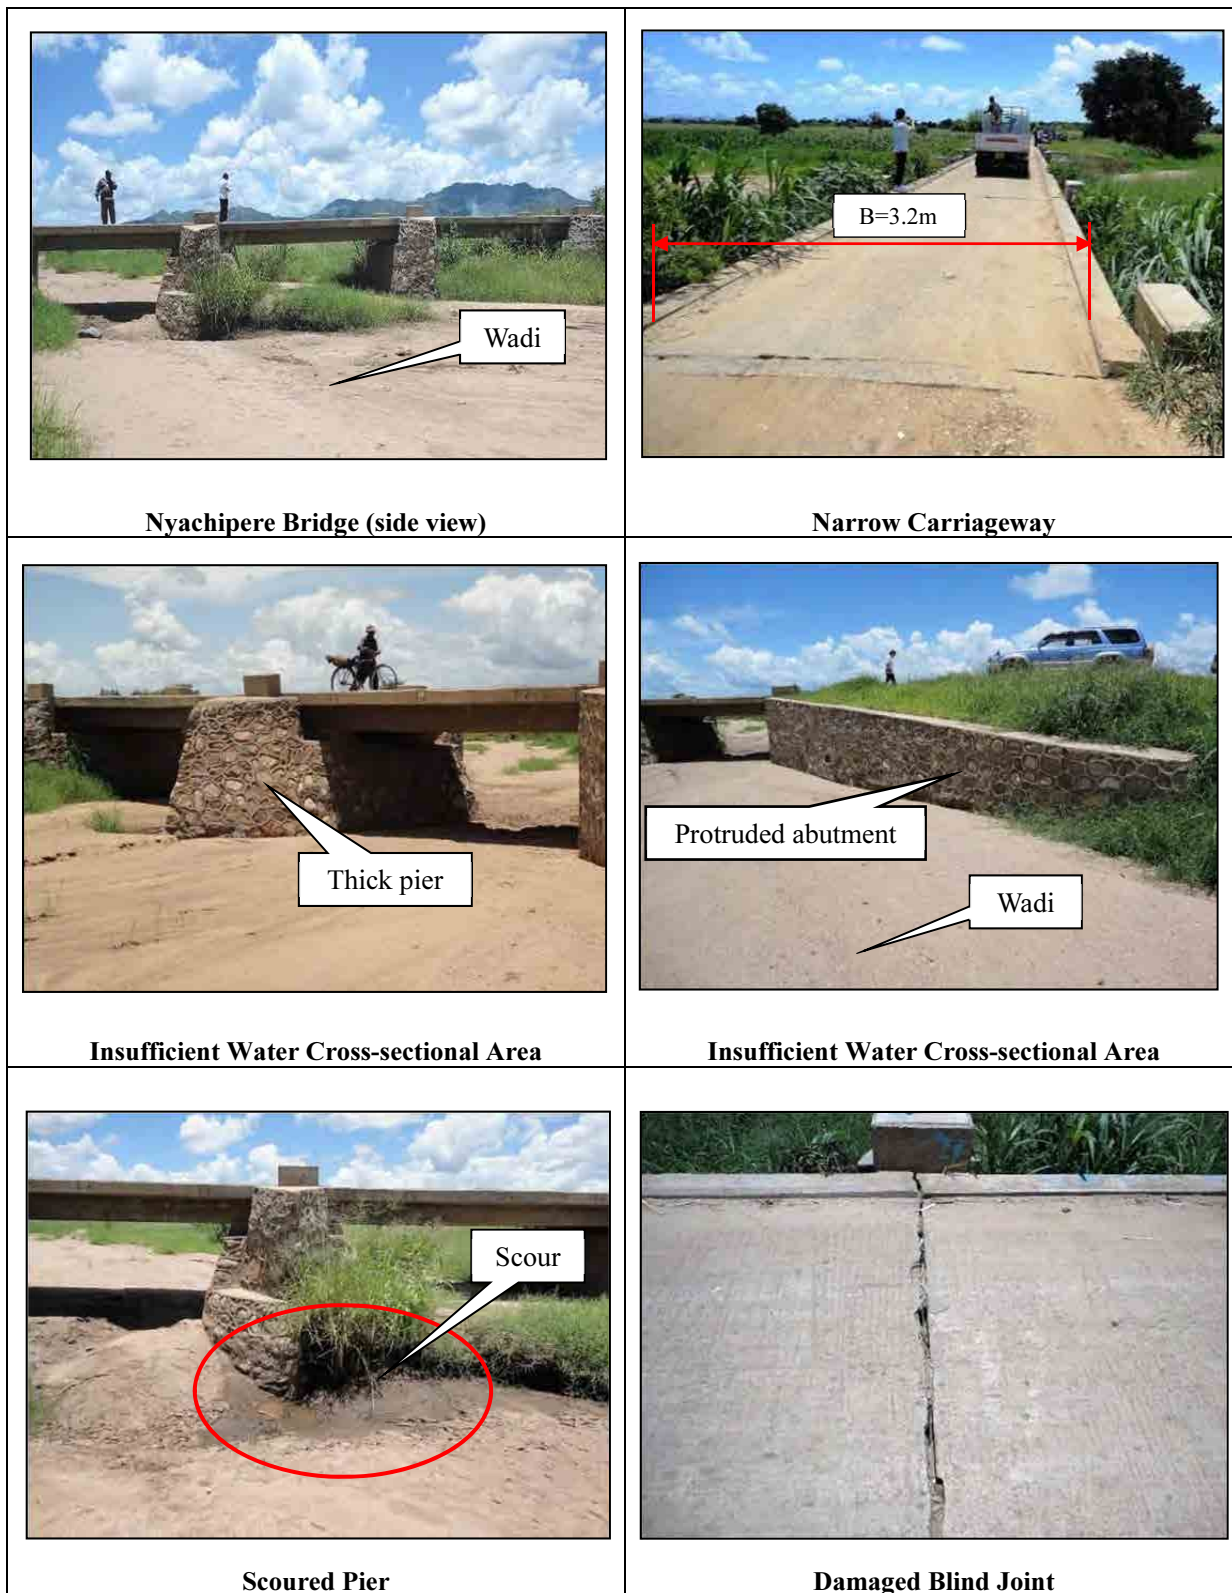
Photos 3-4 Condition of Nyachipere Bridge

Nyachipere Bridge is a 5-span Reinforced Concrete (RC) bridge ($L=5@8.0m=40m$) built over the Nyachipere River. The results of the investigation are as follows:

- 1) The width of carriageway of the bridge is narrow at 3.2 m with single lane.
- 2) Water passing under the bridge is restricted by the number of piers in a small area, causing the river water to go over the bridge during floods in the rainy season.
- 3) The abutments constrict the width of the river causing the water to overflow during floods in the rainy season.
- 4) Because the riverbed is formed by sandy soil, scouring is intense.

- 5) The Nyachipere River dries up in the dry season and is a so-called wadi.
- 6) The blind joint parts have been damaged.
- 7) Since the carriageway is narrow, and the bridge is superannuated, it needs to be rebuilt as follows:
 - Carry out a hydraulic analysis and determine the precise High Water Level (HWL).
 - Decide the longitudinal plan since the planned height of the bridge is likely to be much higher than at present.
 - Determine the bridge length in consideration of the broadening river width.

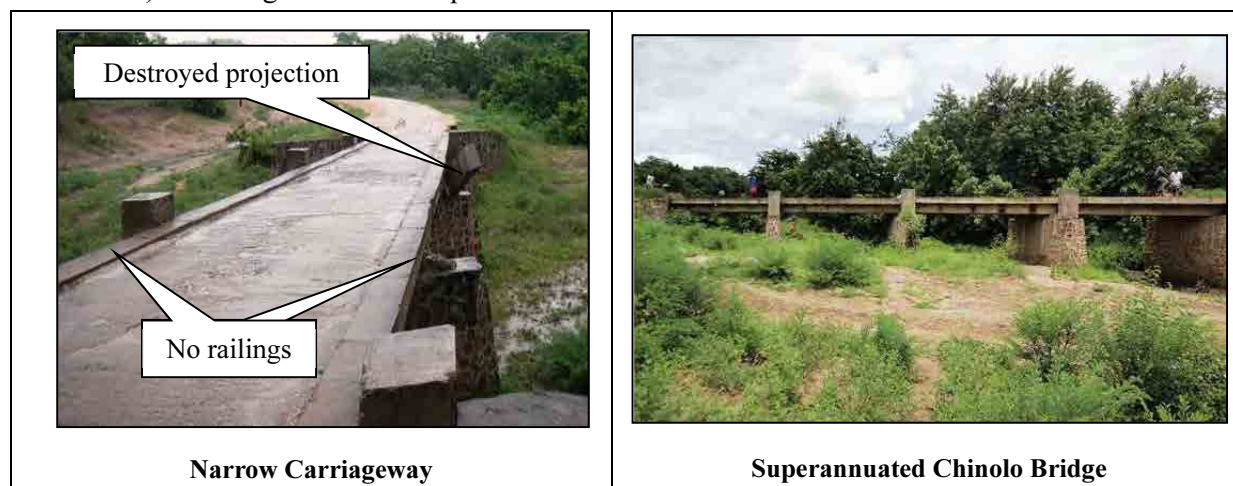
Photos 3-9 Condition of Chinolo Bridge

Chinolo Bridge is a 4-span RC bridge ($4@8.5\text{ m} = 34\text{ m}$) built over the Chidima River. The results of the investigation are as follows:

- 1) The width of the carriageway is narrow at 2.6 m.
- 2) The greater part of the bridge surface pavement has deteriorated and the concrete is bare.
- 3) The projection of the supporting superstructure is broken due to collisions with vehicles.
- 4) Since the bridge has no railing, there is a danger of vehicles falling off the bridge.
- 5) The bridge has an old superstructure and substructures.

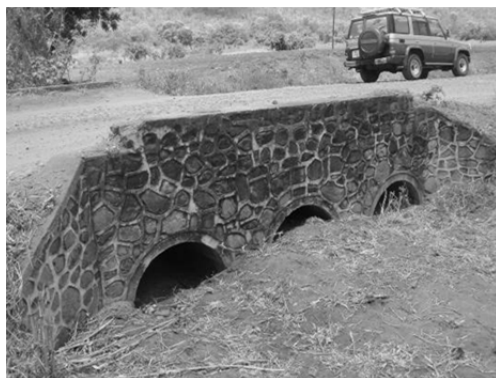
Wiped-out culverts

| 6. Drainage Facilities : | Culvert pipes with 600 or 900 mm in diameter are installed at 92 locations, at every 640 m intervals for the section, out of 11 locations are corrupted or wiped-out. Drifts and vented drifts are installed at 80 locations, at every 740 m intervals for the section, out of 9 locations are corrupted or wiped-out. |

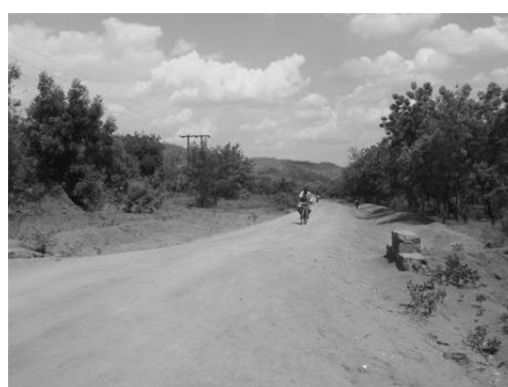
Gullies/ditches on the road sides

7. Condition of Routine Maintenance :
- Poor for cleaning and opening drains
 - Fair for the spot reshaping/ grading of carriageway
 - Good for filling potholes and gullies
 - Poor for repairing drainage structures
 - Fair for cutting grass and shrubs
 - Fair for pruning trees on the road reserve
 - Poor for planting erosion-control vegetation
8. Major Problems of S152-related:
- a) Earth road sections are impassable for several hours or days when wadis become flood in the rainy season.
 - b) All roads are being maintained routinely, however the budget is very small and so repairing of drainage structures and cleaning of drains are inadequate.
