**CHAPTER 7**  
**RESULTS OF NATURAL**  
**CONDITION SURVEYS AND**  
**HYDROLOGICAL ANALYSES**

### 7.1 Results of Natural Condition Surveys

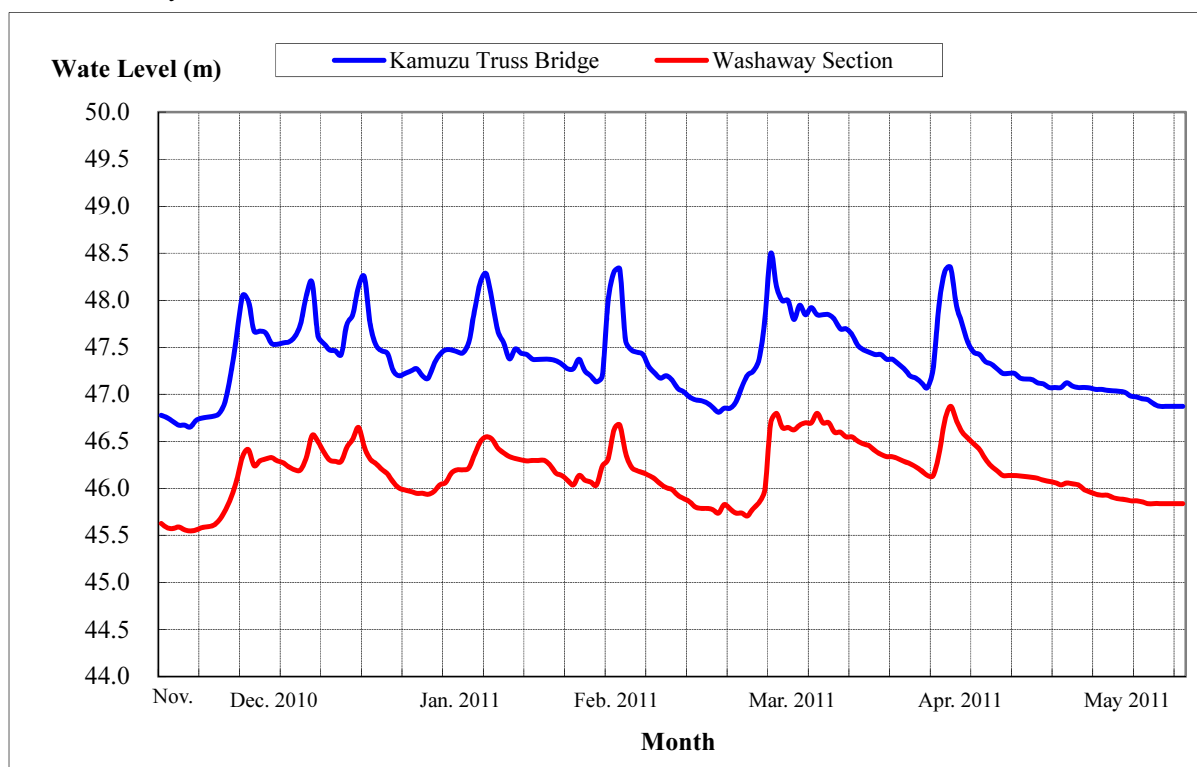
**Figure 7-4 Fluctuation of Water Level at Kamuzu Truss Bridge and the Washaway Section between November 2010 and February 2011**

According to the results of analyses, difference of water levels at the washaway section and Kamuzu Truss Bridge is between 0.9 m and 1.8 m (lower at the washaway section), and the average difference is 1.2 m.

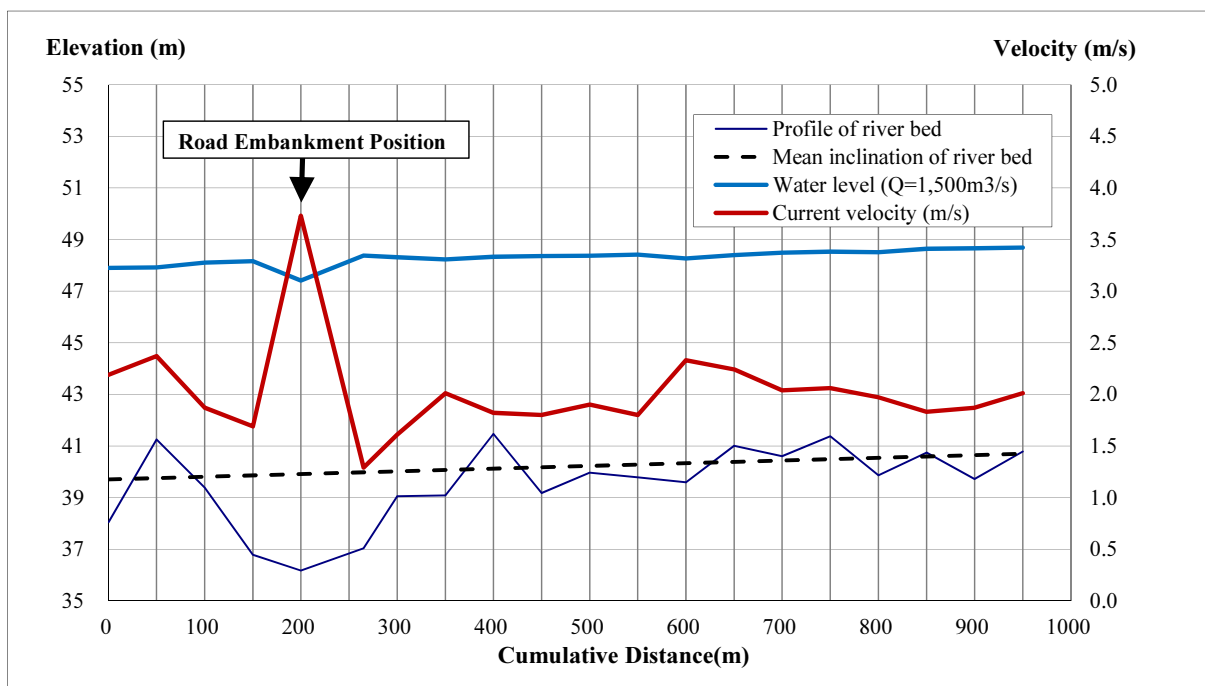
**Figure 7-6 Present Water Level of the New Shire River at the Washaway Section**

Figure 7-6 illustrates the present water level during a flood, the profile of the river bed, the mean inclination of the river bed, and the flow velocity of the New Shire River around the Chiromo washaway section. The water level is estimated for the following conditions:

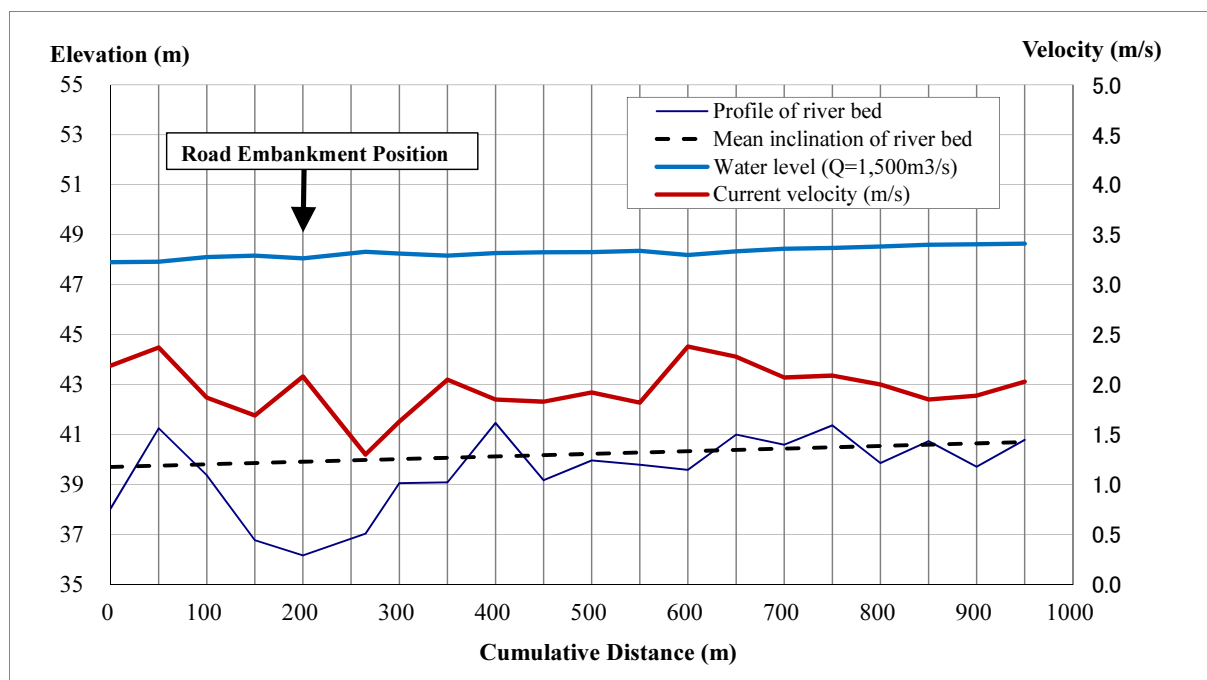
**Figure 7-7 Designed Water Level of the New Shire River at the Chiromo Washaway Section**

The design highest water level at the location of the planned bridge sites ranges from 47.4 m to 48.4 m, as shown in Figure 7-7 and below the maximum HWL of 48.4 m. The water level at the narrowed channel caused by the road embankment is 47.4 m, which is 1.0 m below the designed water level, while the water level at the collapsed railway embankment, just upstream, increases to 48.4 m, 1.0 m higher than the narrowed channel

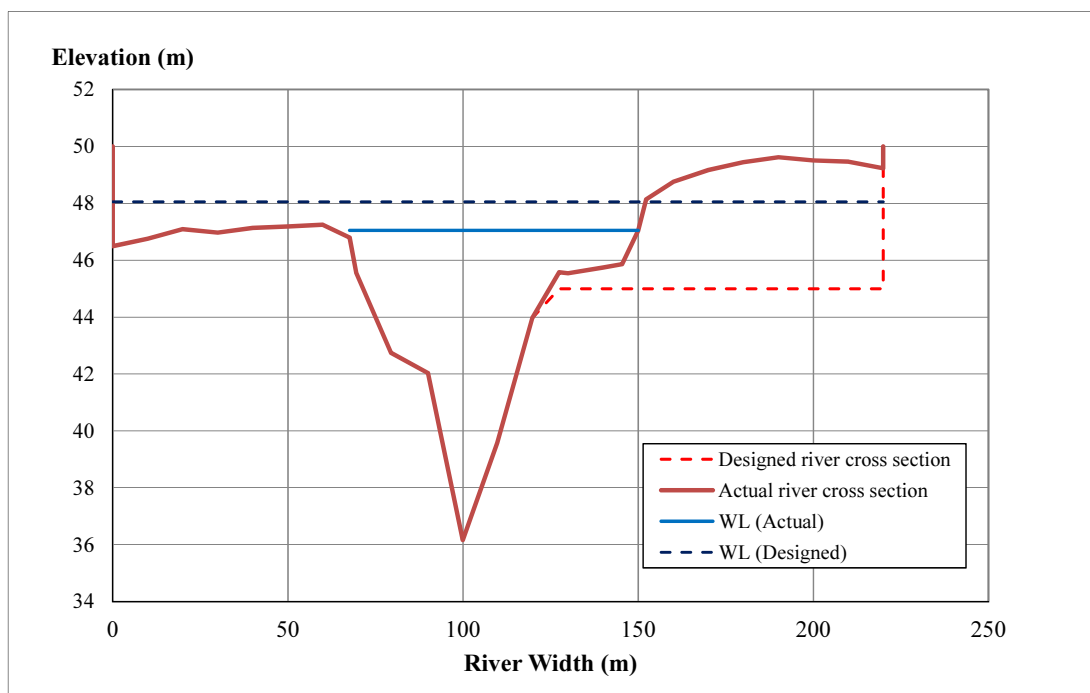
**Figure 7-8 Plan for Improving the River Section at the Narrowed Channel Section**

In this case, it is necessary to protect the excavated river bed by installing gabions (1×2×0.5 m) to protect the whole excavated area. Also, it is necessary to conduct the minimum-scale improvement of the river section in consideration of the condition of the New Shire River, in order to maintain river sections between newly installed abutments and piers of the planned bridges.

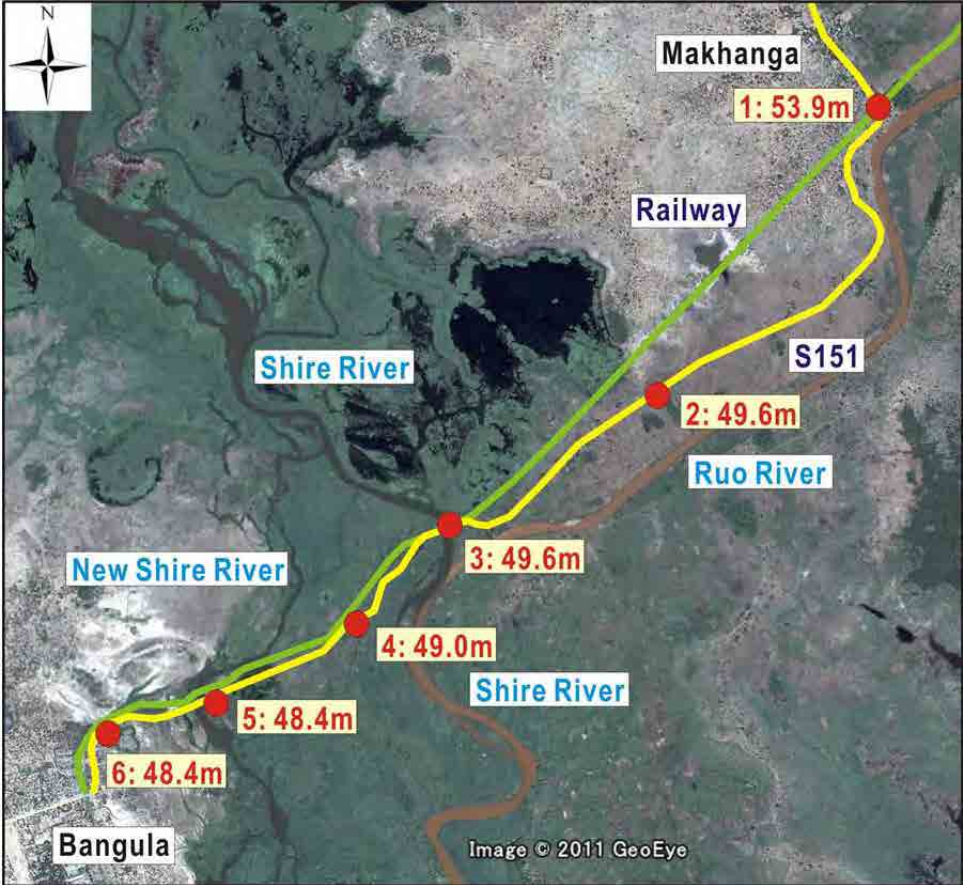
Figure 7-12 Estimated HWL for the Area between Chiromo Washway and the Makhanga

Figure 7-12 shows estimated HWL at six points.

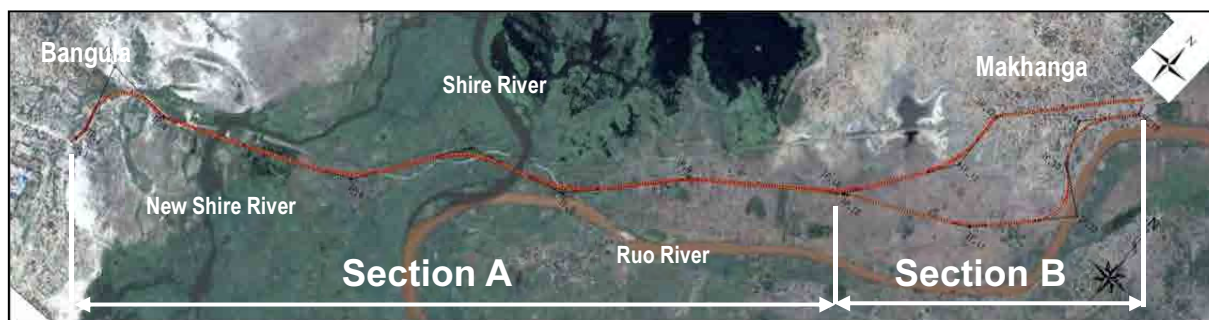
**Figure 8-1 Section Map for the Alignment Plan**

The Study Team selected the proposed road alignment of the project by dividing it into the following two sections (see Figure 8-1).

- Section A: Outside Makhanga Village (L = 6 km) [3 alternatives]
- Section B: In Makhanga Village (L = 3 km) [3 alternatives]

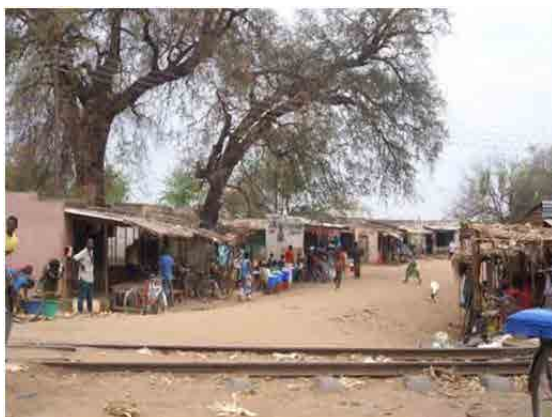
**Photo 8-1 Makhanga Market Area**

- There is a possibility that at least more than 20 houses and shops and 10 huts in the market area around the level crossing with railway could be relocated.(see Photo 8-1)
- There is a possibility that the progressing erosion along the right bank of the Ruo River could influence the S151 road in the future, especially, the section with only 30 m distance between the S151 road and the Ruo River. (see Photo 8-2)

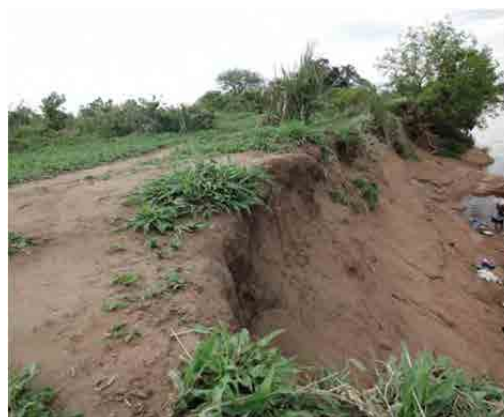
**Photo 8-2 Bank Erosion of the Ruo River**

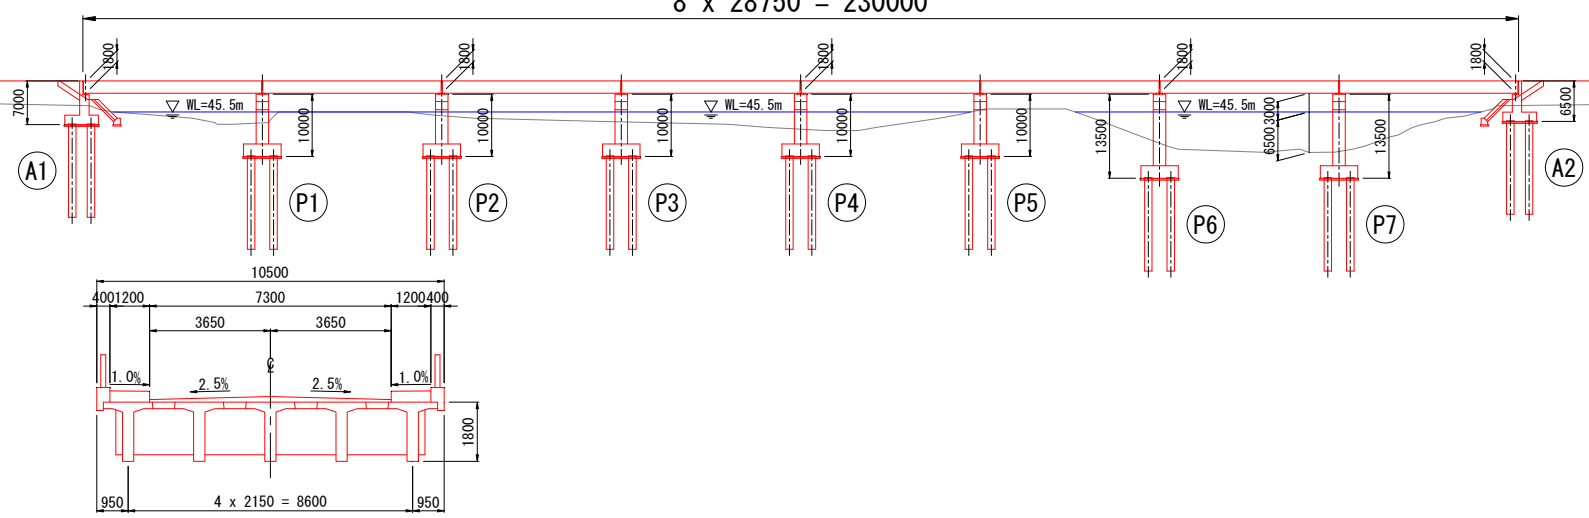
Bridge type	Characteristics	
<p><b>Alternative 1: PC 8-span connected post-tensioned T-girder bridge</b> 8 x 28750 = 230000</p>

Structural features	<ul style="list-style-type: none"> <li>The structure is common for a PC girder type bridge and is adopted in many past constructions.</li> <li>The connected type offers smooth driving performance and earthquake resistance.</li> </ul>
	Construction efficiency	<ul style="list-style-type: none"> <li>Since the New Shire River is five to nine meters deep, it is extremely hard to construct bridge piers in the river.</li> <li>The adoption of an erection girder enables the construction of a superstructure without influence from the river.</li> </ul>
	Maintenance performance	<ul style="list-style-type: none"> <li>Since it is made of concrete, the bridge itself does not require maintenance.</li> <li>Maintenance is required for bridge accessories such as bearings and expansion joints.</li> </ul>

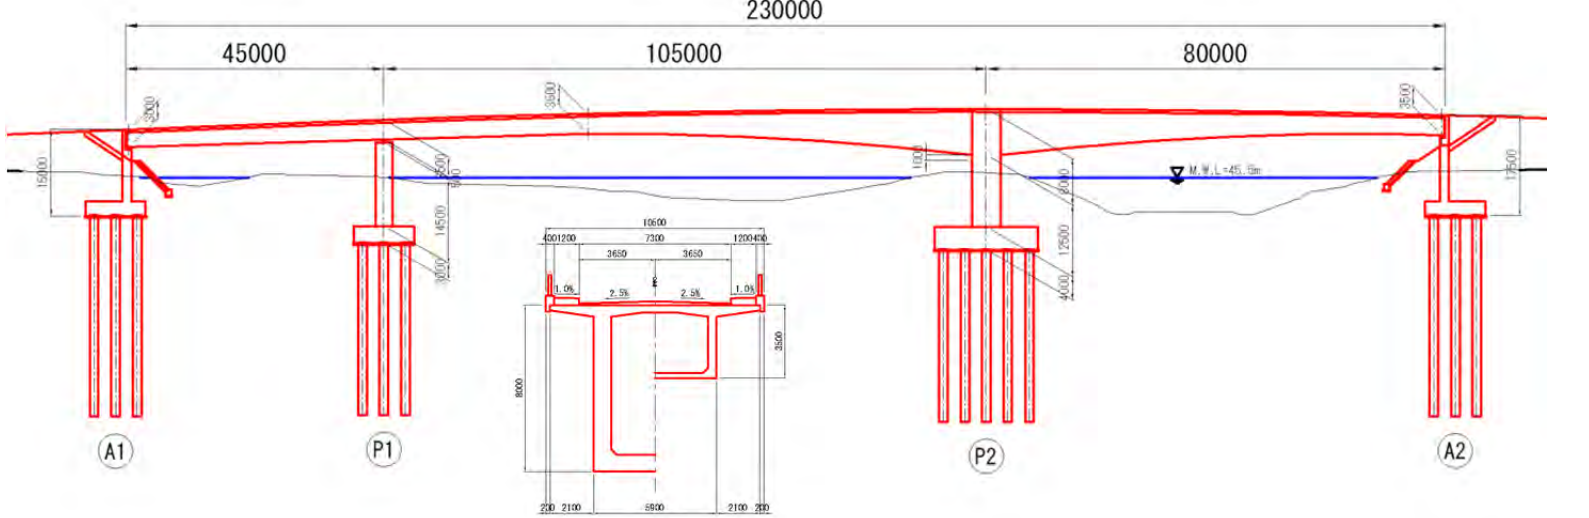
Structural features	<ul style="list-style-type: none"> <li>A PC box-girder bridge type is appropriate for long spans and was adopted in many past constructions.</li> <li>The continuous structure offers smooth driving performance and earthquake resistance.</li> </ul>

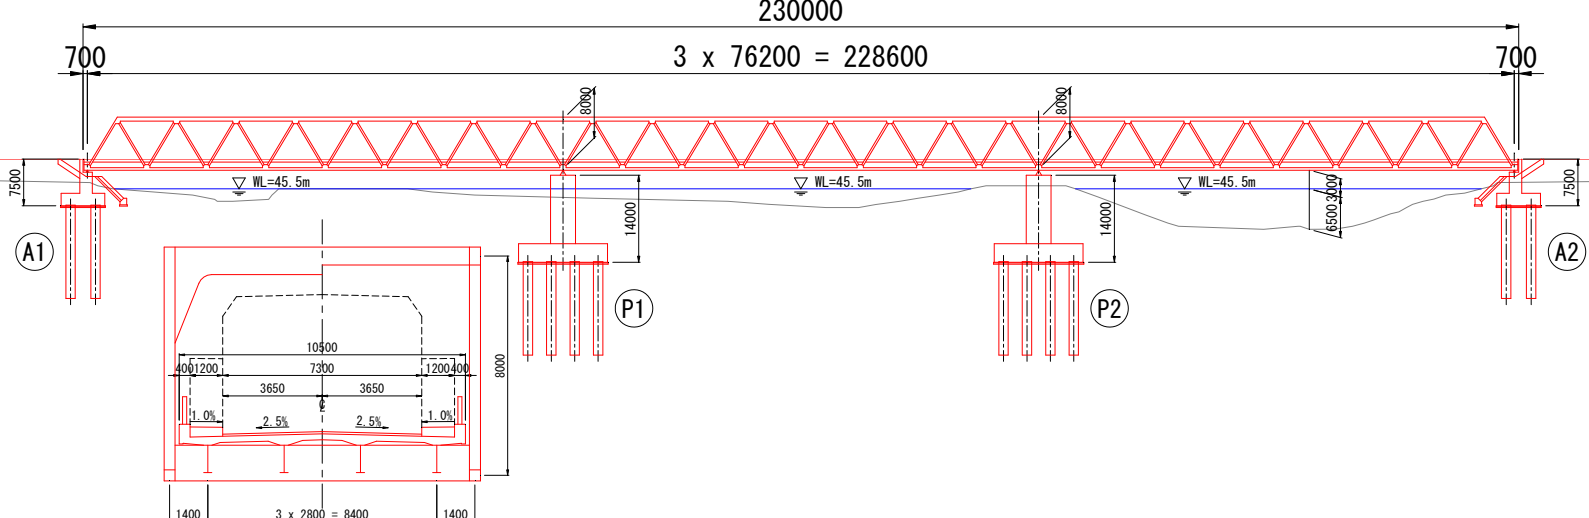
<p><b>Alternative 3: Steel 3-span continuous truss bridge</b> 230000 3 x 76200 = 228600</p>

Structural features	<ul style="list-style-type: none"> <li>A truss bridge is appropriate for long spans and adopted when the adoption of a PC bridge is difficult.</li> <li>The continuous structure offers smooth driving performance and earthquake resistance.</li> </ul>
	Construction efficiency	<ul style="list-style-type: none"> <li>The adoption of the cantilever erection method enables construction of the bridge without influence from the river.</li> <li>The on-site assembly of truss members makes the construction period the shortest.</li> </ul>
	Maintenance performance	<ul style="list-style-type: none"> <li>Being a steel bridge, there is a problem of corrosion and recoating is needed.</li> <li>Maintenance is required for bridge accessories such as bearings and expansion joints.</li> </ul>
	River characteristics	<ul style="list-style-type: none"> <li>Having piers in the river, the bridge has an impact on the river.</li> <li>The reduction of river cross-section is below the standard value of 5%.</li> </ul>

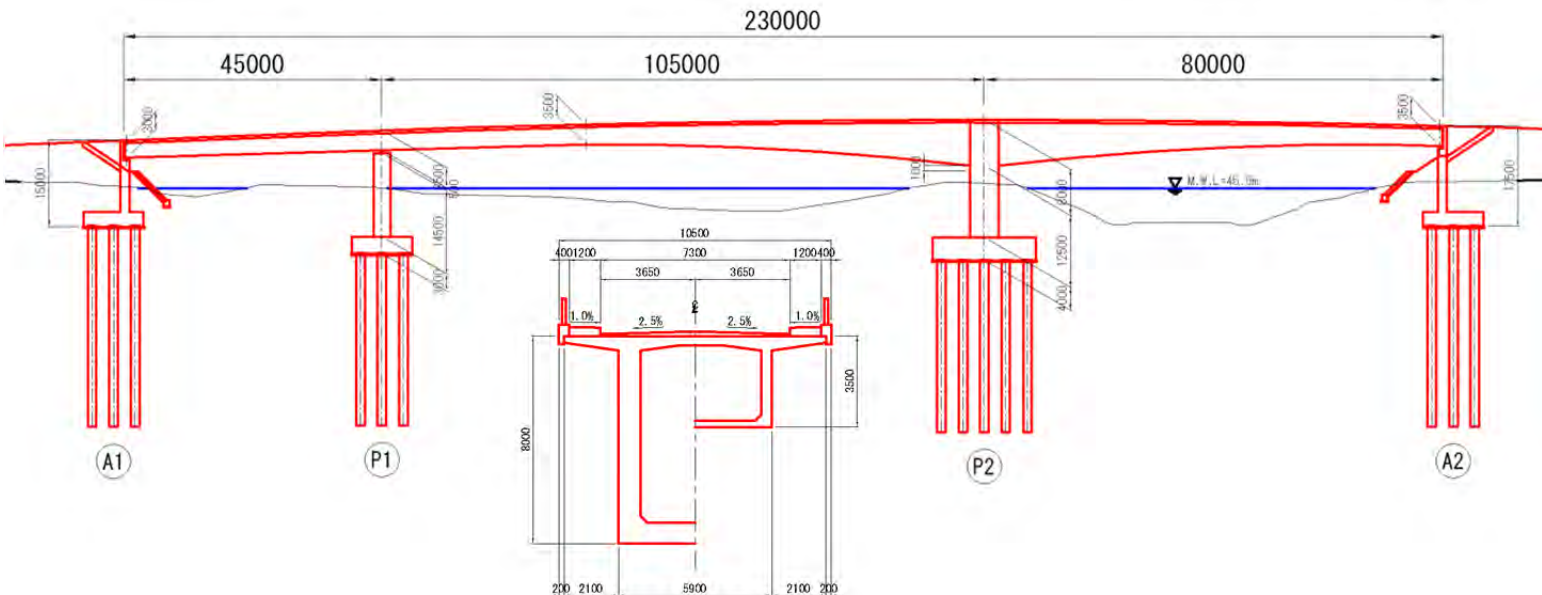
Bridge type	Characteristics	
<p><b>Alternative 1: PC 3-span continuous box-girder bridge</b></p>

Structural features	The continuous structure offers smooth driving performance, earthquake resistance, and maintenance performance.
Girder height	• With the maximum span length of 105 m, the girder height is as high as 8.0 m.	
Abutment height	• The high girders make the A1 and A2 abutments as high as 15 m and 17.5 m, respectively.	
Embankment height	• The high abutments make the embankments of the A1 and A2 abutments as high as 8.1 m and 9.7 m, respectively.	
Cost efficiency	<ul style="list-style-type: none"> <li>• Although the cost for the superstructure is lower than in Alternative 2, the cost for the substructure is considerably high. The overall construction cost is higher than that of Alternative 2.</li> <li>• Ratio of overall construction cost: 1.24</li> </ul>	
Overall evaluation	<ul style="list-style-type: none"> <li>• The high girders make the abutments and embankments very high.</li> <li>• Although the cost for the superstructure is lower than in Alternative 2, the cost for the substructure is considerably high. The overall construction cost is higher than that of Alternative 2. This alternative has an inferior cost efficiency compared to Alternative 2.</li> </ul>

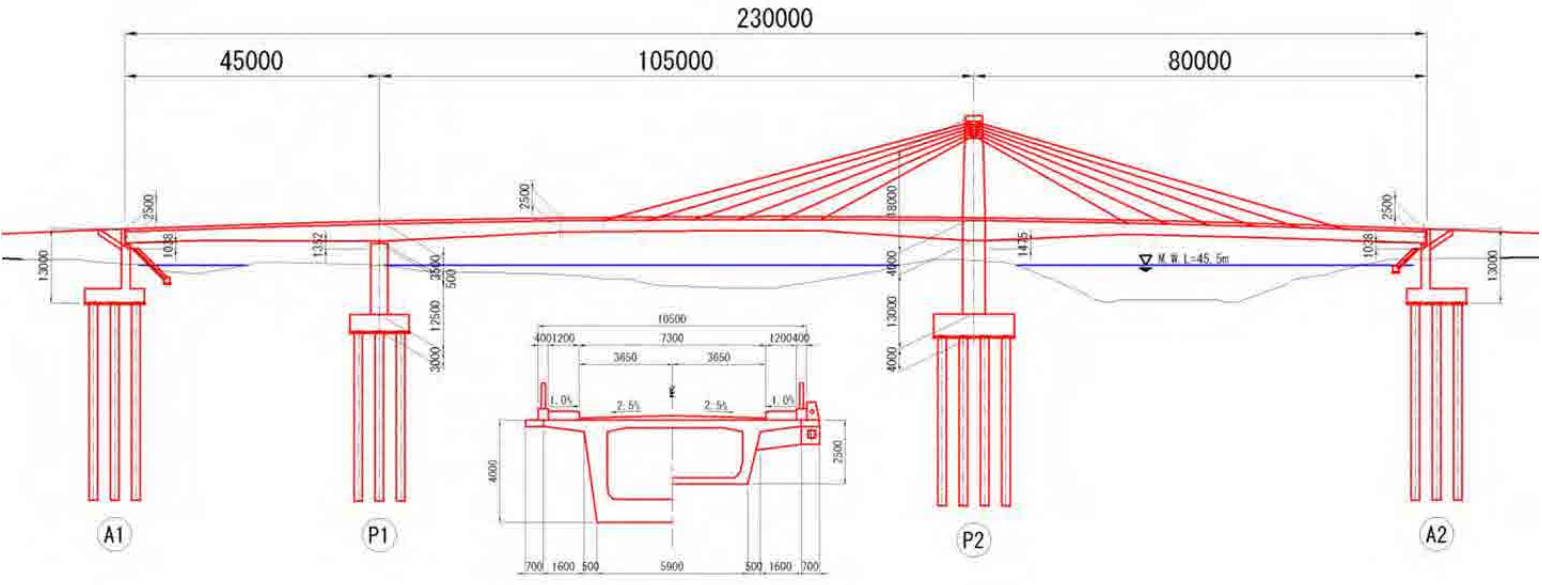
<p><b>Alternative 2: Extradosed bridge</b></p>

Structural features	<ul style="list-style-type: none"> <li>• The Extradosed type, more appropriate for long spans than Alternative 1 (PC box-girder type), is often used for the span lengths of 100 m to 200 m and was adopted in many past constructions.</li> <li>• The continuous structure offers smooth driving performance, earthquake resistance, and maintenance performance.</li> </ul>
Girder height	• Since the girder height can be kept low with this bridge type, the maximum girder height of this bridge is 4 m, half the girder height of Alternative 1.	
Abutment height	• The low girders make both the A1 and A2 abutments 13 m high, considerably lower than those in Alternative 1.	
Embankment height	• The low abutments make the embankments of the A1 and A2 abutments as low as 6.1 m and 5.3 m, respectively, considerably lower than those in Alternative 1.

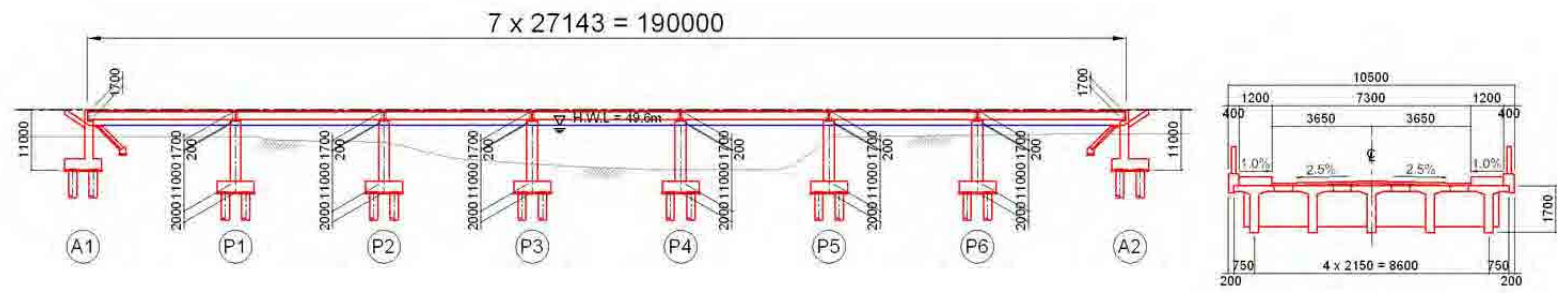
Bridge type	Characteristics	
<p><b>Alternative 1: PC 7-span connected post-tensioned T-girder bridge</b></p>

<p>Structural features</p> <ul style="list-style-type: none"> <li>A common PC girder bridge that was adopted in many past constructions.</li> <li>The connected type offers superior traveling performance and earthquake resistance.</li> </ul> <p>Construction efficiency</p> <ul style="list-style-type: none"> <li>The new Shire River is five to eight meters deep, making it very difficult to construct bridge piers in the river.</li> <li>The adoption of an erection girder enables the construction of the superstructure without influence from the river.</li> </ul> <p>Maintenance performance</p> <ul style="list-style-type: none"> <li>Since this is a concrete bridge, basically no maintenance is needed.</li> <li>Maintenance is needed for bridge accessories such as bearings and expansion joints.</li> </ul> <p>River characteristics</p> <ul style="list-style-type: none"> <li>Having bridge piers in the river, the bridge has the highest impact on the river.</li> <li>The reduction of river cross-section exceeds 6% (standard value: 5%).</li> </ul> <p>Cost efficiency</p> <ul style="list-style-type: none"> <li>The cost of this bridge type becomes somewhat higher than the alternative 2. (Construction cost ratio: 1.01)</li> </ul> <p>Overall evaluation</p> <ul style="list-style-type: none"> <li>The construction of bridge piers in the river is very difficult due to water depth.</li> <li>Despite high cost efficiency and maintenance performance, this bridge type had better not be adopted due river cross-section reduction exceeding the standard value.</li> </ul>	<p>△</p>

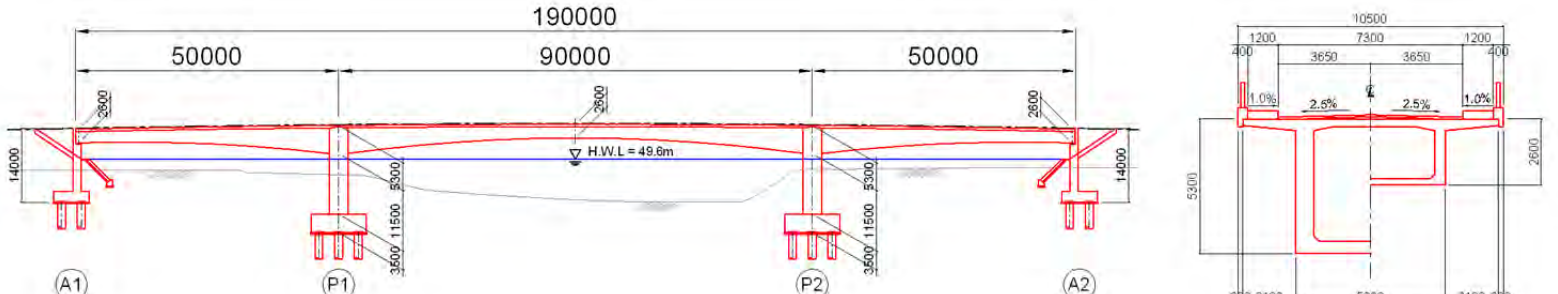
<p><b>Alternative 2: PC 3-span continuous box-girder bridge</b></p>

<p>Structural features</p> <ul style="list-style-type: none"> <li>A PC box-girder bridge type appropriate for long spans and adopted in many past constructions.</li> <li>The continuous structure offers superior traveling performance and earthquake resistance.</li> </ul> <p>Construction efficiency</p> <ul style="list-style-type: none"> <li>The construction of bridge piers is easy as they are constructed on river terrace.</li> <li>The adoption of the Dywidag method enables the construction of the superstructure without influence from the river.</li> </ul> <p>Maintenance performance</p> <ul style="list-style-type: none"> <li>Since this is a concrete bridge, basically no maintenance is needed.</li> <li>Maintenance is needed for bridge accessories such as bearings and expansion joints.</li> </ul> <p>River characteristics</p> <ul style="list-style-type: none"> <li>The river cross-section reduction is 4.2%, which is below the standard upper limit.</li> </ul> <p>Cost efficiency</p> <ul style="list-style-type: none"> <li>This bridge type is the most economic. (Construction cost ratio: 1.00)</li> </ul> <p>Overall evaluation</p> <ul style="list-style-type: none"> <li>The cost efficiency of this bridge type is the highest.</li> <li>The reduction of river cross-section is below the standard value.</li> <li>This bridge type is the most desirable alternative in overall evaluation because of cost efficiency, construction efficiency, and river characteristics.</li> </ul>	<p>○</p>

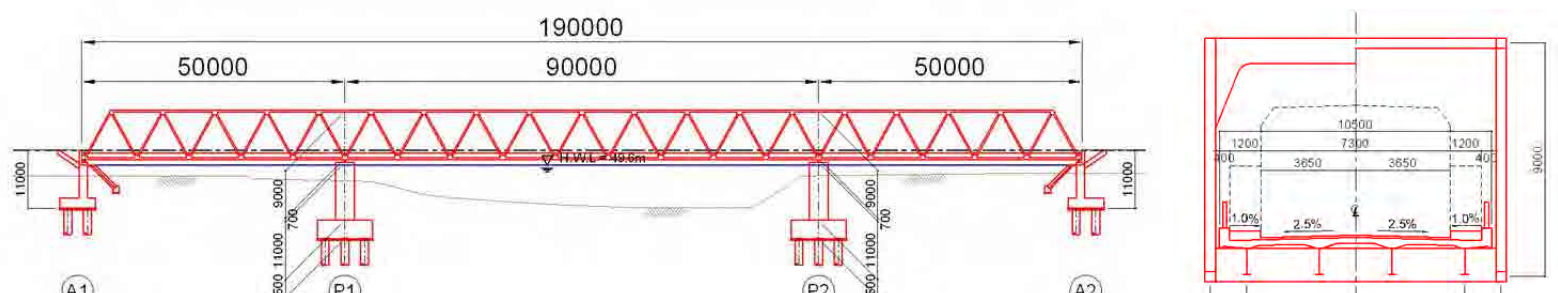
<p><b>Alternative 3: Steel 3-span continuous truss bridge</b></p>

<p>Structural features</p> <ul style="list-style-type: none"> <li>This bridge type is appropriate for long spans and is adopted when a PC bridge is difficult to implement.</li> <li>The continuous structure offers superior traveling performance and earthquake resistance.</li> </ul> <p>Construction efficiency</p> <ul style="list-style-type: none"> <li>The adoption of the cantilever erection method enables the construction of the bridge without influence from the river.</li> <li>The on-site assembly of truss members makes the construction period the shortest.</li> </ul> <p>Maintenance performance</p> <ul style="list-style-type: none"> <li>Being a steel bridge, there is a problem of corrosion and recoating is needed.</li> <li>Maintenance is needed for bridge accessories such as bearings and expansion joints.</li> </ul> <p>River characteristics</p> <ul style="list-style-type: none"> <li>The river cross-section reduction is 4.2%, which is below the standard upper limit.</li> </ul> <p>Cost efficiency</p> <ul style="list-style-type: none"> <li>Being a steel bridge, both the construction and maintenance costs are high, and the cost efficiency is the lowest. (Construction cost ratio: 1.16)</li> </ul> <p>Overall evaluation</p> <ul style="list-style-type: none"> <li>Being a steel bridge, the maintenance cost is the highest.</li> <li>Although this is a bridge type appropriate for long spans, the cost efficiency is the lowest because it is a steel bridge.</li> </ul>	<p>×</p>
